NATIONAL TRANSPORTATION SAFETY BOARD
Office of Aviation Safety
Washington, D.C. 20594

Computed Tomography Specialist's Factual Report

DCA-15-MA-019

Operator: Scaled Composites, LLC
Location: near Koehn Dry Lake, CA
Date: October 31, 2014
Time: 1007 Pacific Daylight Time
Vehicle: Scaled Composites SpaceShipTwo reusable suborbital rocket, N339SS

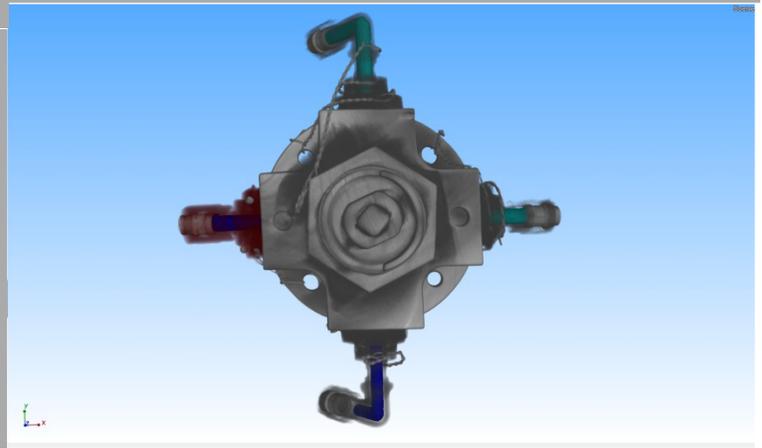
3. Port 3 was found to be open to port 4;
4. The valve lock tube was found to be installed in port 4.

Figure 1
Feather lock actuation valve – Overall cross section

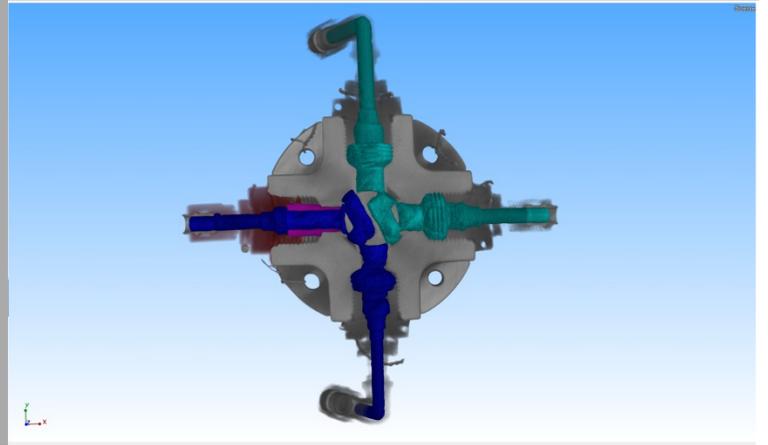
1. The valve ball was found to be in a position where none of the openings were completely aligned with the valve ports;
2. Port 1 was found to be open to port 2;

Figure 2
Feather lock actuation valve – Overall cross section through valve ball

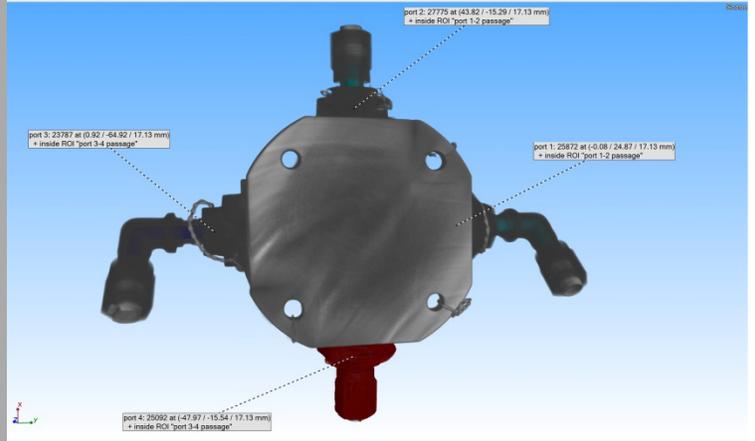
Figure 3
Feather lock actuation valve – View from mounting plate side showing port identification

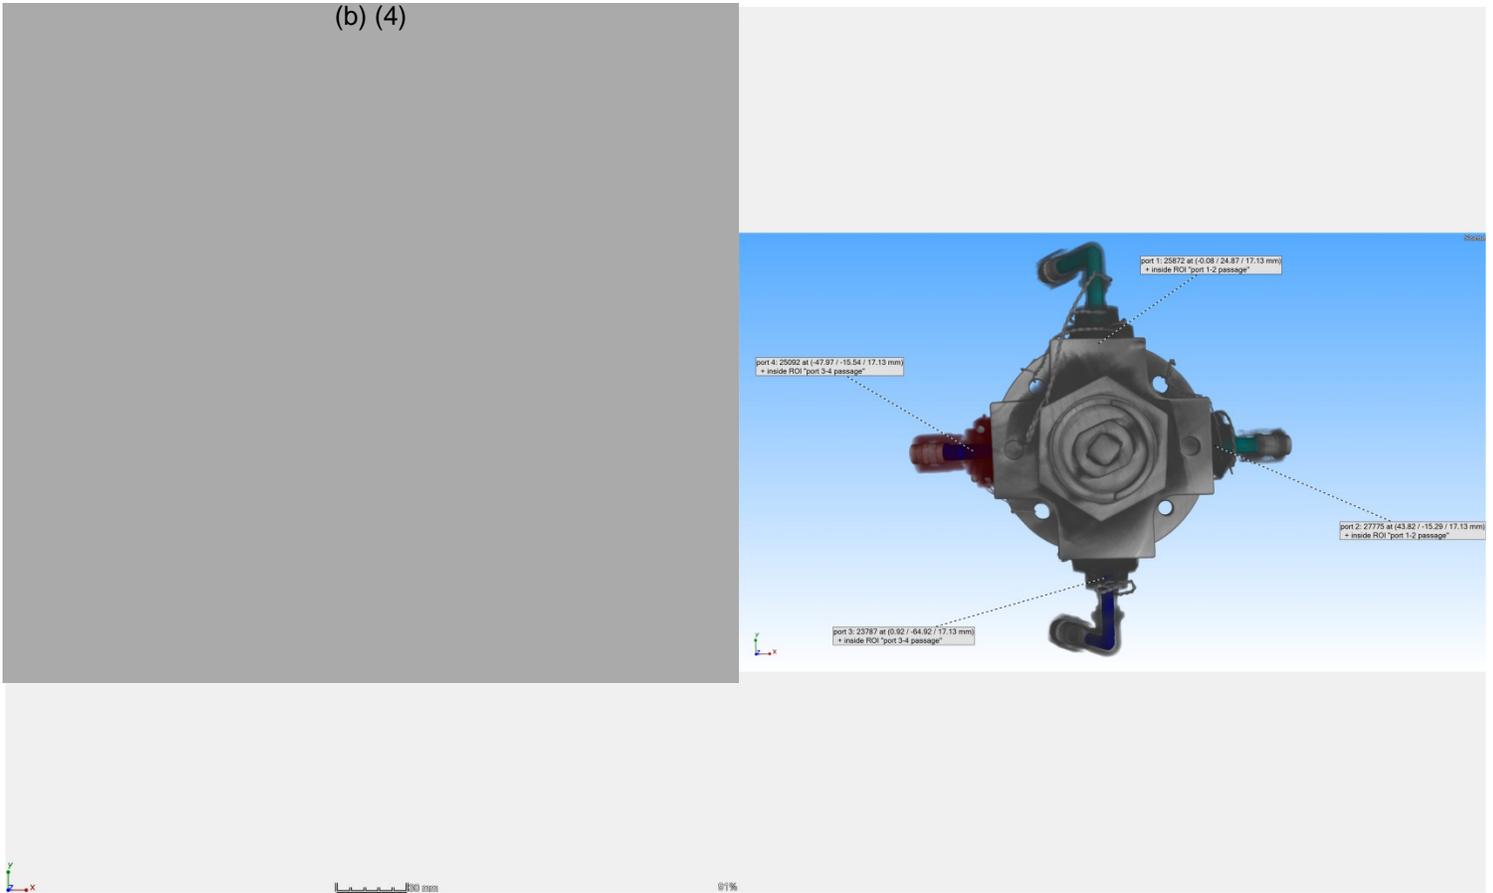
Figure 4
Feather lock actuation valve – View from shaft side showing port identifications

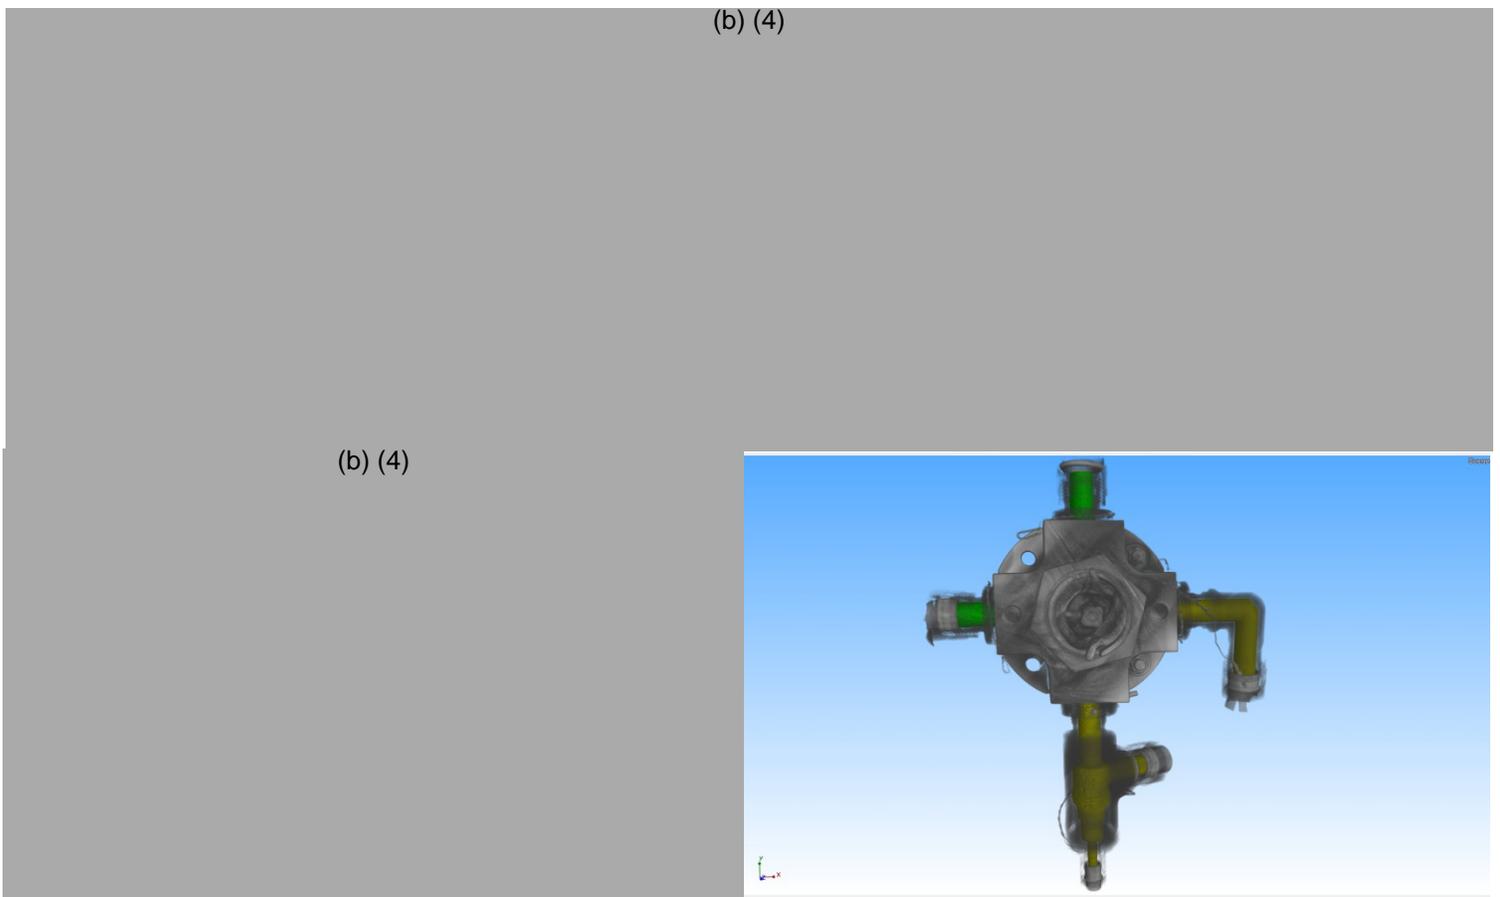
Figure 5
Right hand feather valve – Overall cross section

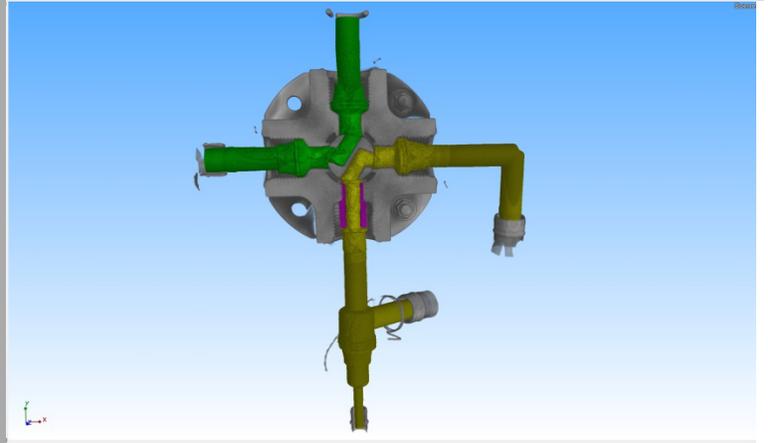
1. The valve ball was found to be in a position where the openings were almost fully aligned with the valve ports;
2. Port 1 was found to be open to port 4;
3. Port 2 was found to be open to port 3;
4. The valve lock tube was found to be installed in port 3.

Figure 6
Right hand feather valve – Overall cross section through valve ball

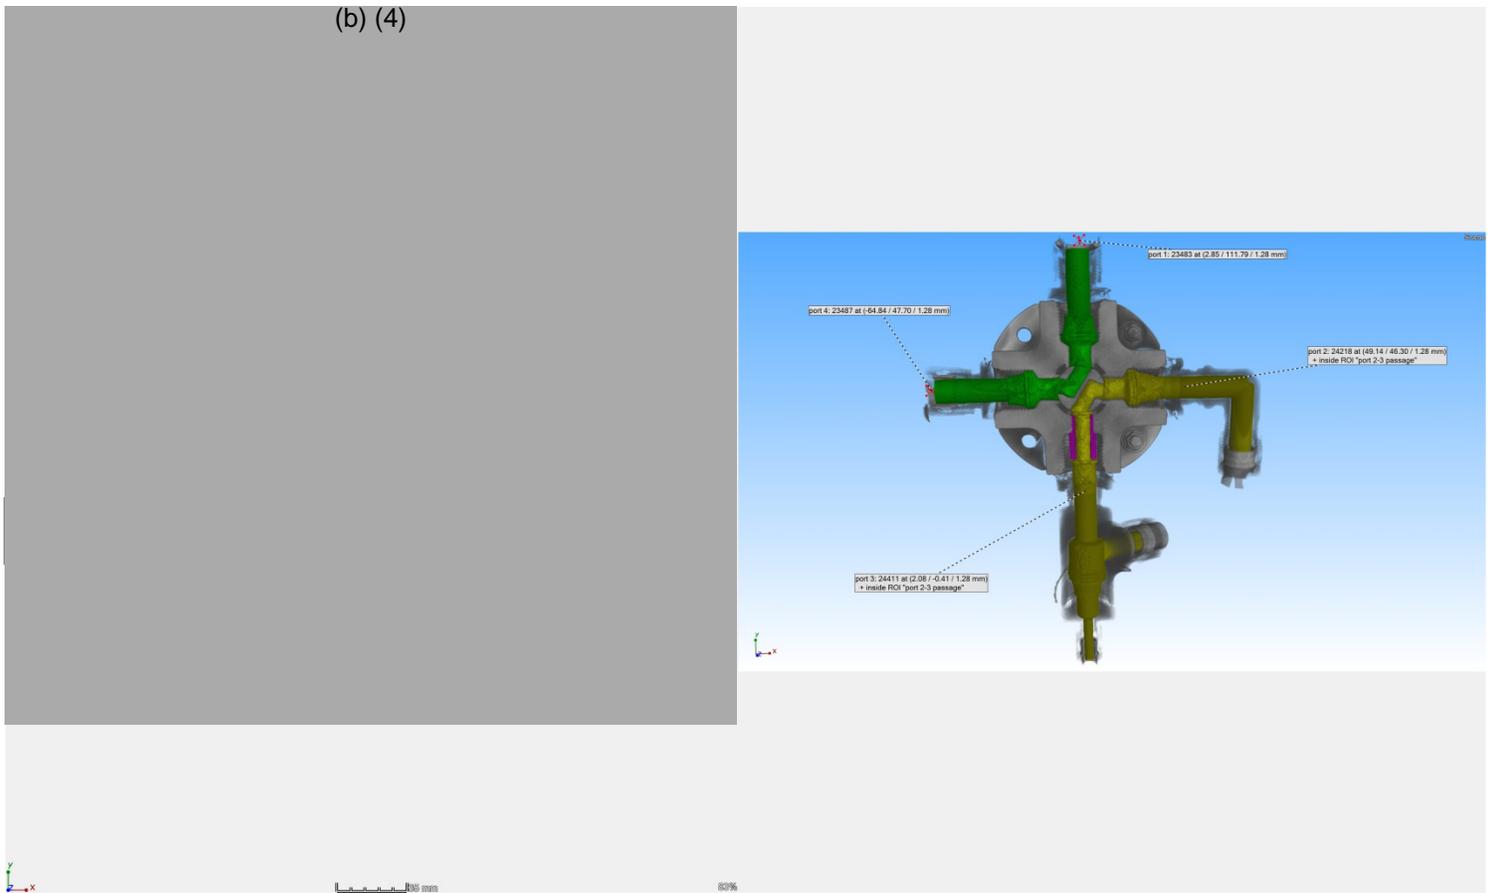
Figure 7
Right hand feather valve – View from shaft side showing port identifications

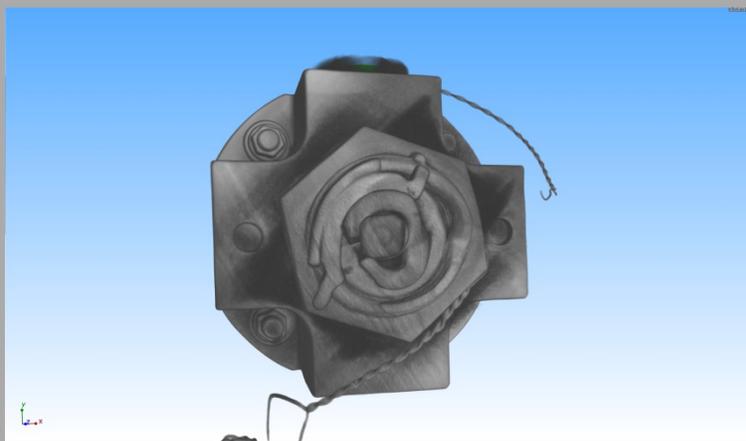
Figure 8
Left hand feather valve – Overall cross section

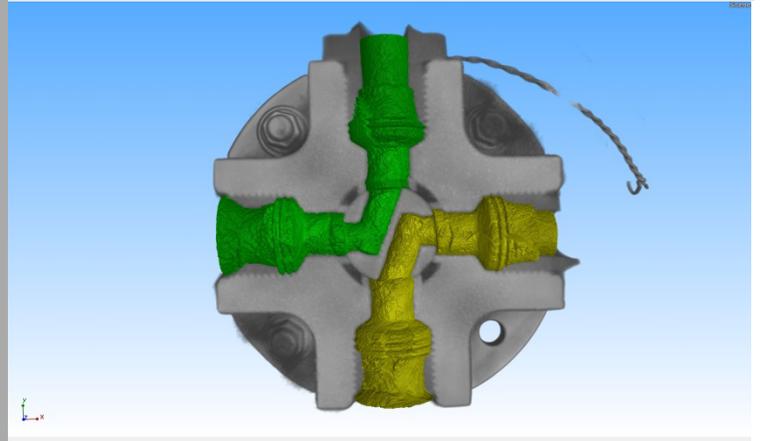
Figure 9

1. The valve ball was found to be in a position where the openings were aligned with the valve ports;
2. The valve shaft was bent in a direction towards port 4;
3. Port 1 was found to be open to port 4;
4. Port 2 was found to be open to port 3;
5. The valve body contained stamped impressions with the symbols “X” (located in two different locations on the valve body), “U”, “D”, and “S”;
6. The valve lock tube was not present within the valve as recovered;
7. The ball valve packing materials were misaligned in some locations around the valve.

Left hand feather valve – Overall cross section through valve ball

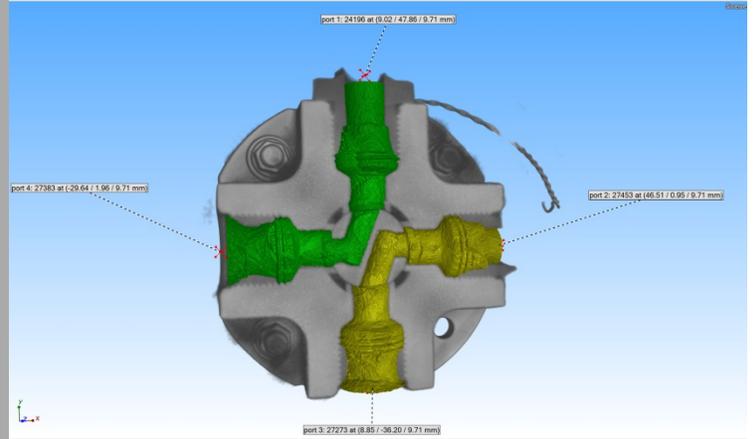
Figure 11
Left hand feather valve – View from shaft side showing port identifications

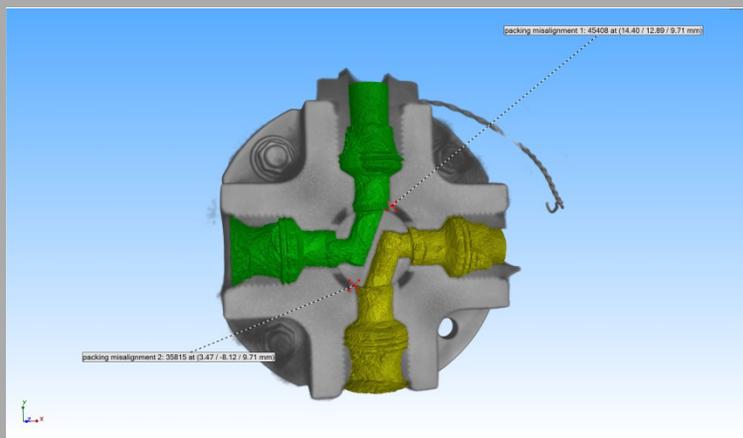
Figure 12
Left hand feather valve – View from shaft side showing packing misalignment

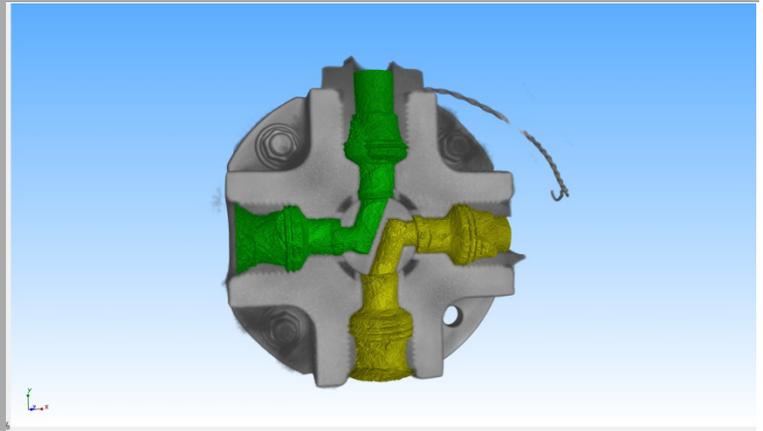
Figure 13

Left hand feather valve – View from shaft side showing packing misalignments without indicators

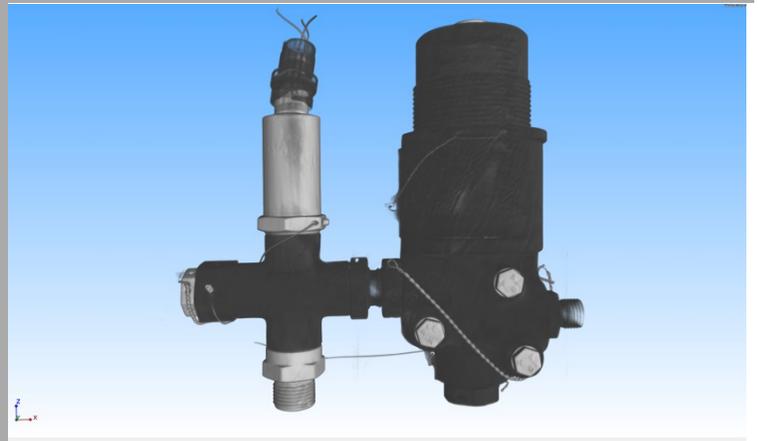
Figure 14
Left hand pressure regulator – Overall cross section through regulator section

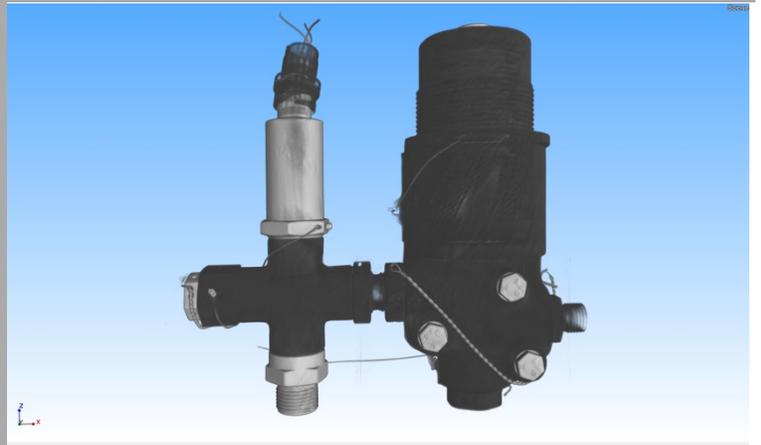
Figure 15
Left hand pressure regulator – Overall cross section through pressure transducer

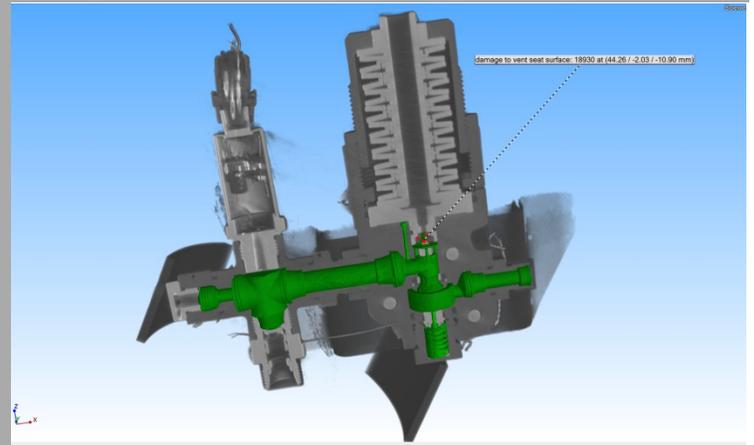
Figure 18

1. No obstructions were noted within the regulator flow path;
2. The burst disc at the cap end of the regulator was present and intact;
3. There was an indication of an anomaly present in the area of the vent seat. The nature of the anomaly (i.e. damage or debris/particles) could not be determined;
4. The check valve on the outlet port of the regulator was present.

Left hand pressure regulator – Overall cross section showing an anomaly in the vent seat area

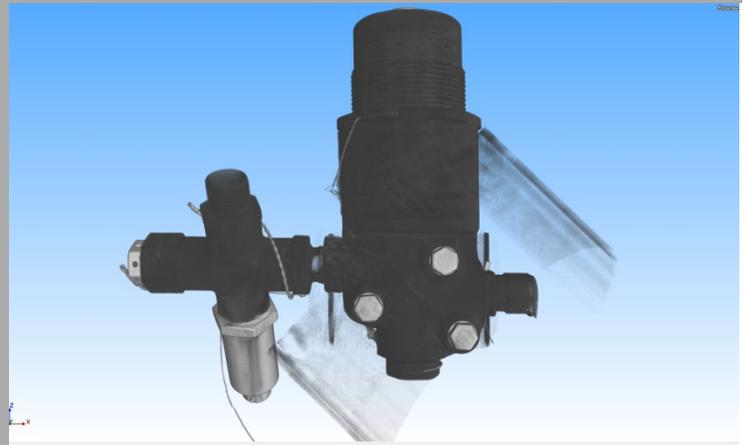
Figure 21
Right hand pressure regulator – Overall cross section through regulator section

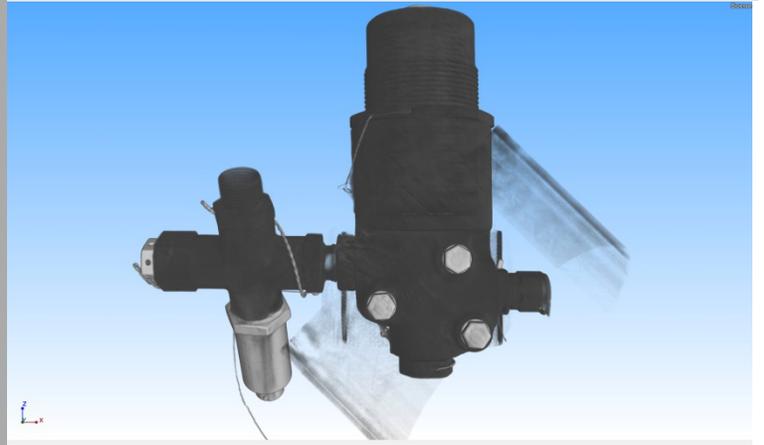
Figure 22
Right hand pressure regulator – Overall cross section through pressure transducer

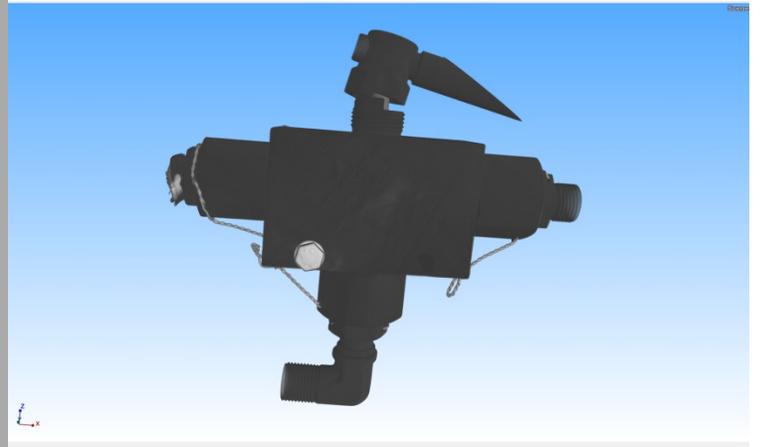
Figure 25
Left hand feather enable valve – Overall cross section

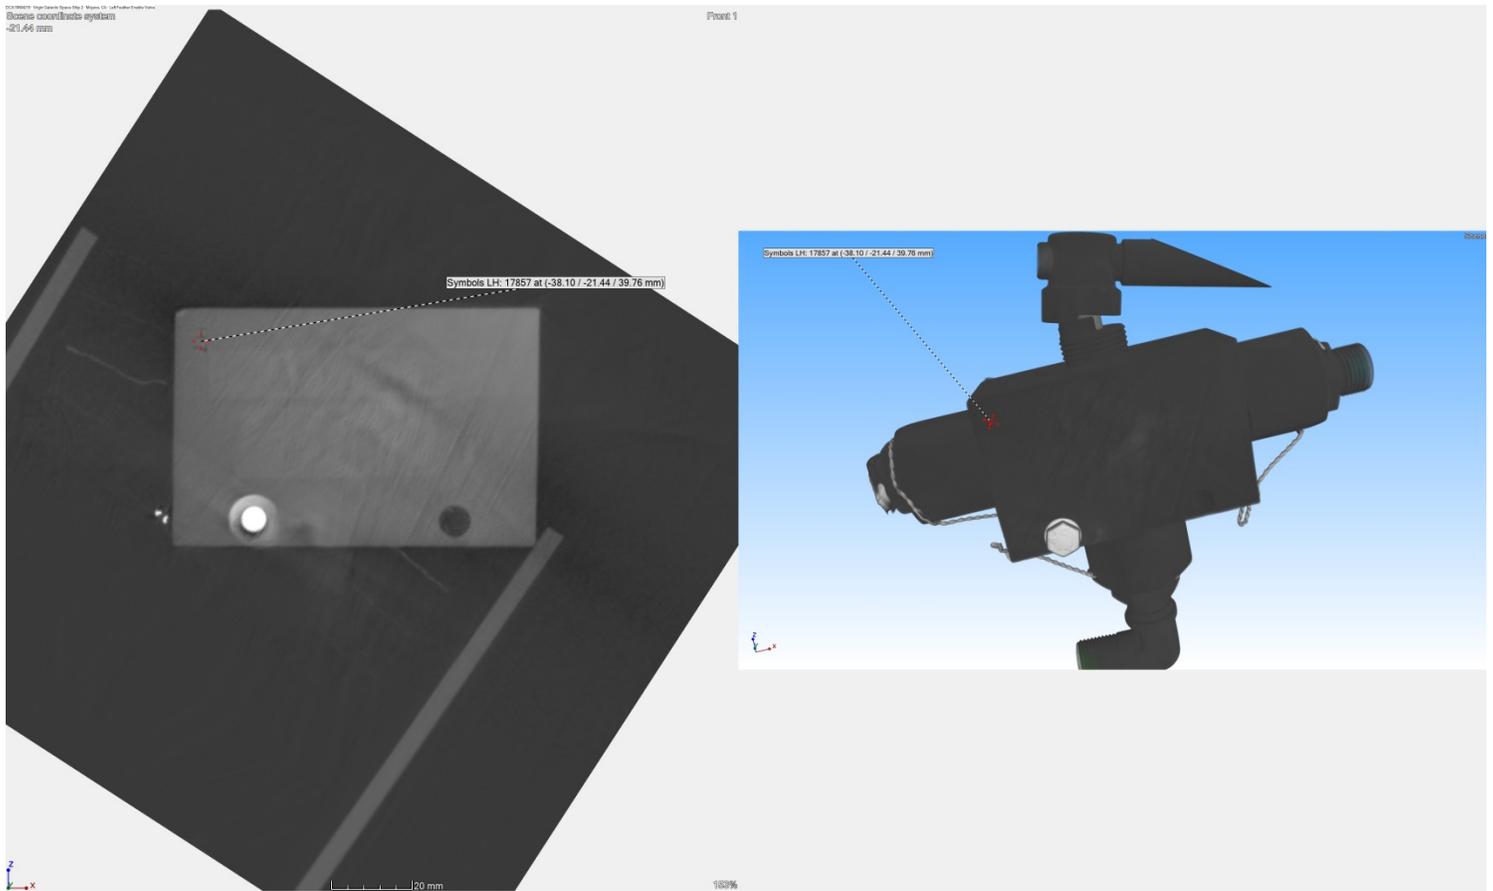
Figure 29
Left hand feather enable valve – Location of symbols “LH”

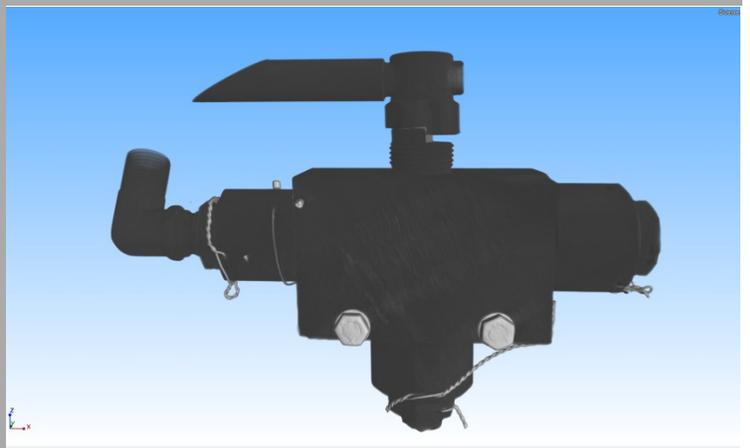
Figure 33
Right hand feather enable valve – Overall cross section

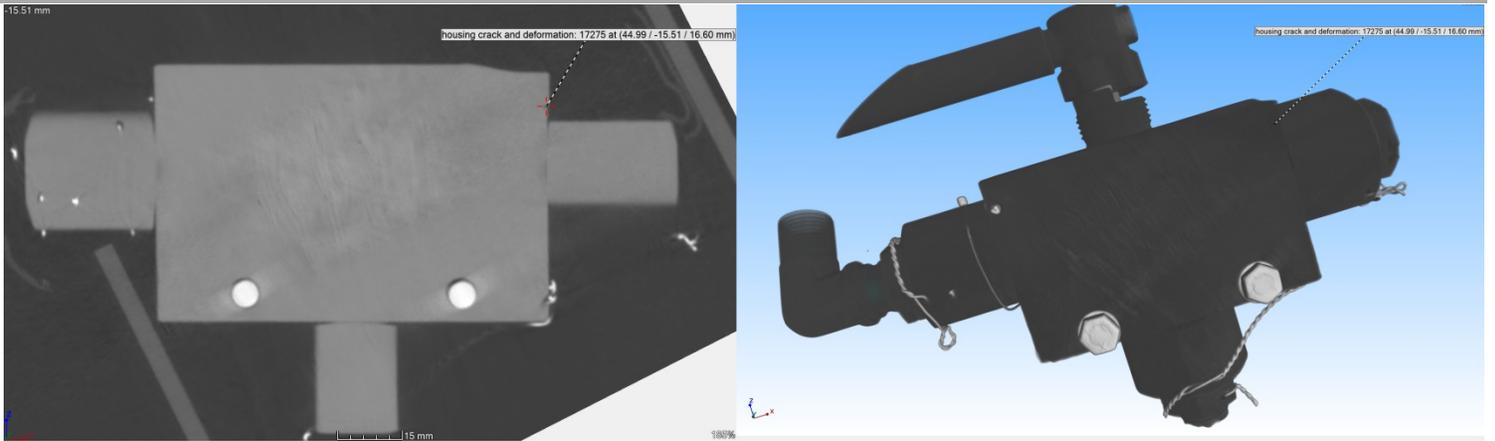
Figure 38
Right hand feather enable valve – Location of housing crack and deformation

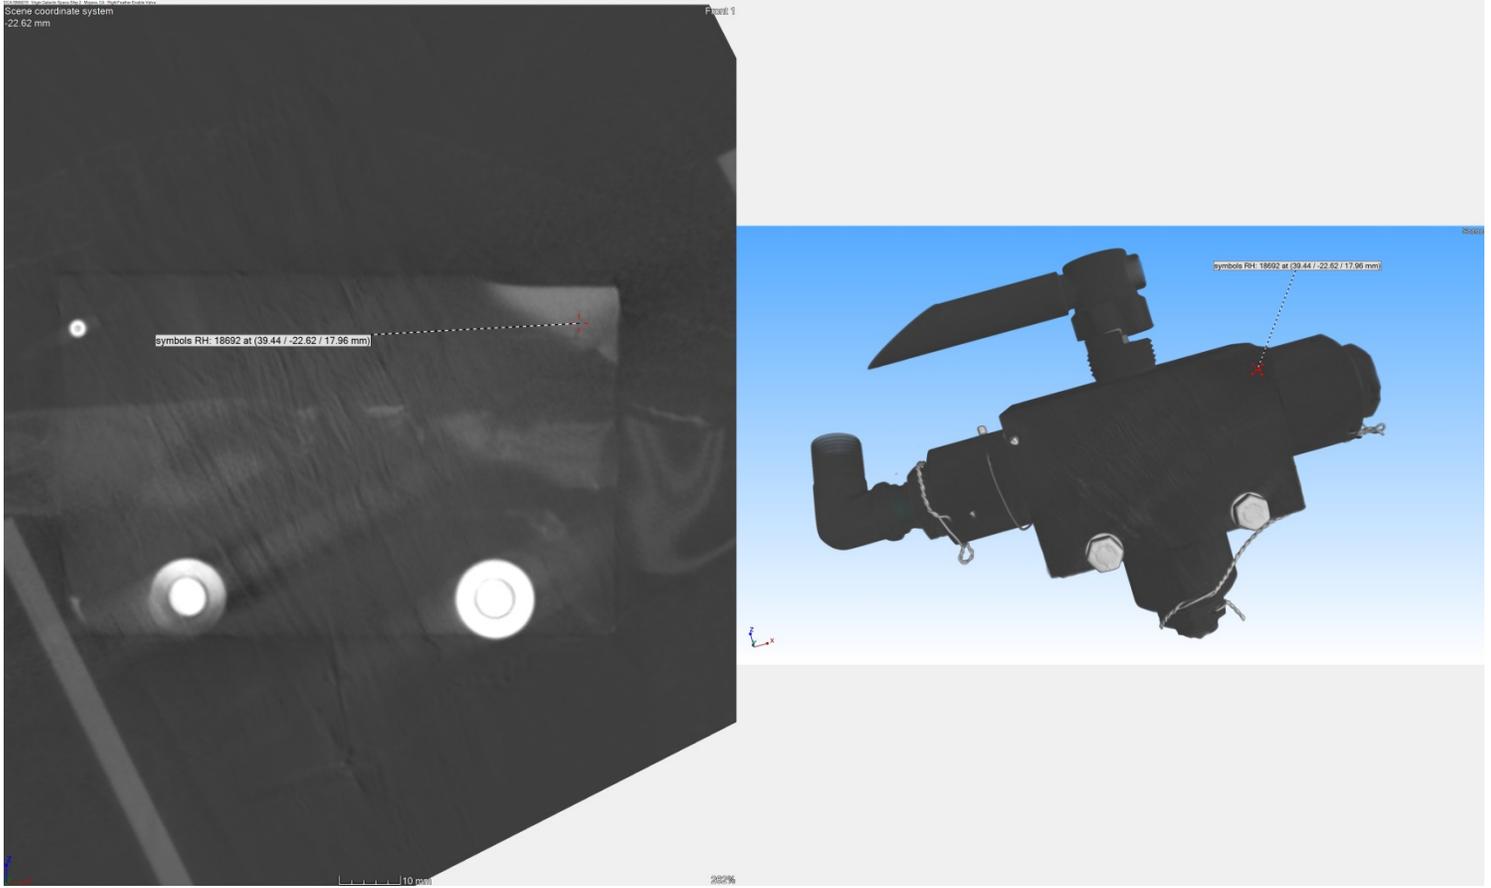
Figure 39
Right hand feather enable valve – Location of symbols “RH”

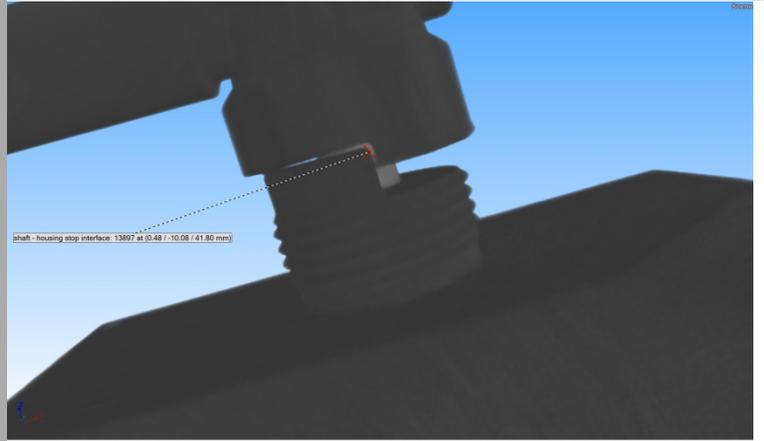
Figure 41
Right hand feather enable valve – Shaft/housing interface
