**NATIONAL TRANSPORTATION SAFETY BOARD**  
Office of Aviation Safety  
Washington, D.C. 20594

**Computed Tomography Specialist's Factual Report**

CEN15MA290

Operator: Air Methods Corp  
Location: Frisco, Colorado  
Date: July 3, 2015  
Time: 1339 mountain daylight time  
Vehicle: Airbus Helicopter Inc. (formerly American Eurocopter) AS350B3e  
helicopter, N390LG

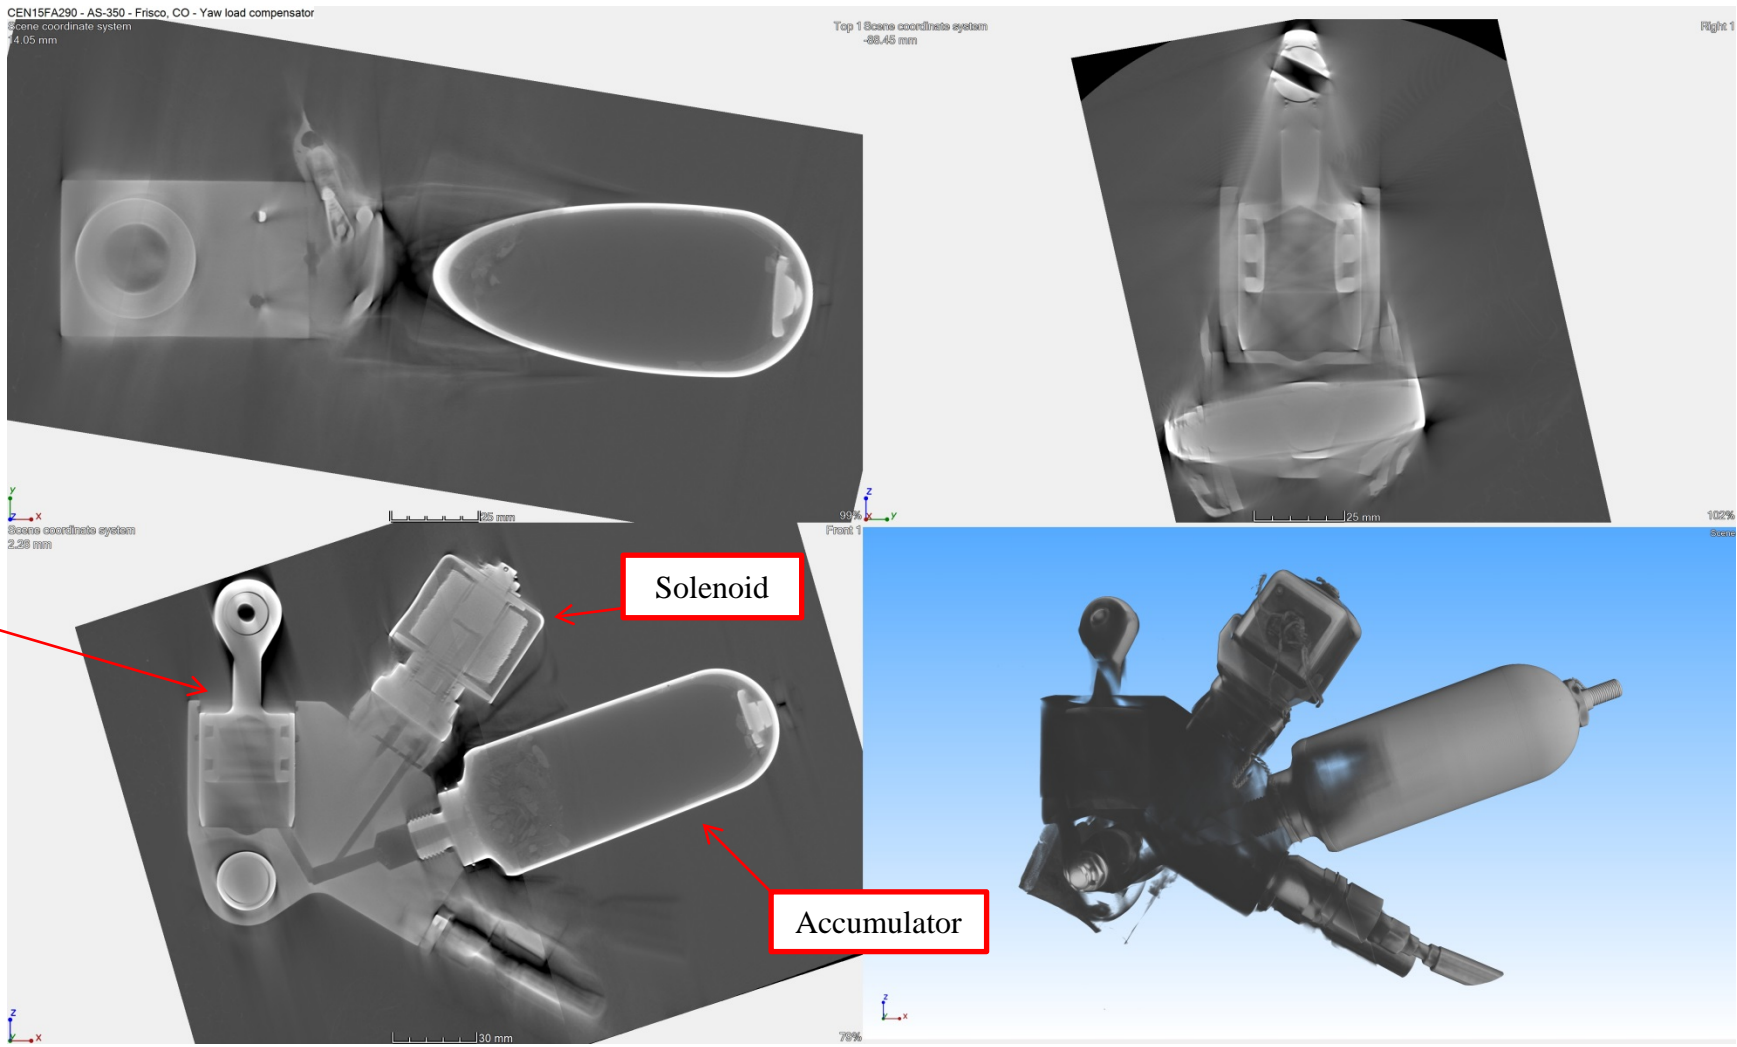
Figure 1  
 Yaw load compensator – Overall cross section through piston

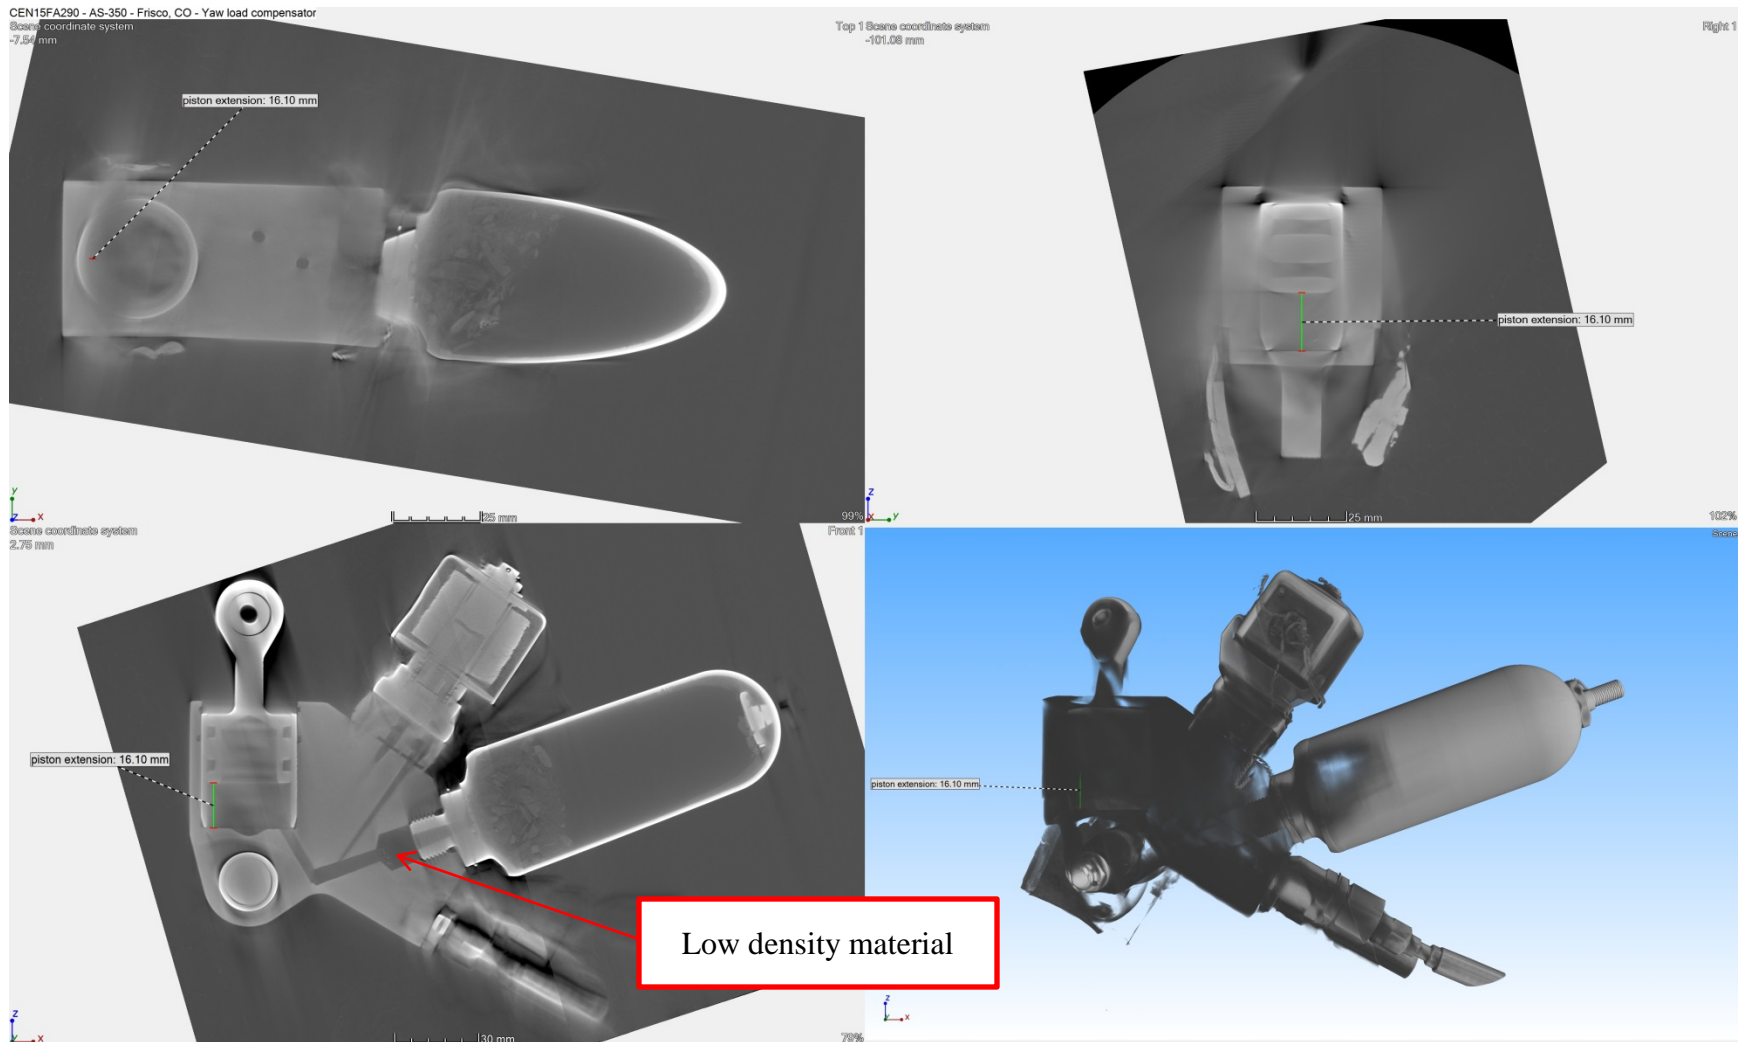
Figure 2

Yaw load compensator – Overall cross section through piston showing piston extension measurement

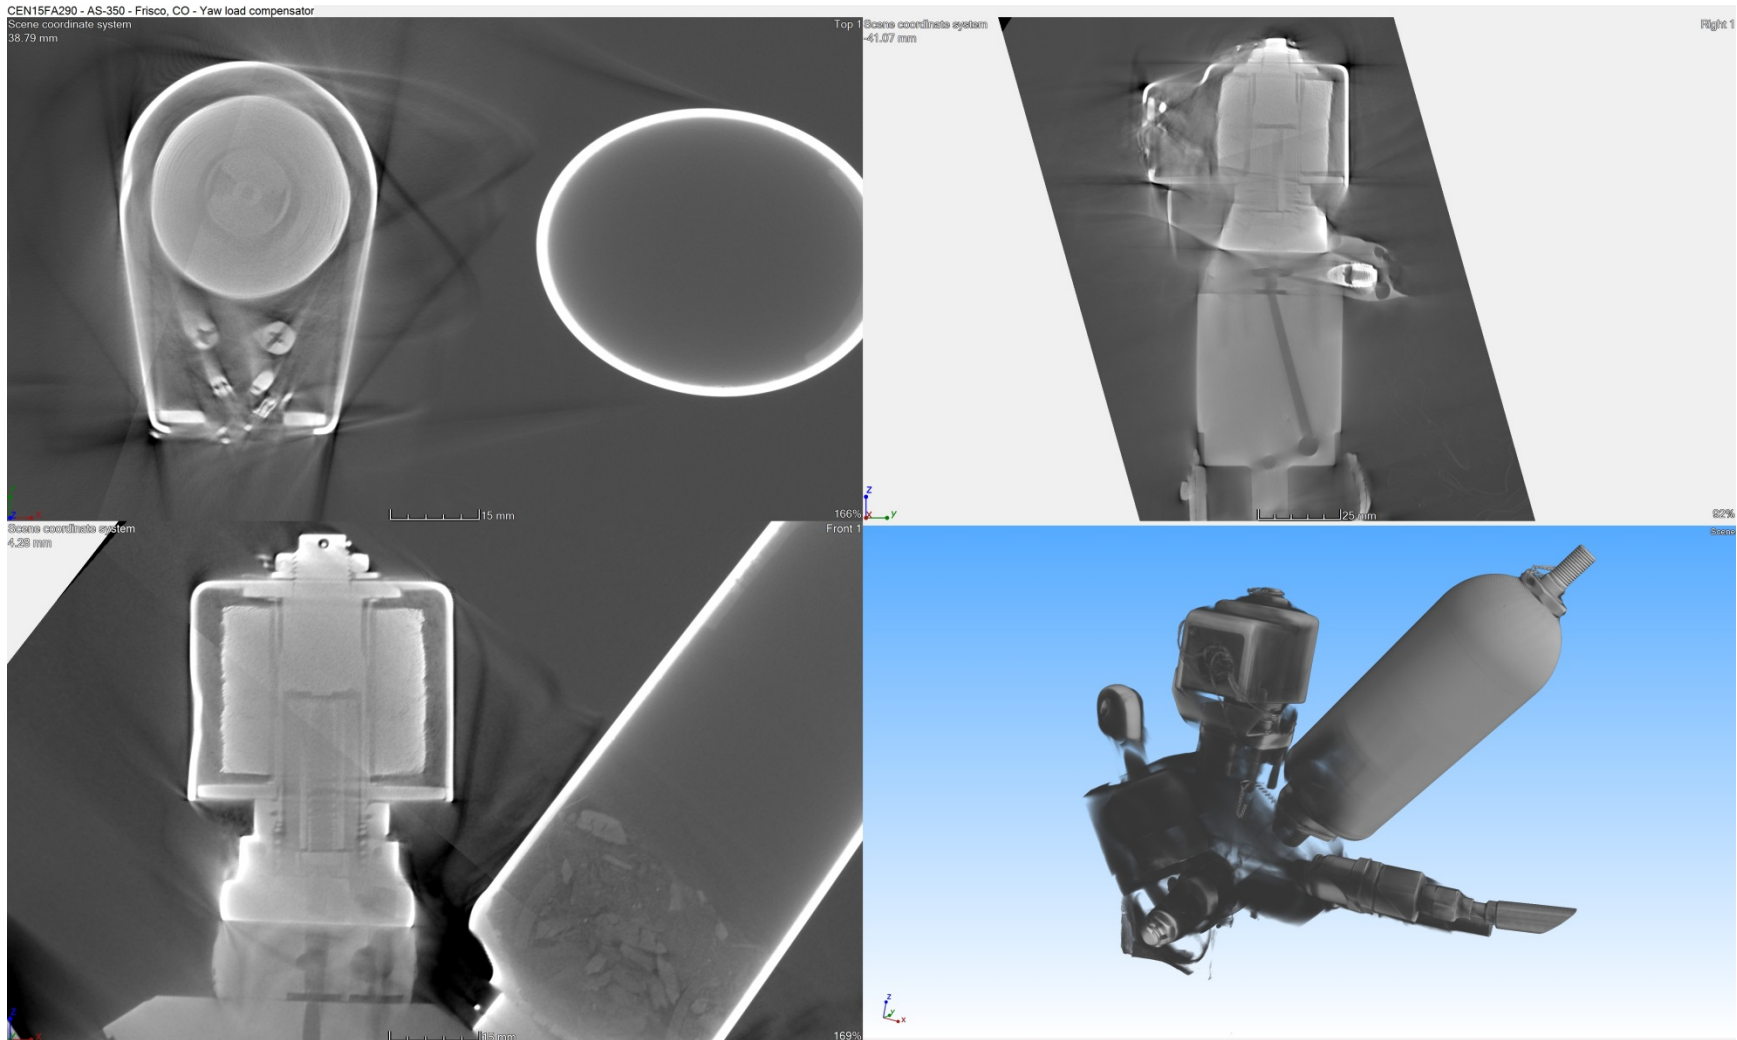
Figure 3  
Yaw load compensator – Overall cross section through solenoid

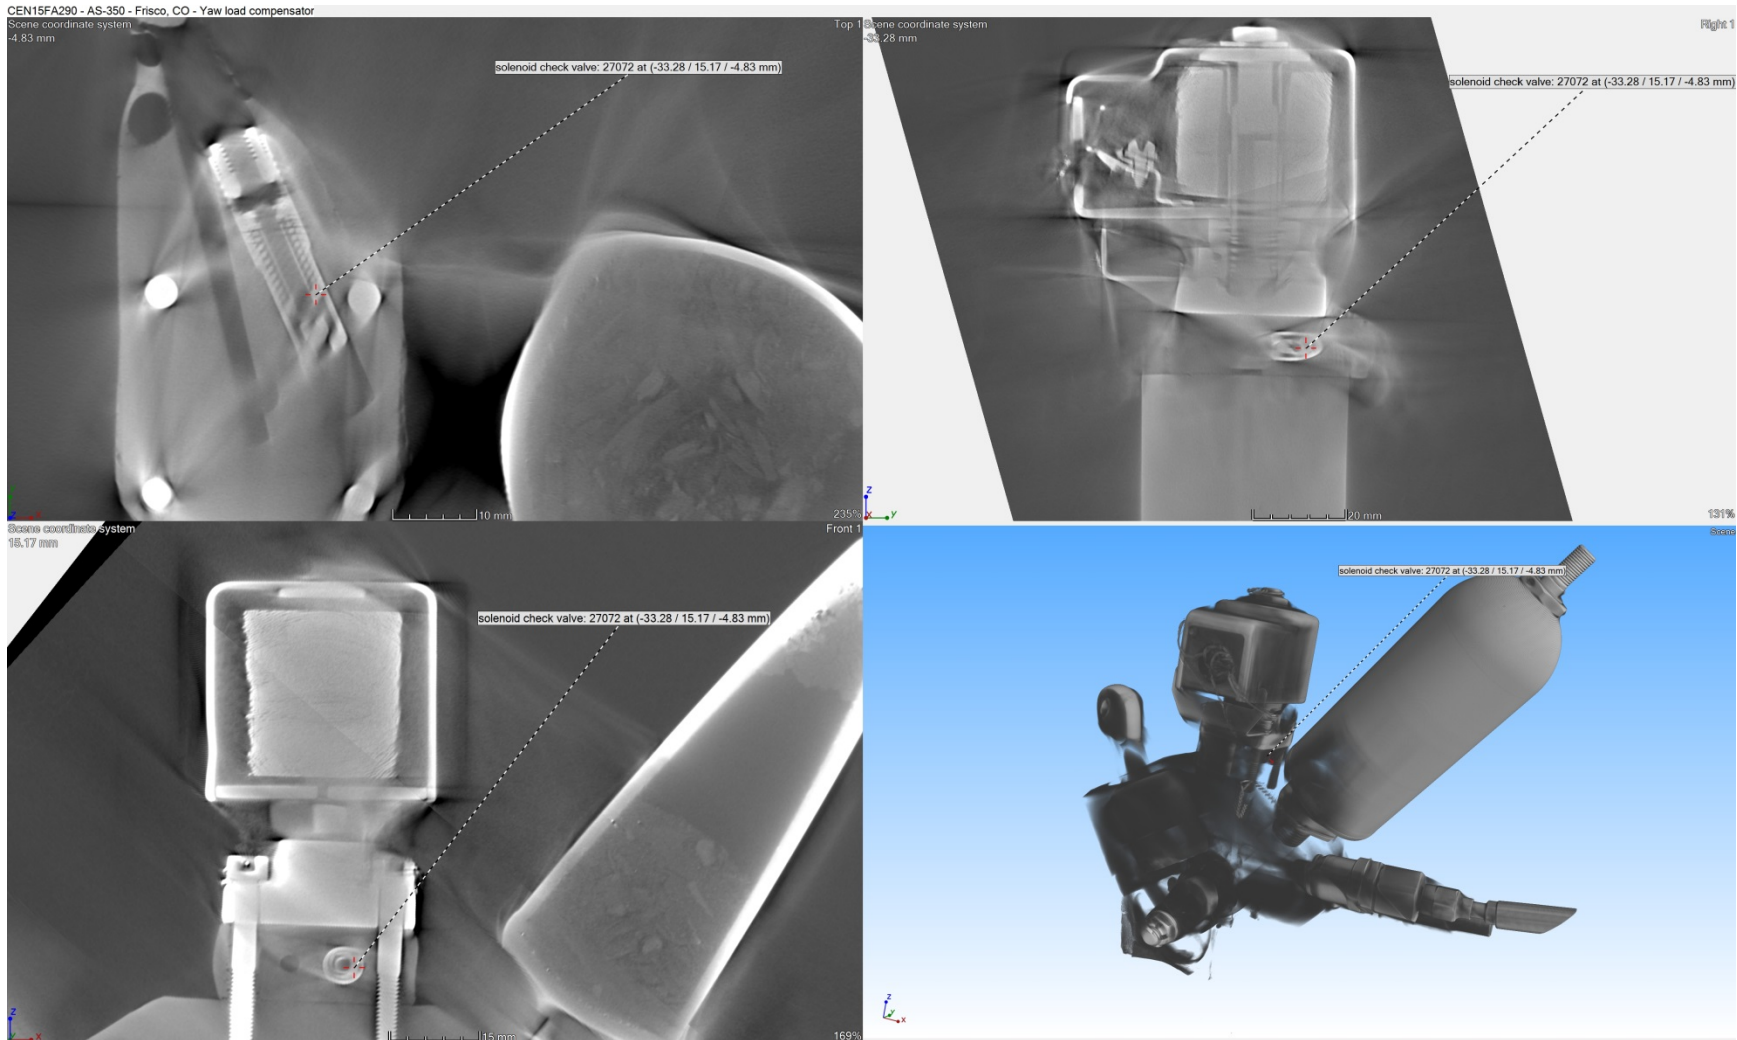
Figure 4  
Yaw load compensator – Solenoid check valve

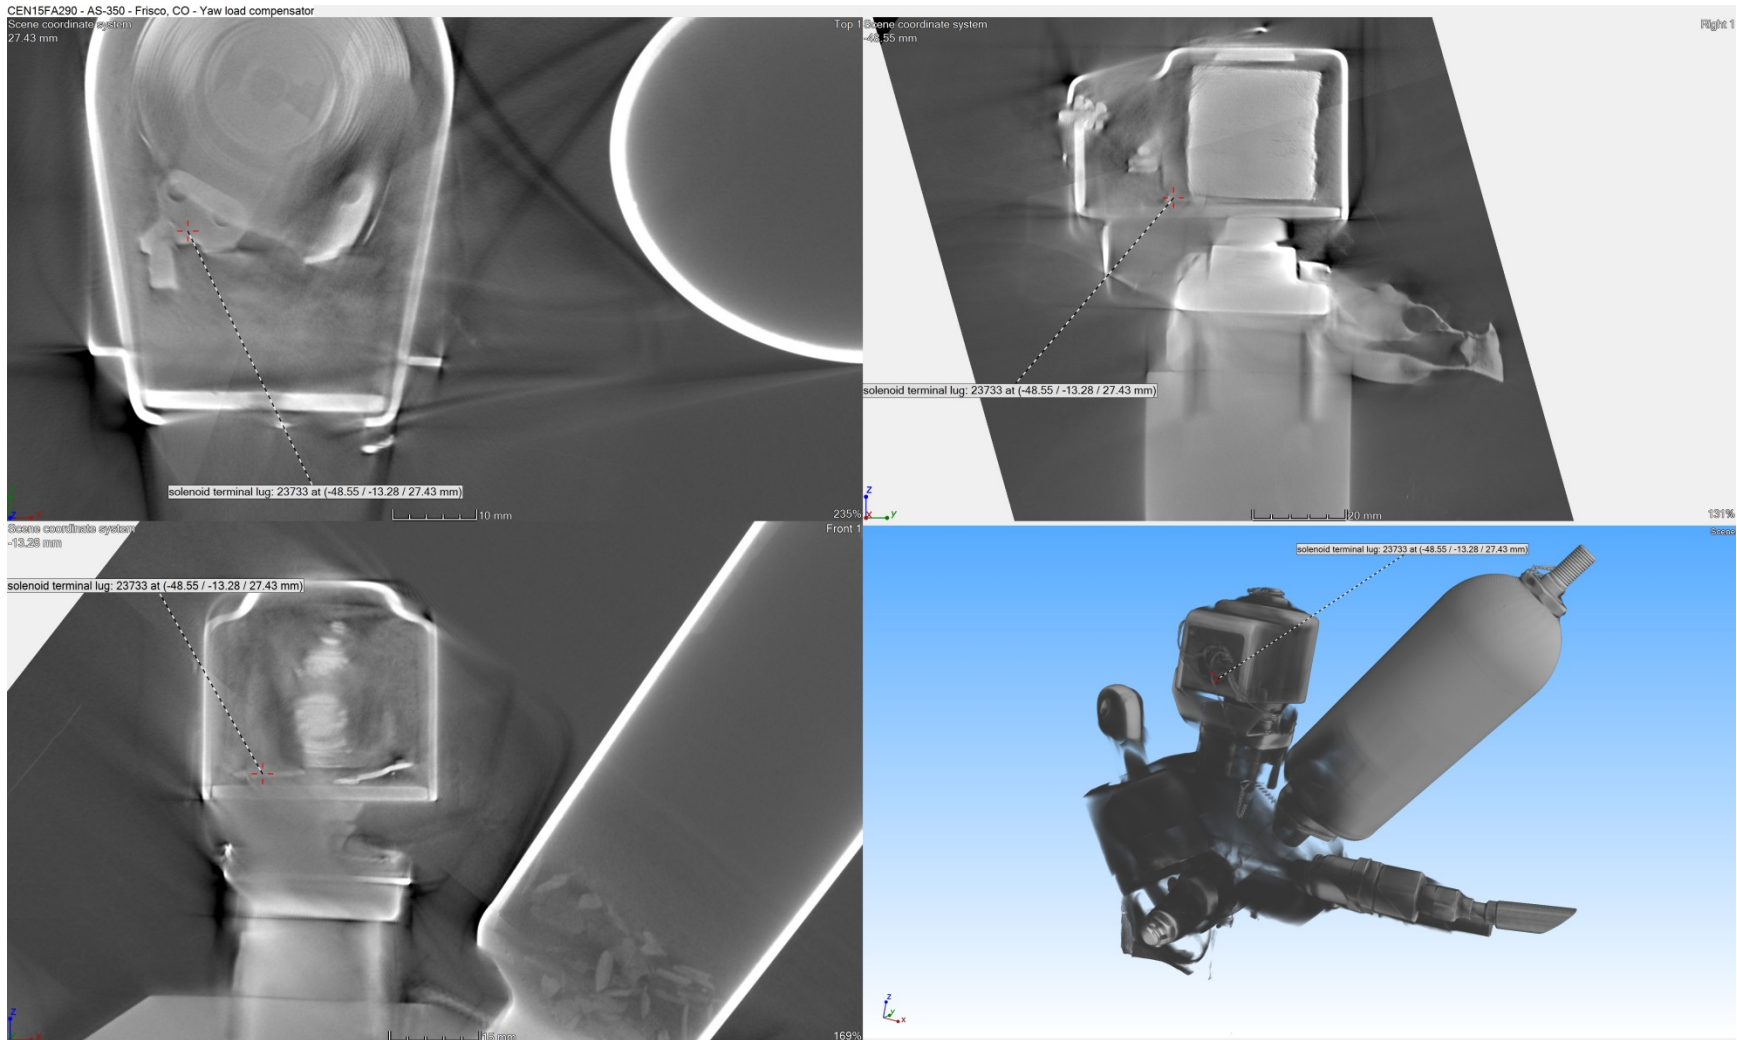
Figure 5  
Yaw load compensator – Solenoid terminal lug

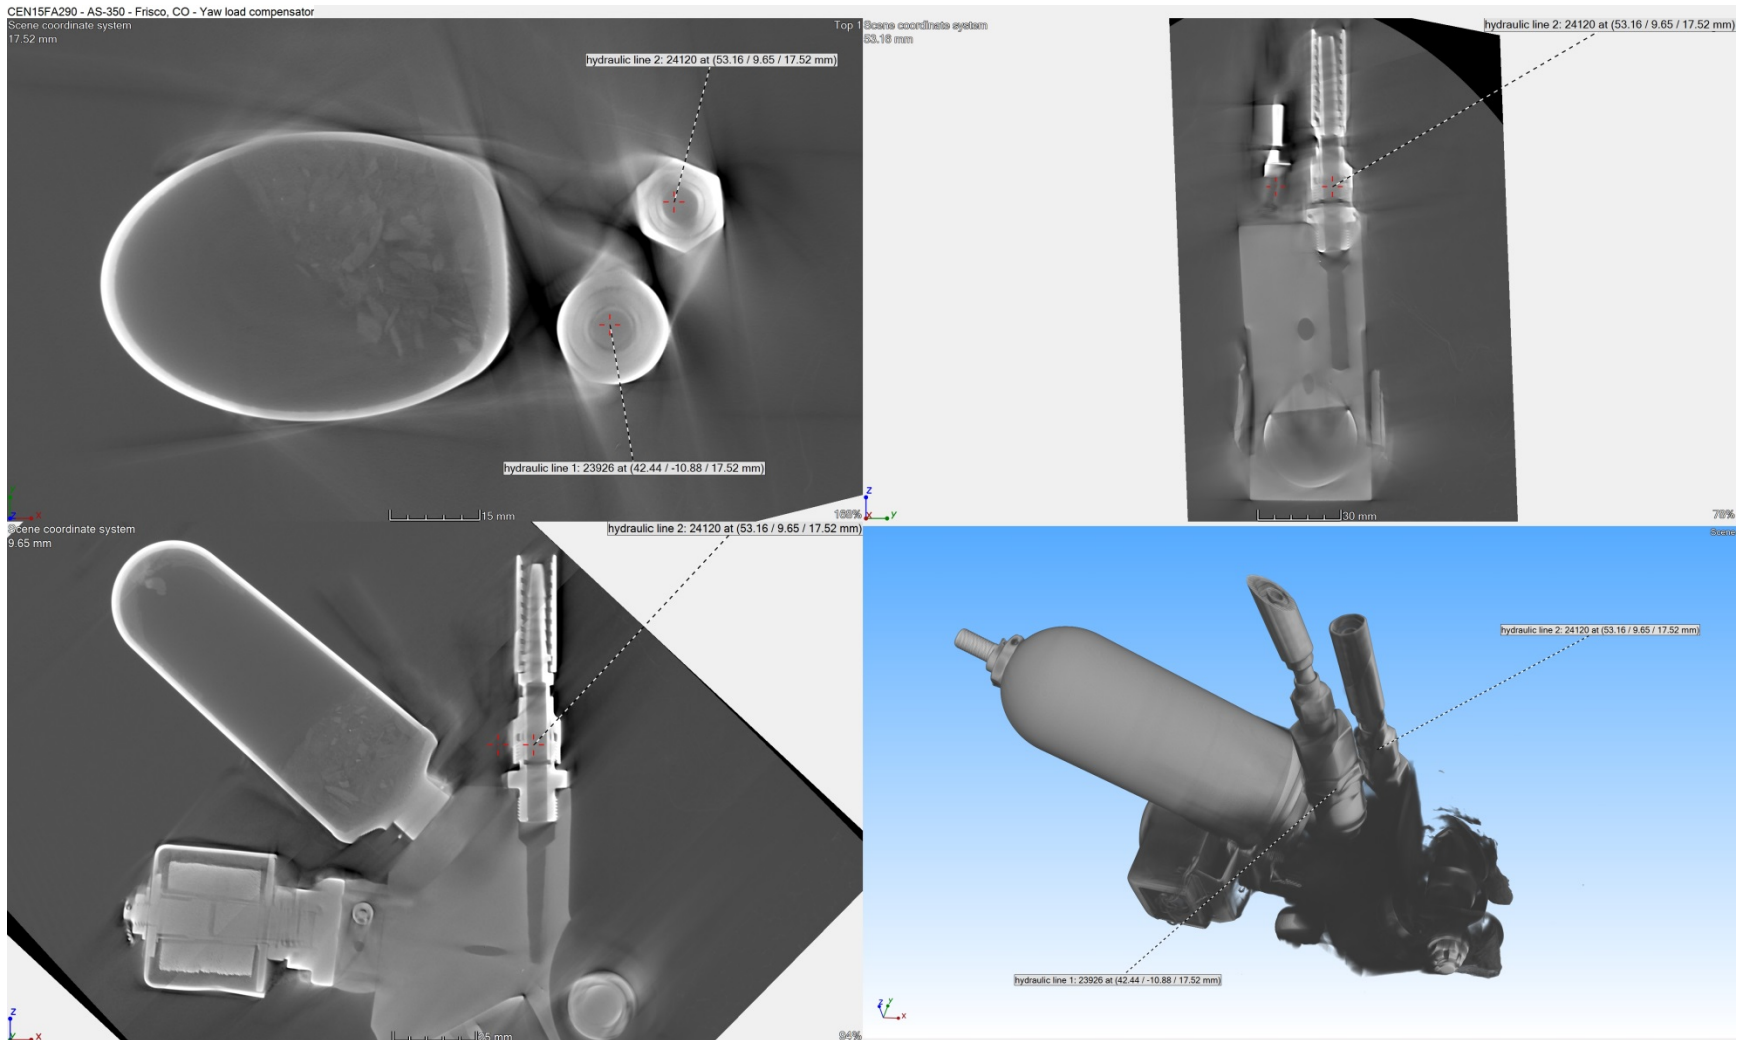
Figure 7

Yaw load compensator – Overall cross section through hydraulic line 2

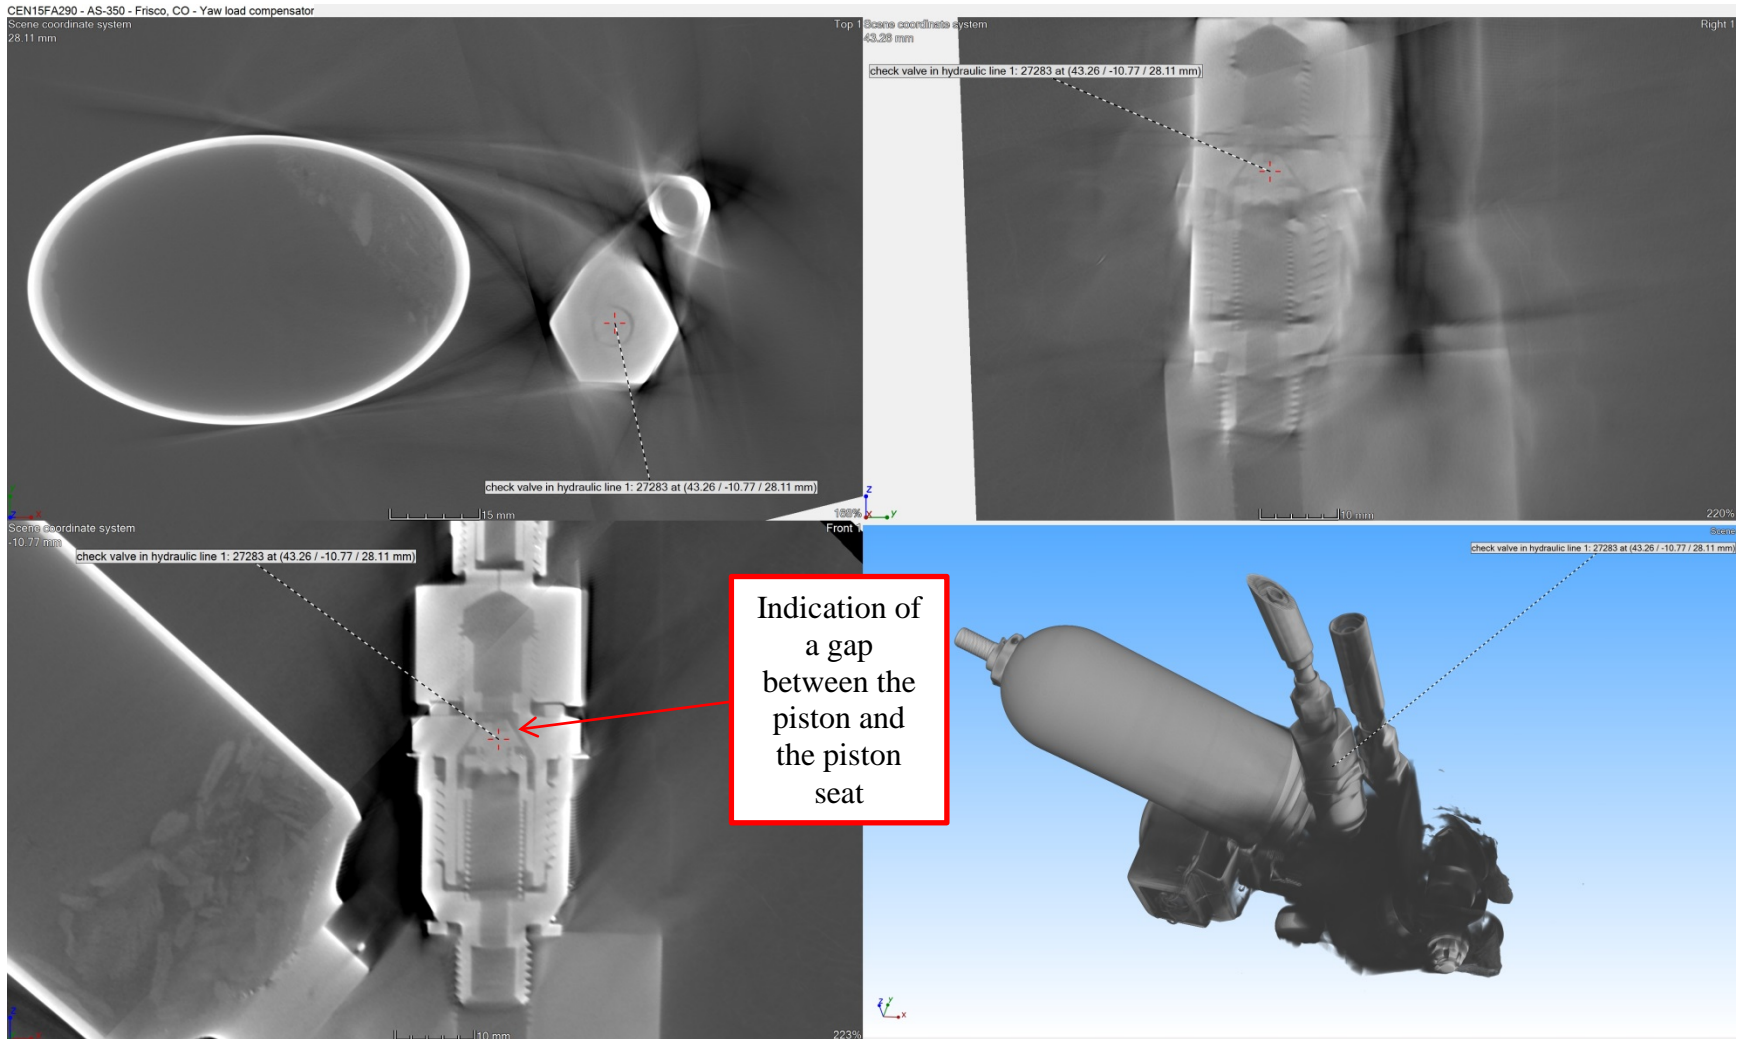
1. There were indications of low density material inside the hydraulic passages of the yaw load compensator;
2. There was an indication of a gap between the piston and piston seat within the check valve located within hydraulic line 1;
3. There were indications of debris noted within the accumulator;
4. There were indications of pitting noted on multiple locations of the inner accumulator wall and on the accumulator filling assembly;
5. There were indications that some of the holes in the lower accumulator screen were blocked and some were open.

Figure 8  
Yaw load compensator – hydraulic line 1 check valve

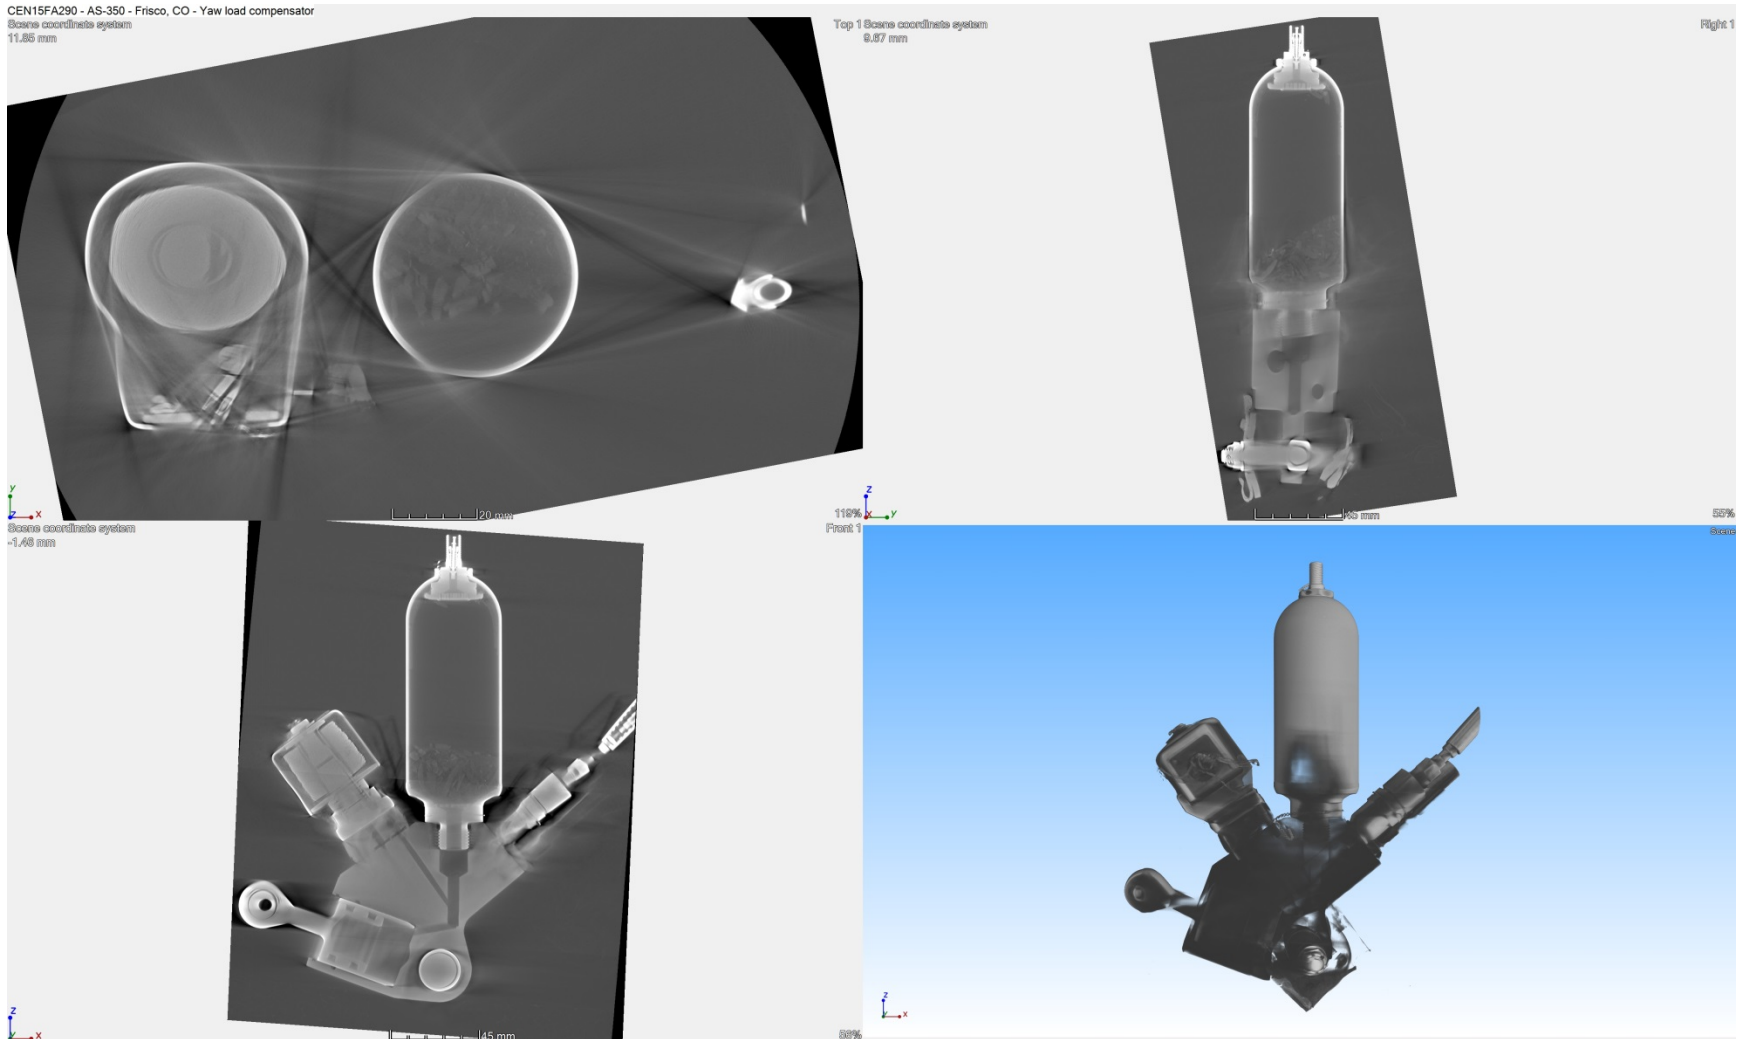
Figure 9  
Yaw load compensator – Overall cross section through accumulator

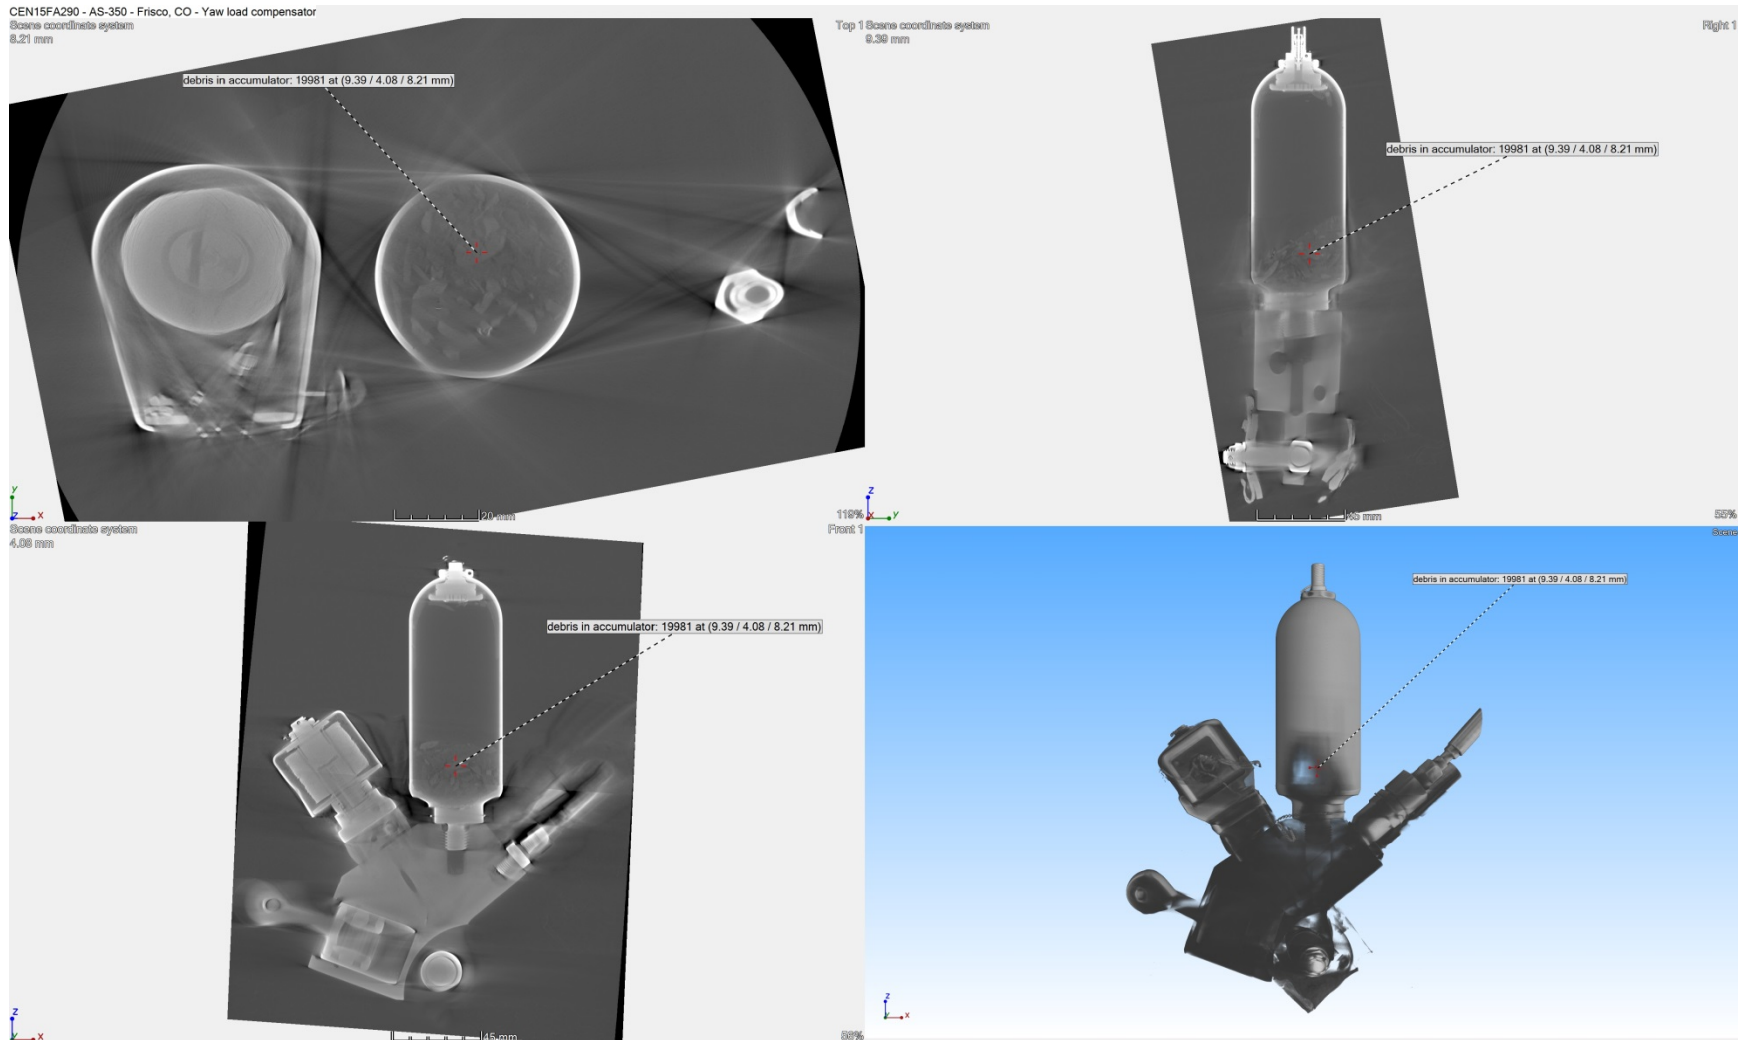
Figure 10  
Yaw load compensator – Debris in accumulator

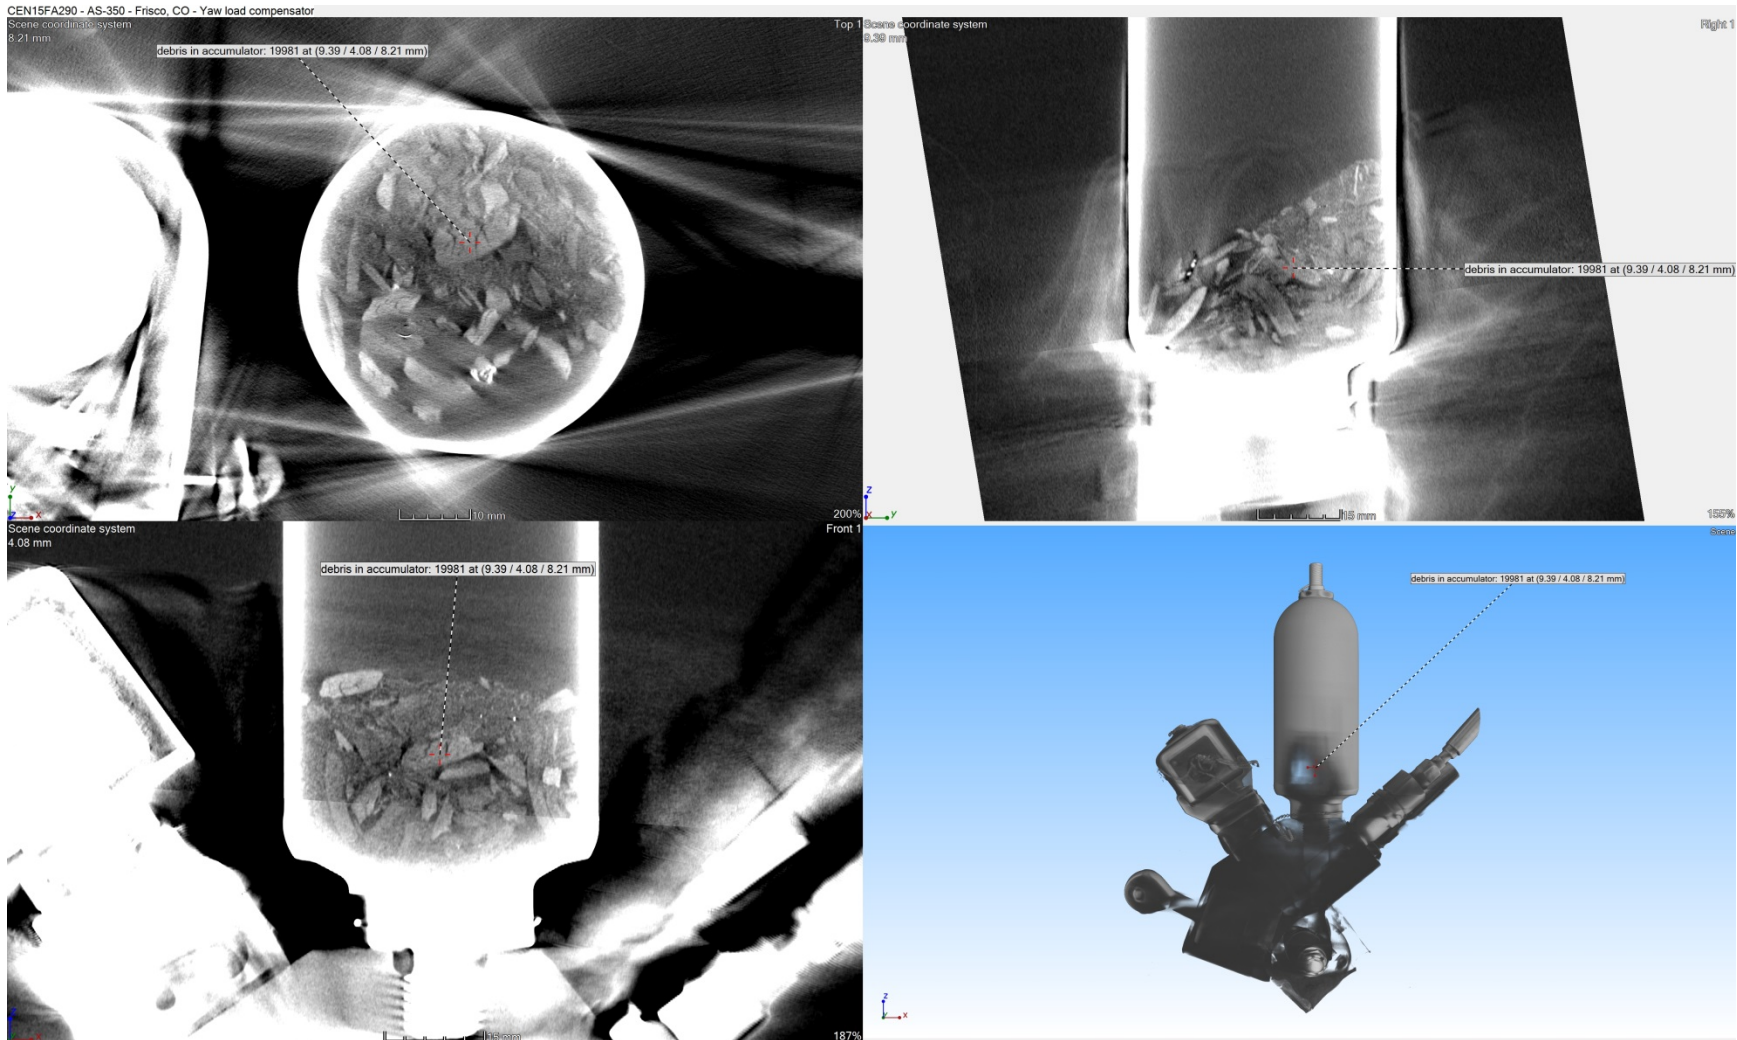
Figure 11

Yaw load compensator – Debris in accumulator – enhanced contrast

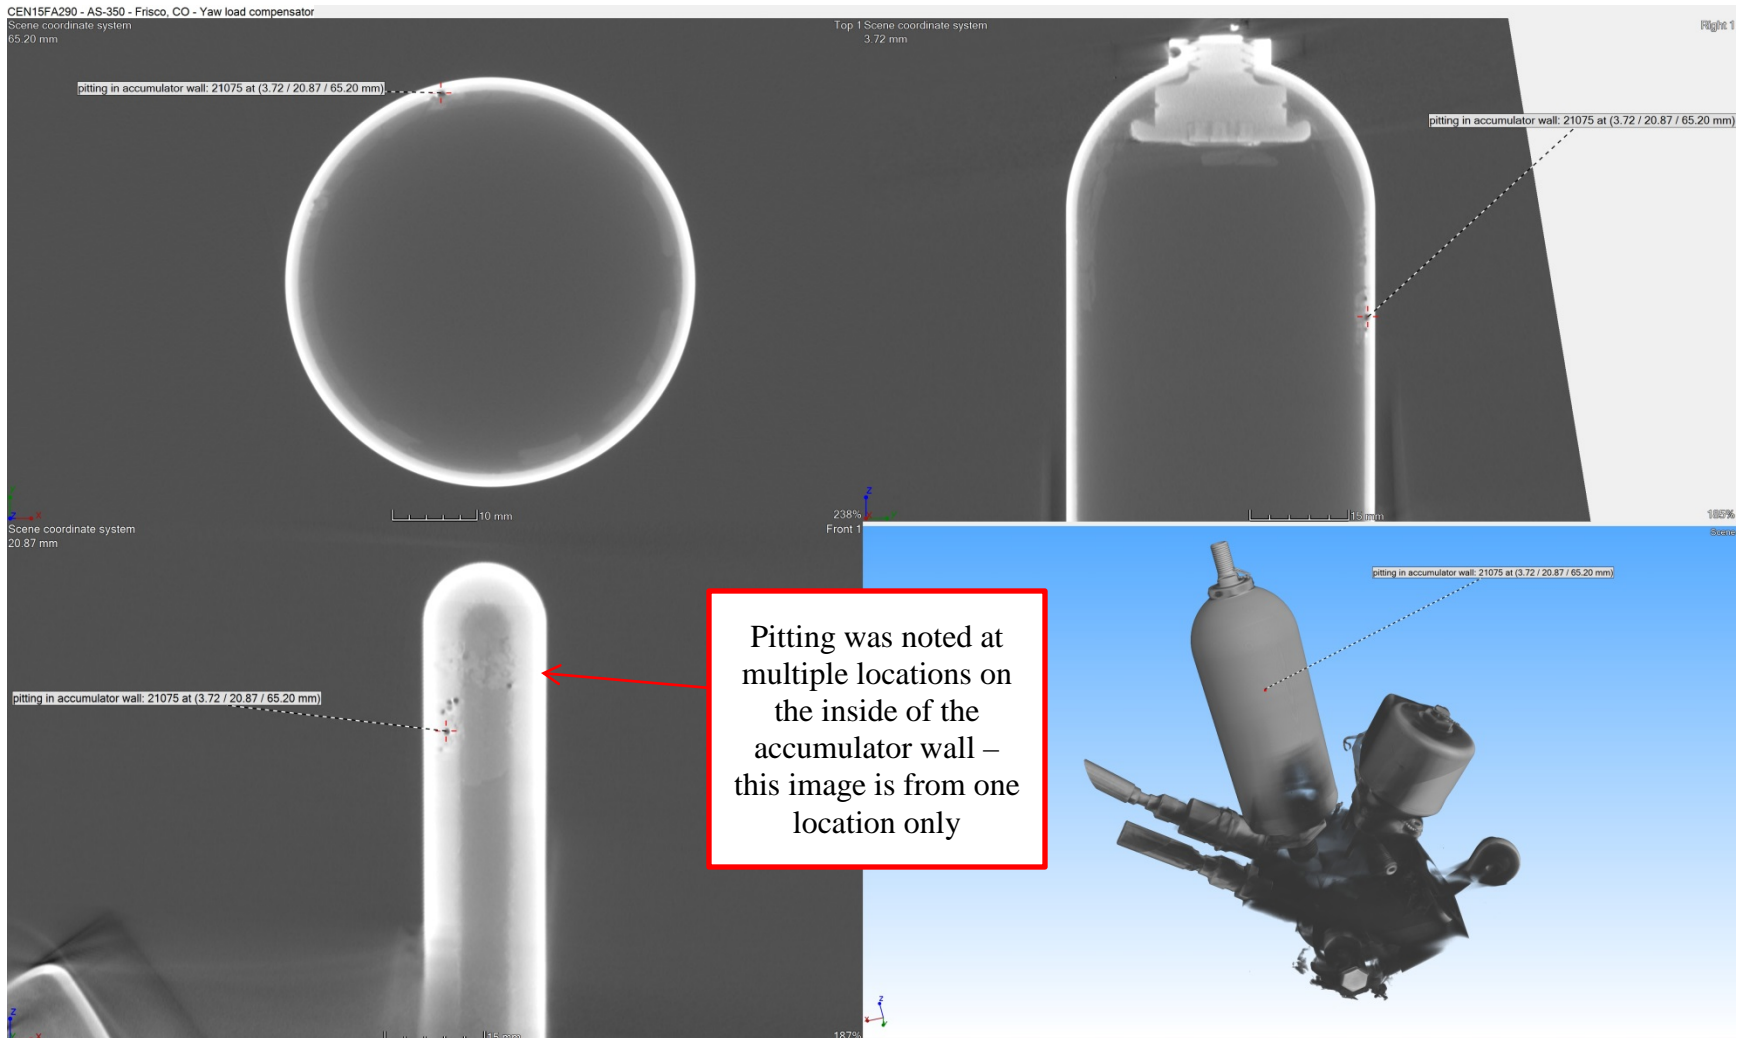
Pitting was noted at multiple locations on the inside of the accumulator wall – this image is from one location only

Figure 12  
 Yaw load compensator – Pitting in the interior accumulator wall

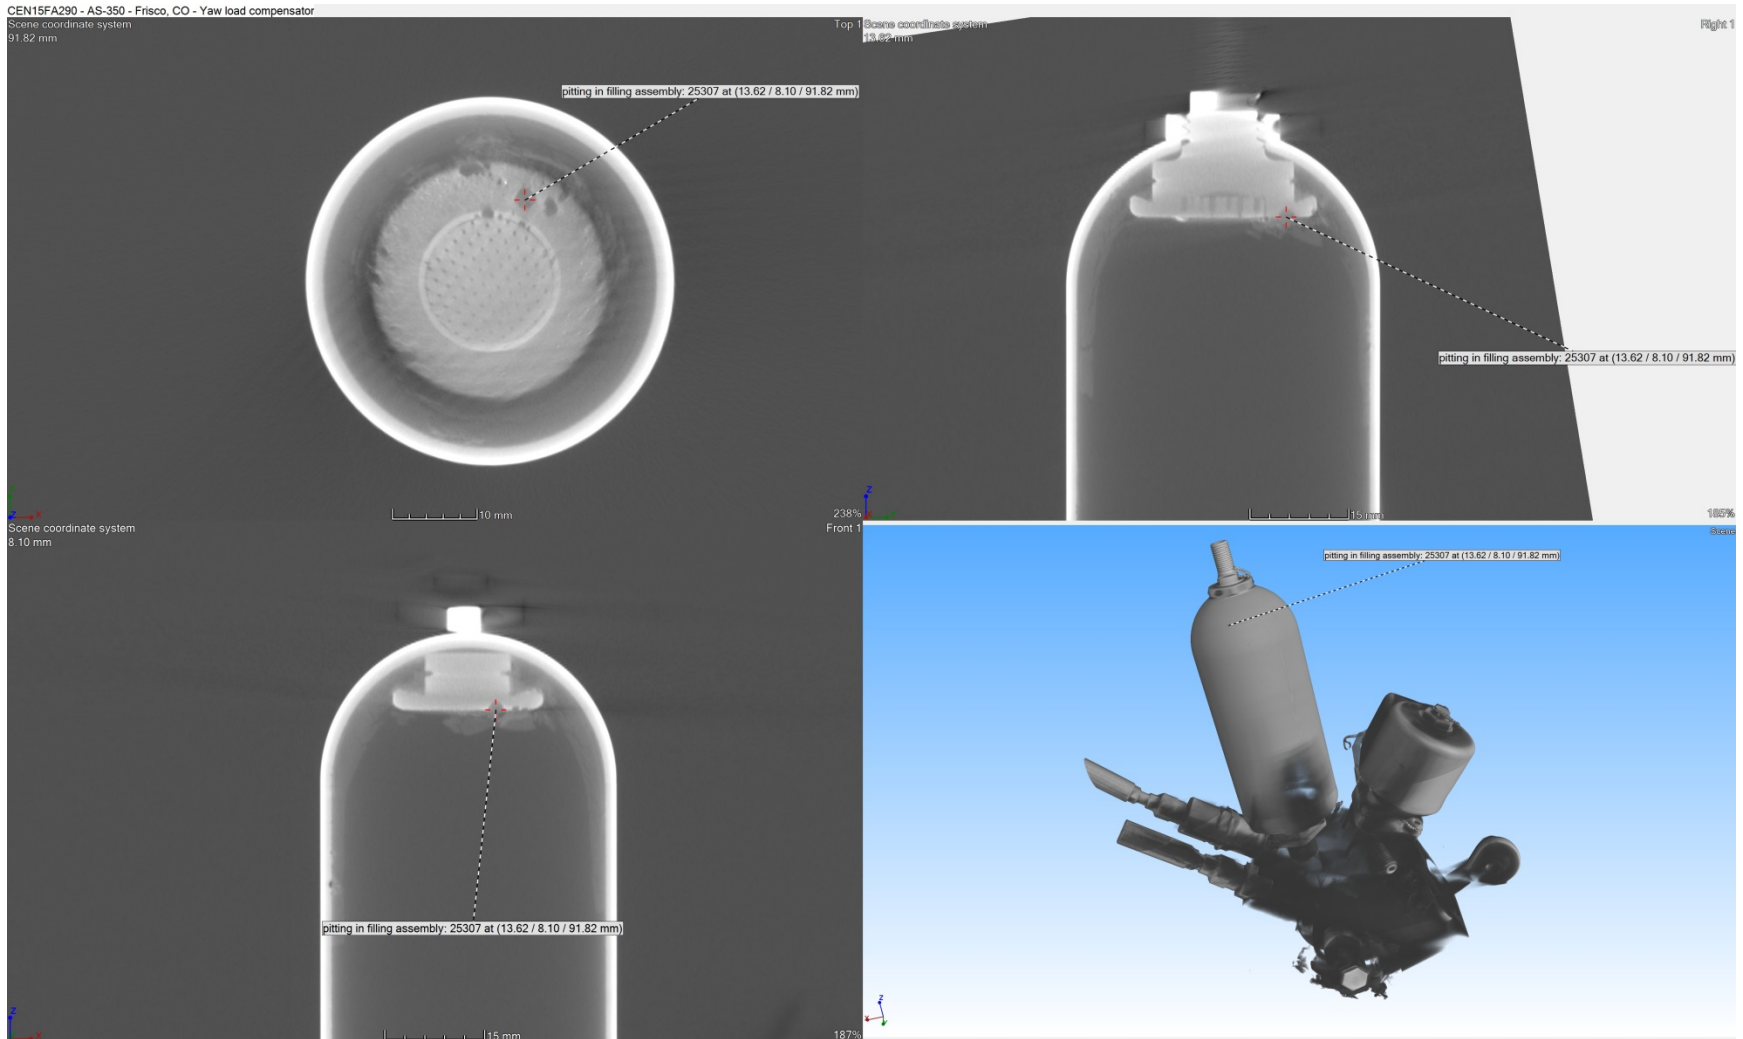
Figure 13  
Yaw load compensator – Pitting in the accumulator filling assembly
