**NATIONAL TRANSPORTATION SAFETY BOARD**  
Office of Aviation Safety  
Washington, D.C. 20594

**Computed Tomography Specialist's Factual Report**

CEN15MA290

Operator: Air Methods Corp  
Location: Frisco, Colorado  
Date: July 3, 2015  
Time: 1339 mountain daylight time  
Vehicle: Airbus Helicopter Inc. (formerly American Eurocopter) AS350B3e  
helicopter, N390LG

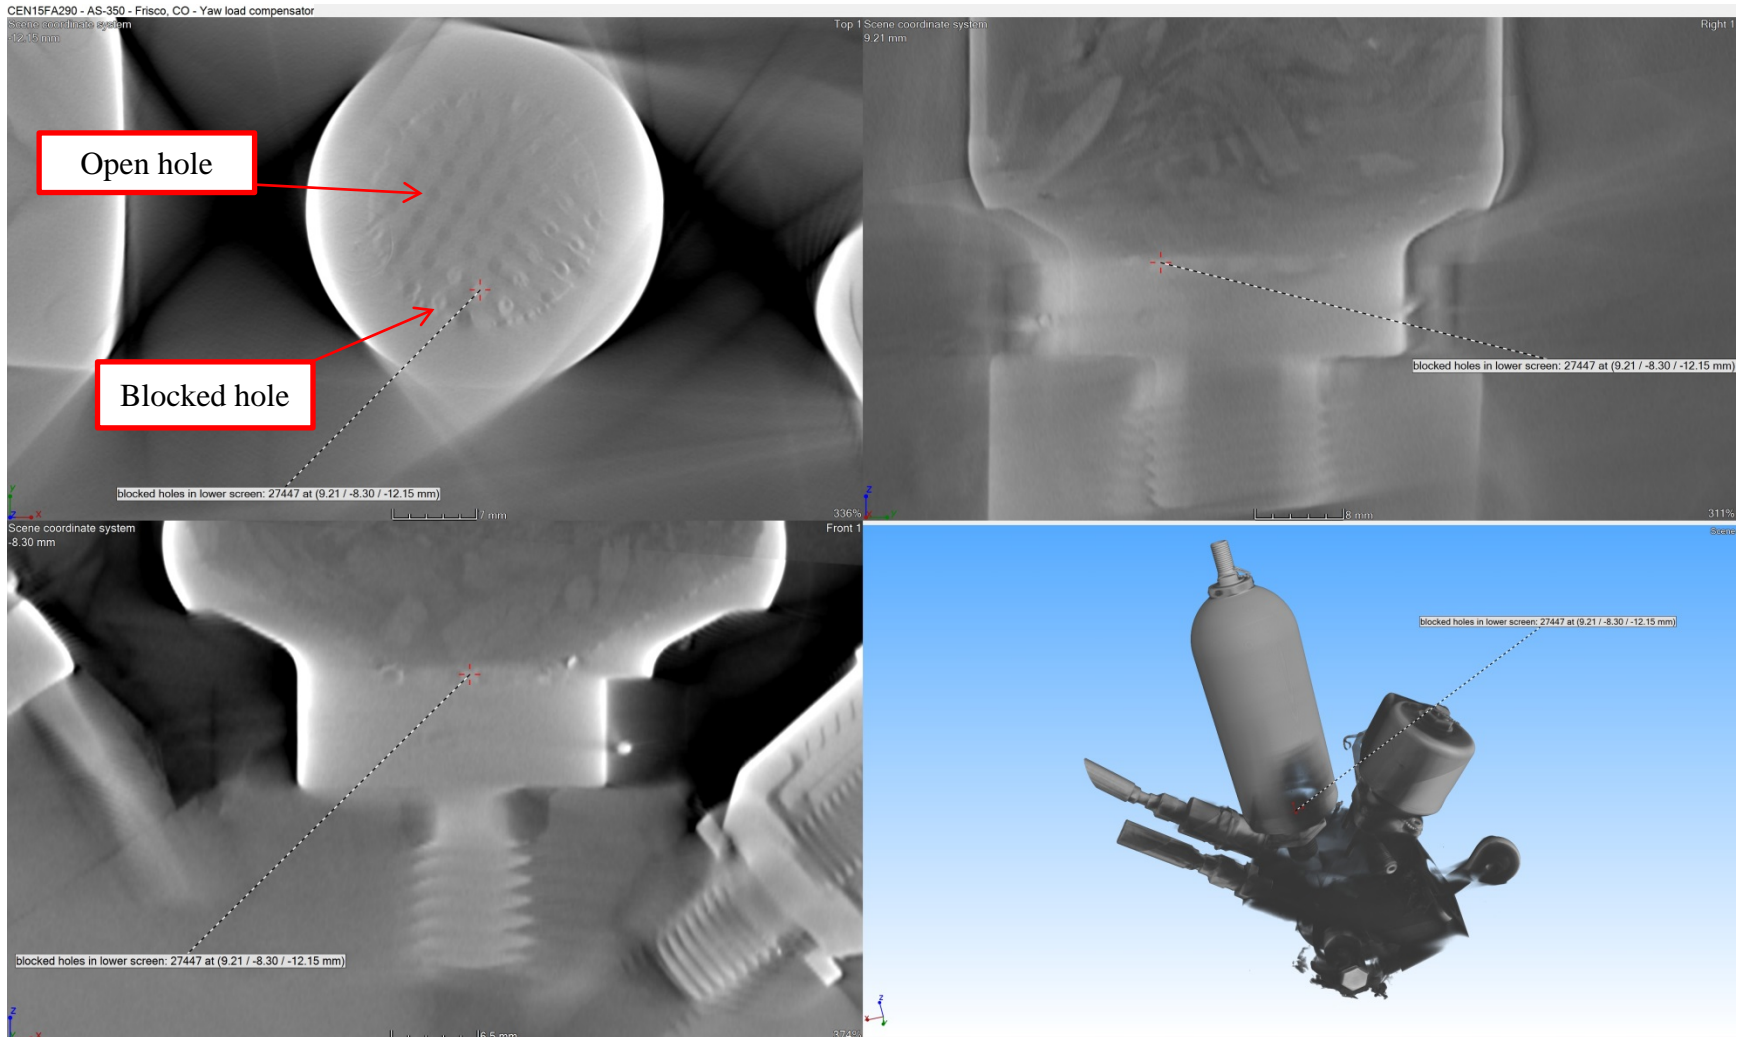
Figure 14  
Yaw load compensator – Blocked holes in the lower accumulator screen

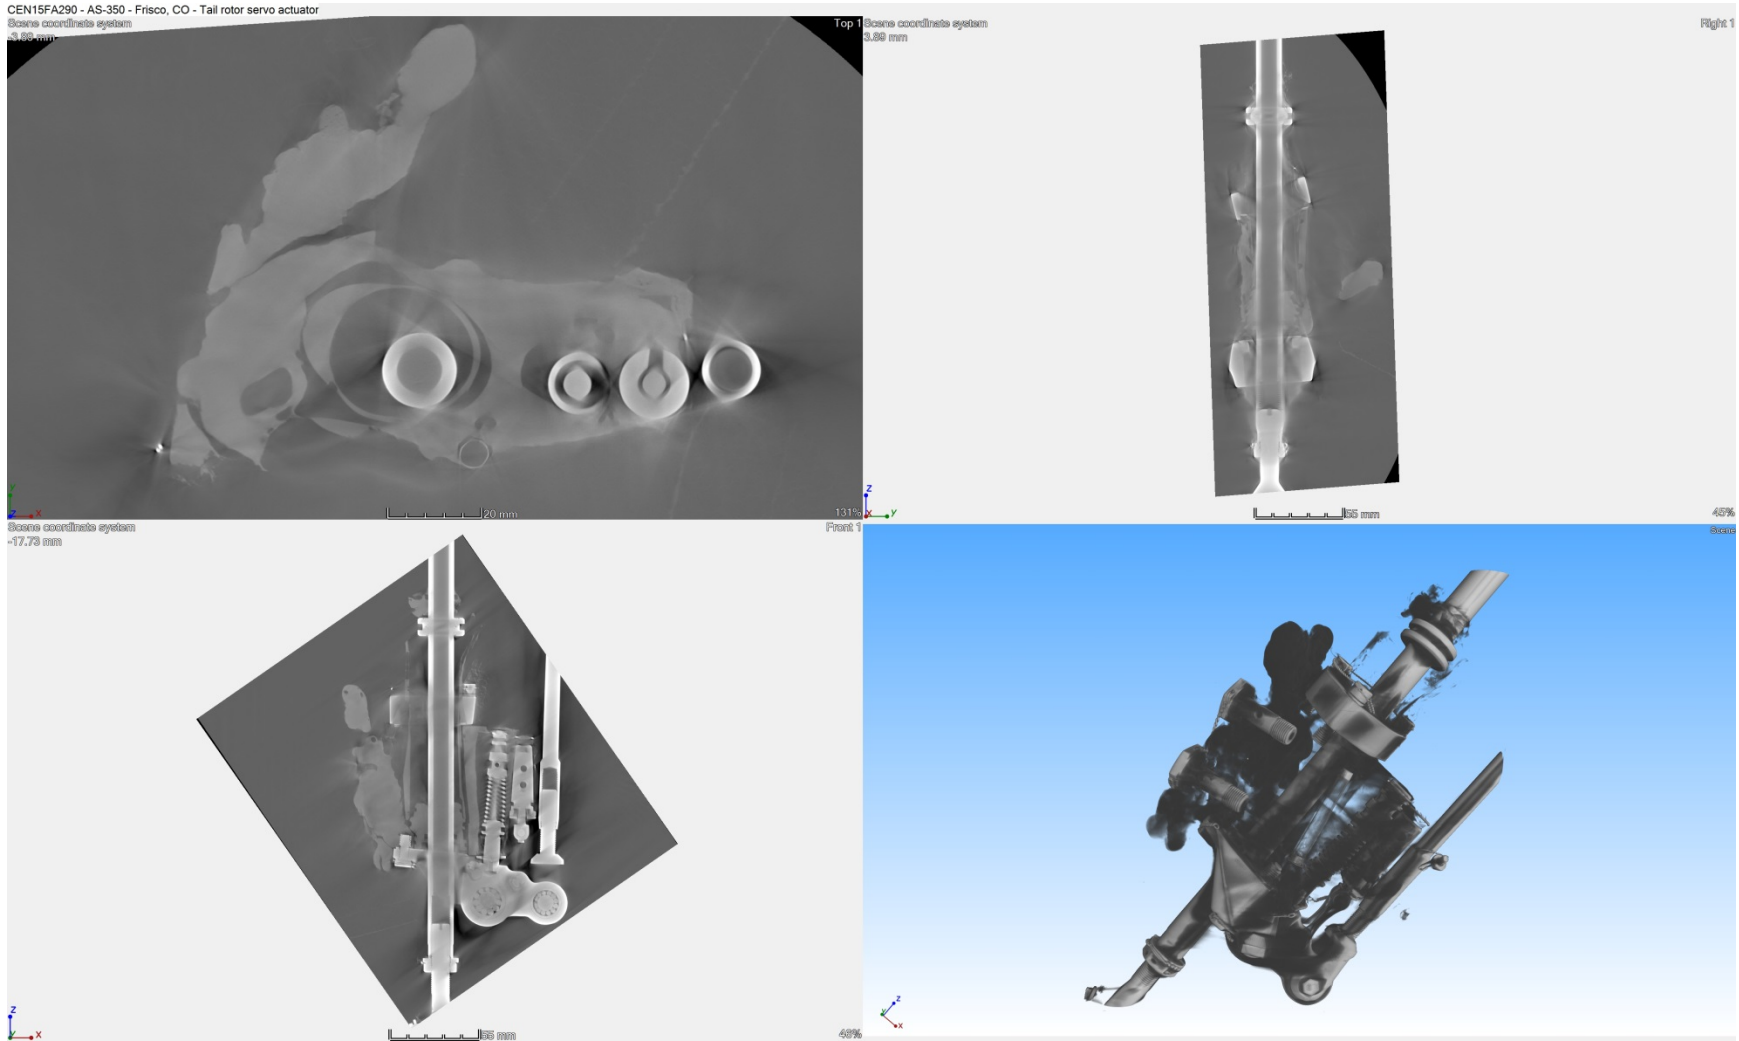
Figure 15  
Tail rotor actuator – Overall cross section through piston

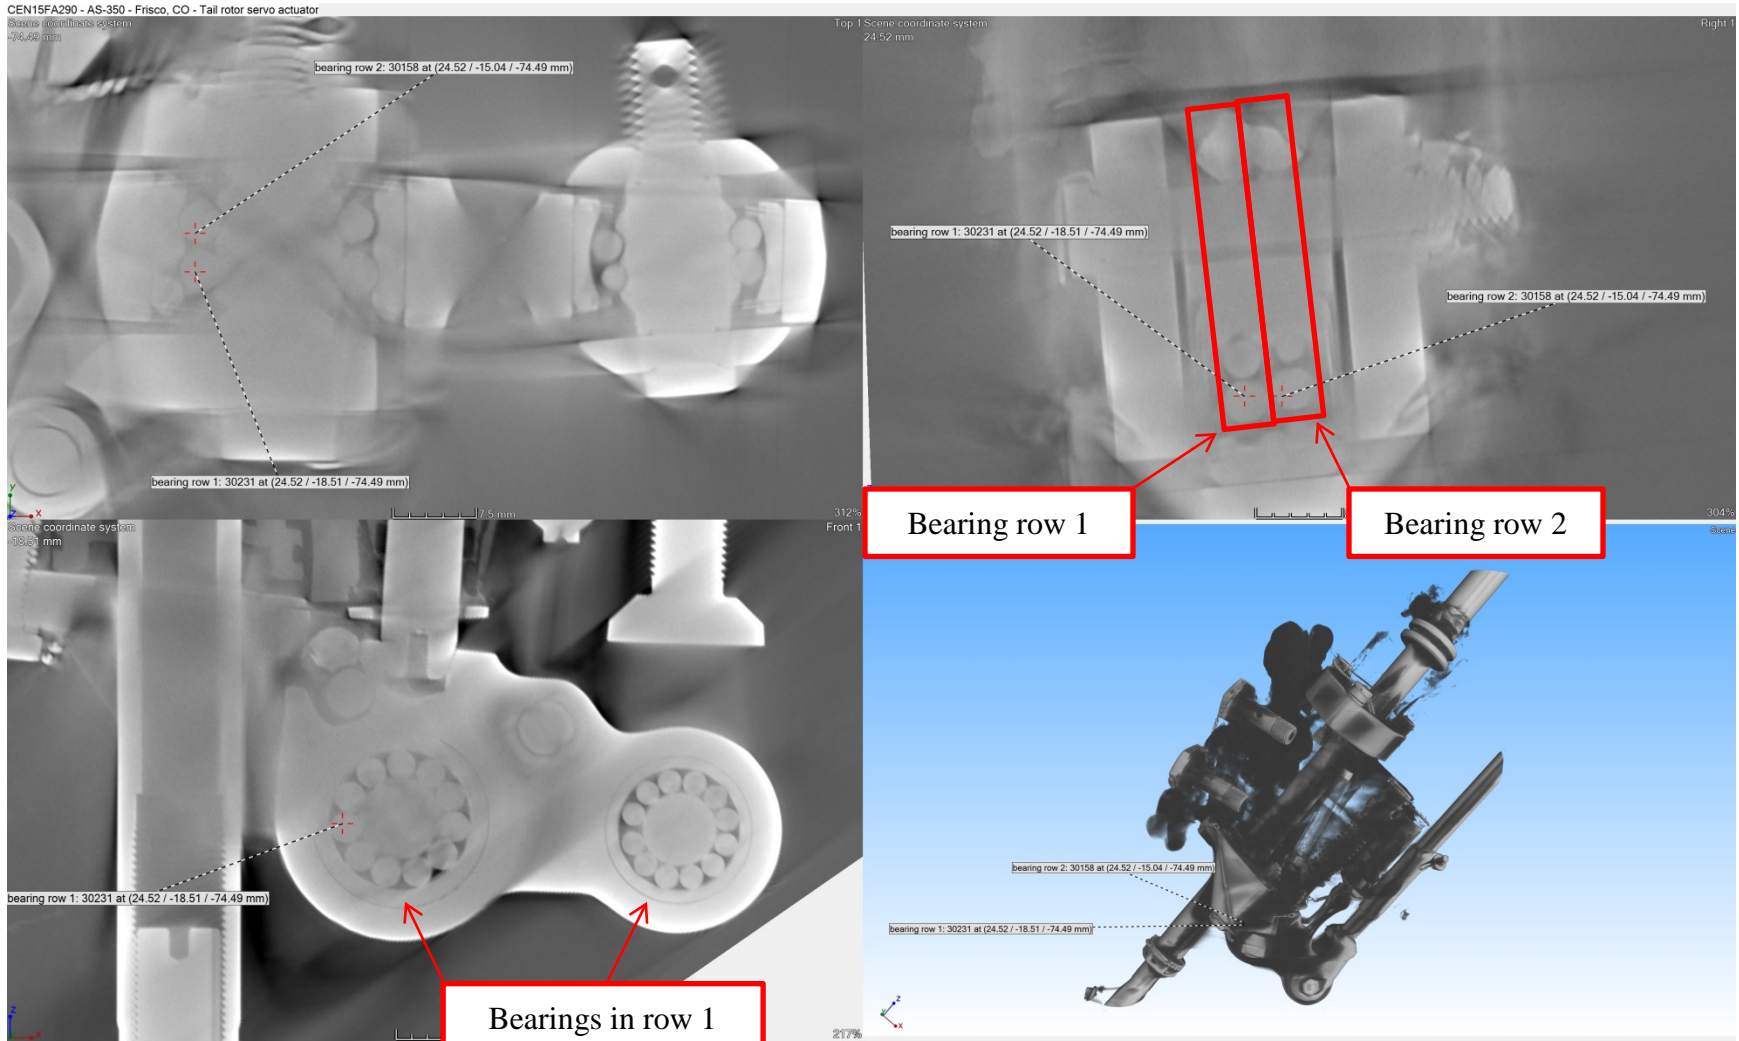
Figure 16  
Tail rotor actuator – Bearings in row 1

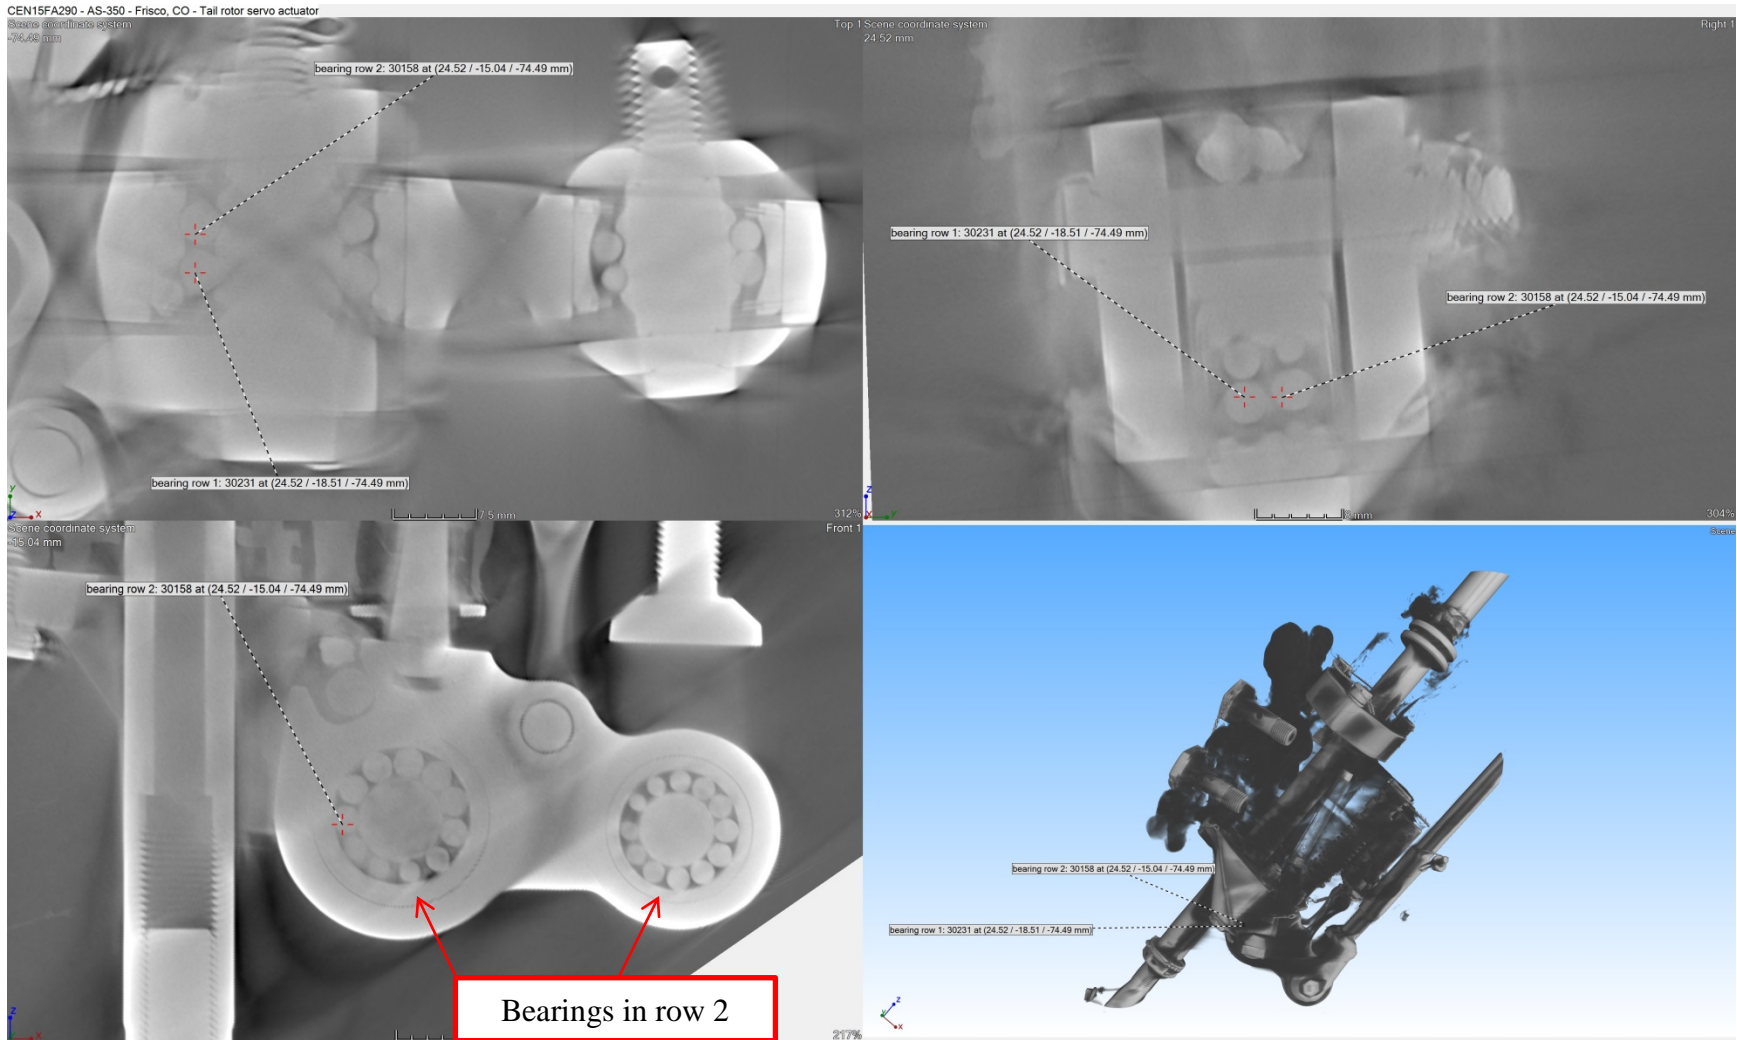
Figure 17  
Tail rotor actuator – Bearings in row 2

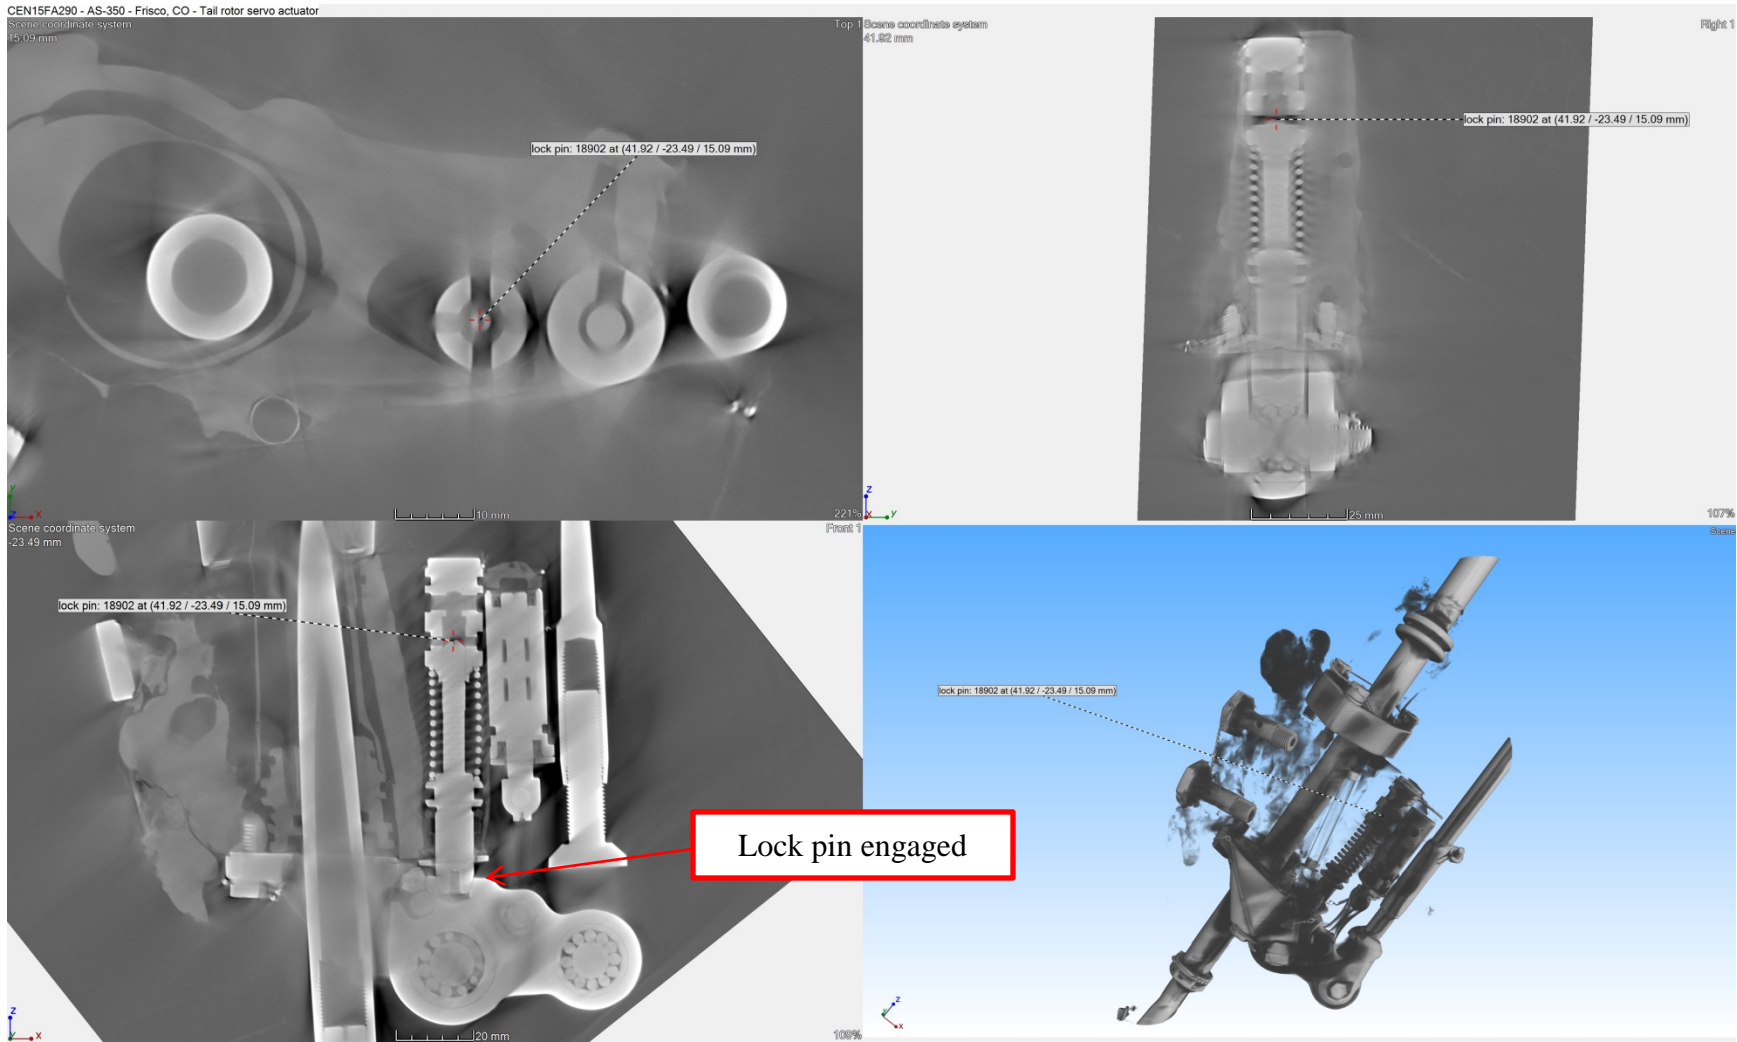
Figure 18  
Tail rotor actuator – Overall cross section through lock pin

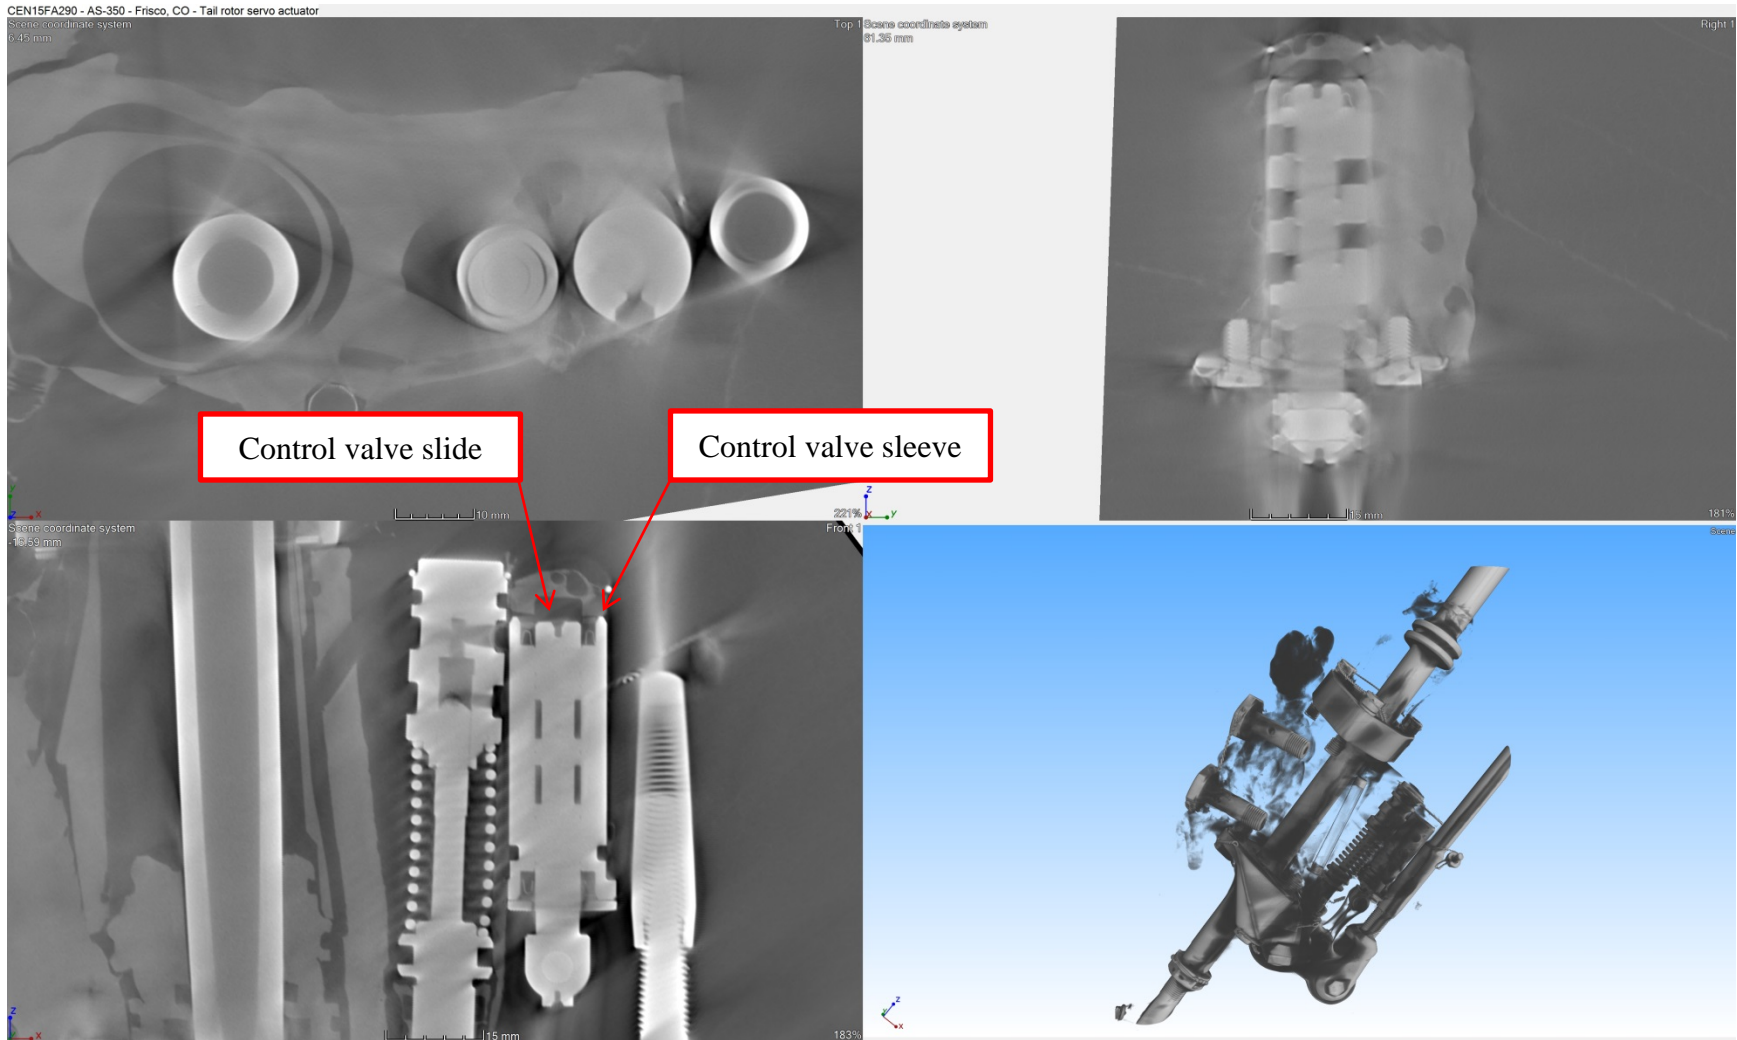
Figure 19  
Tail rotor actuator – Overall cross section through control valve

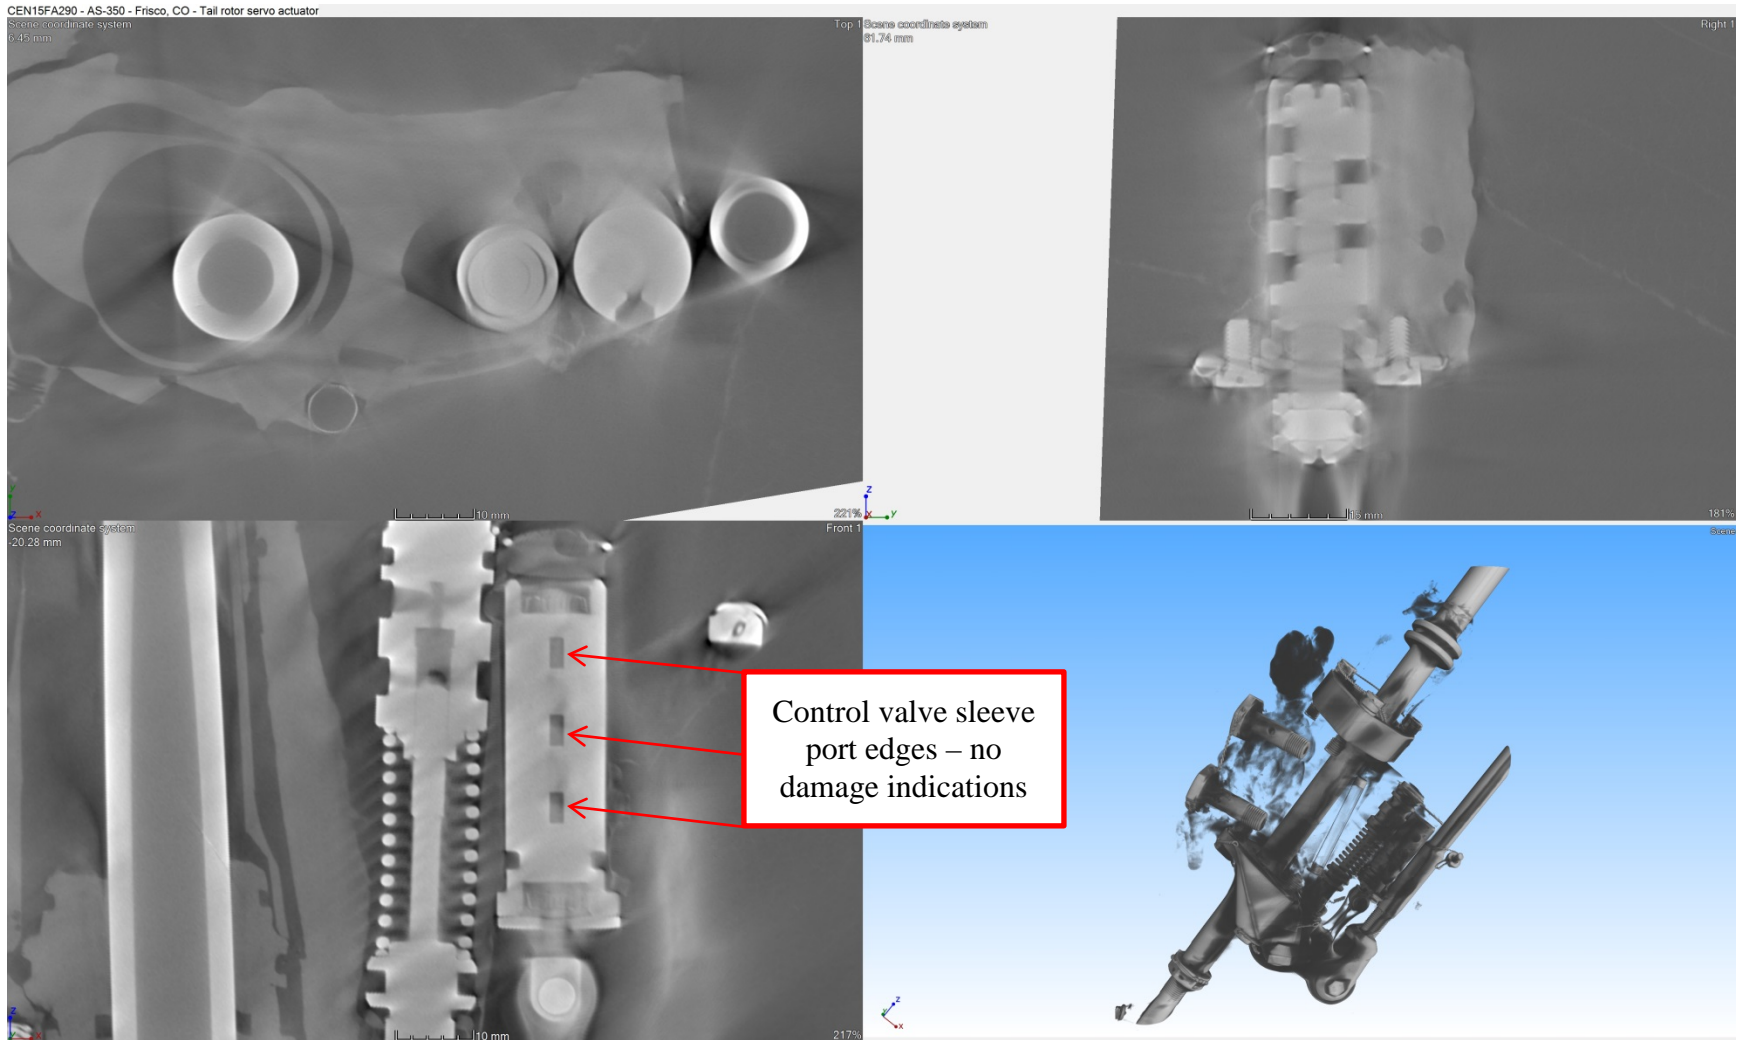
Figure 20  
Tail rotor actuator – Overall cross section through control valve – port edges

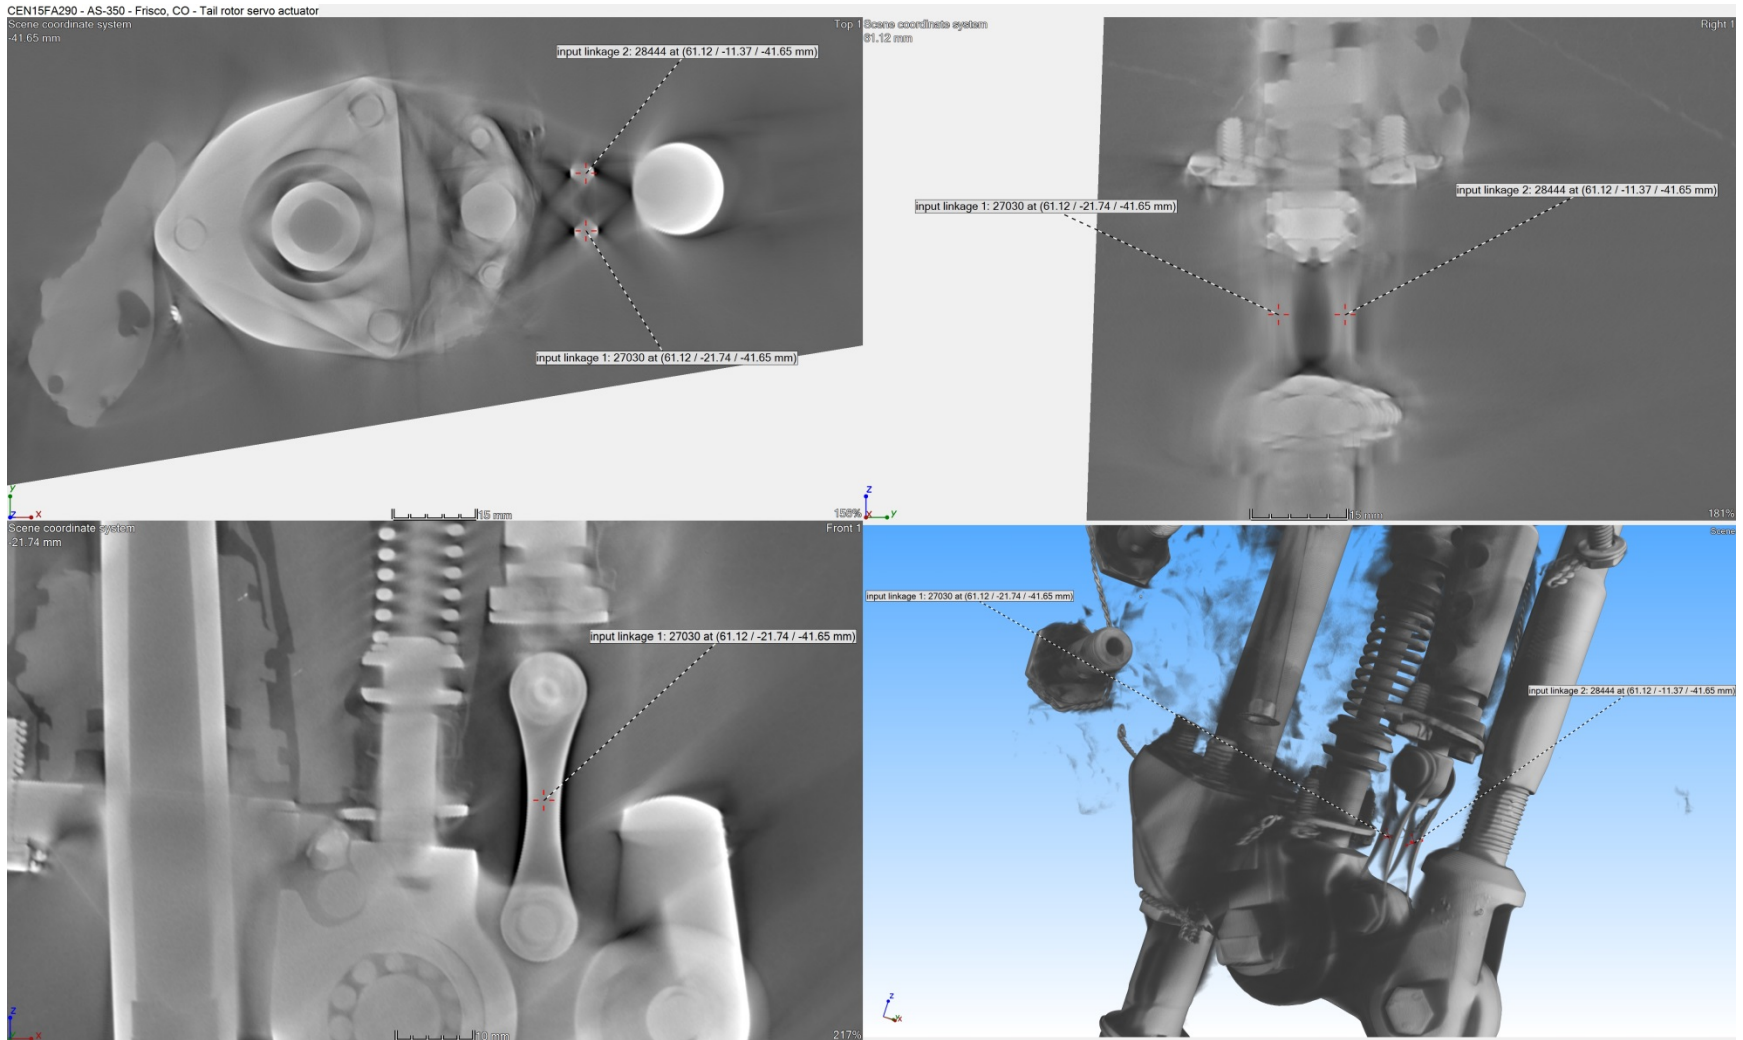
Figure 22  
Tail rotor actuator – Input linkage 1

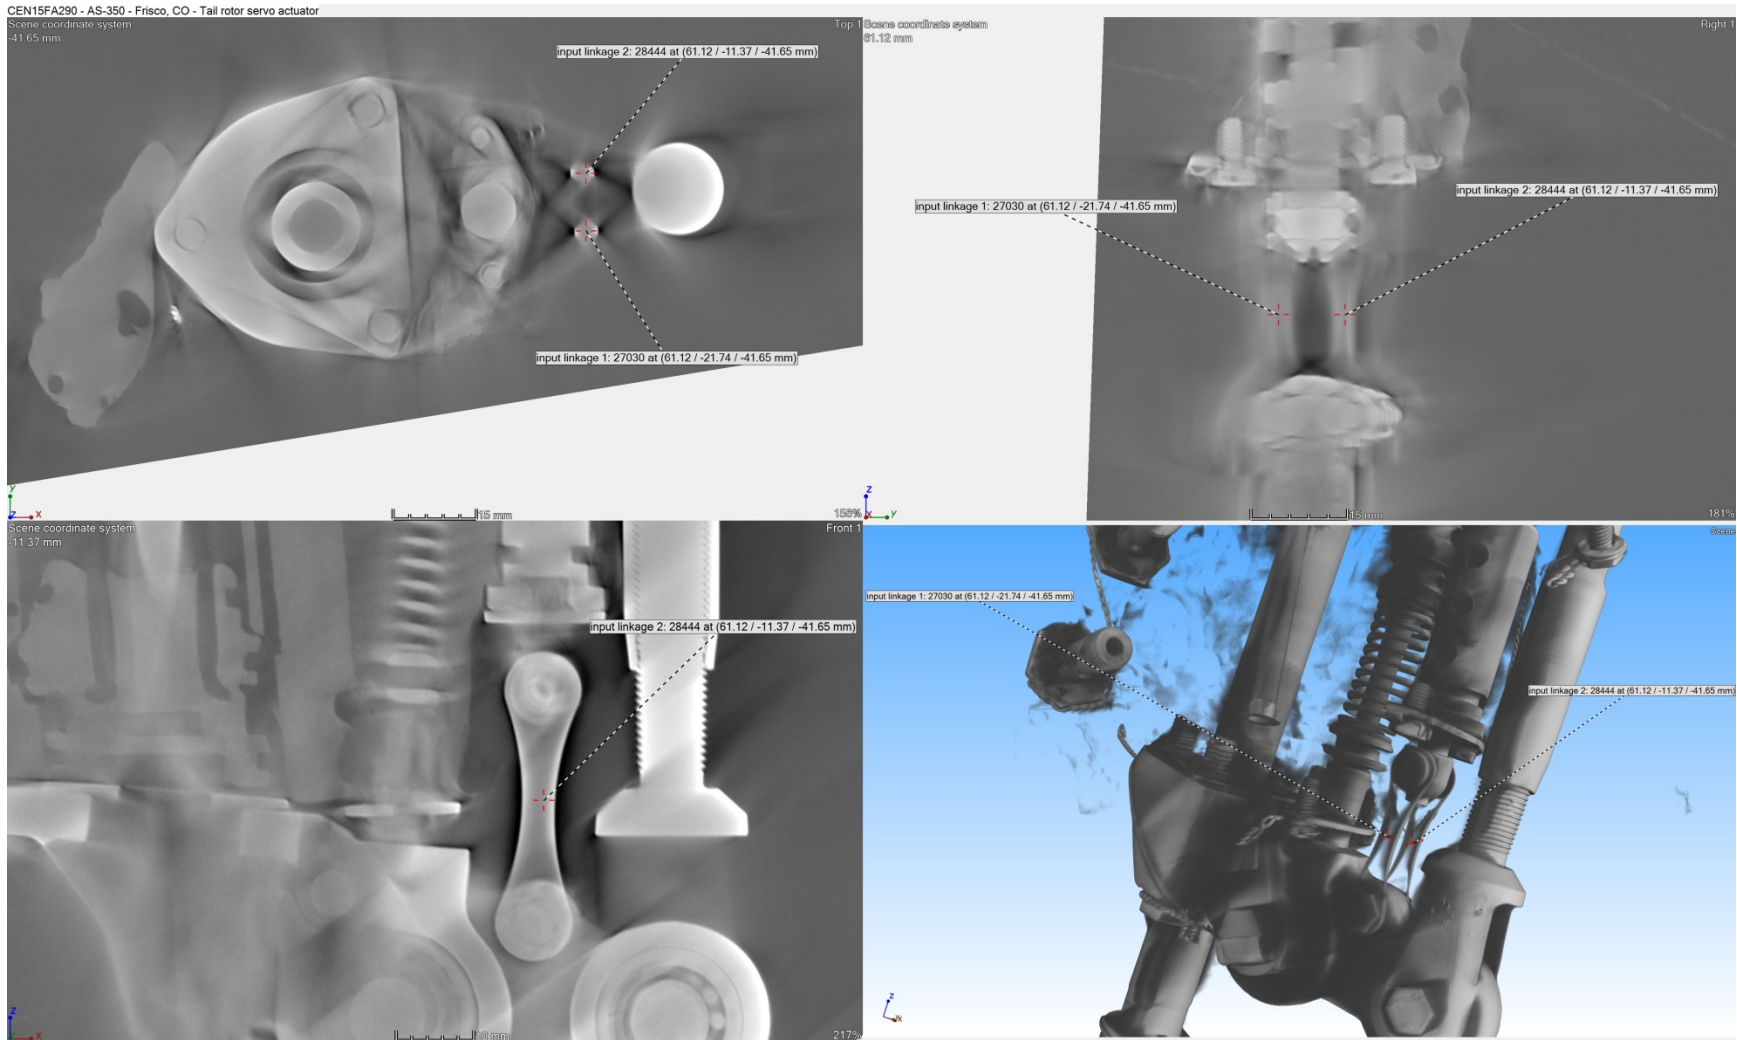
Figure 23  
Tail rotor actuator – Input linkage 2

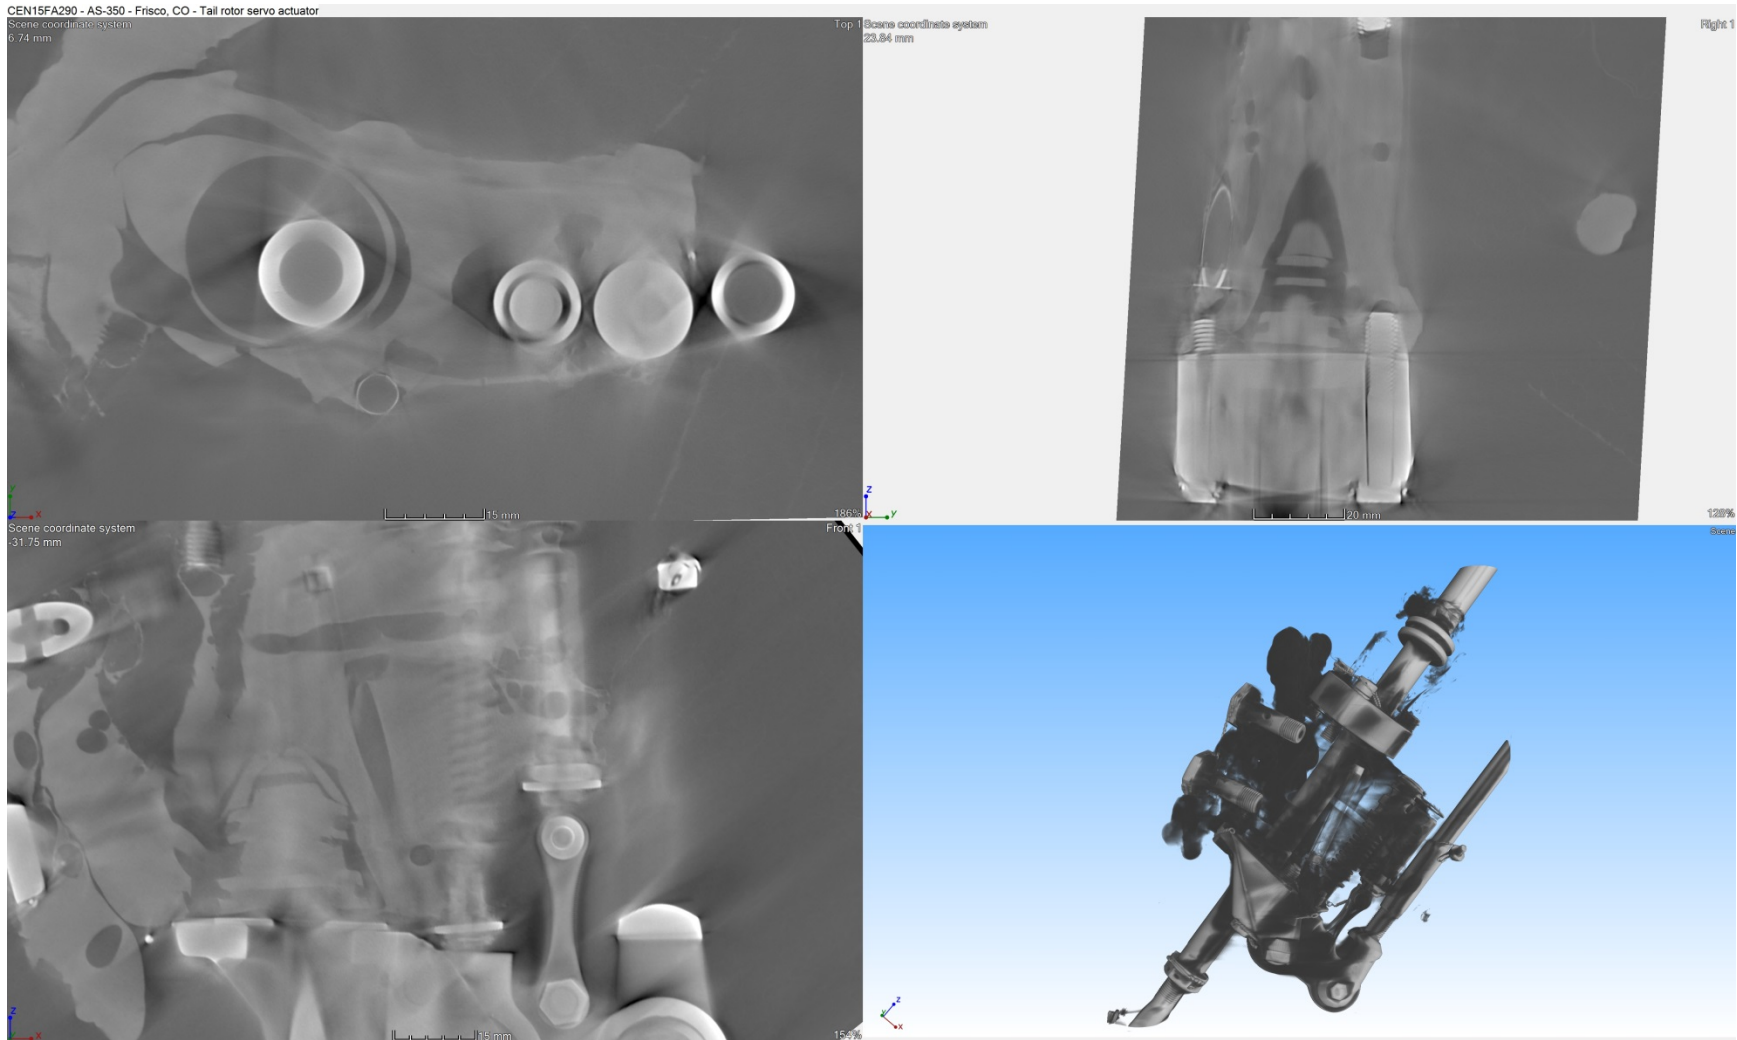
1. There were no indications of damage noted on any of the tail rotor actuator bearings sets;
2. The lock pin was noted to be in the engaged position;
3. There were no indications of damage noted on the control valve port edges;
4. No foreign material was noted inside or outside of the tail rotor actuator filter;
5. The hydraulic passages within the actuator were distorted in a manner consistent with heat damage.

Figure 24  
Tail rotor actuator – Distorted hydraulic passages
