NATIONAL TRANSPORTATION SAFETY BOARD

Computed Tomography Specialist's Factual Report

WPR-15-IA-046

Operator: Hawkeye Aviation Holdings Ltd
Location: Palm Springs International Airport (PSP), Palm Springs, California
Date: November 23, 2014
Time: 1052 pacific standard time
Vehicle: Embraer EMB-505, C-GJOL

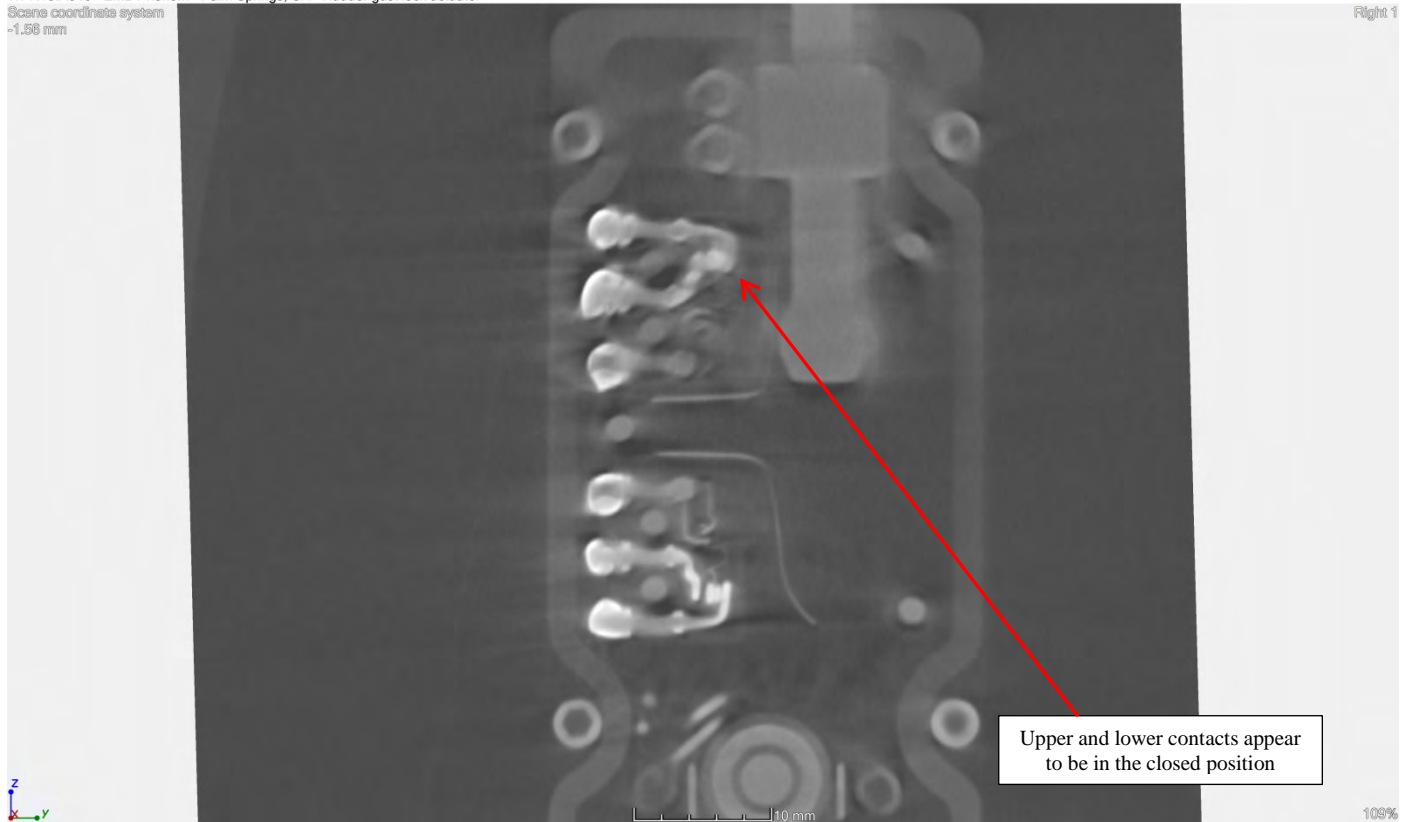
Figure 6

1. The extend limit switch contacts appeared to be closed during the standard focus scans (see figure 6) and open during the microfocus scans (see figure 7). Whether this difference was due to an actual position change of the contacts or due to the resolution differences of the two scanning methods could not be determined;

Rudder gust lock actuator – standard focus – limit switches close up view (note that the extend limit switch contacts (lower and upper) appear to be closed)

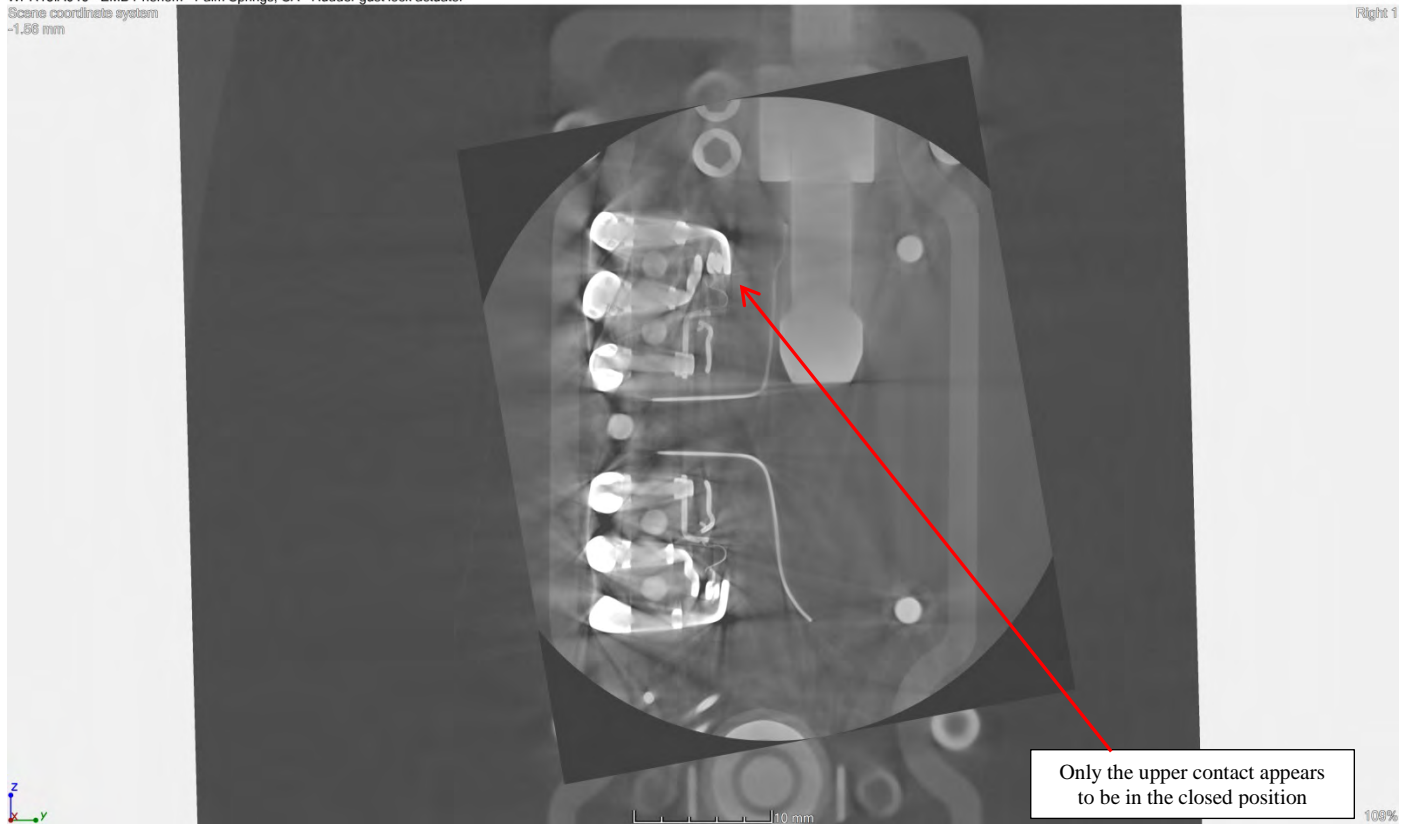
Figure 7

Rudder gust lock actuator – standard focus – limit switches close up view with microfocus view overlaid (note that the extend limit switch lower contact appears to be open)

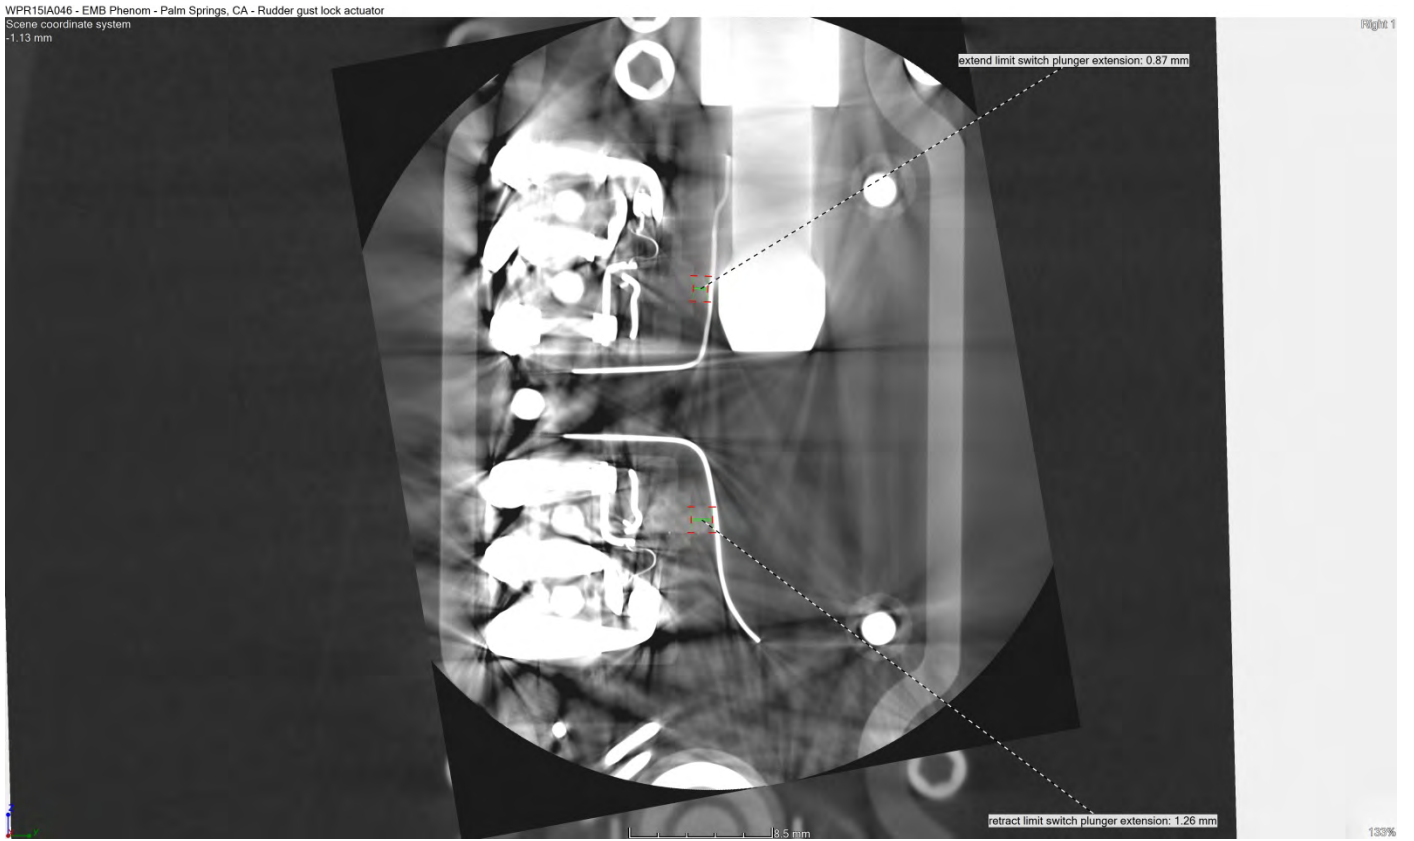
Figure 10

2. The extend and retract limit switch plungers were extended different lengths (0.87 mm and 1.26 mm respectively) (see figure 10);
3. High and medium density particles were found in various locations throughout the actuator;

Rudder gust lock actuator – microfocus (re-reconstructed to enhance low density objects) – extend and retract limit switch plunger extension distances

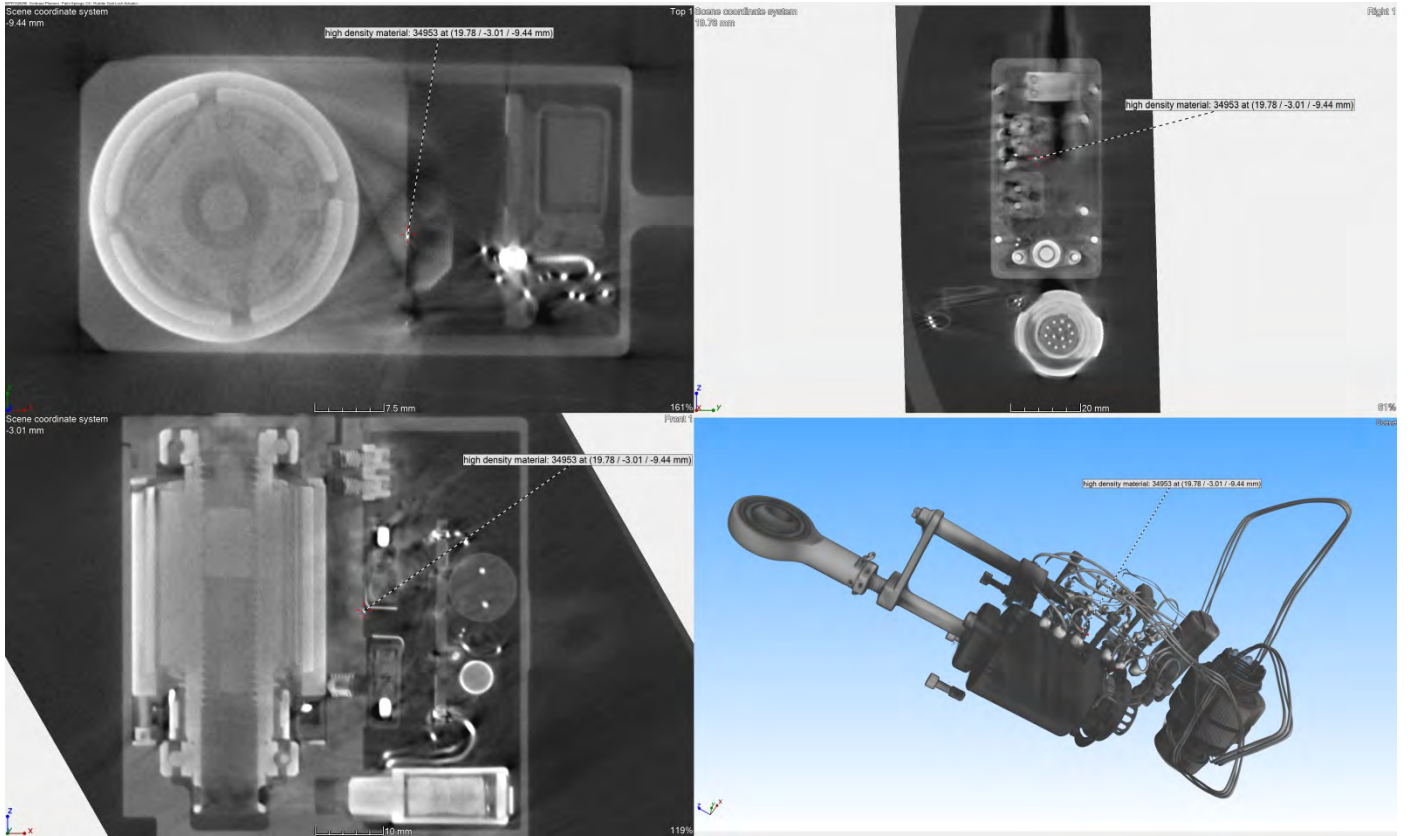
Figure 11
Rudder gust lock actuator – standard focus – high density particle

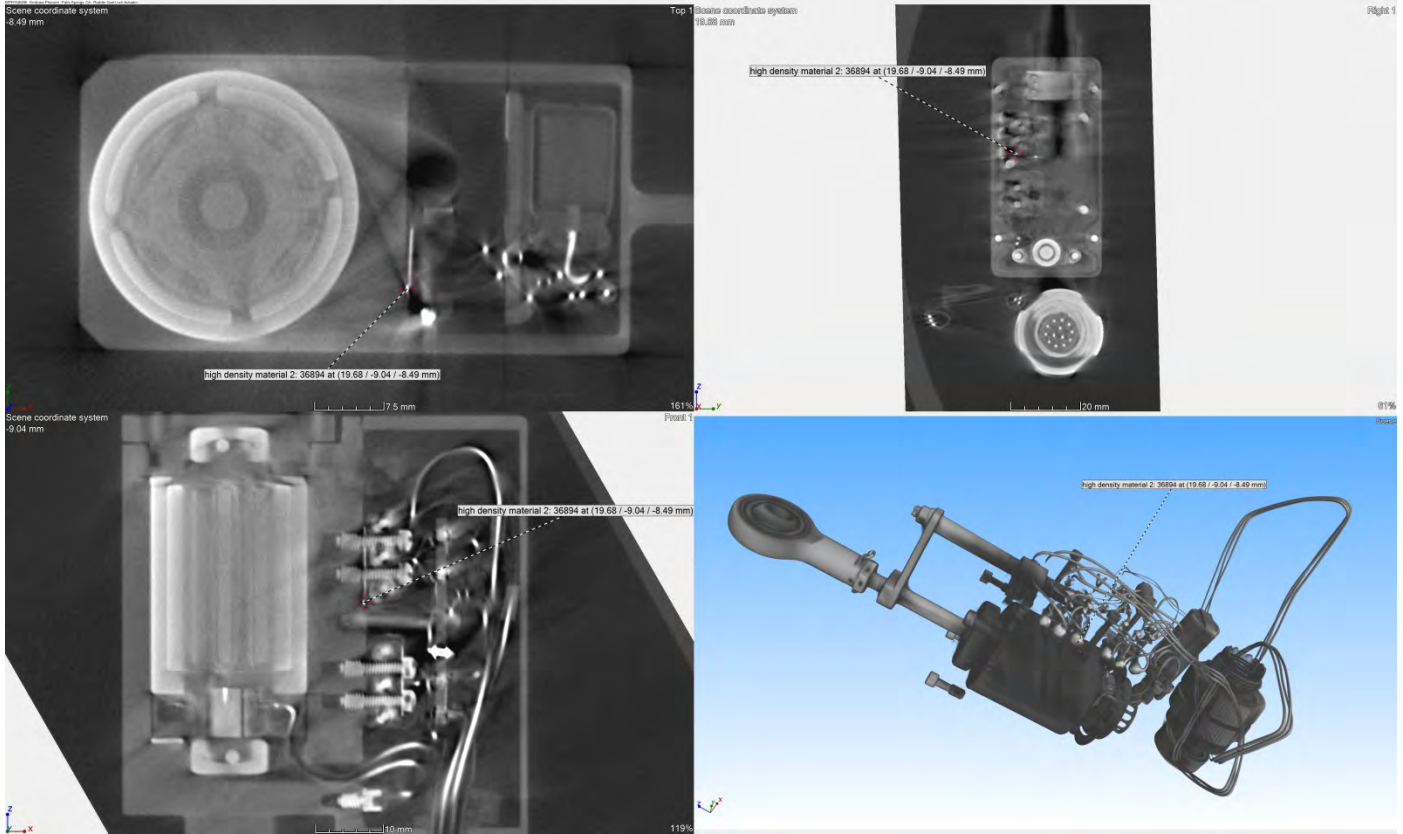
Figure 12
Rudder gust lock actuator – standard focus – high density particle 2

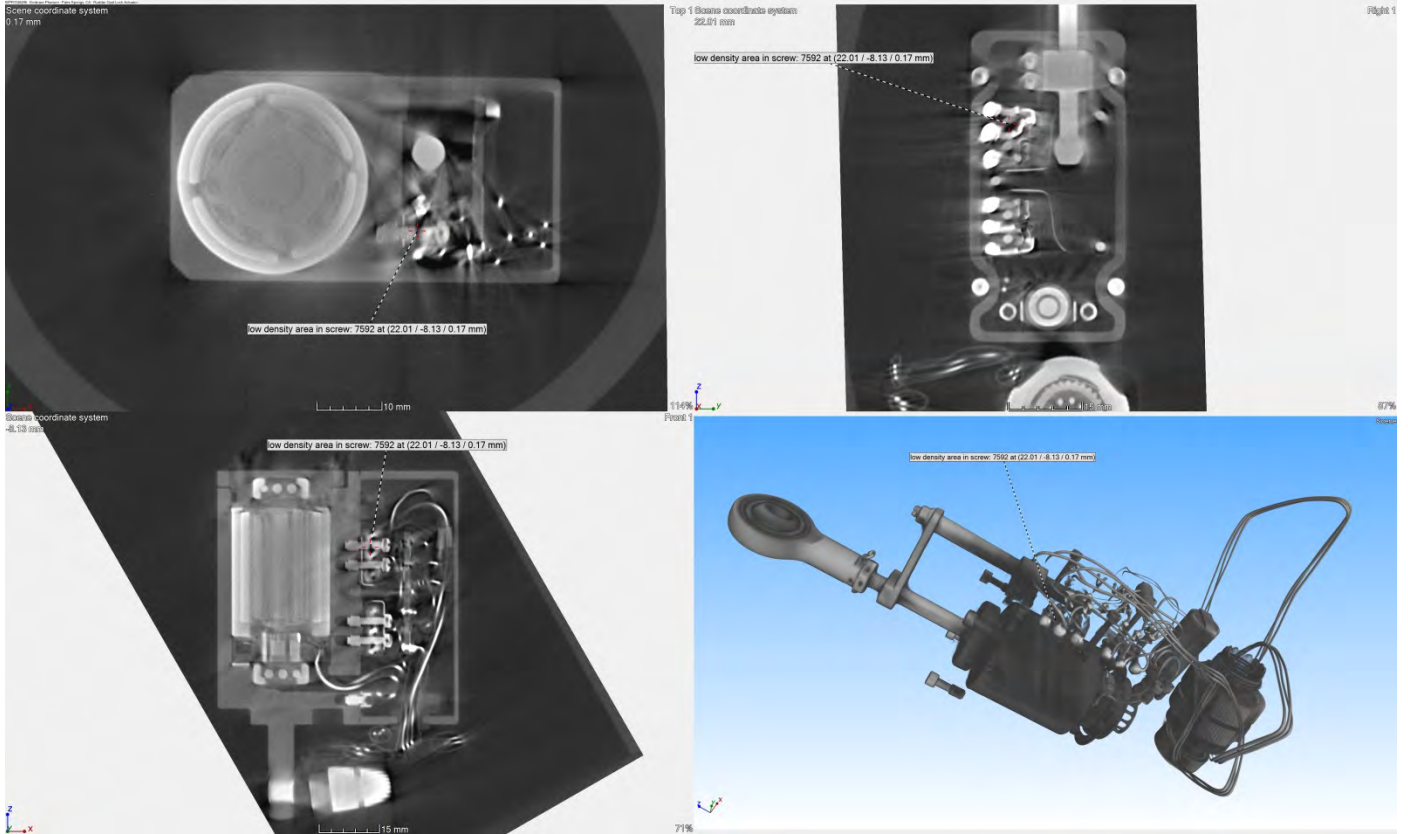
4. A low density indication within one of the extend limit switch screws was only visible in the standard focus scans and not the microfocus scans – this indication is consistent with the apparent low density area being a scanning artifact (see figures 13-15);

Figure 13
Rudder gust lock actuator – standard focus – low density area in screw

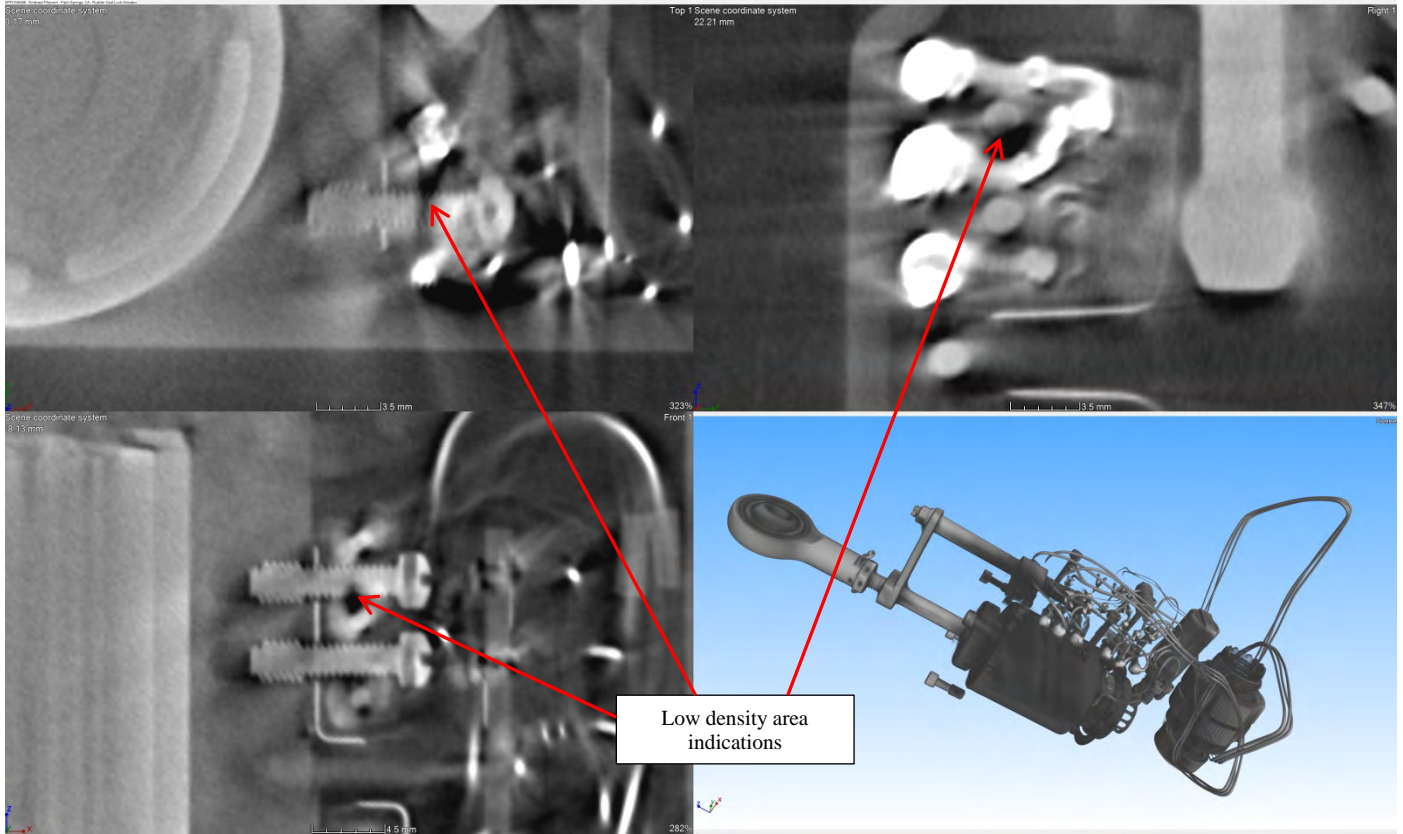
Figure 14
Rudder gust lock actuator – standard focus – low density area in screw close up view

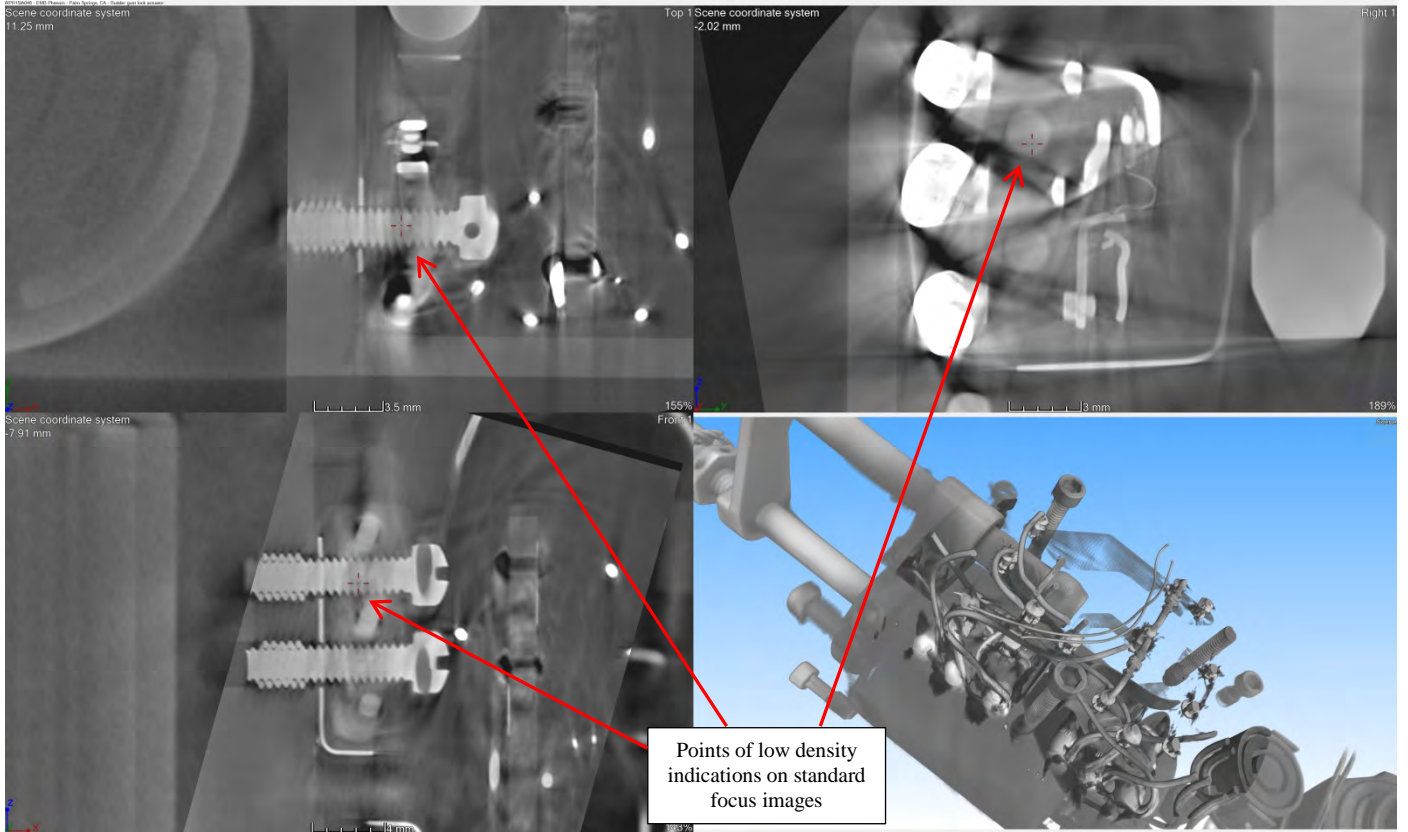
Figure 15

Rudder gust lock actuator – microfocus – low density area in screw close up view (low density area indicated in standard focus images is no longer present)

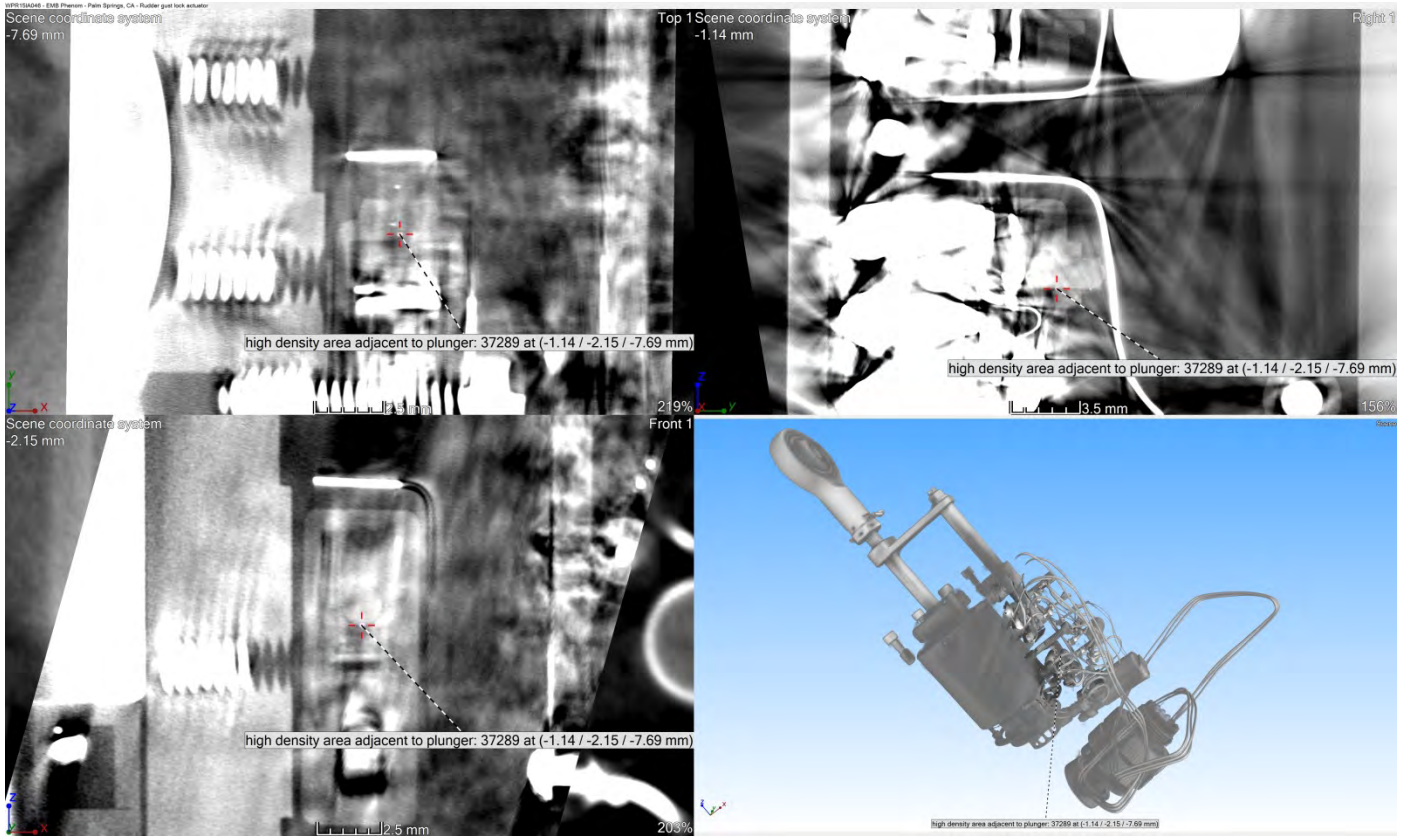
Figure 17

Rudder gust lock actuator – microfocus (re-reconstructed to enhance low density objects) – high density area adjacent to retract limit switch plunger

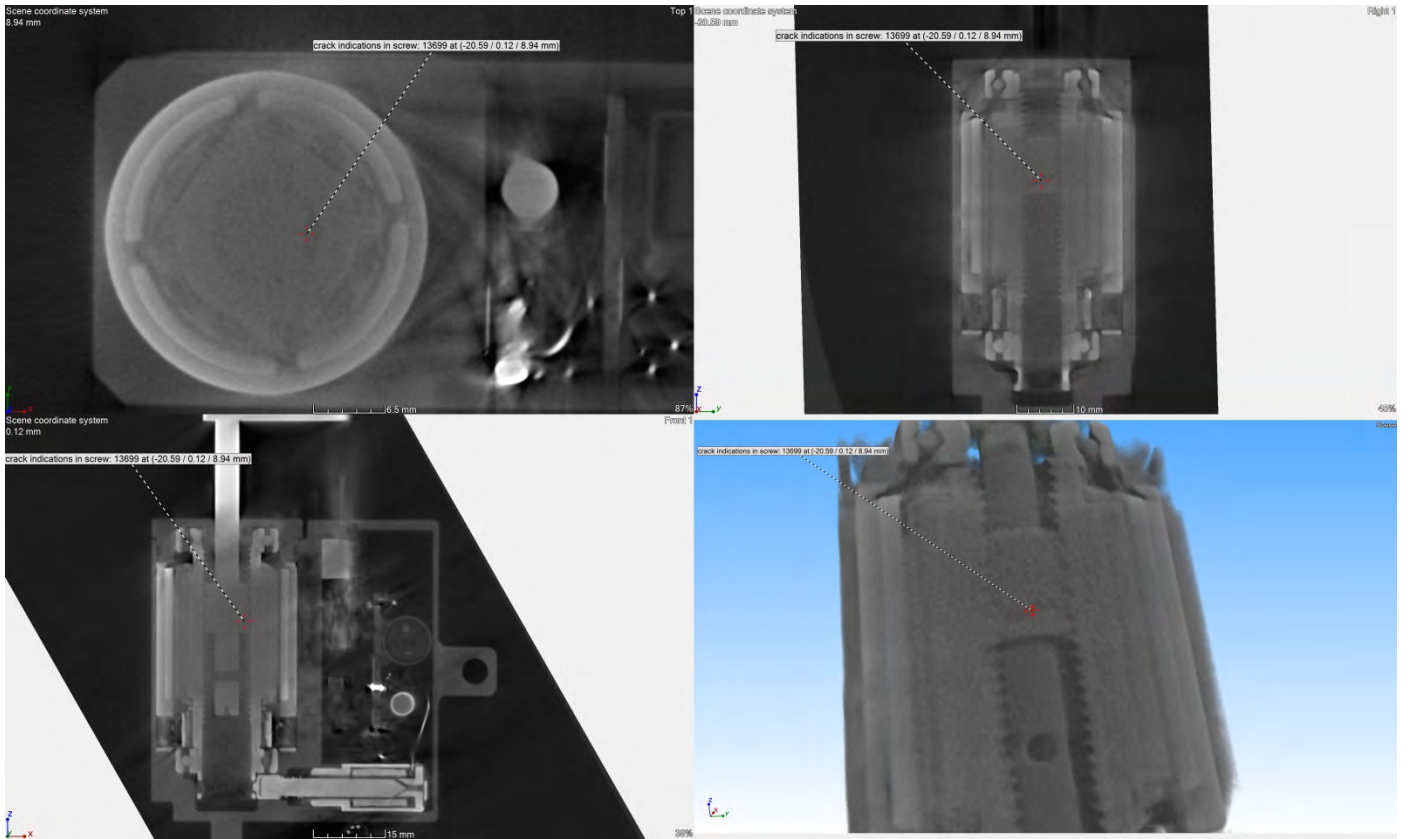
5. Indications of a crack in the ball screw that were noted in the standard focus scans were more completely resolved in the microfocus scans as the balls and groove located on the ball screw. However, there was an indication of a discontinuity within one of the balls shown on the microfocus images (see figures 19-26);

Figure 19
Rudder gust lock actuator – standard focus – crack indication in screw ball area

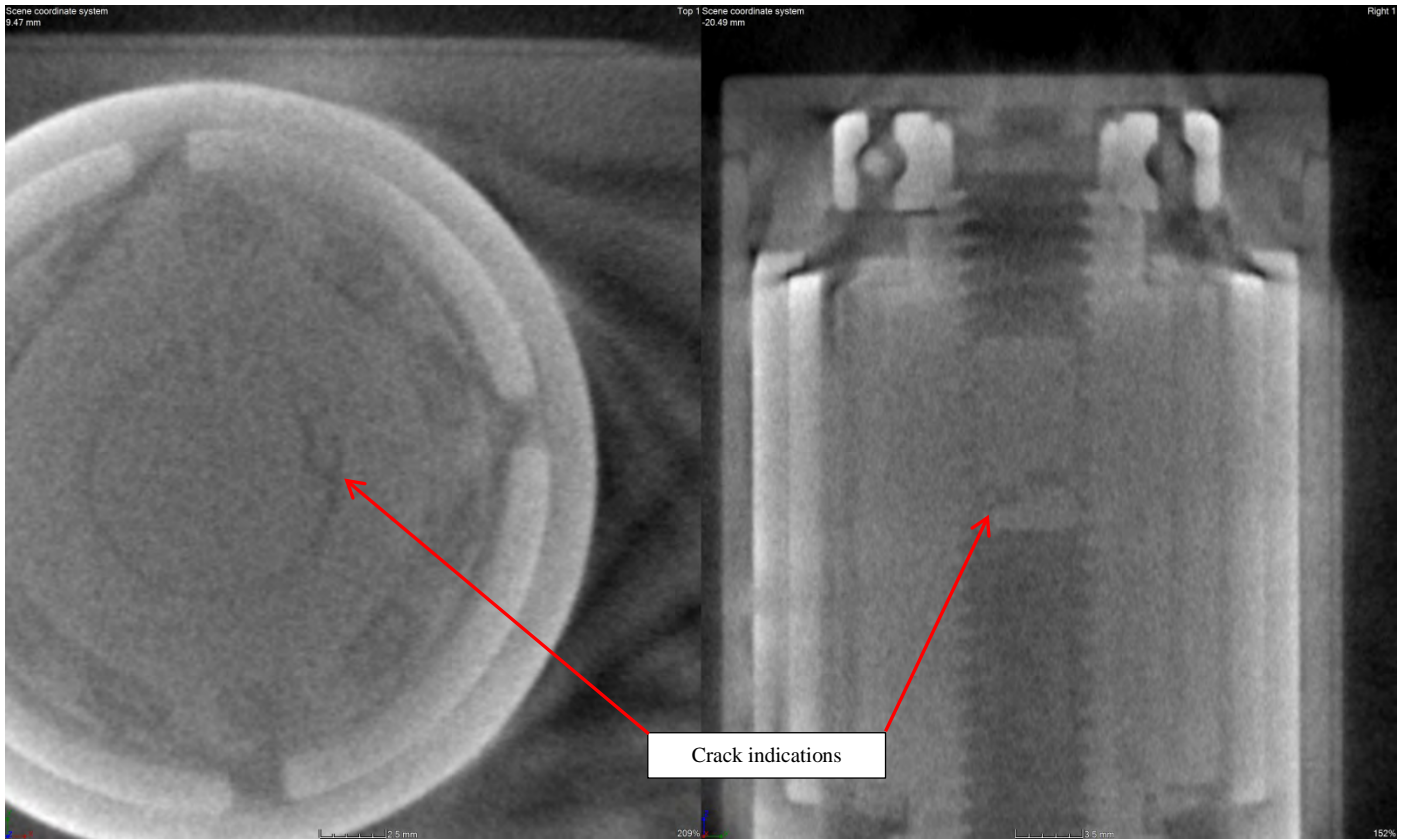
Figure 20
Rudder gust lock actuator – standard focus – crack indication in screw ball area close up view

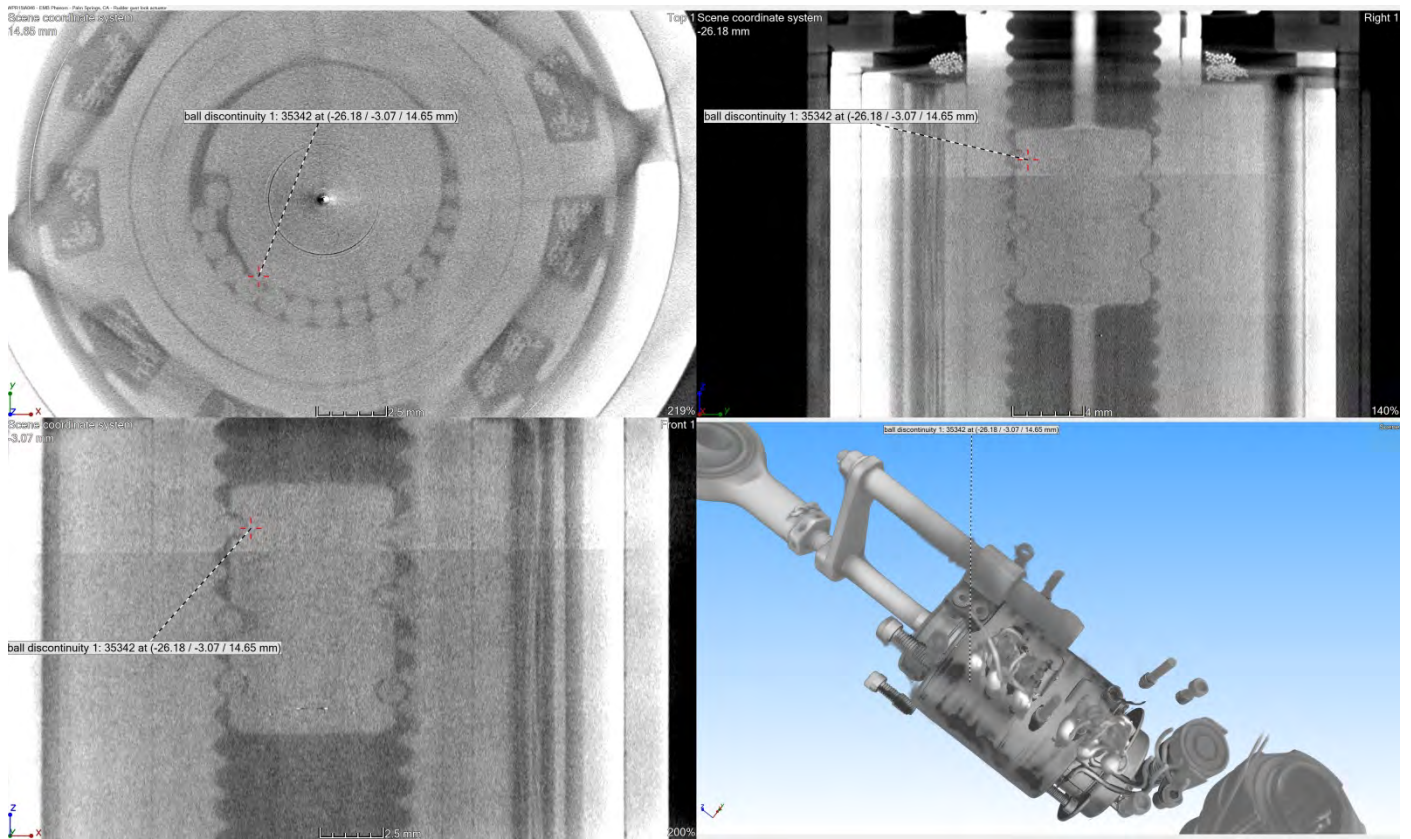
Figure 25
Rudder gust lock actuator – microfocus – ball screw showing possible ball discontinuity

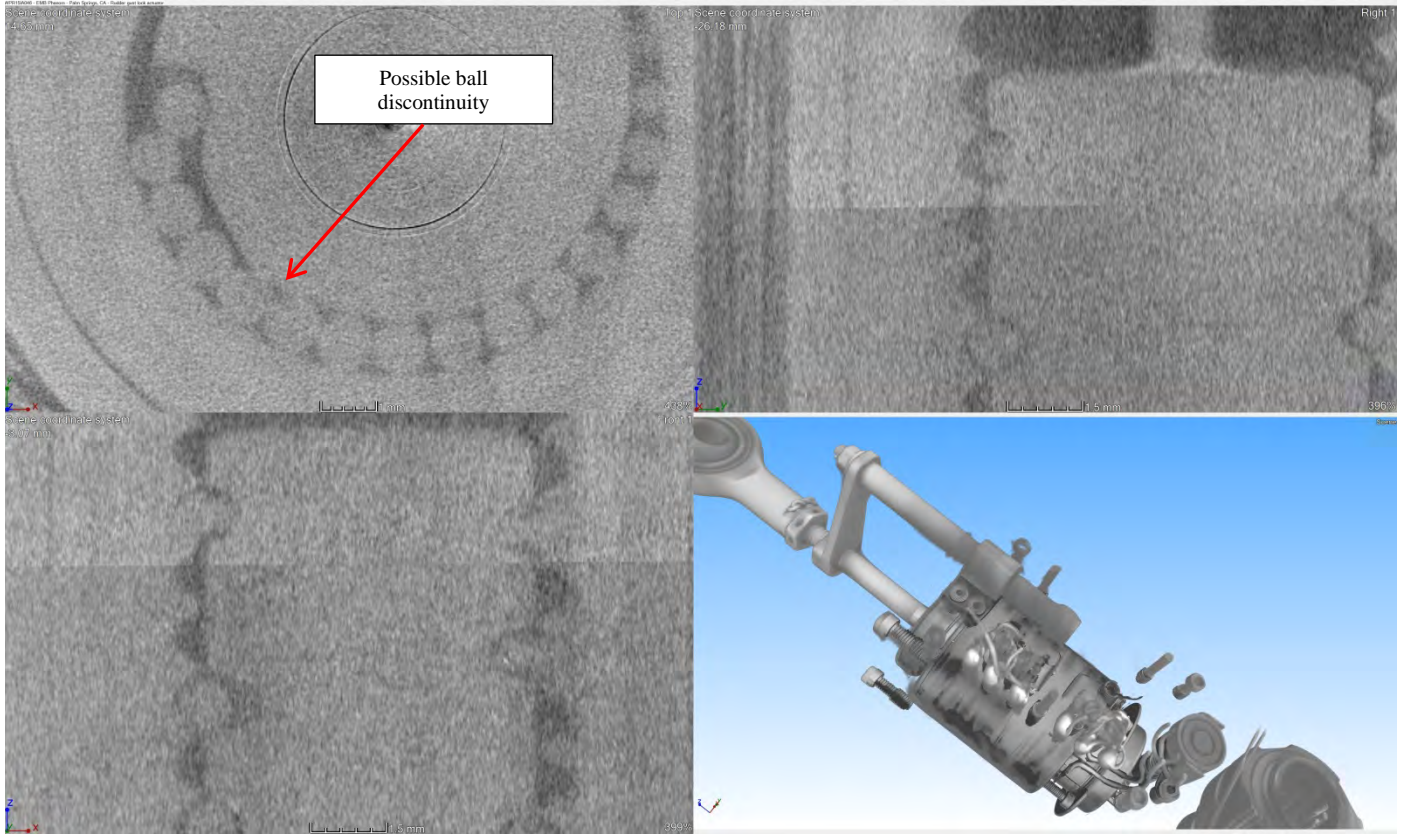
Figure 26
Rudder gust lock actuator – microfocus – ball screw showing possible ball discontinuity close up view

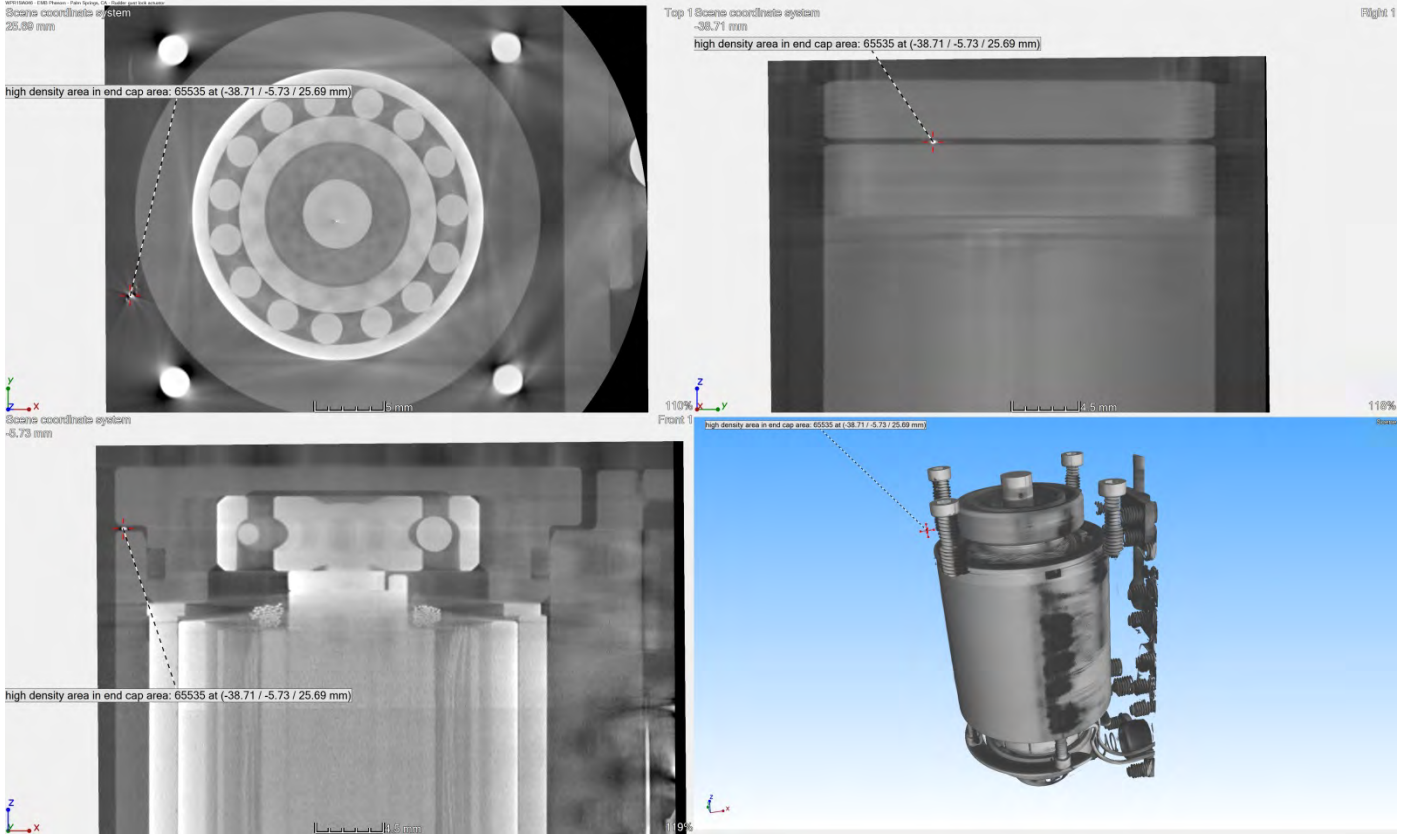
Figure 28
Rudder gust lock actuator – microfocus – high density particle in end cap area

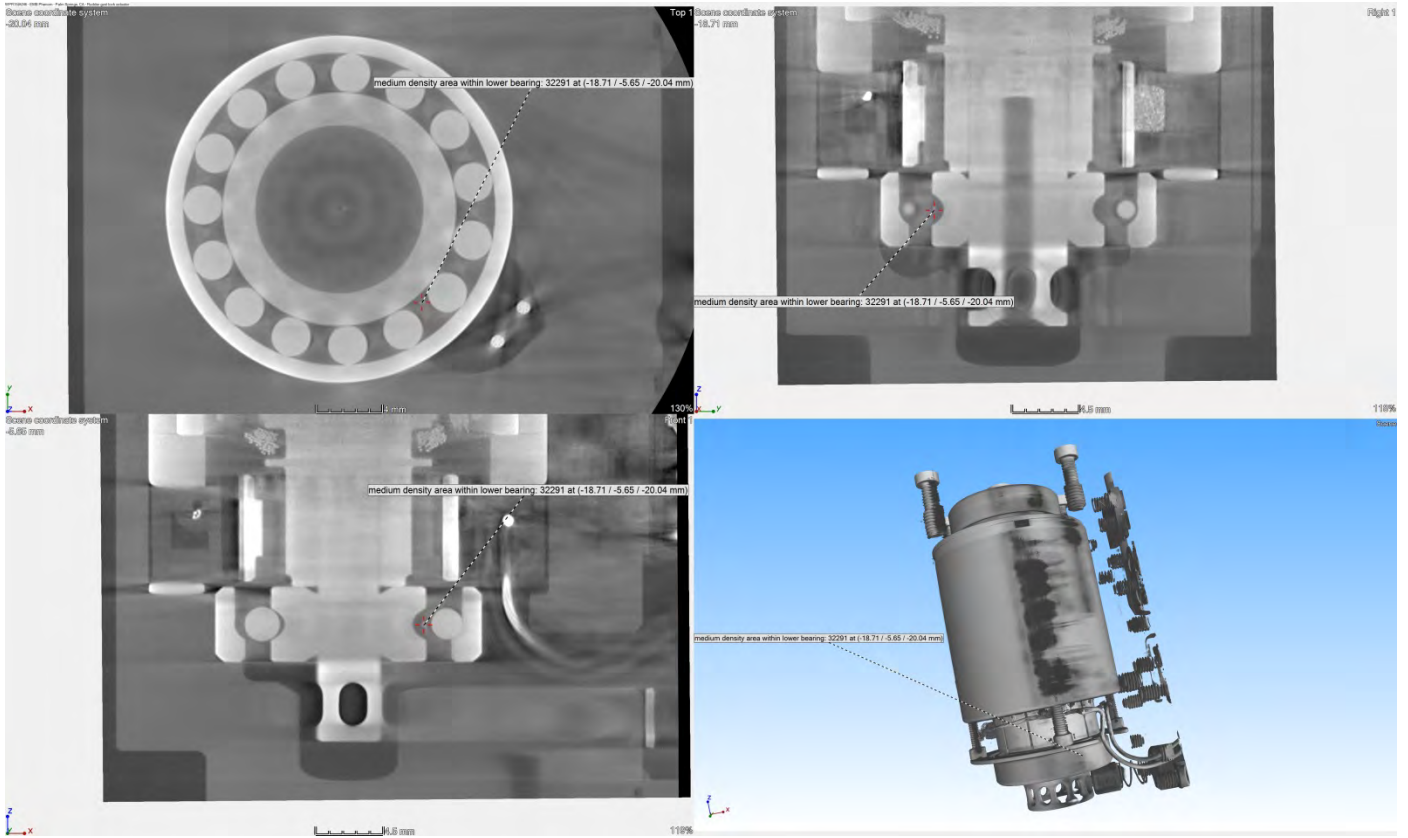
Figure 34
Rudder gust lock actuator – microfocus – medium density area within the lower bearing

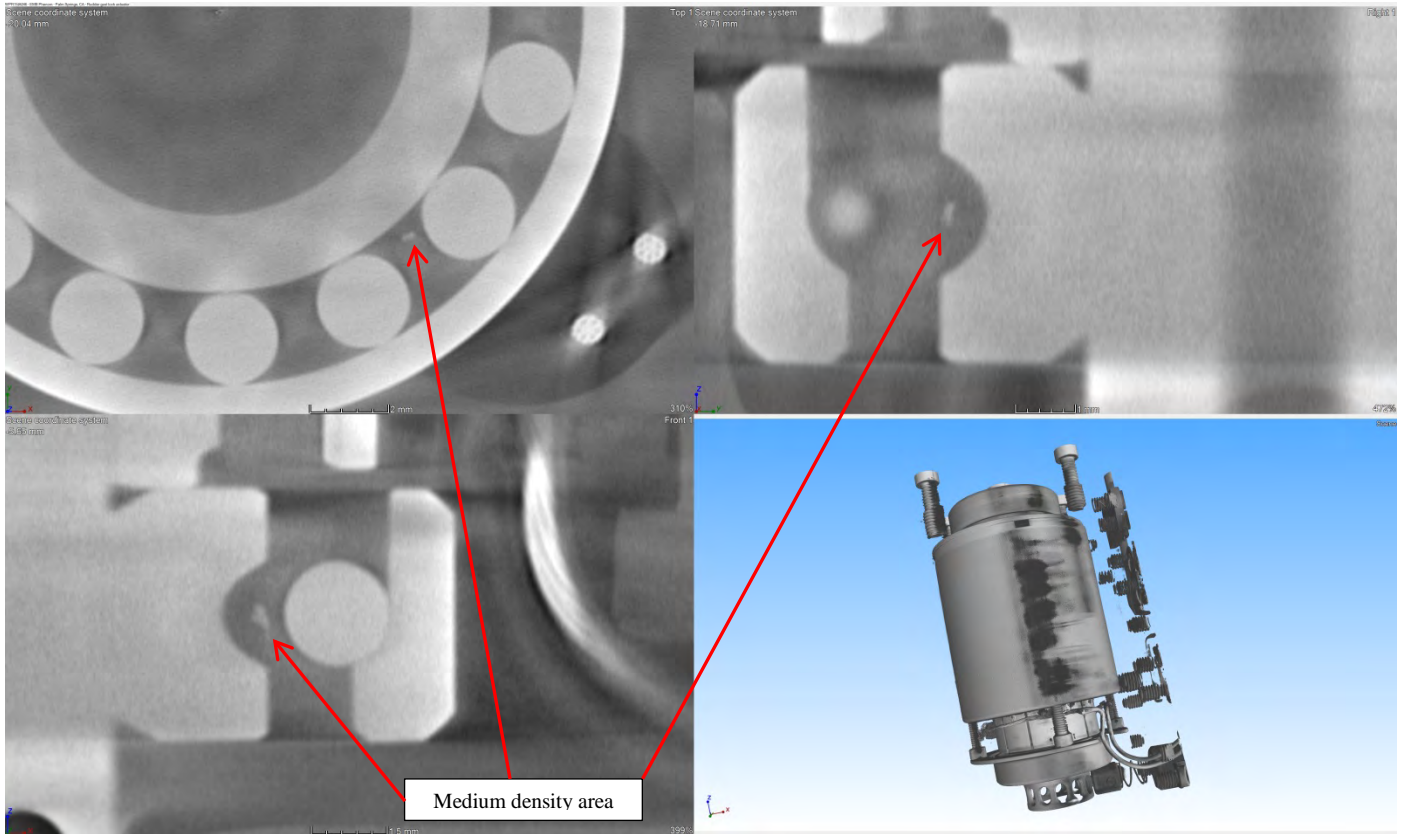
Figure 35
Rudder gust lock actuator – microfocus – medium density area within the lower bearing close up view

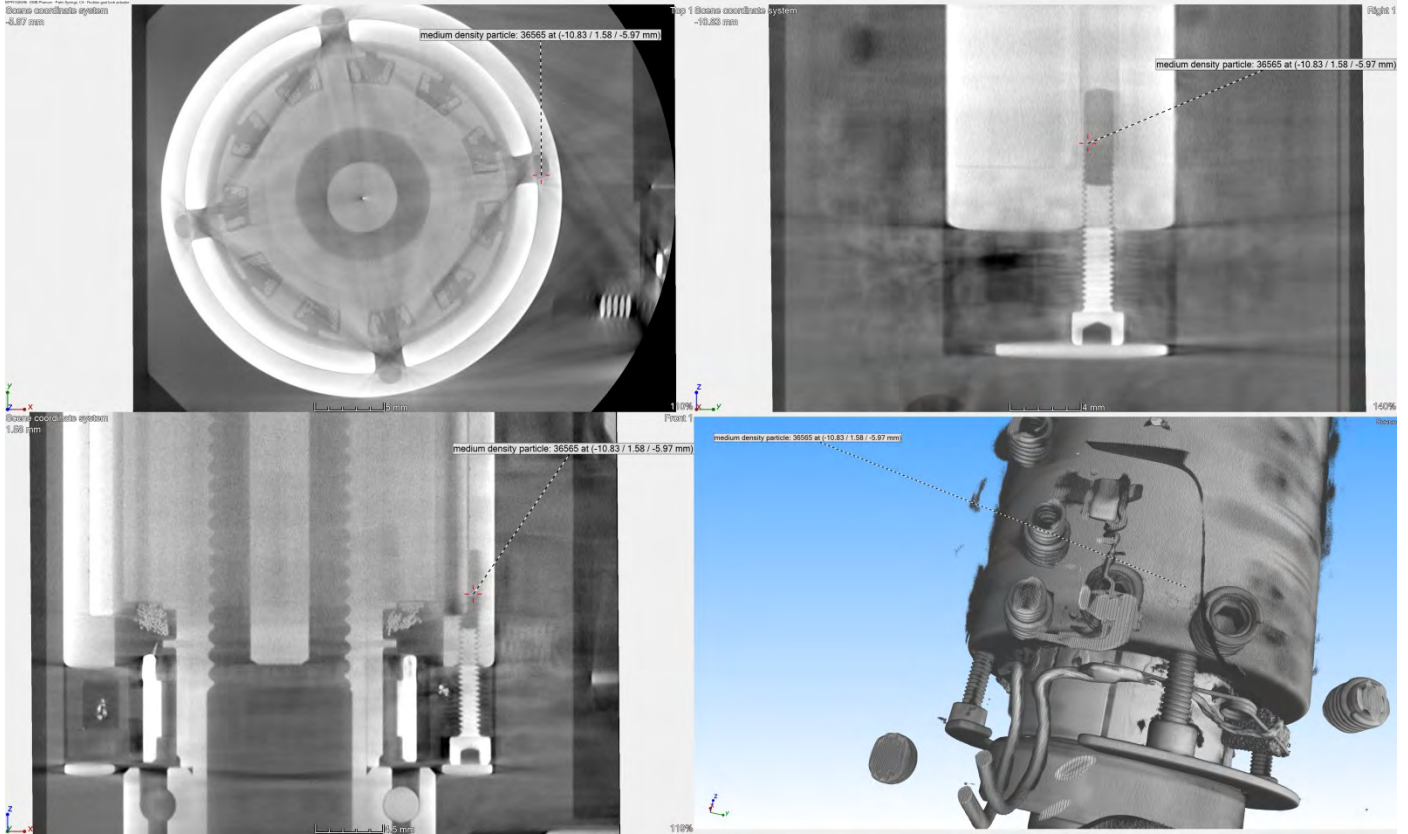
Figure 36
Rudder gust lock actuator – microfocus – medium density particle in housing

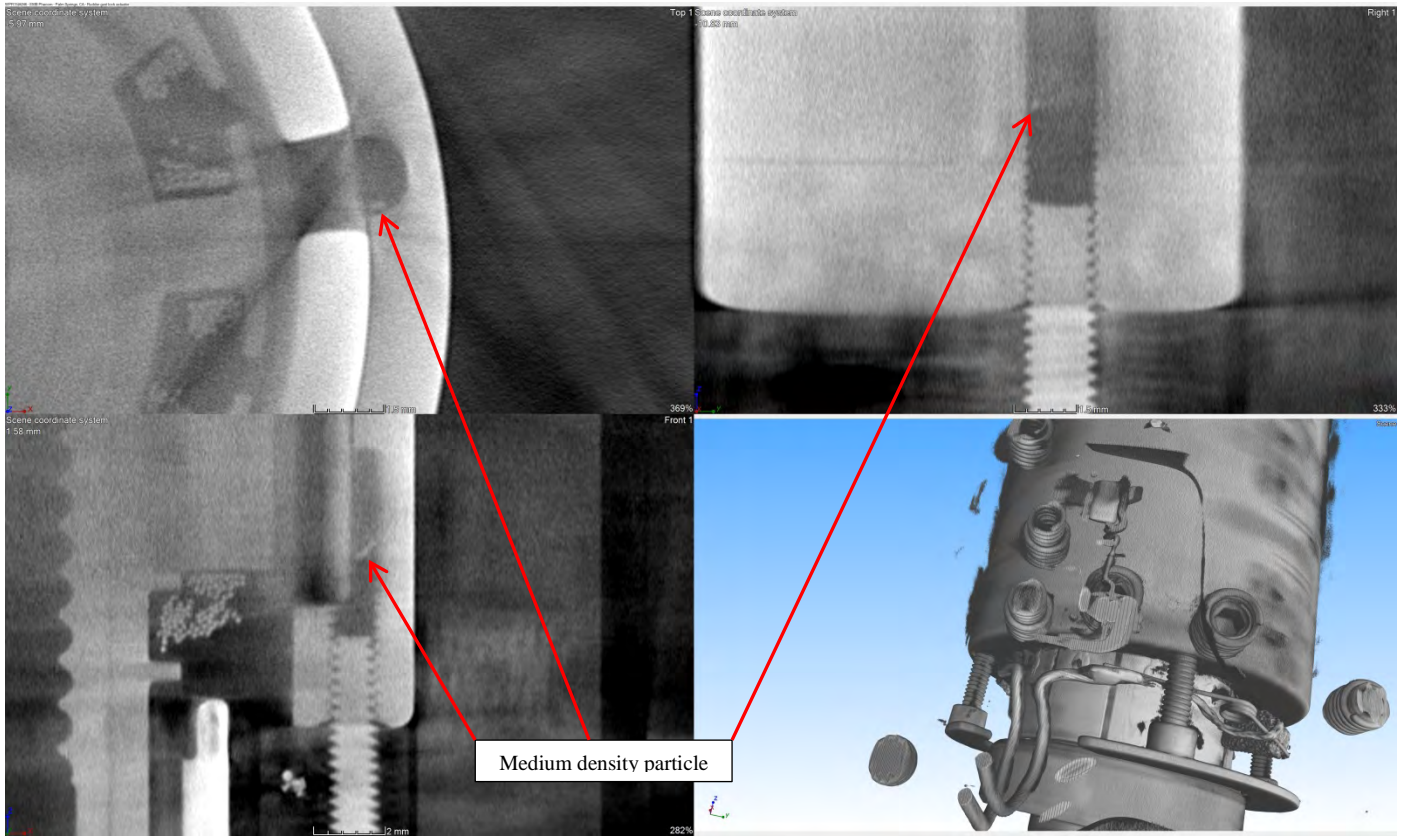
Figure 37
Rudder gust lock actuator – microfocus – medium density particle in housing close up view
