NATIONAL TRANSPORTATION SAFETY BOARD

Computed Tomography Specialist's Factual Report

WPR-15-IA-046

Operator: Hawkeye Aviation Holdings Ltd
Location: Palm Springs International Airport (PSP), Palm Springs, California
Date: November 23, 2014
Time: 1052 pacific standard time
Vehicle: Embraer EMB-505, C-GJOL

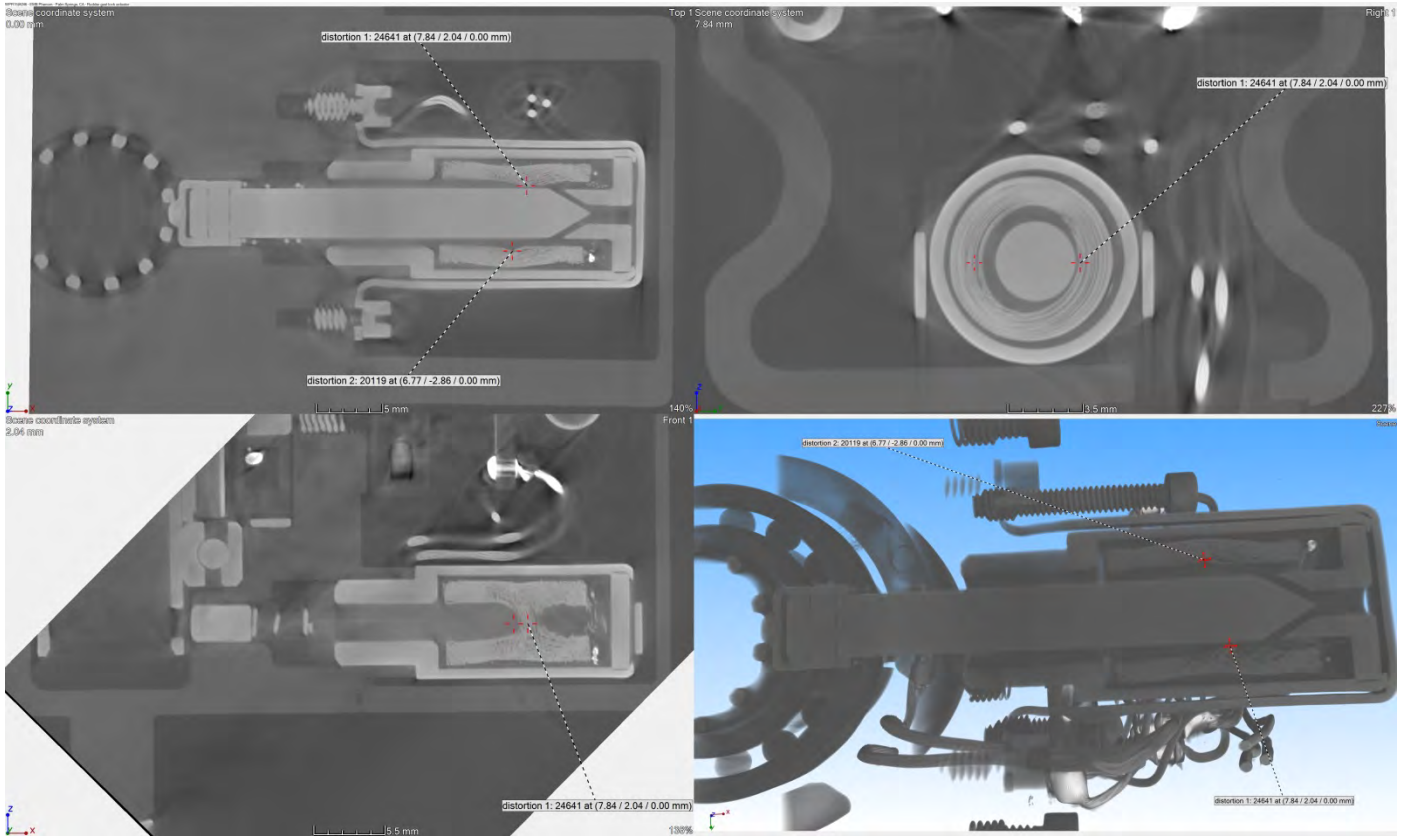
Figure 39

6. There were indications of two areas with distorted windings within the solenoid. Neither of these areas appeared to contain breaks in the windings, nor did either area contact the solenoid plunger (see figures 38-42);

Rudder gust lock actuator – microfocus – solenoid overall cross section showing winding distortions 1 and 2

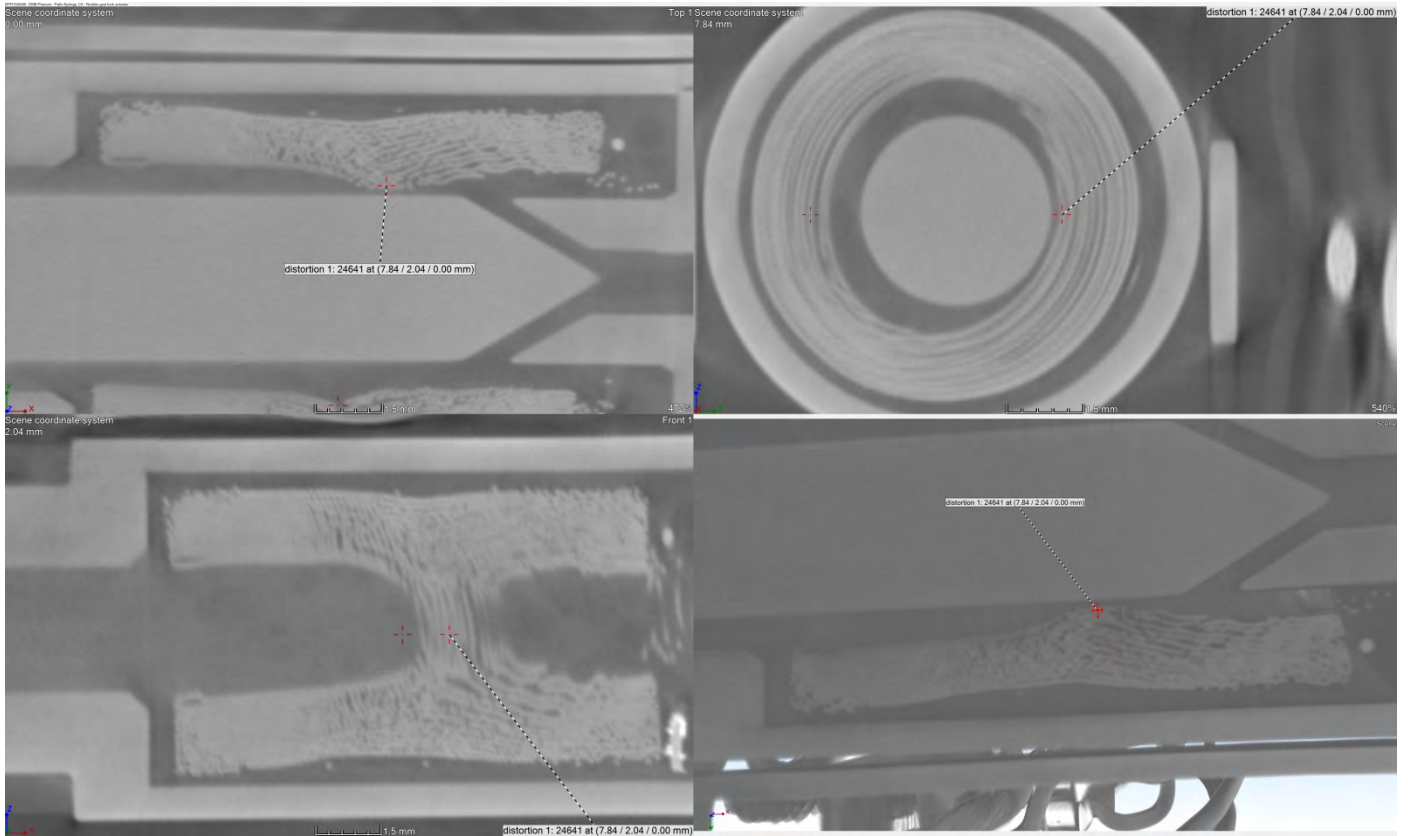
Figure 40
Rudder gust lock actuator – microfocus – solenoid showing winding distortion 1 close up view

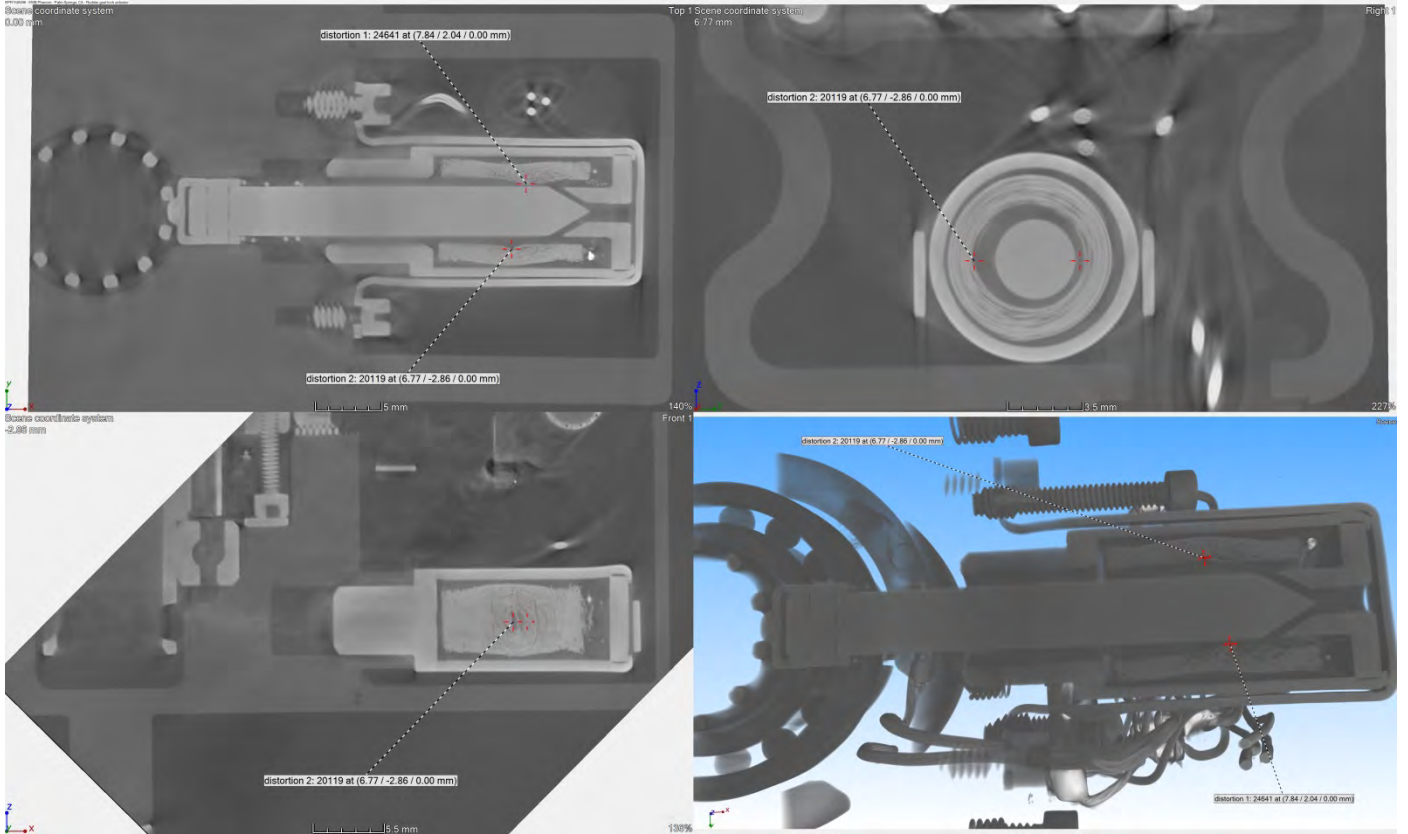
Figure 41
 Rudder gust lock actuator – microfocus – solenoid overall cross section showing winding distortion 2

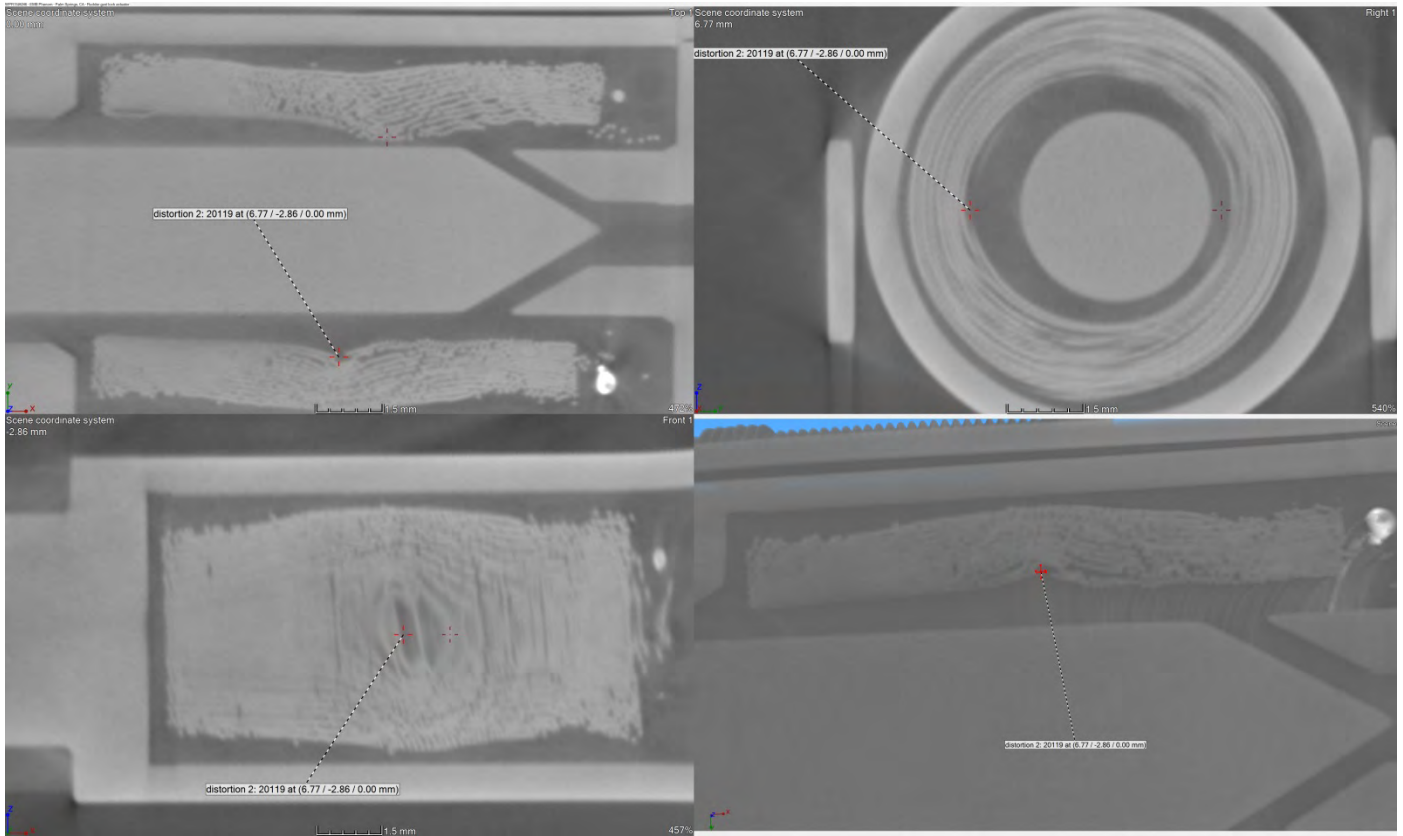
Figure 42
Rudder gust lock actuator – microfocus – solenoid showing winding distortion 2 close up view

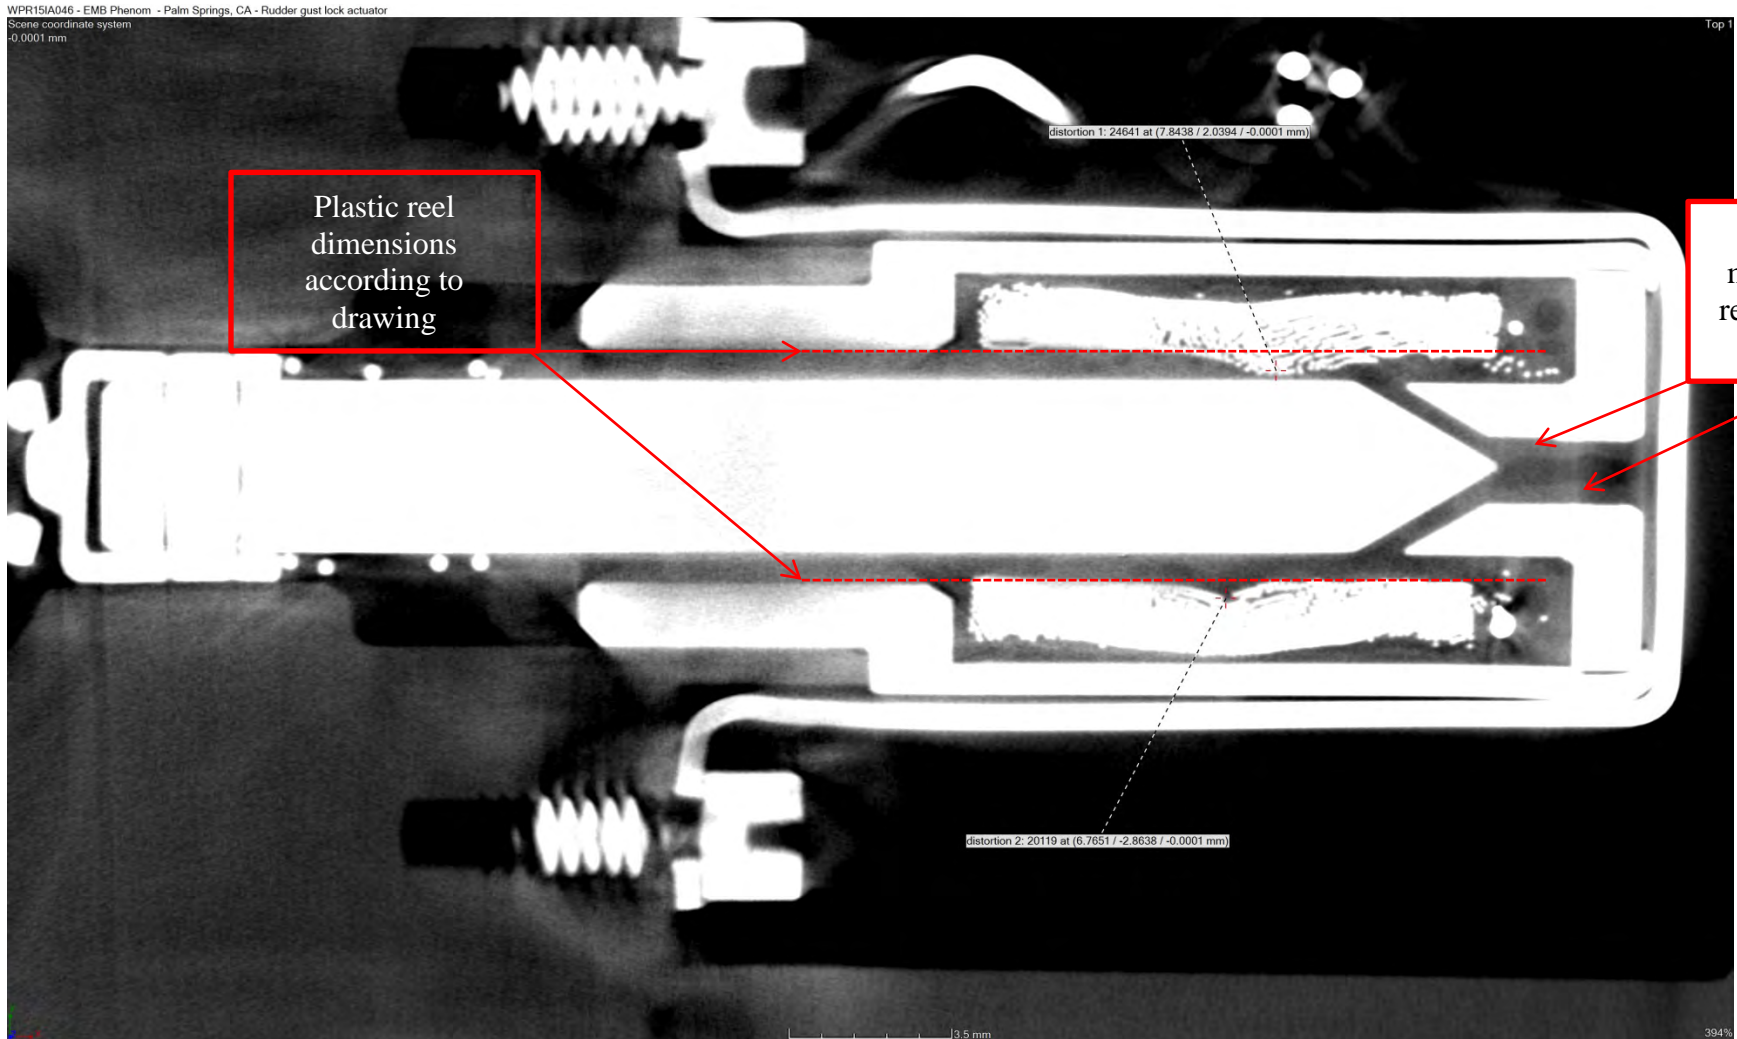
Figure 43

7. Review of the solenoid images using enhanced contrast methods indicated that there was material containing voids within the passages of the solenoid (see figures 43-45);
8. A high density particle was noted within the solenoid within the area of the piston to housing gap (see figures 46 and 47).

Rudder gust lock actuator – enhanced contrast microfocus – solenoid showing winding distortions 1 and 2, the plastic reel dimensions according to the drawing, and possible melted and re-solidified material

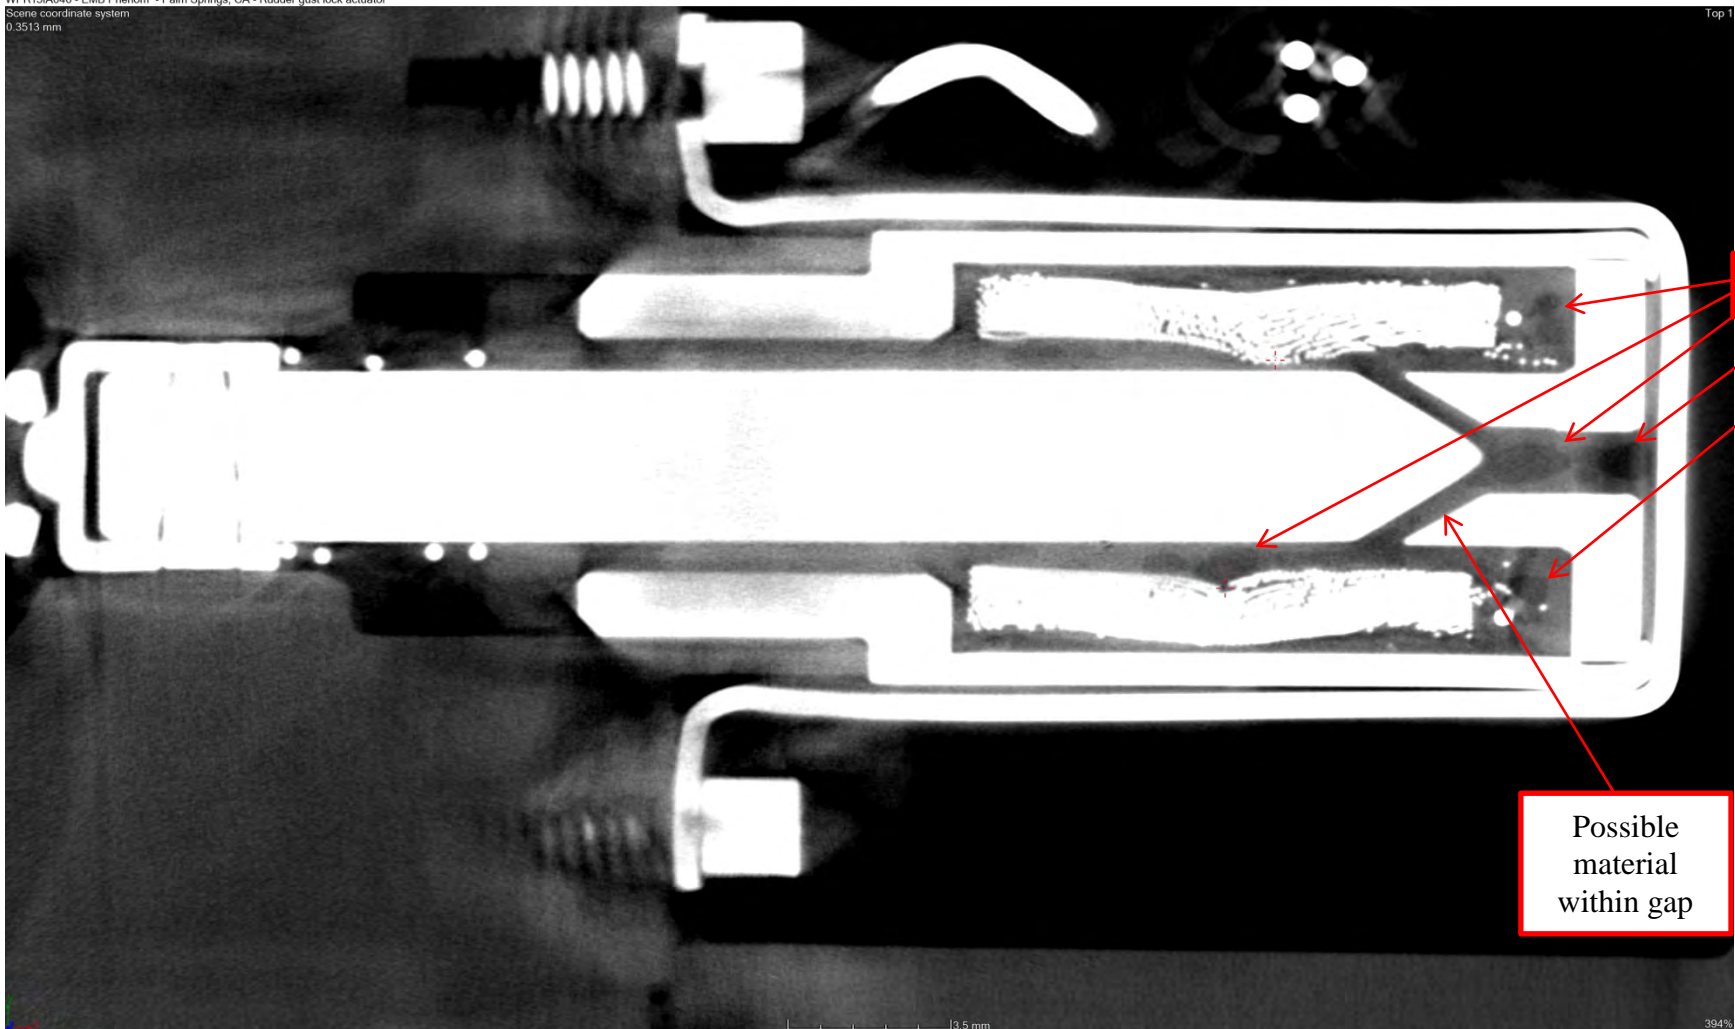
Figure 44

Rudder gust lock actuator – enhanced contrast microfocus – solenoid showing possible material within the solenoid gaps along with voids in those areas

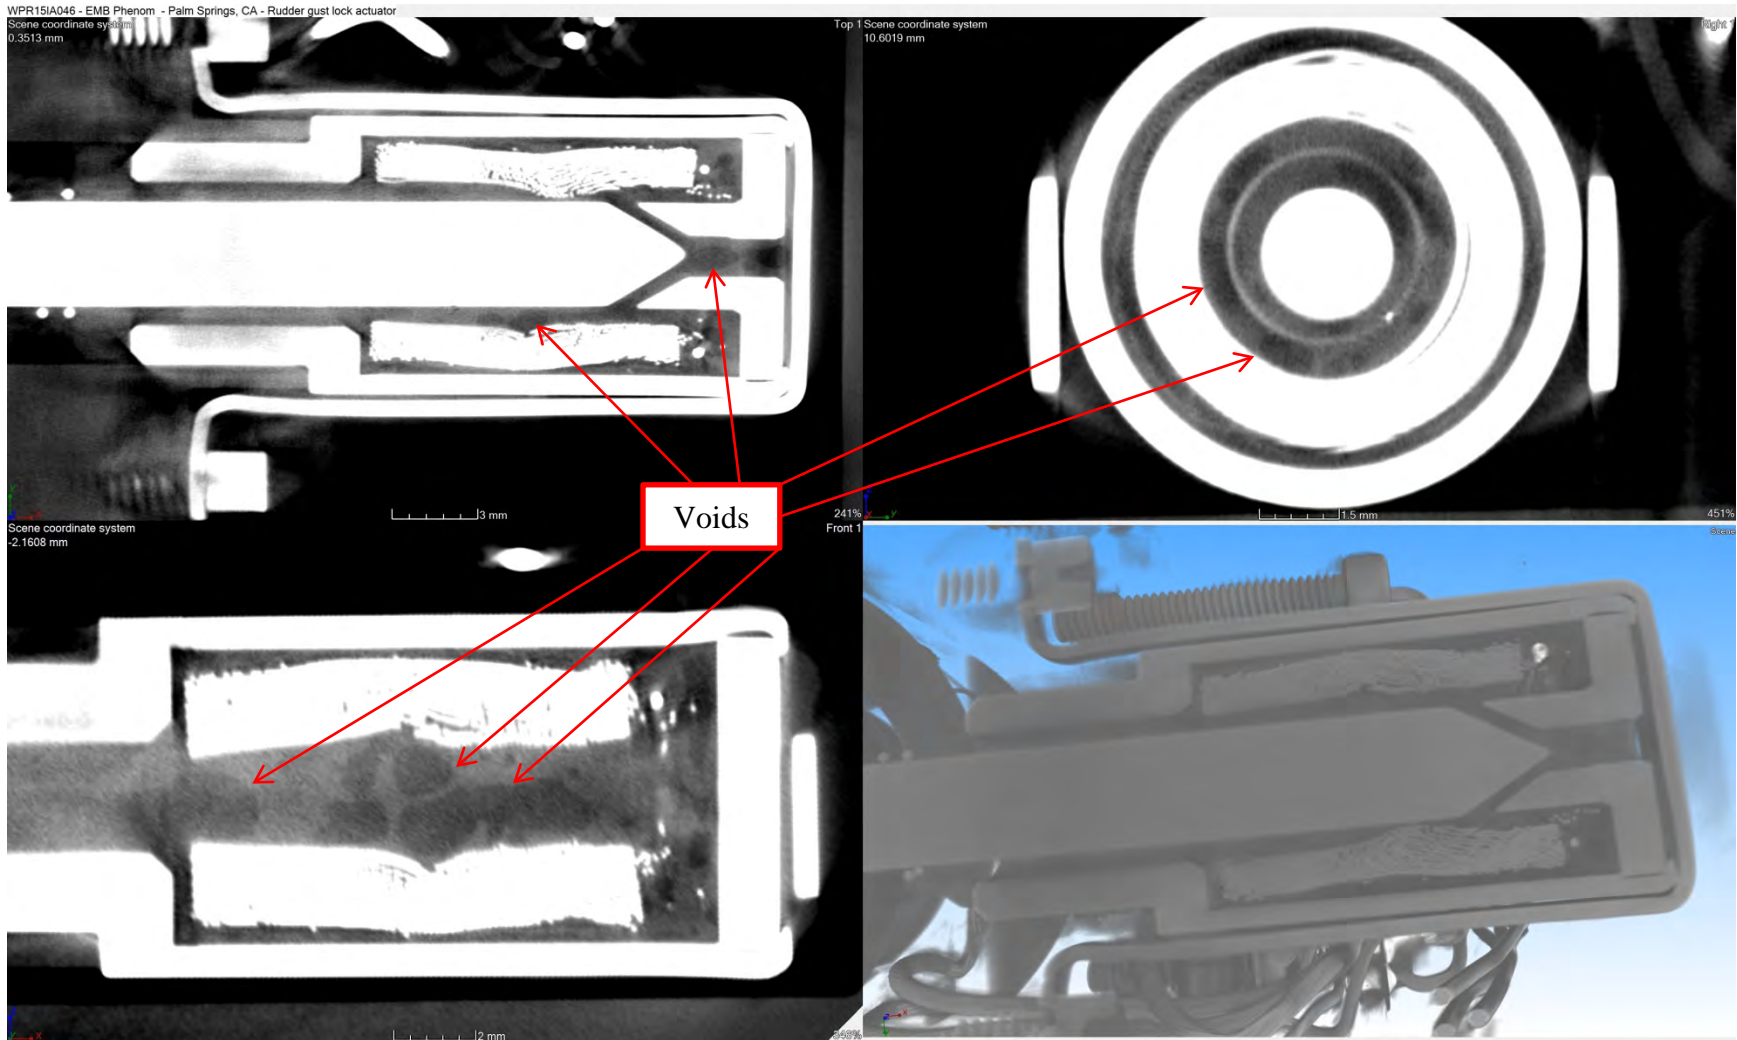
Figure 45

Rudder gust lock actuator – enhanced contrast microfocus – solenoid showing possible material and voids in areas between the solenoid windings and piston

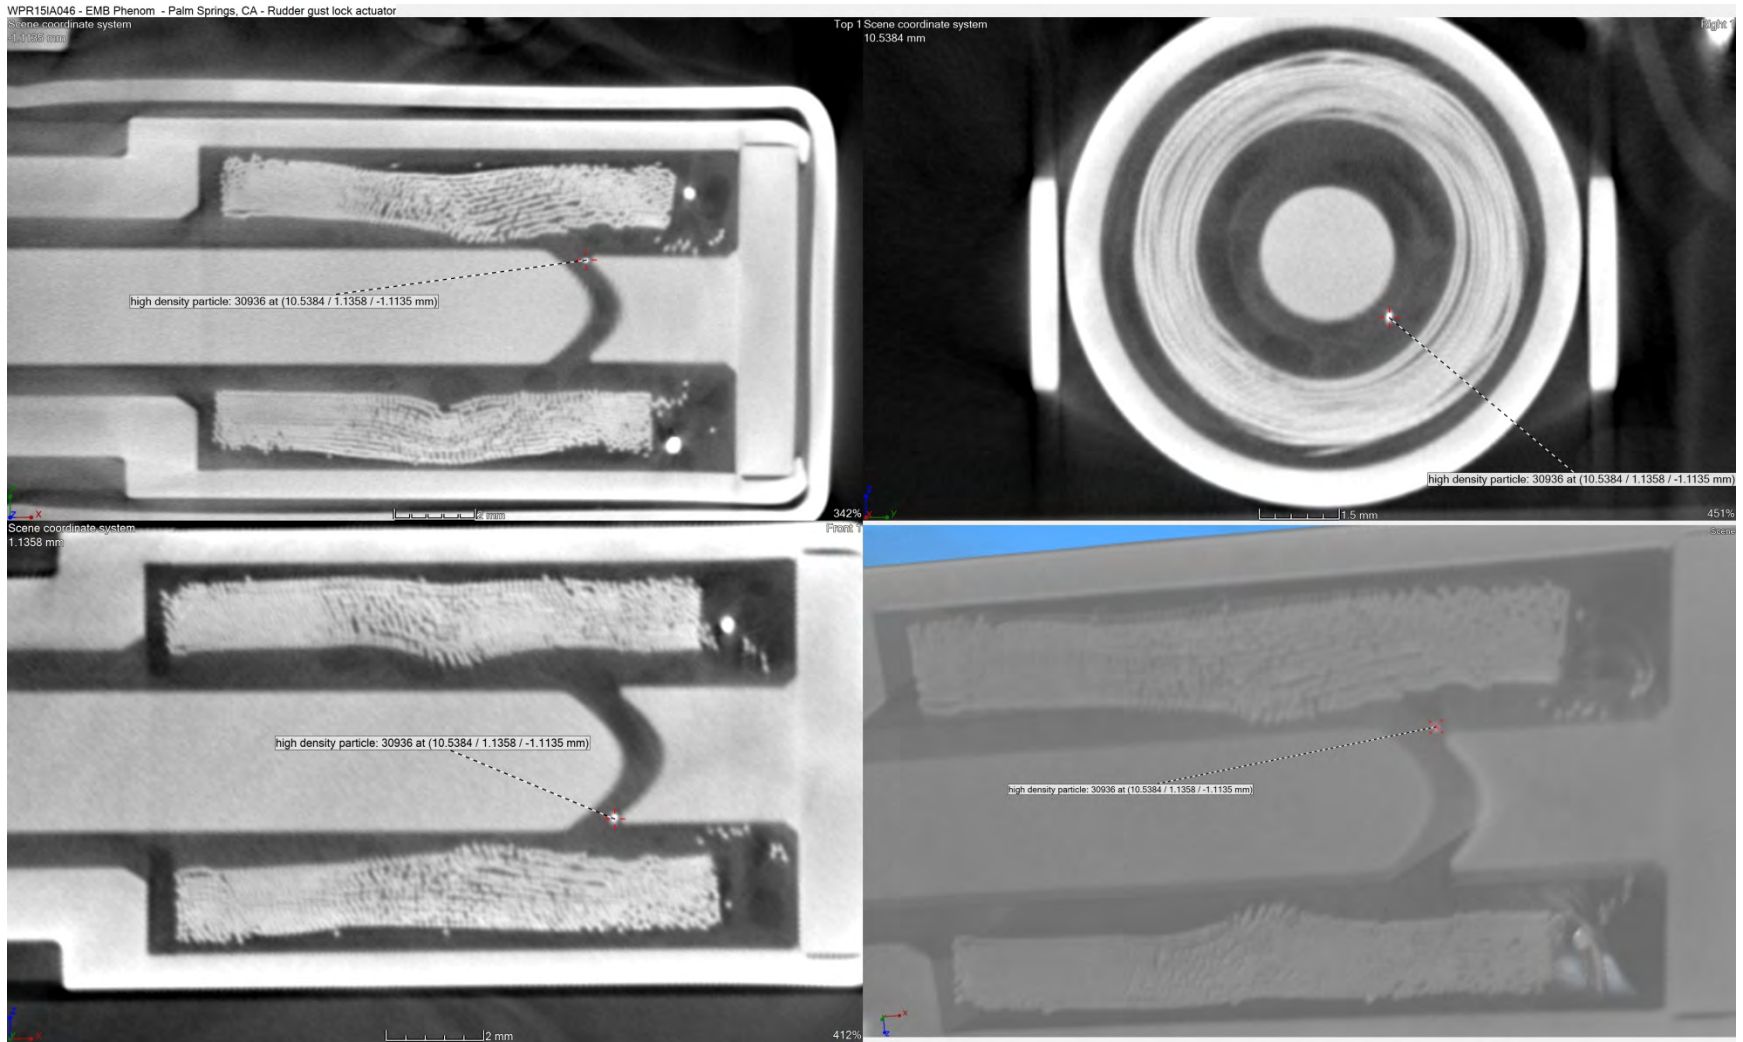
Figure 46

Rudder gust lock actuator – enhanced contrast microfocus – solenoid showing high density particle

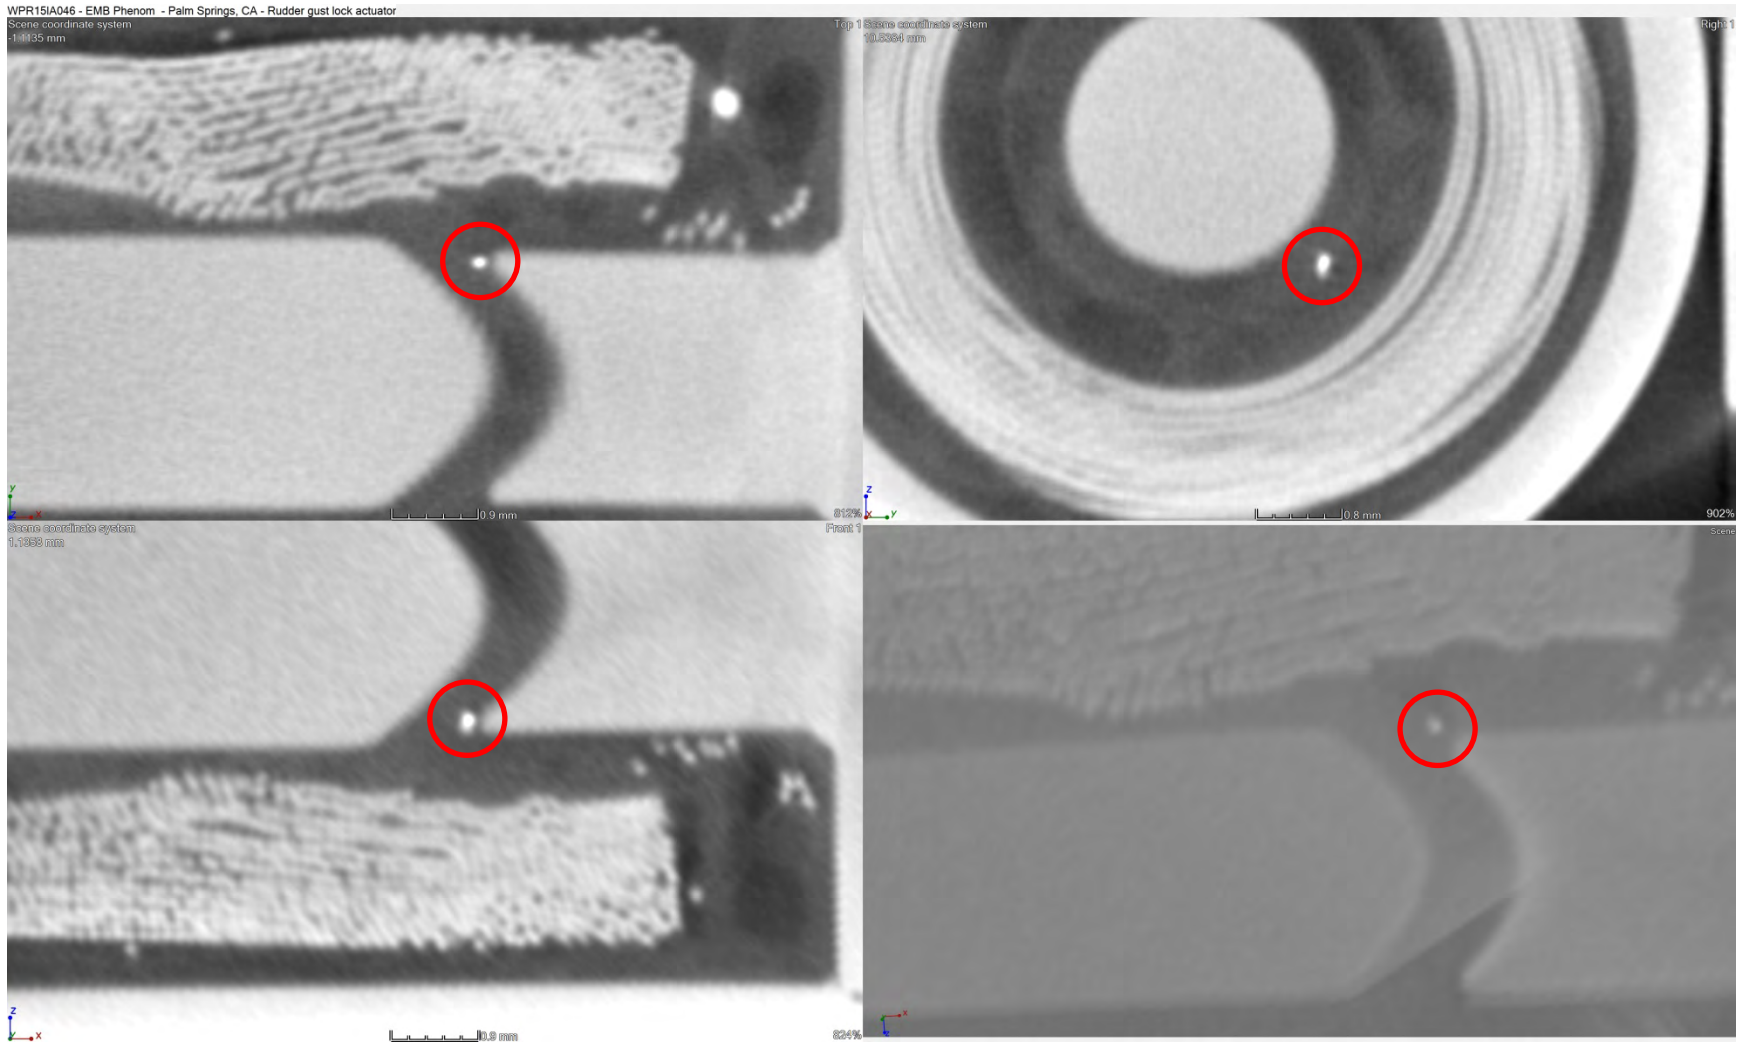
Figure 47

Rudder gust lock actuator – enhanced contrast microfocus – solenoid showing a close up view of the high density particle
