NATIONAL TRANSPORTATION SAFETY BOARD
Office of Aviation Safety
Washington, D.C. 20594

Computed Tomography Specialist's Factual Report

ANC-17-MA-001

Operator: Hageland Aviation Services, Inc.
Location: 12 miles northwest of Togiak, Alaska
Date: October 2, 2016
Time: 1154 Alaska daylight time
Airplane: Cessna 208B Grand Caravan airplane, N208SD

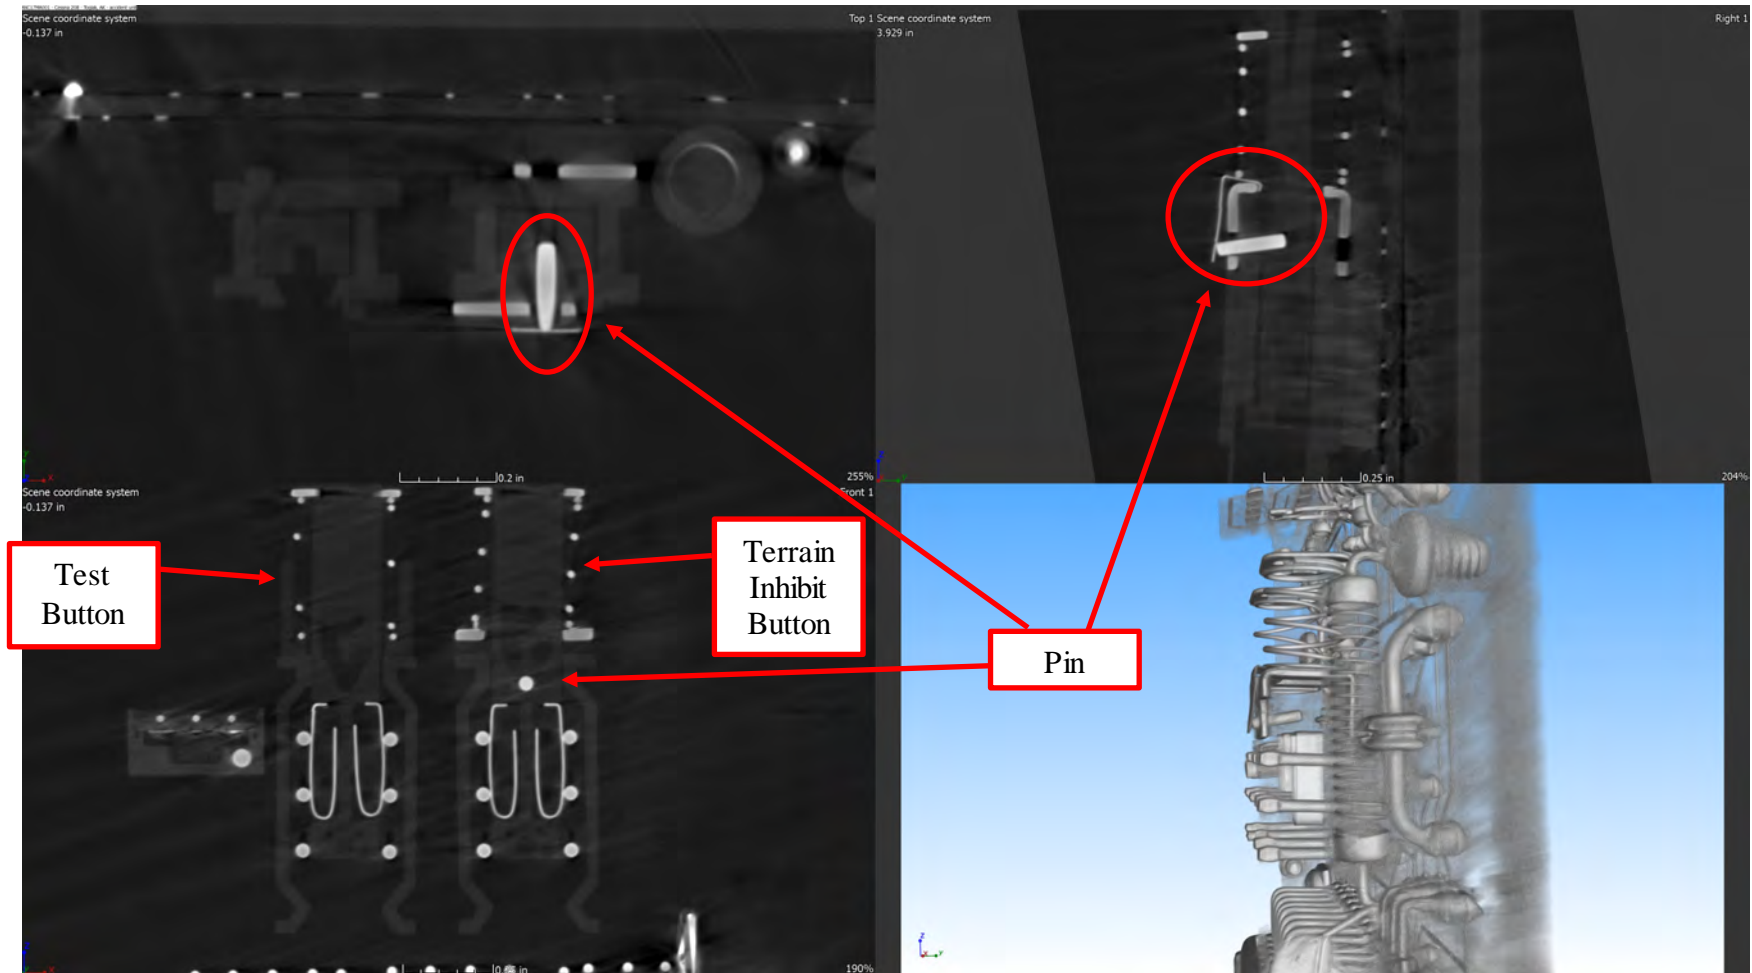
Figure 2
Accident TAAC unit – button pin

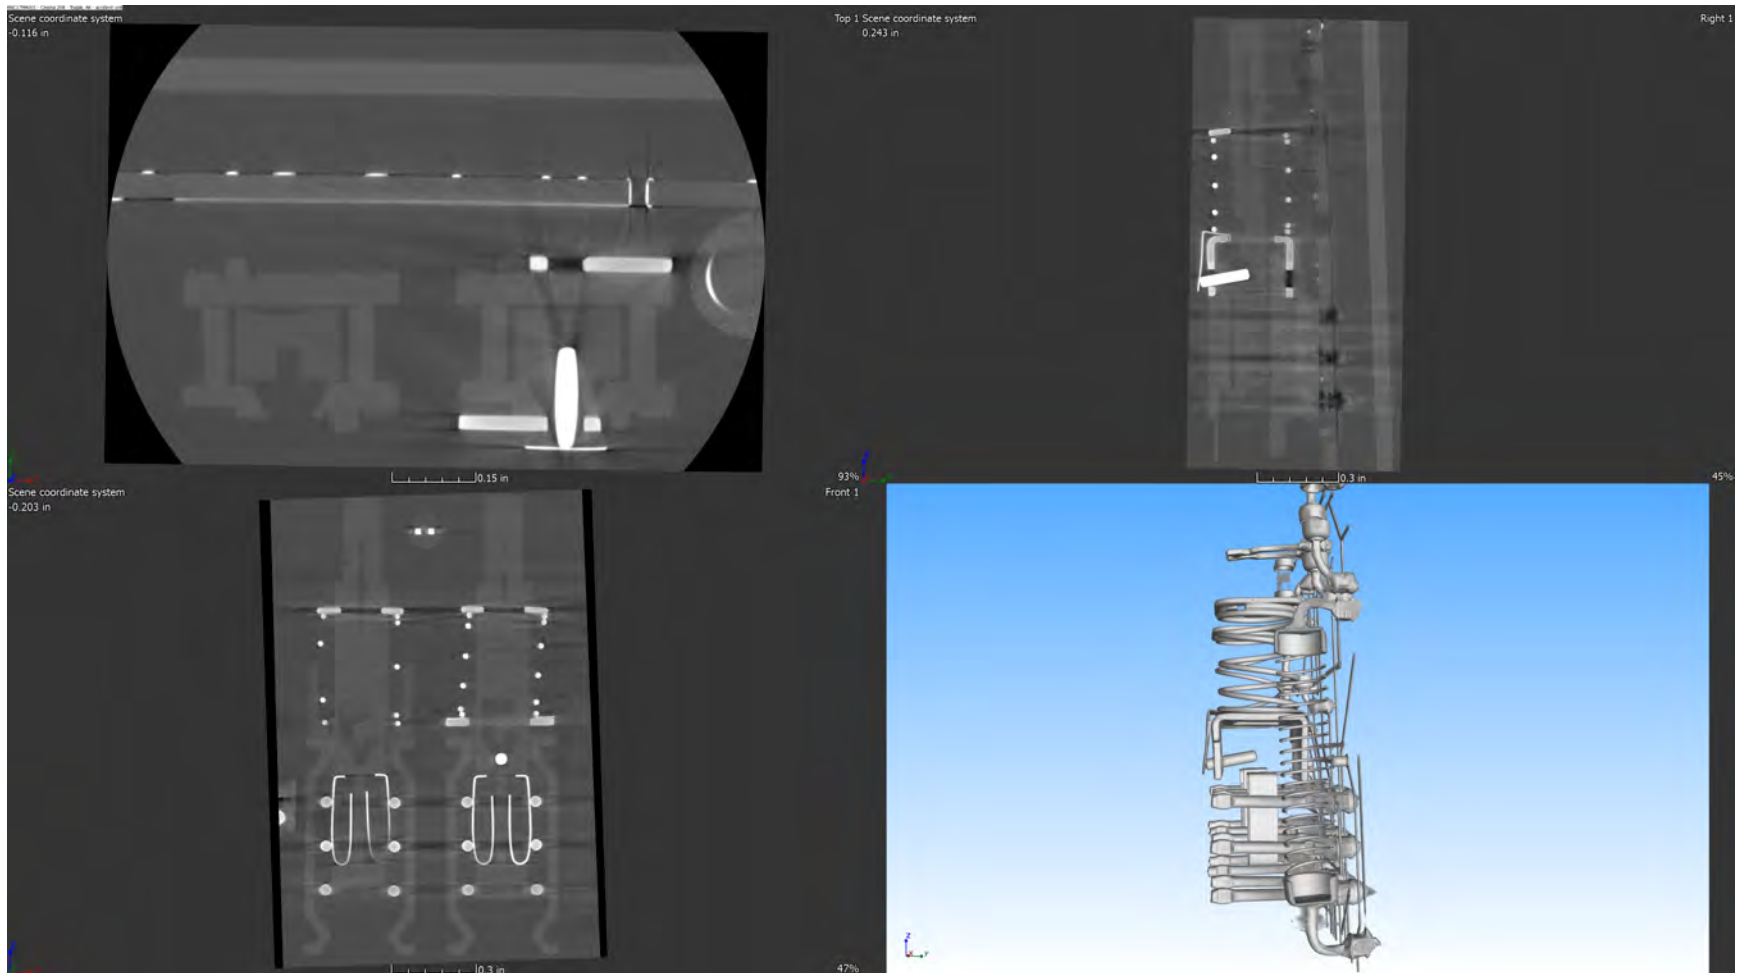
Figure 14
Accident TAAC unit target CT –button pin

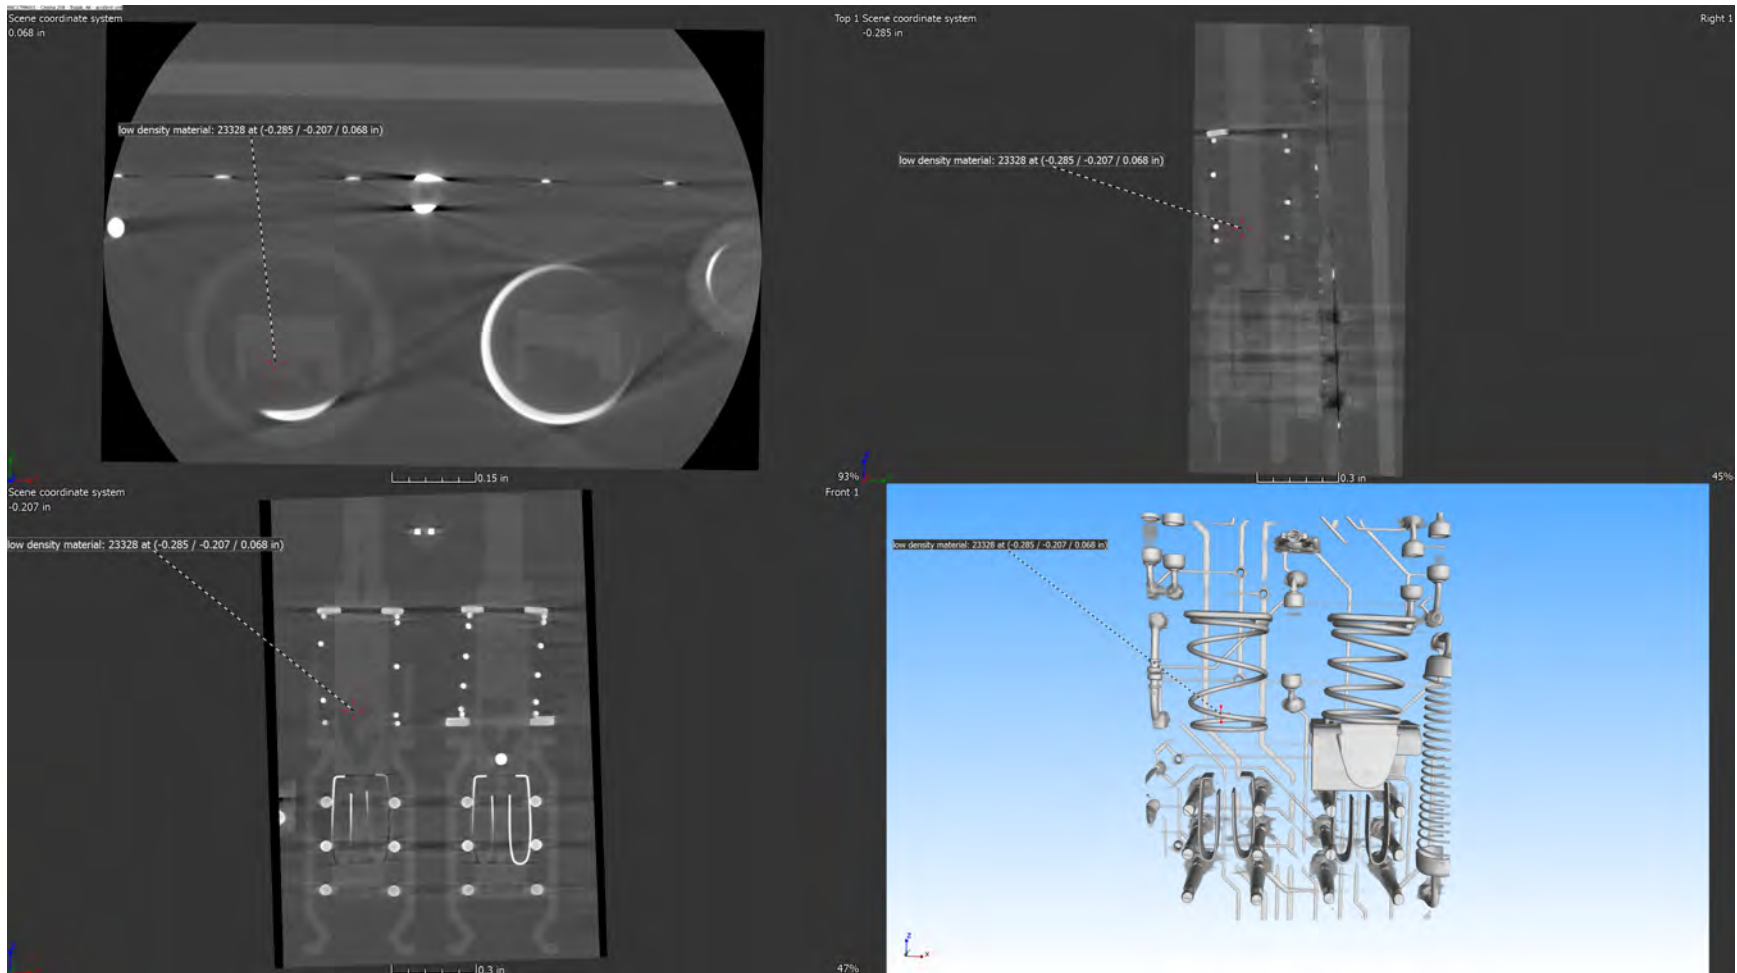
Figure 15
Accident TAAC unit target CT – low density material in test button channel

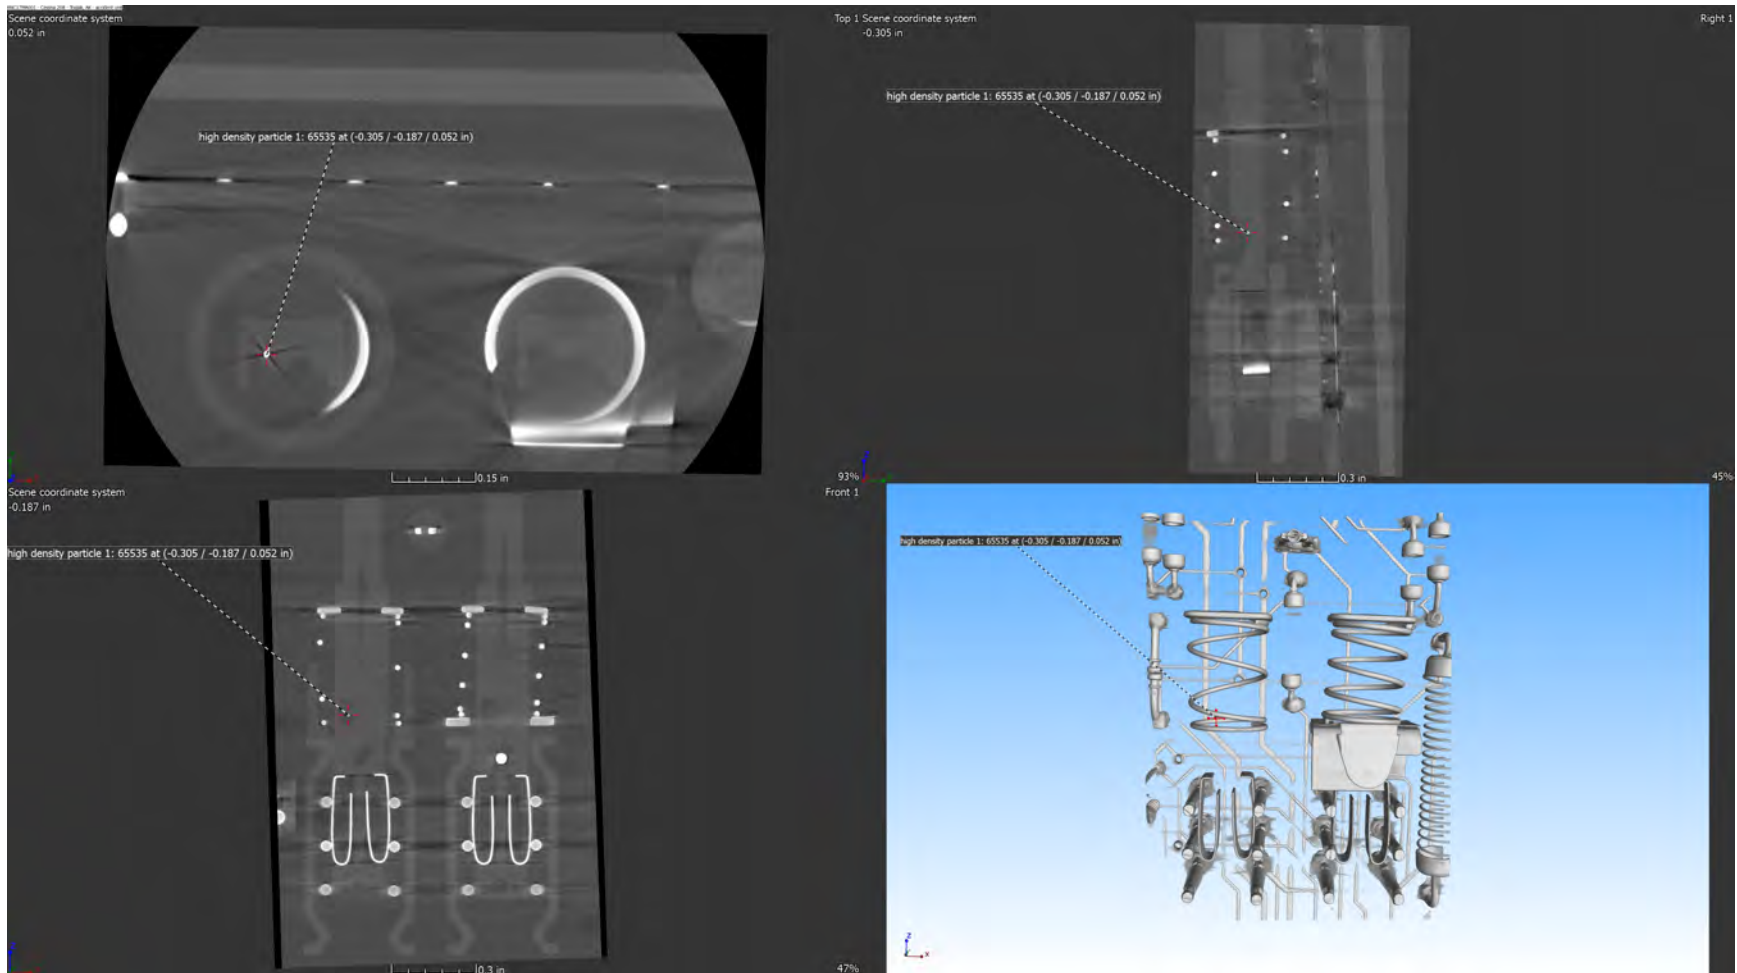
Figure 16
Accident TAAC unit target CT – high density particle in test button channel

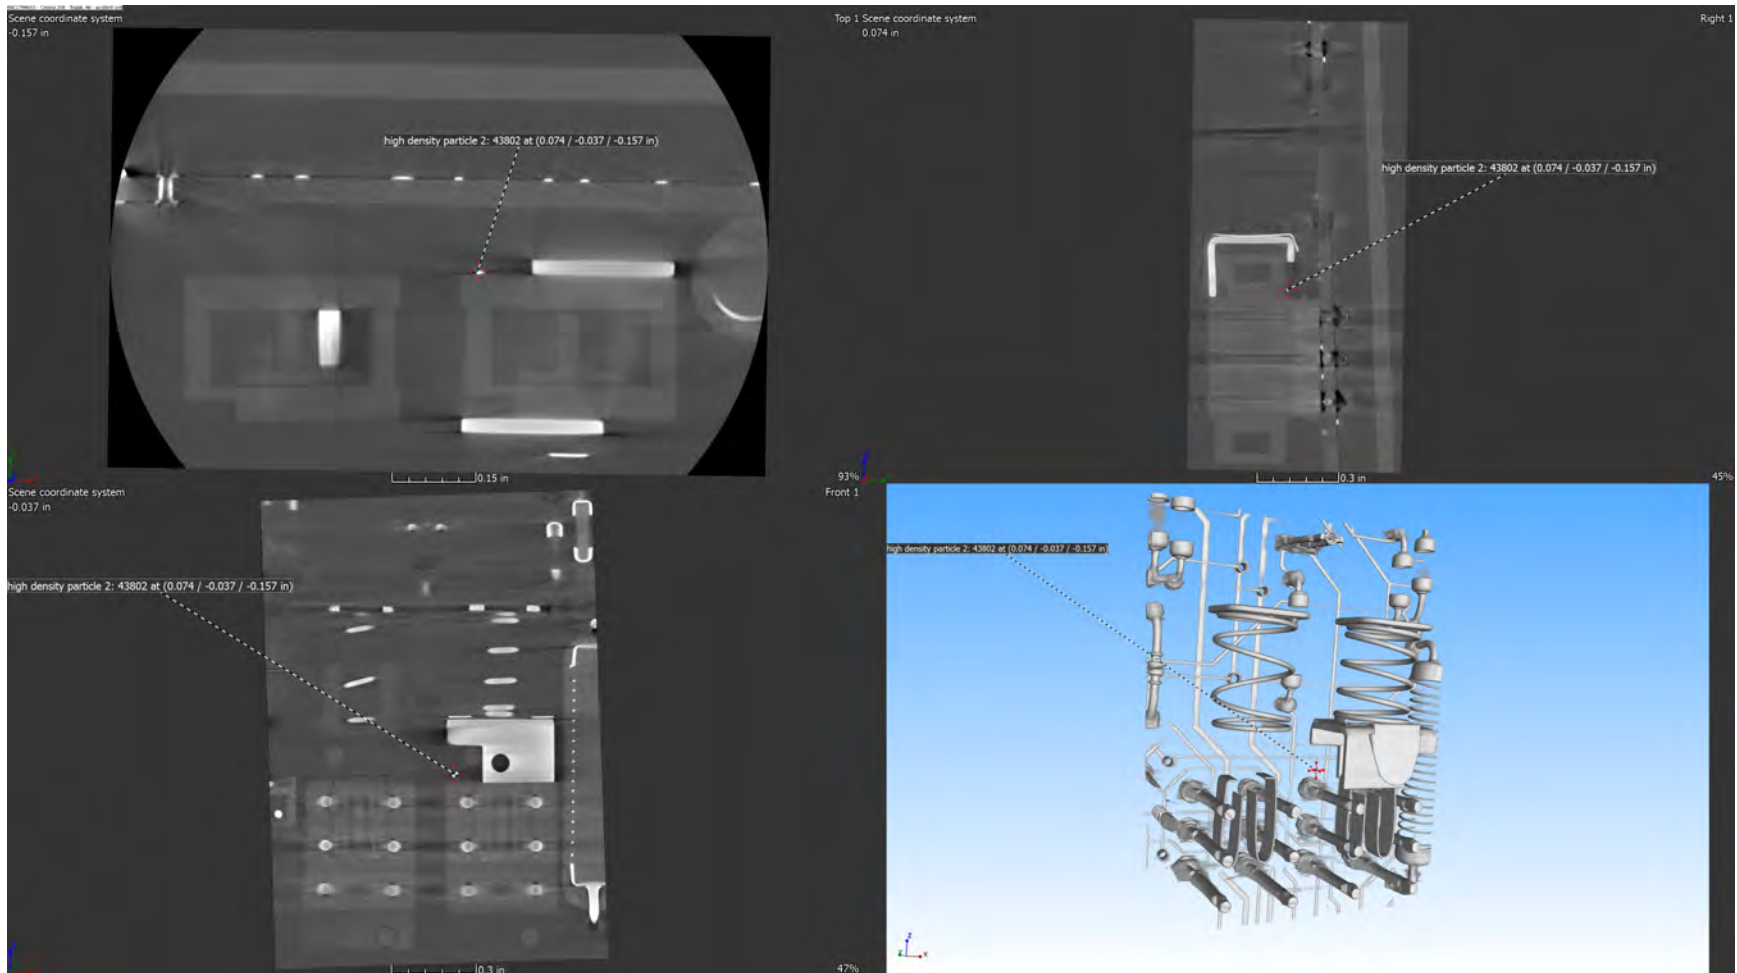
Figure 17
Accident TAAC unit target CT – high density particle on terrain inhibit button exterior

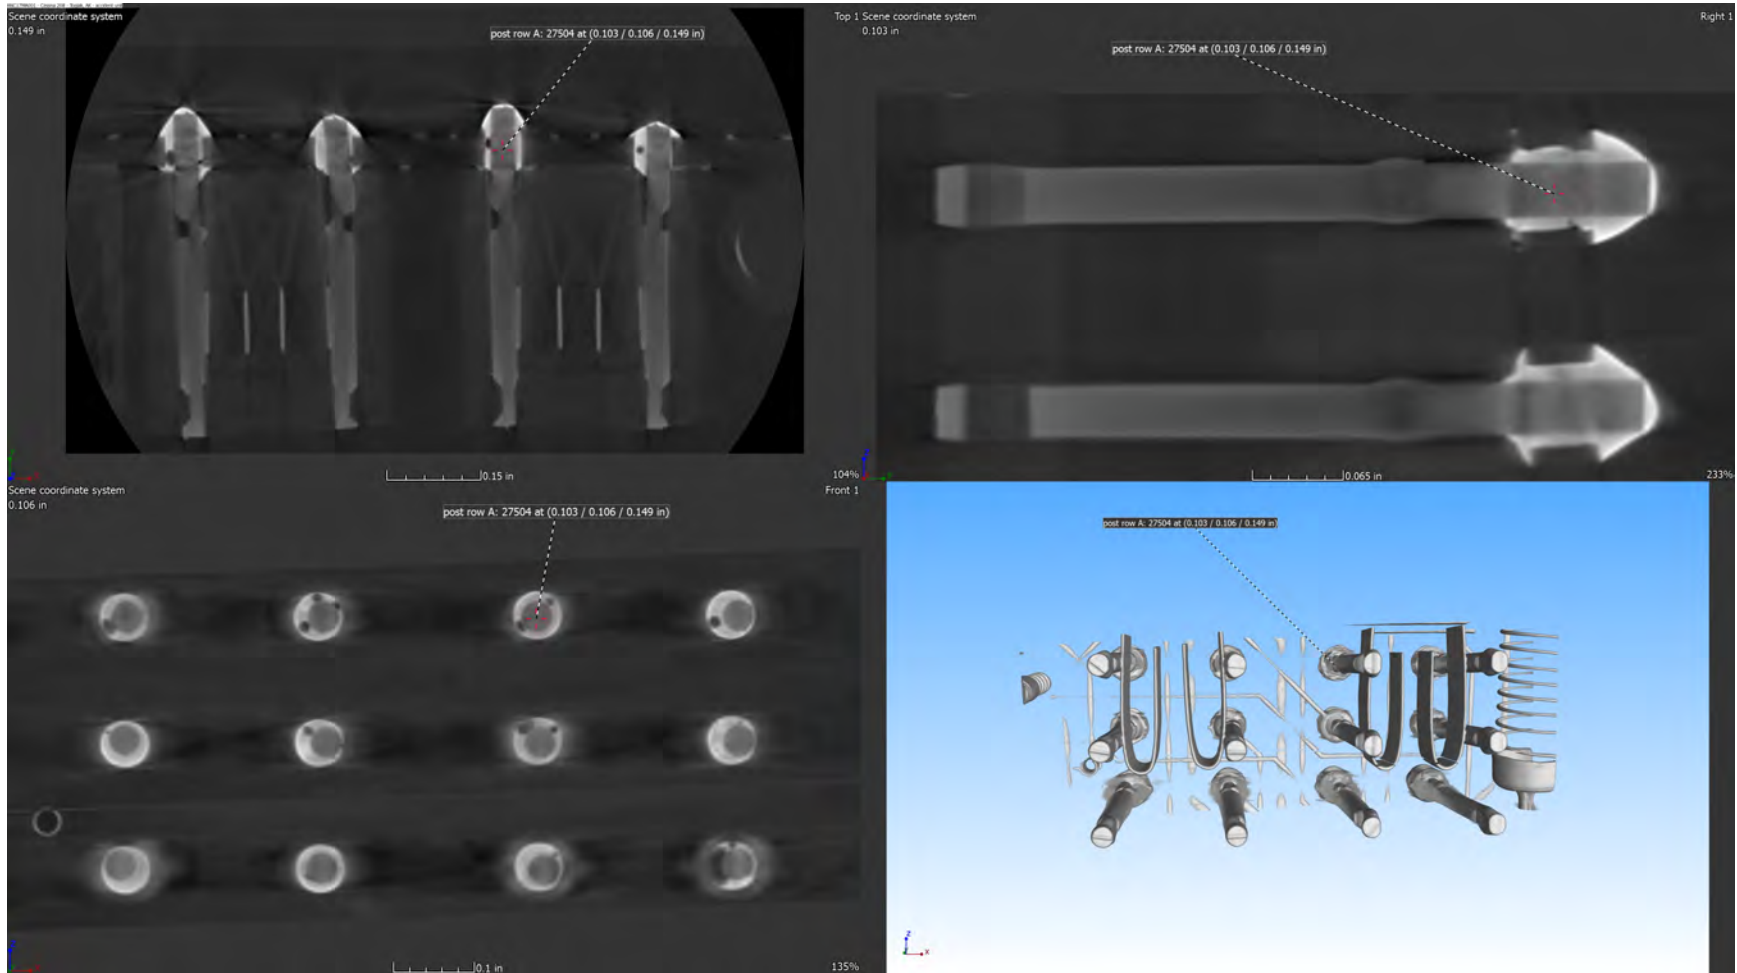
Figure 21
 Accident TAAC unit target CT – connection posts – row A with contrast enhanced to show solder joint

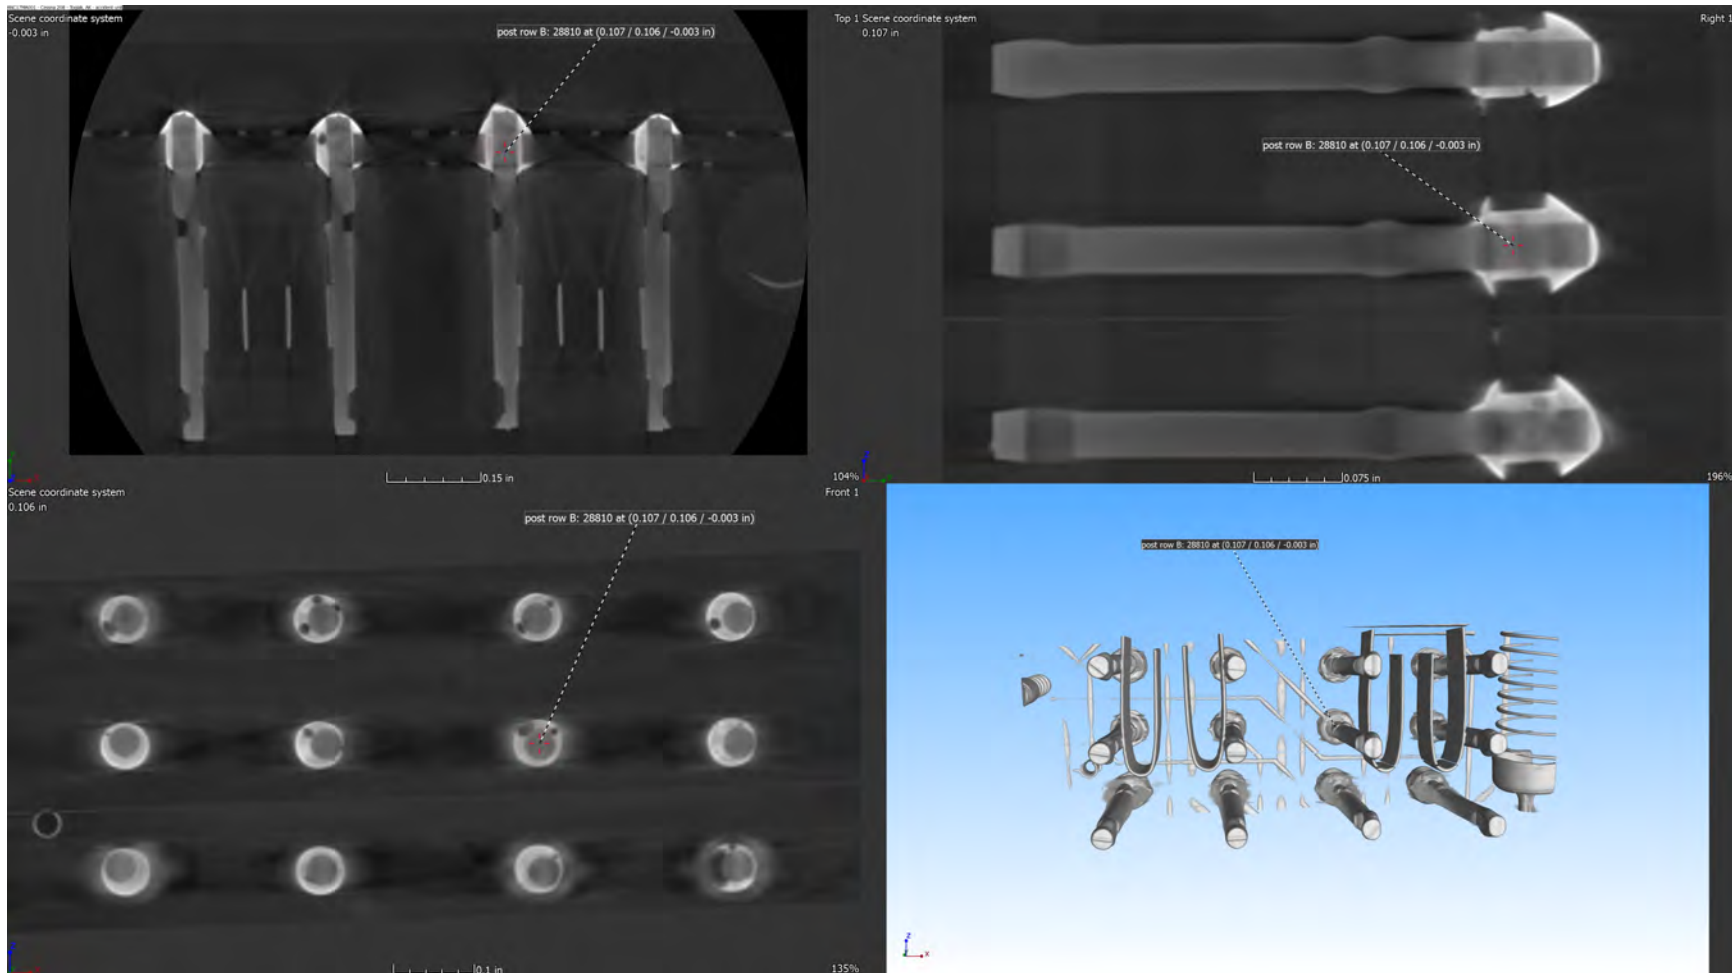
Figure 22
Accident TAAC unit target CT – connection posts – row B with contrast enhanced to show solder joint

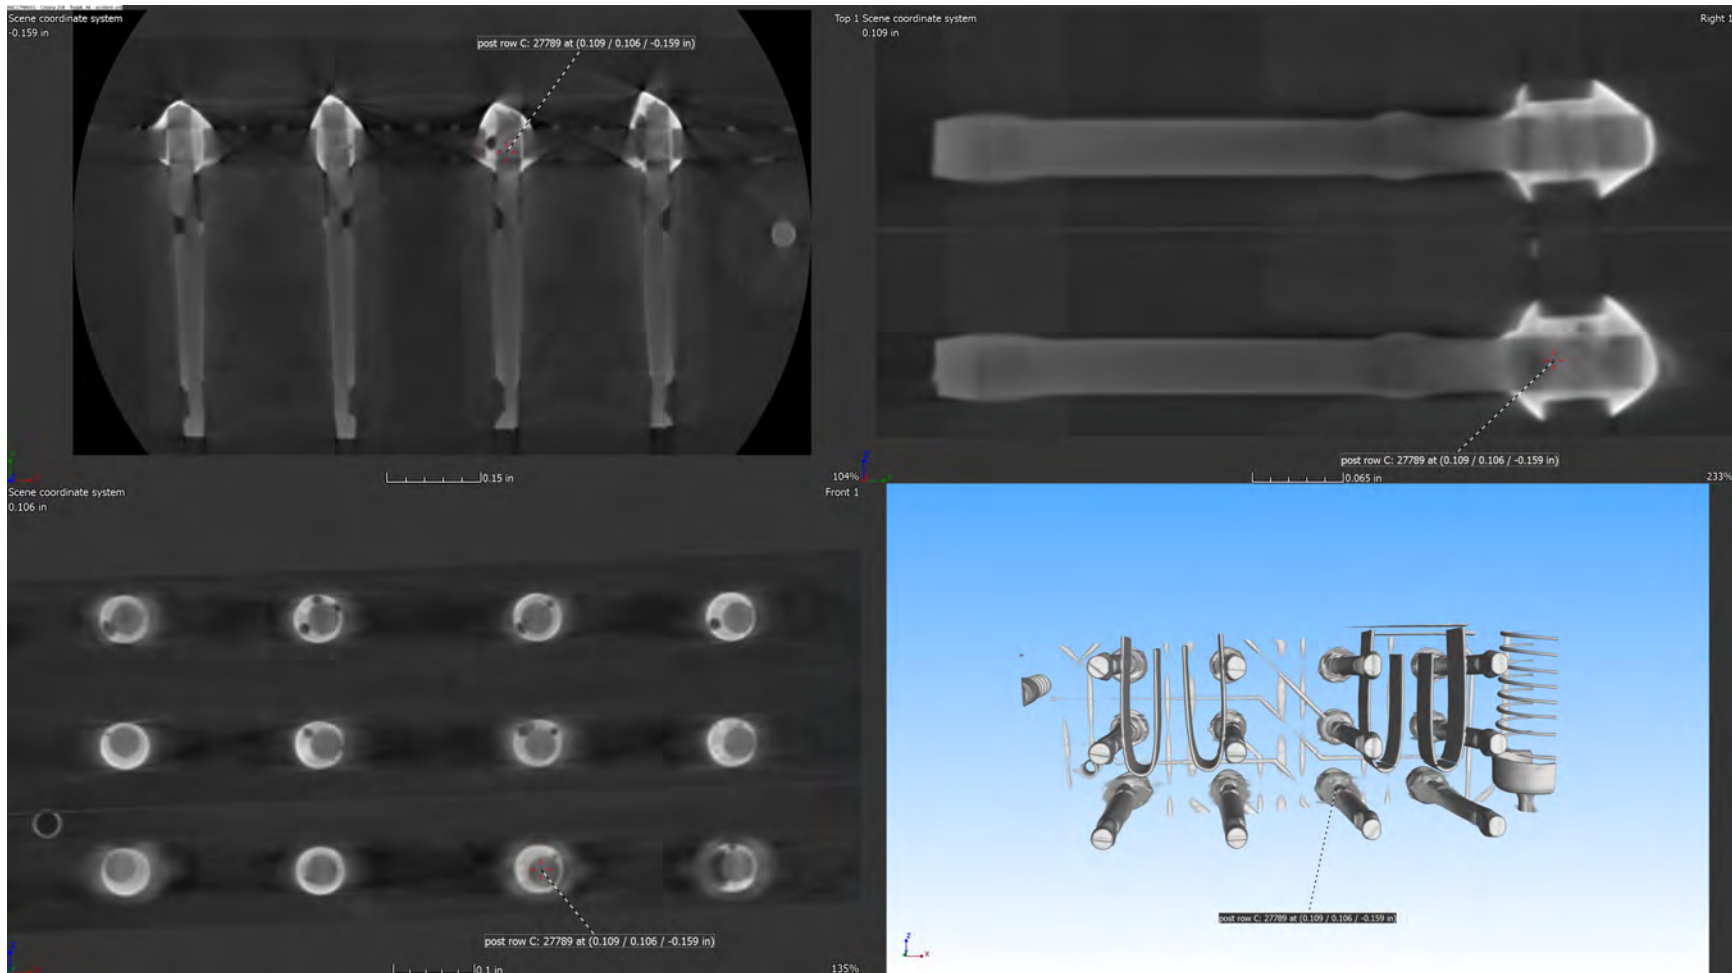
Figure 23
Accident TAAC unit target CT – connection posts – row C with contrast enhanced to show solder joint
