**NATIONAL TRANSPORTATION SAFETY BOARD**  
Office of Aviation Safety  
Washington, D.C. 20594

**Computed Tomography Specialist's Factual Report**

ENG-17-IA-005

Location: San Antonio International Airport (KSAT), San Antonio, TX  
Date: December 4, 2016  
Time: 1453 central daylight time  
Airplane: Embraer ERJ170 200L, N161SY

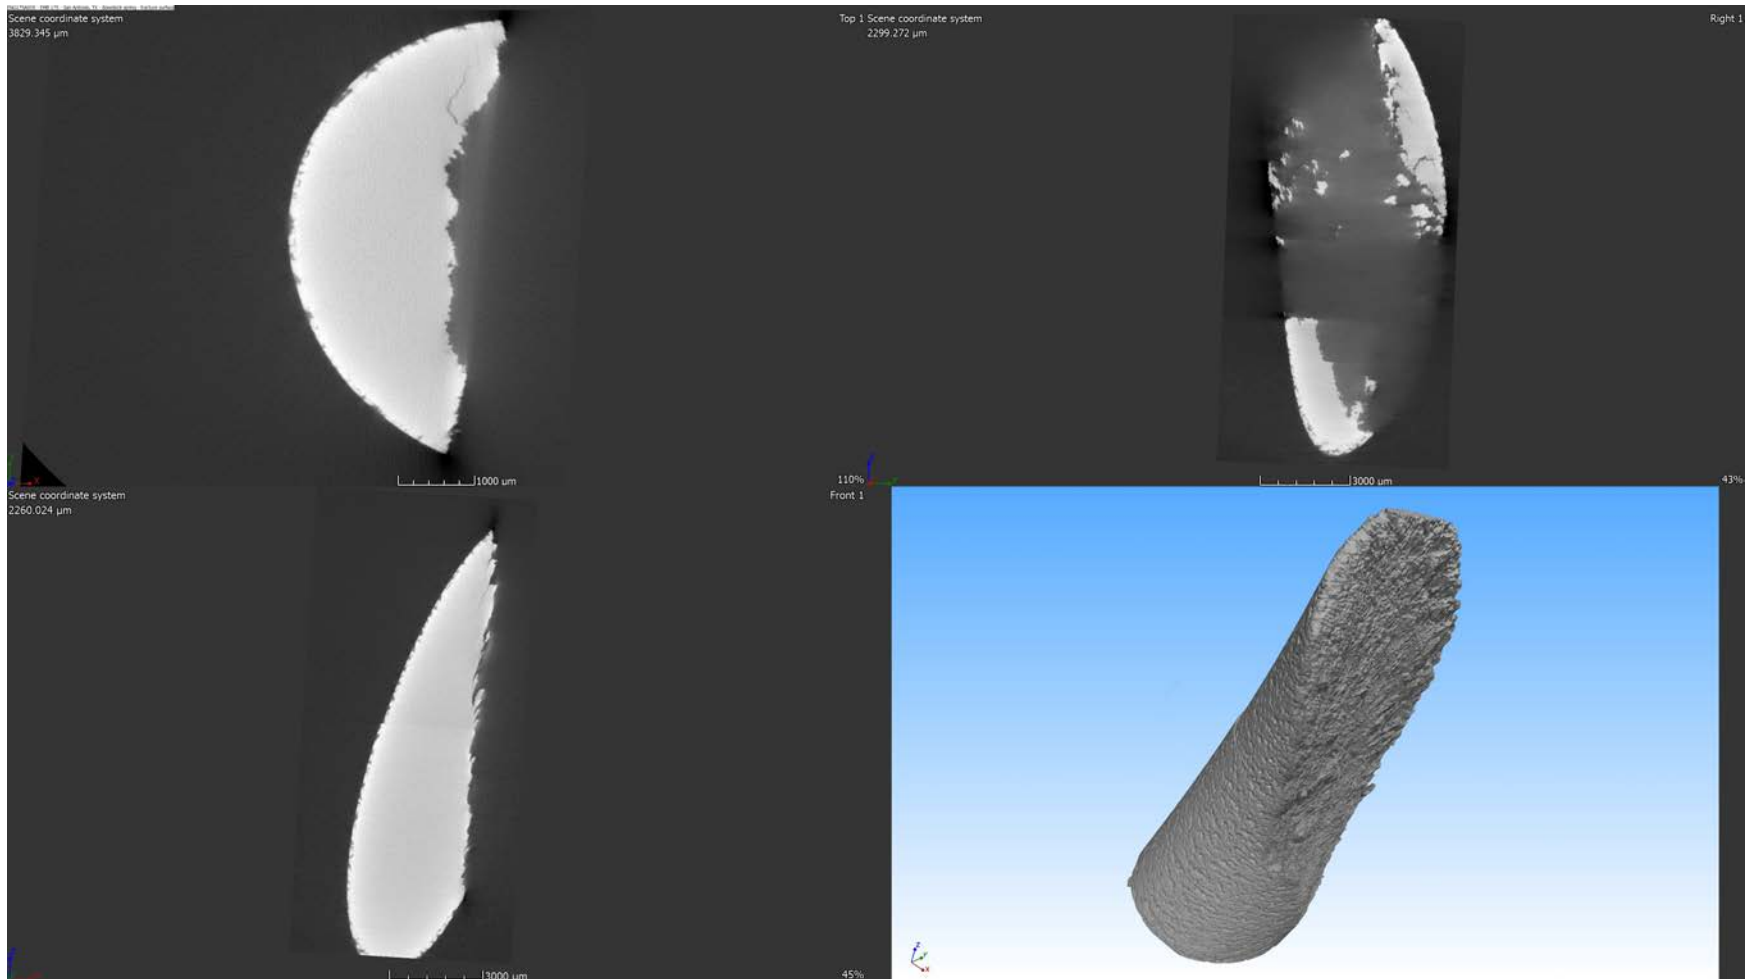
Figure 1  
Spring end segment – overall view

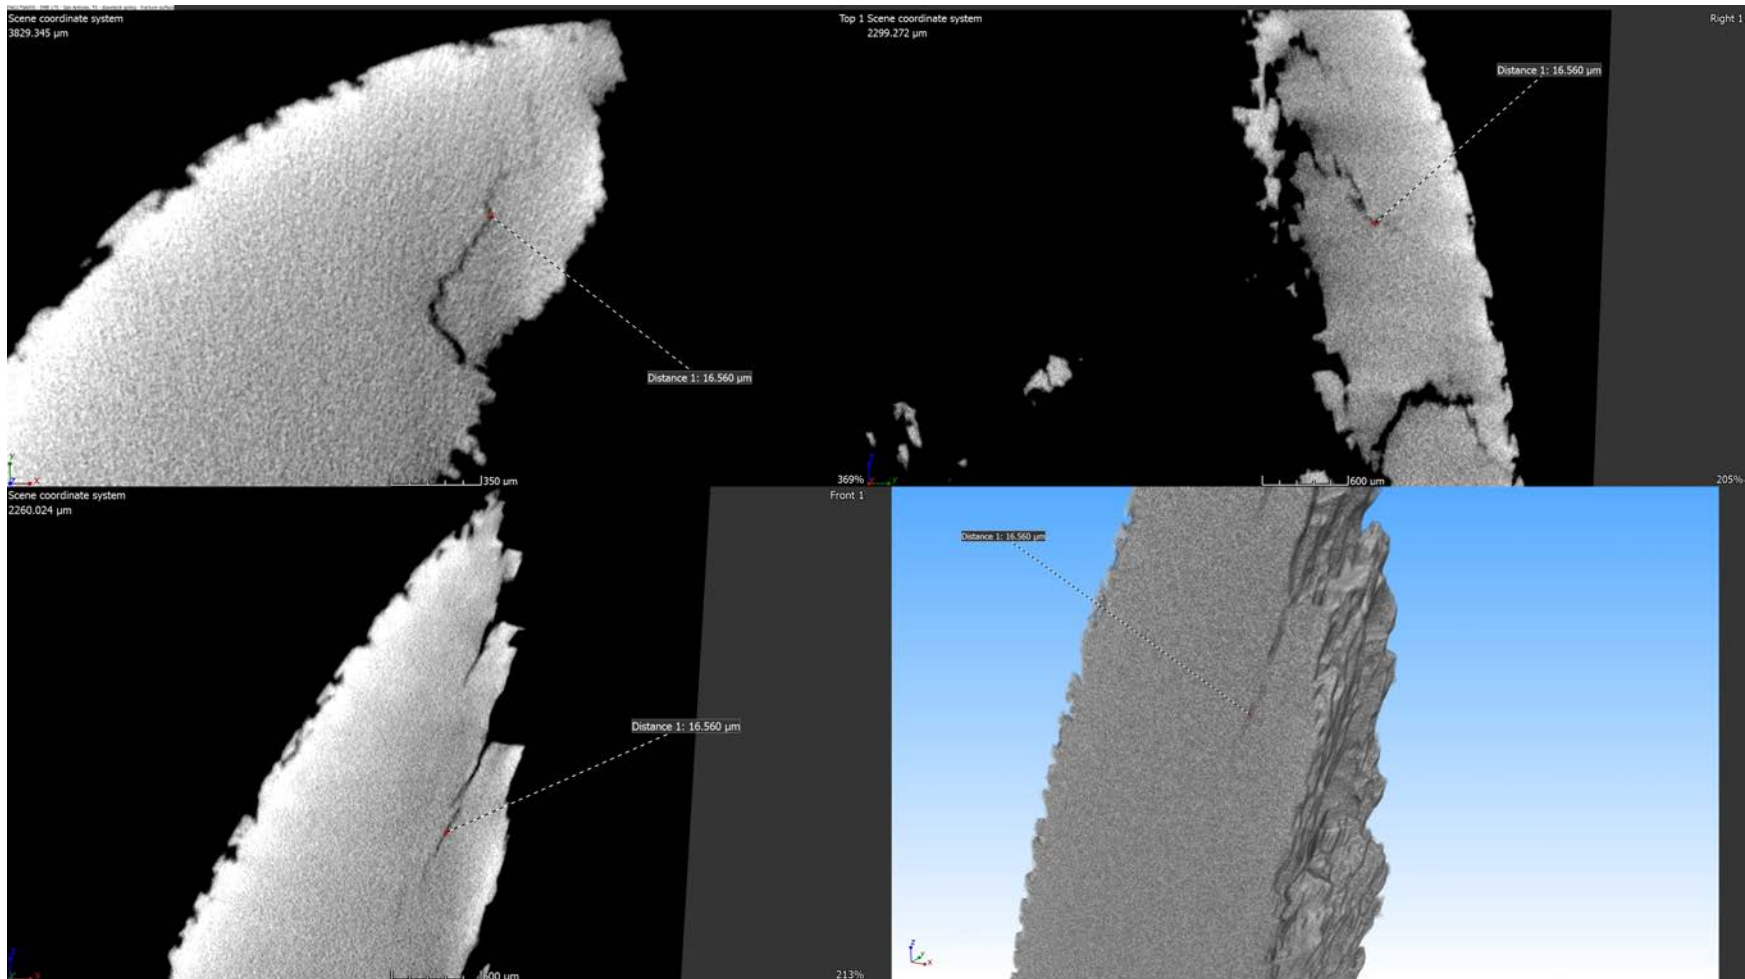
Figure 2  
Spring end segment – crack width measurement of 16.560 microns

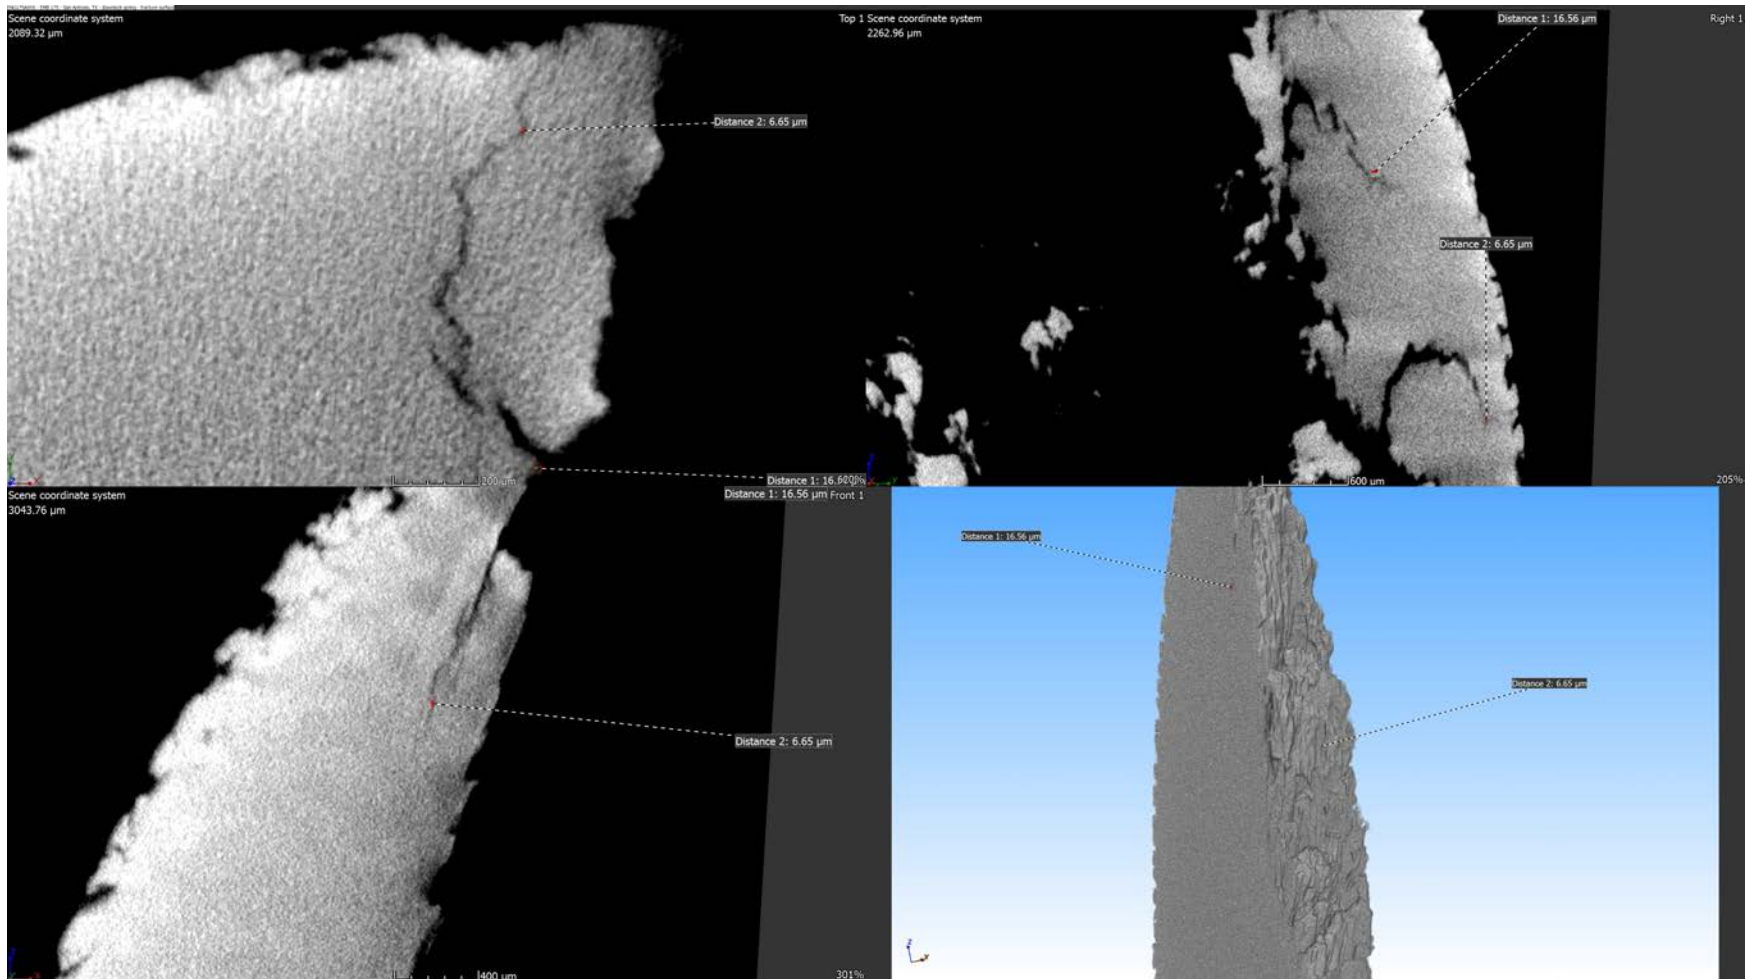
Figure 3  
Spring end segment – crack width measurement of 6.65 microns

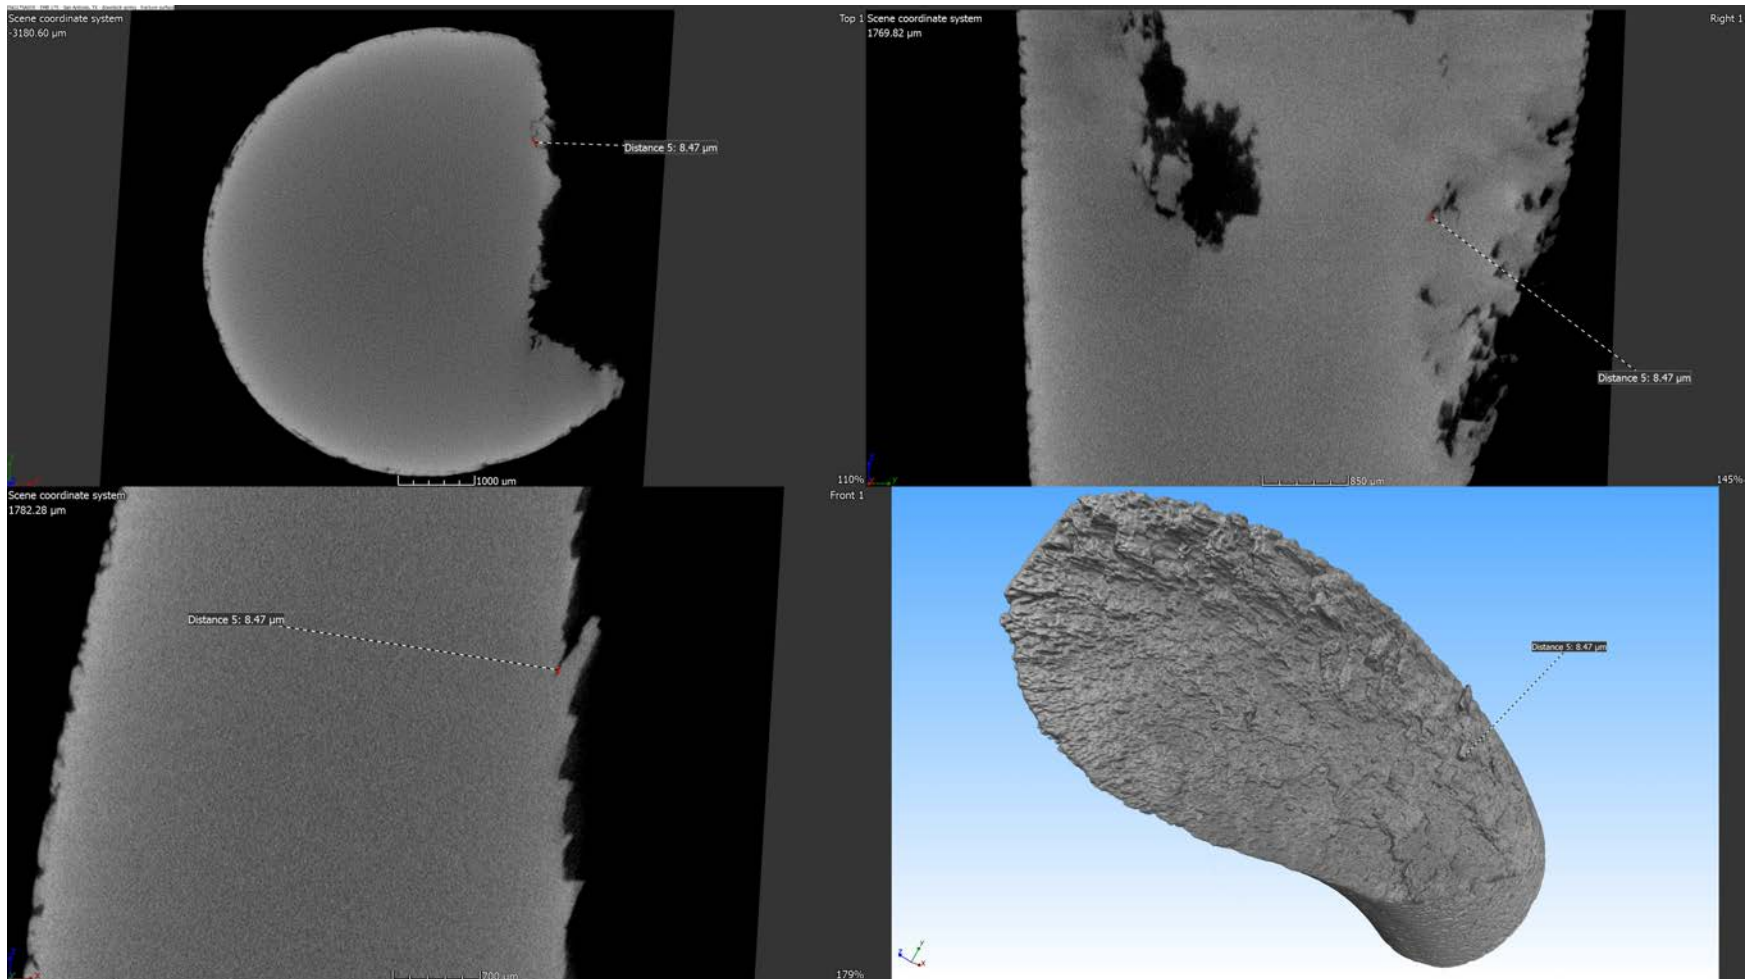
Figure 4  
Spring end segment – crack width measurement of 8.47 microns

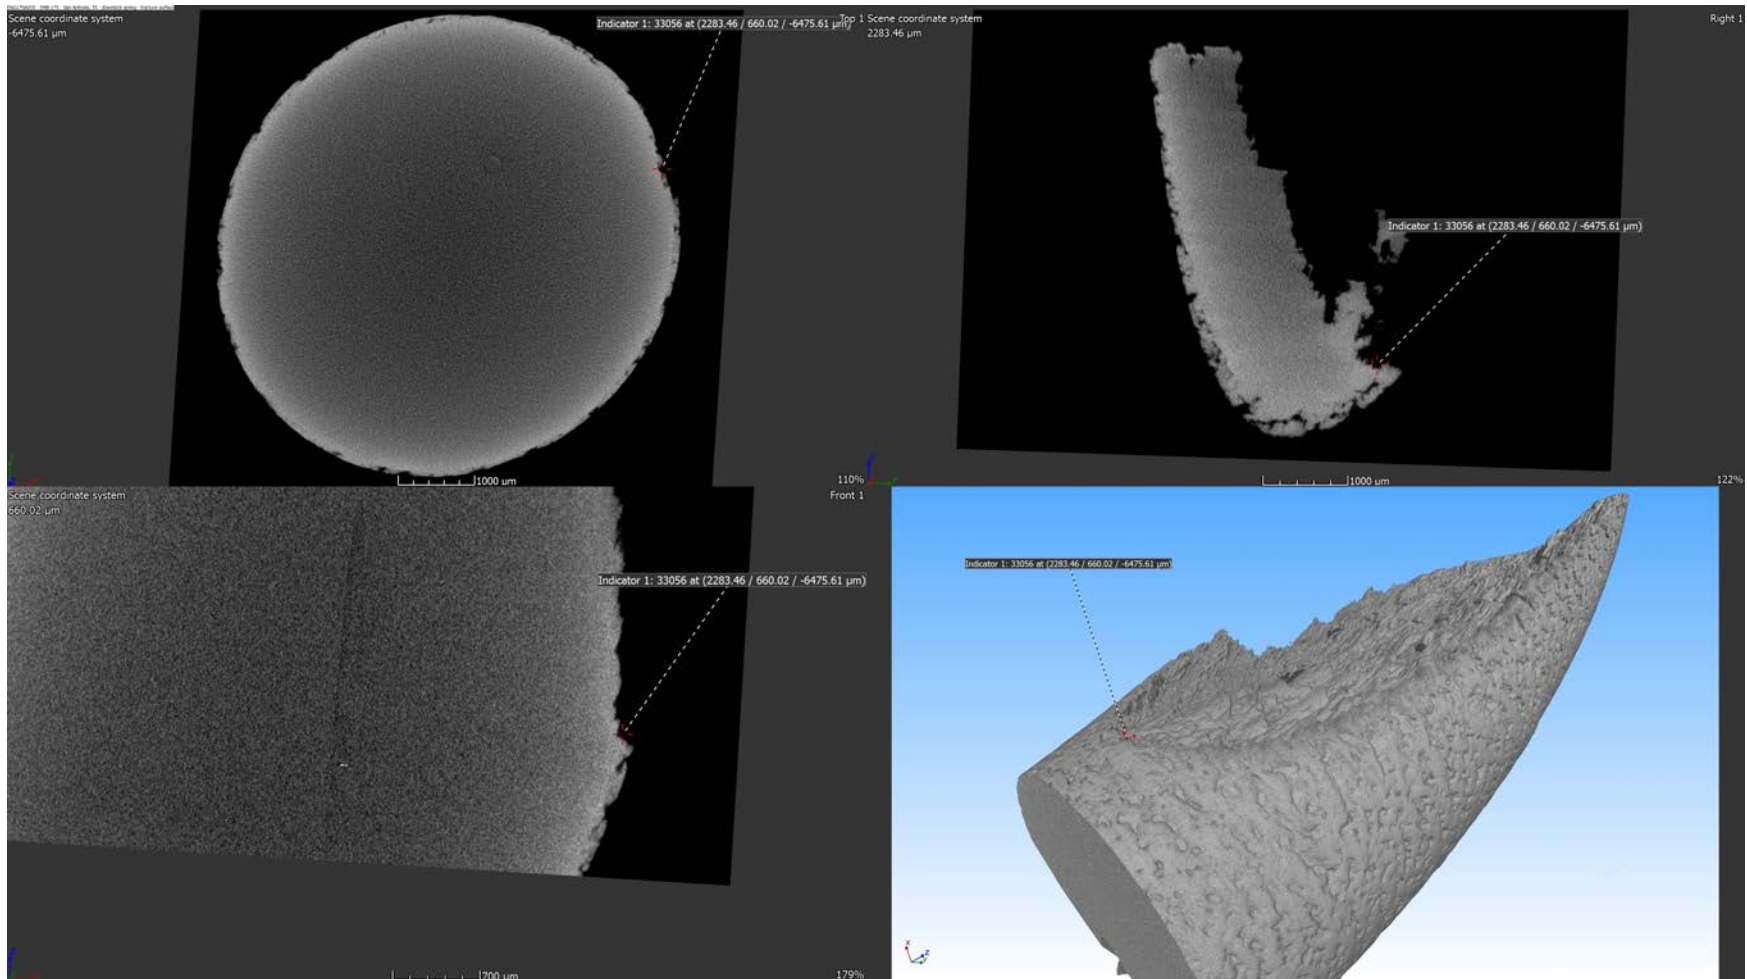
Figure 5  
Spring end segment – surface pitting

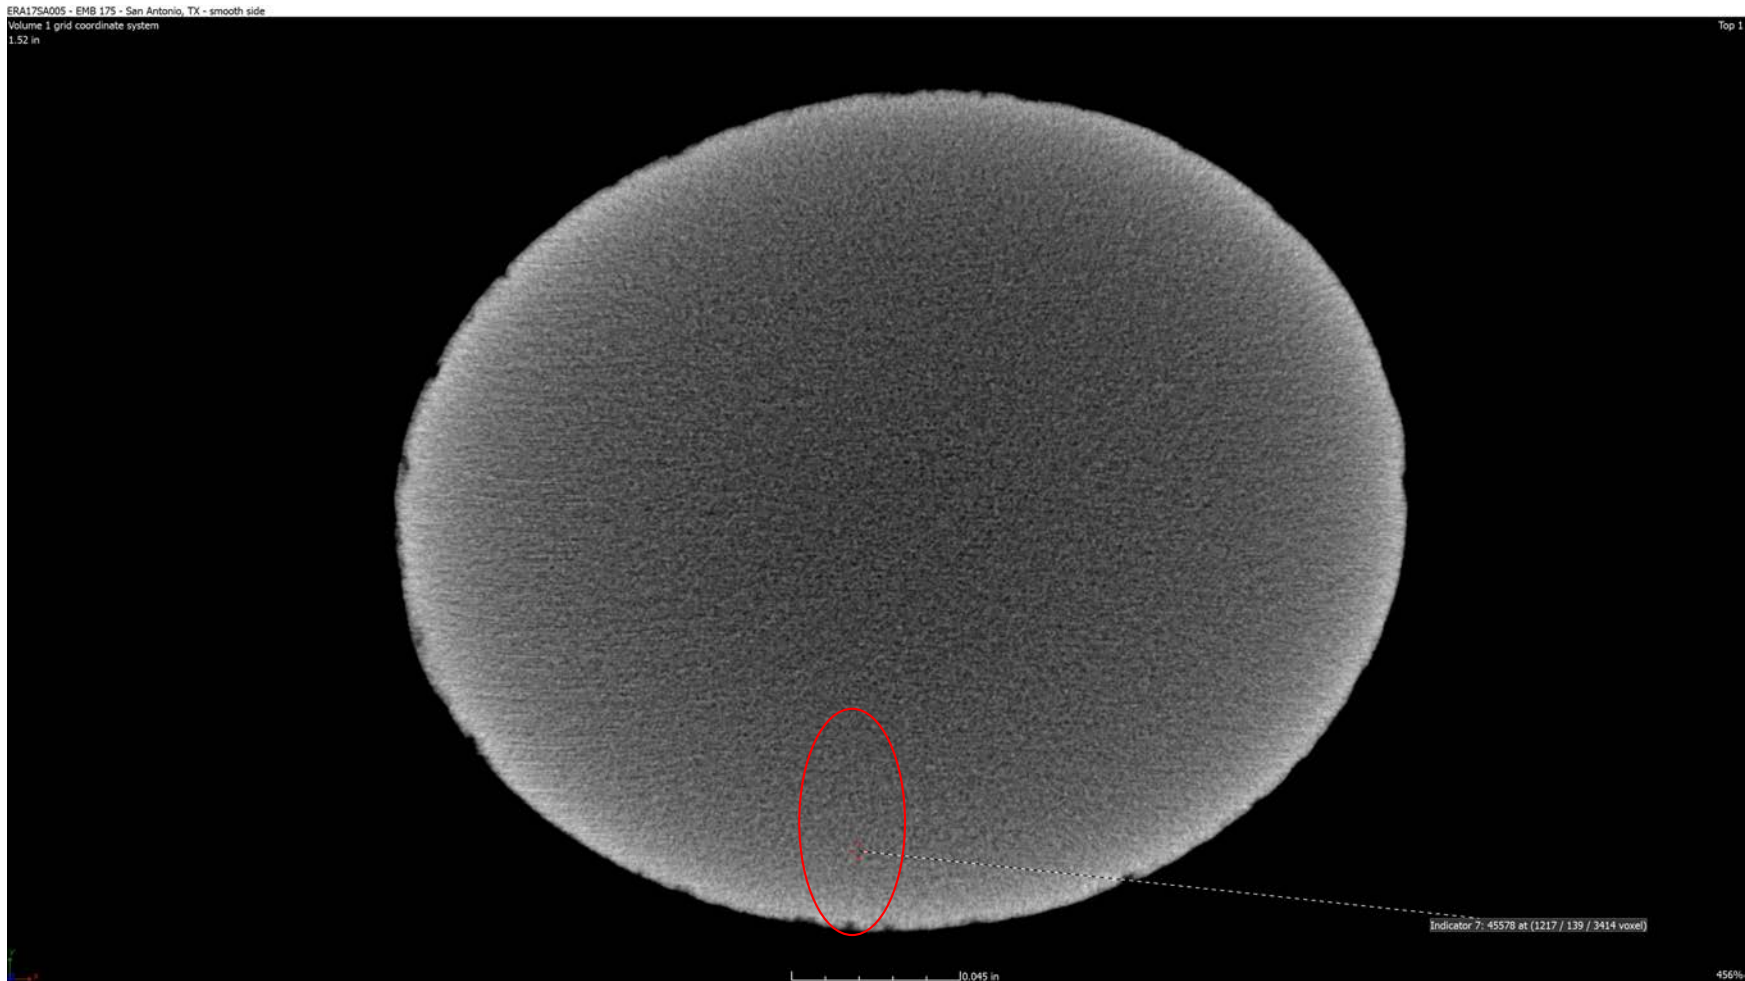
The computed tomography (CT) results for the spring end segment and ring segment are shown in figures 1 through 8. Review of the images indicated that, when they were scanned, there were cracks in multiple locations within the spring end segment; there were crack indications in the ring segment, but those indications could not be confirmed as actual cracks; there were also crack indications noted in the “air” portion of the ring segment scans which was consistent with these crack indications being a product of sensor noise or other characteristic.

Figure 6  
Spring ring segment – apparent crack indication 1

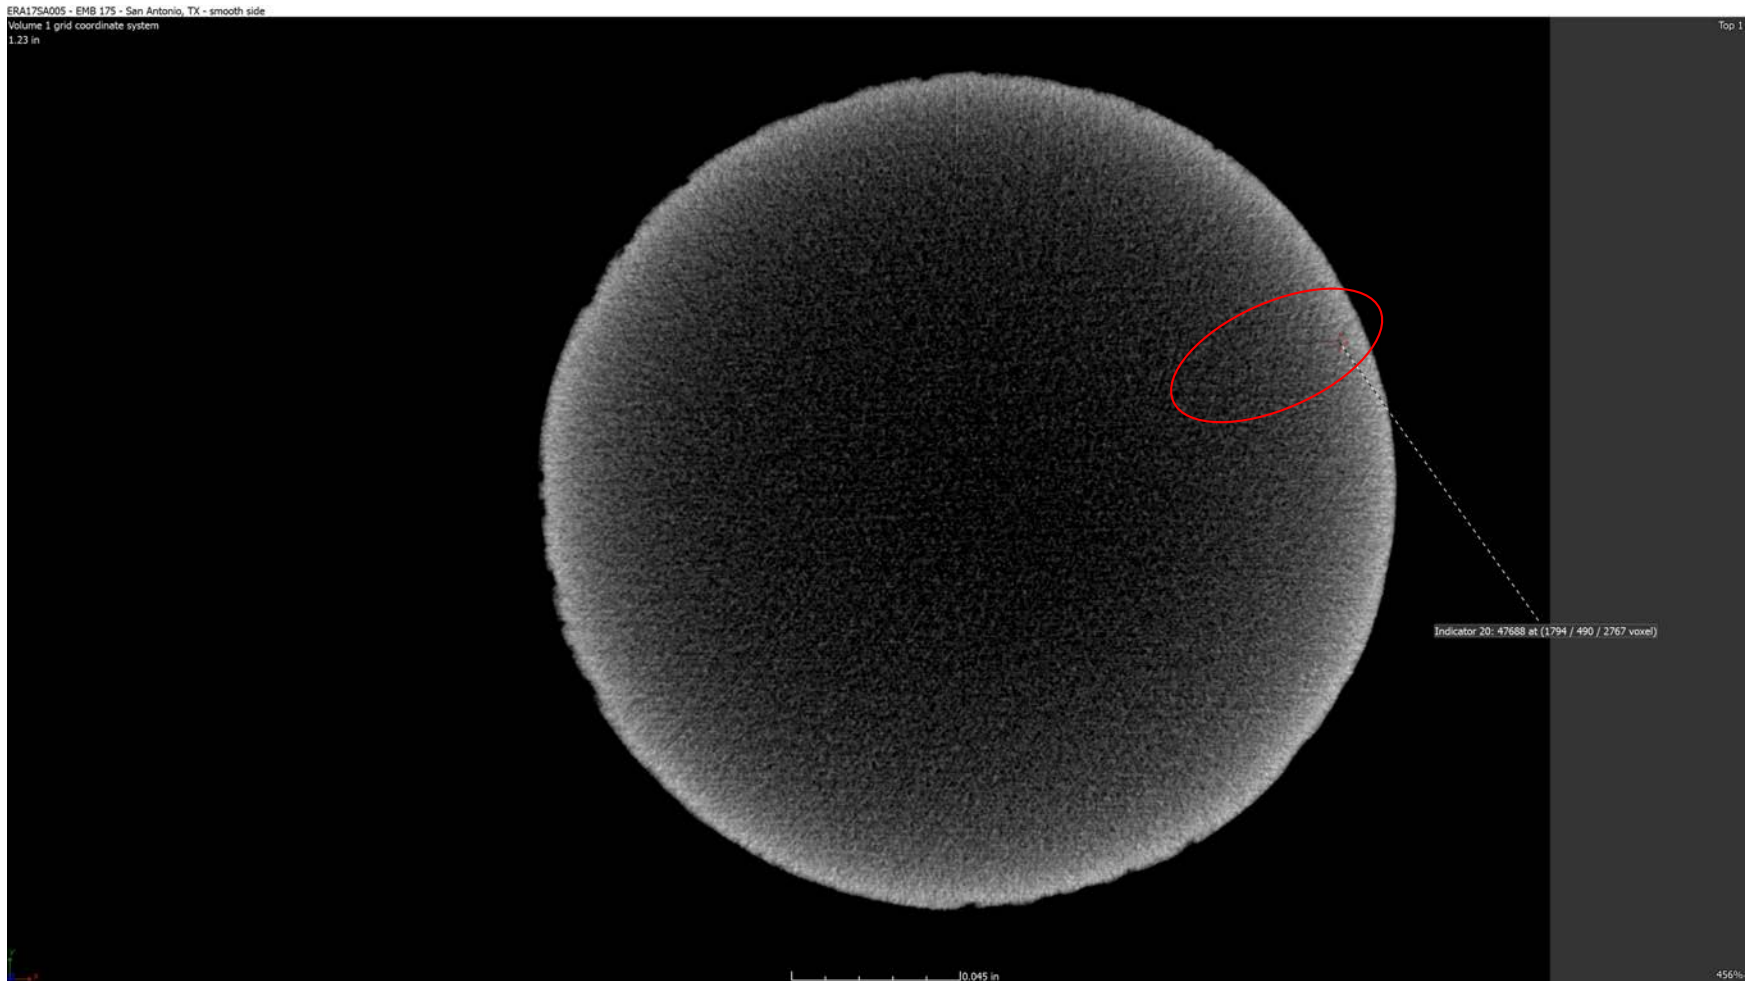
Figure 7  
Spring ring segment – apparent crack indication 2 (note: other apparent crack indications are present in this image)

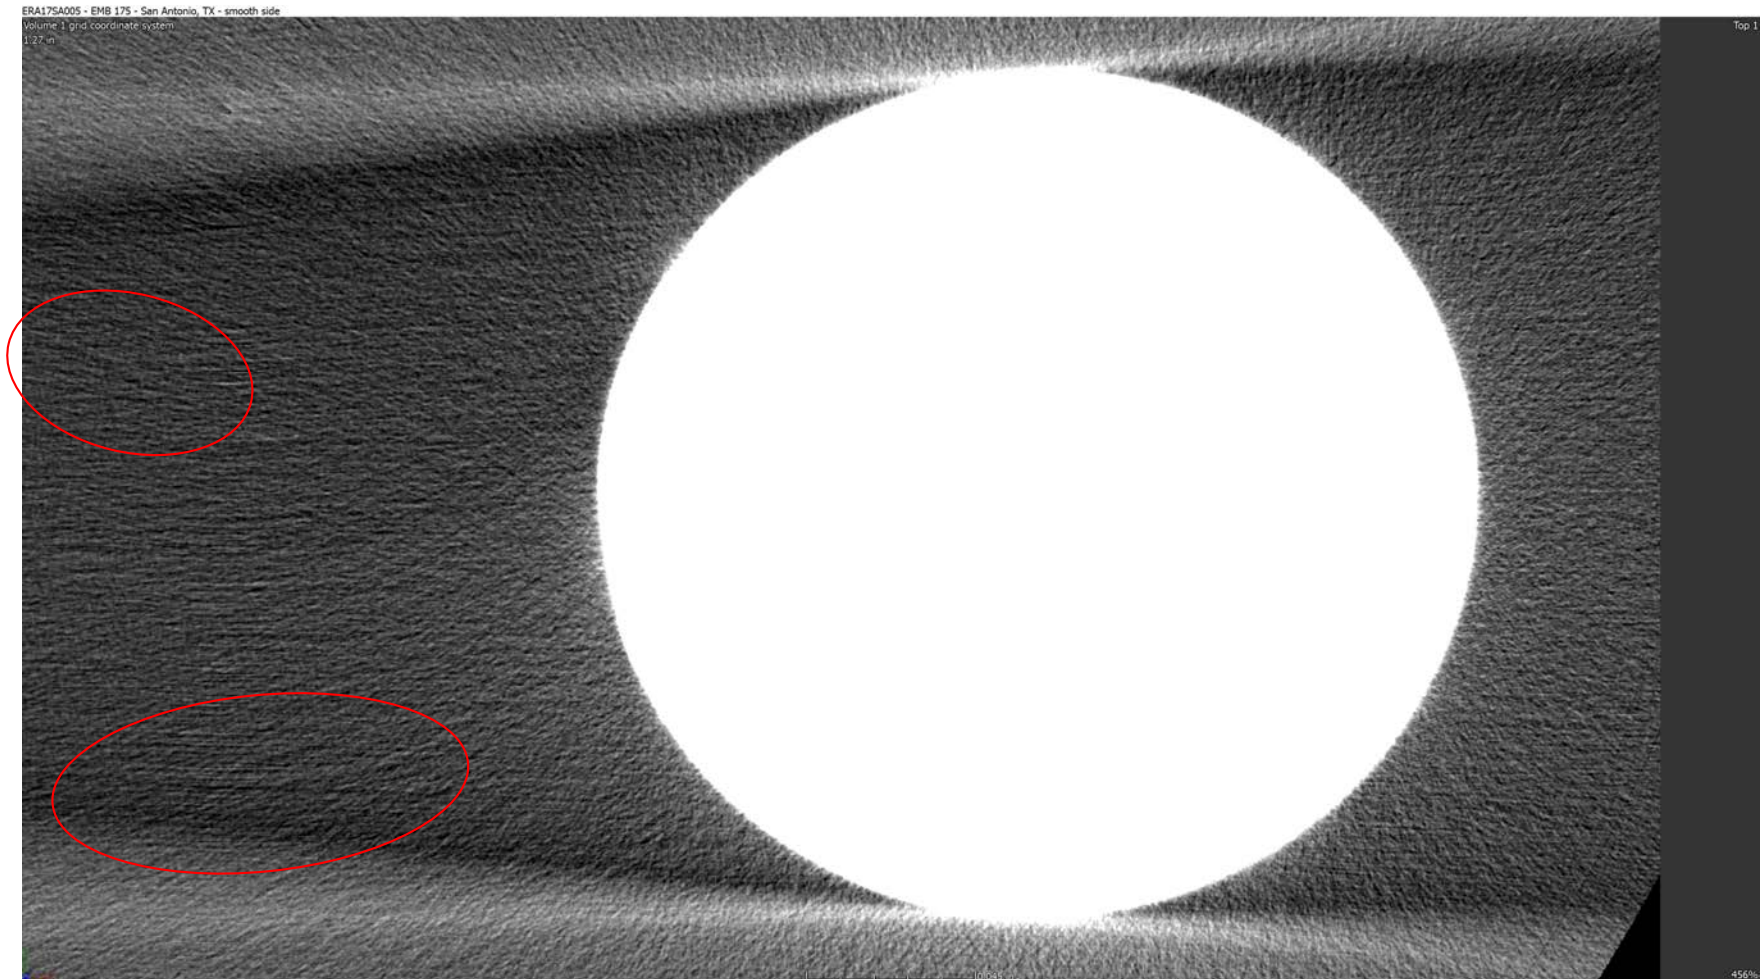
Figure 8

Spring ring segment – apparent crack indications in the air surrounding the ring segment (note: the contrast in this image has been modified to enhance the visibility of fine details in the air surrounding the ring segment)
