NATIONAL TRANSPORTATION SAFETY BOARD
Office of Aviation Safety
Washington, D.C. 20594

Computed Tomography Specialist's Factual Report

ERA18MA099

Location: the East River, near New York, New York
Date: March 11, 2018
Time: 1908 eastern daylight time
Airplane: American Eurocopter Corp (Airbus Helicopters) AS350B2, N350LH

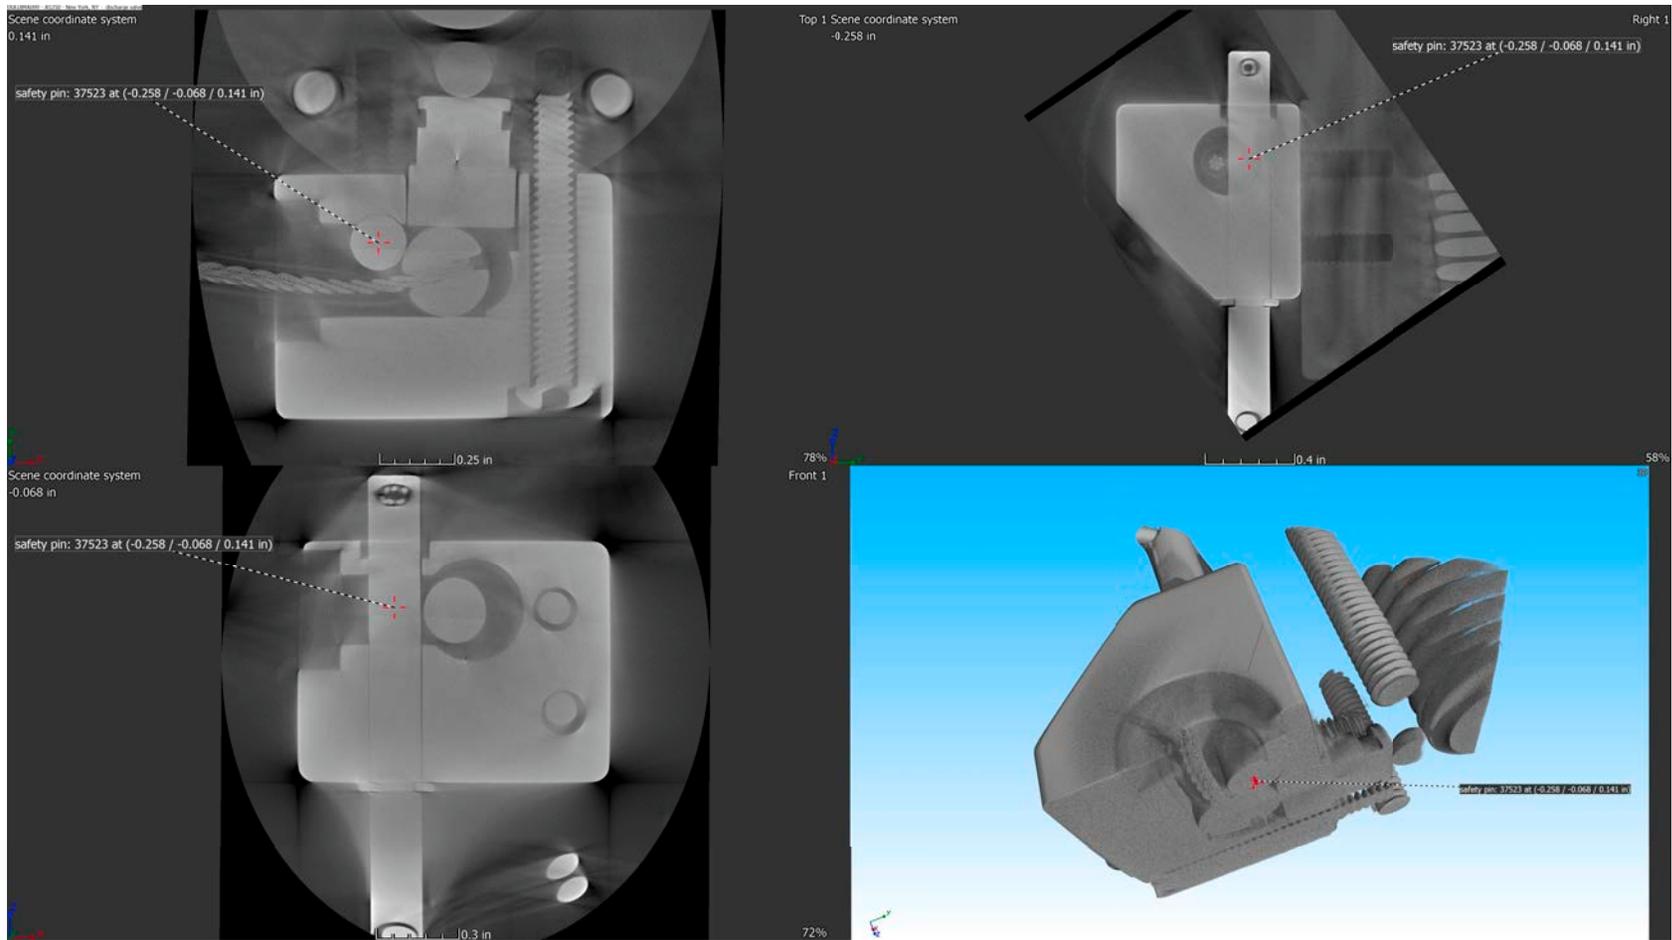
Figure 21
Discharge valve – target CT – safety pin²

² As stated in Note 1, the valve safety pin was installed by the investigative team after the valve was recovered from the accident helicopter and prior to shipment to Varex for CT scanning.
