NATIONAL TRANSPORTATION SAFETY BOARD
Office of Aviation Safety
Washington, D.C. 20594

Computed Tomography Specialist's Factual Report

DCA-08-MA-076

Operator: ABX Air
Location: San Francisco International Airport, California
Date: June 28, 2008
Time: Approximately 1015 pm local time
Airplane: Boeing 767-281SF, N799AX

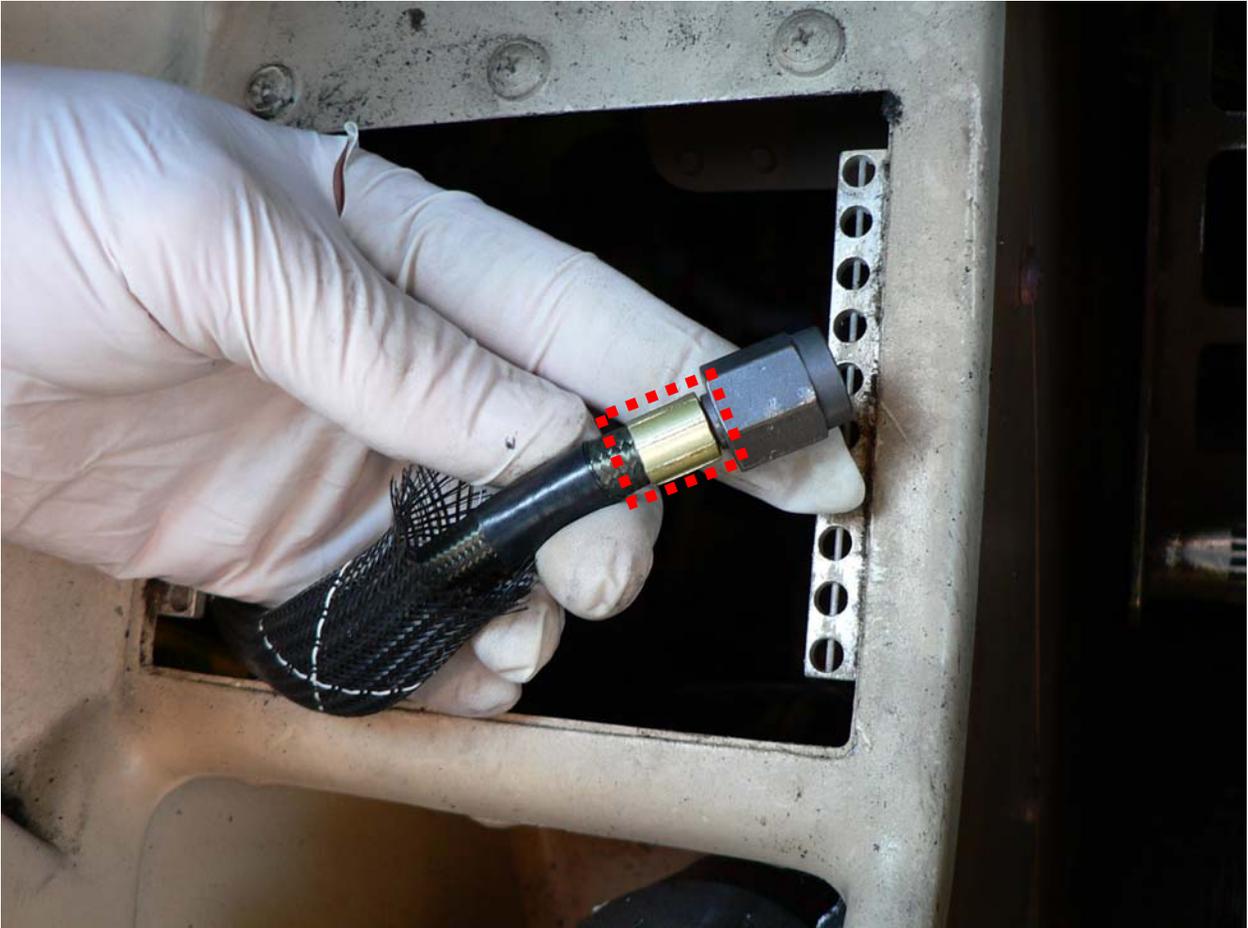
During this evaluation, the hose ends were randomly assigned designations lettered A-F. A representative hose end is shown in figure 1 prior to removal from the aircraft. The red dashed area represents the portion of the hose end documented in the CT images. The DR images cover a longer section of the hose end.

Figure 1
Representative Hose End

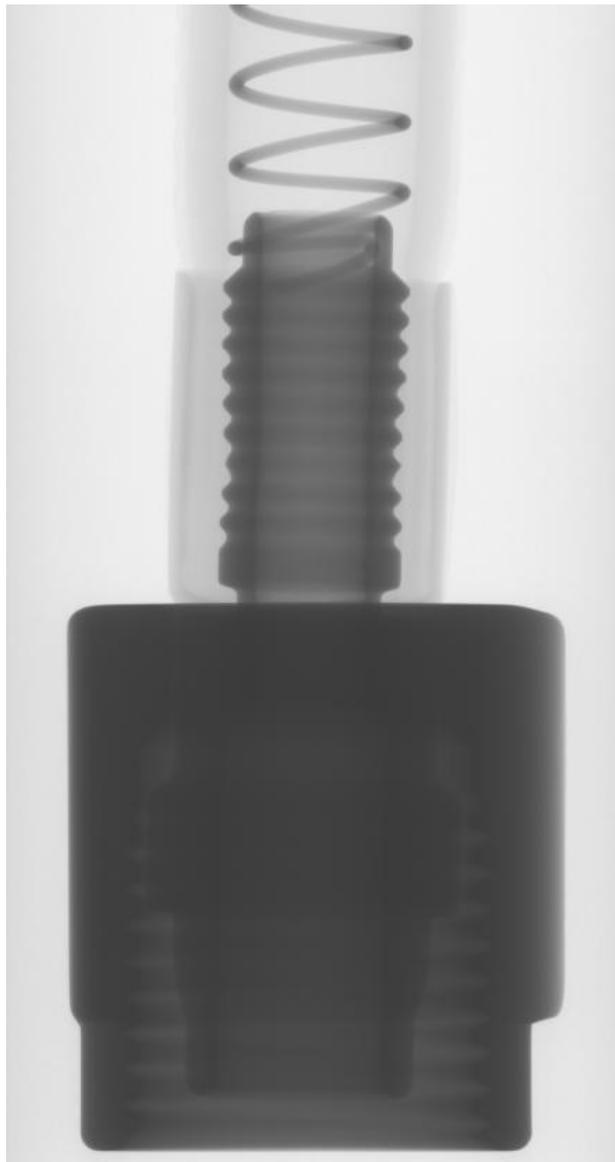
Figure 13
Hose End F – Digital Radiograph

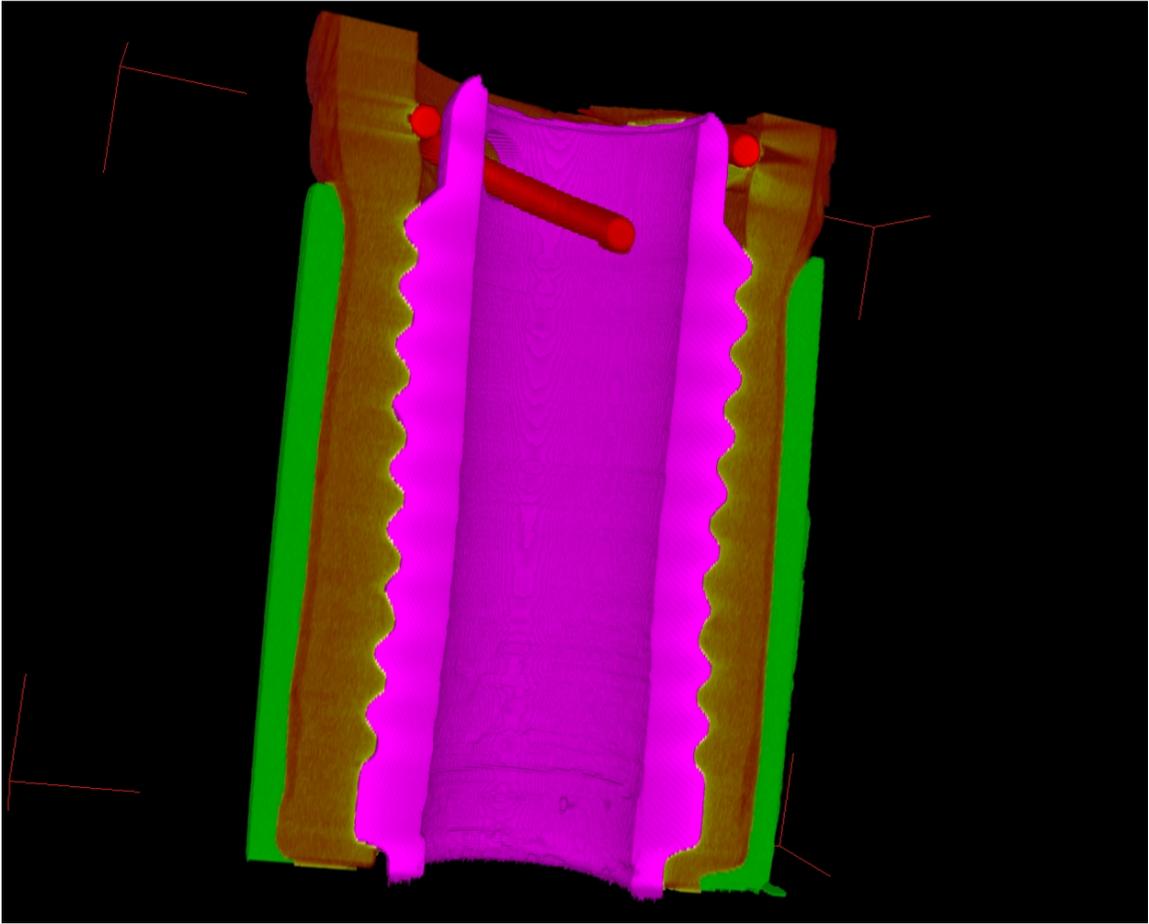
Figure 14
Hose End F – Cross Section

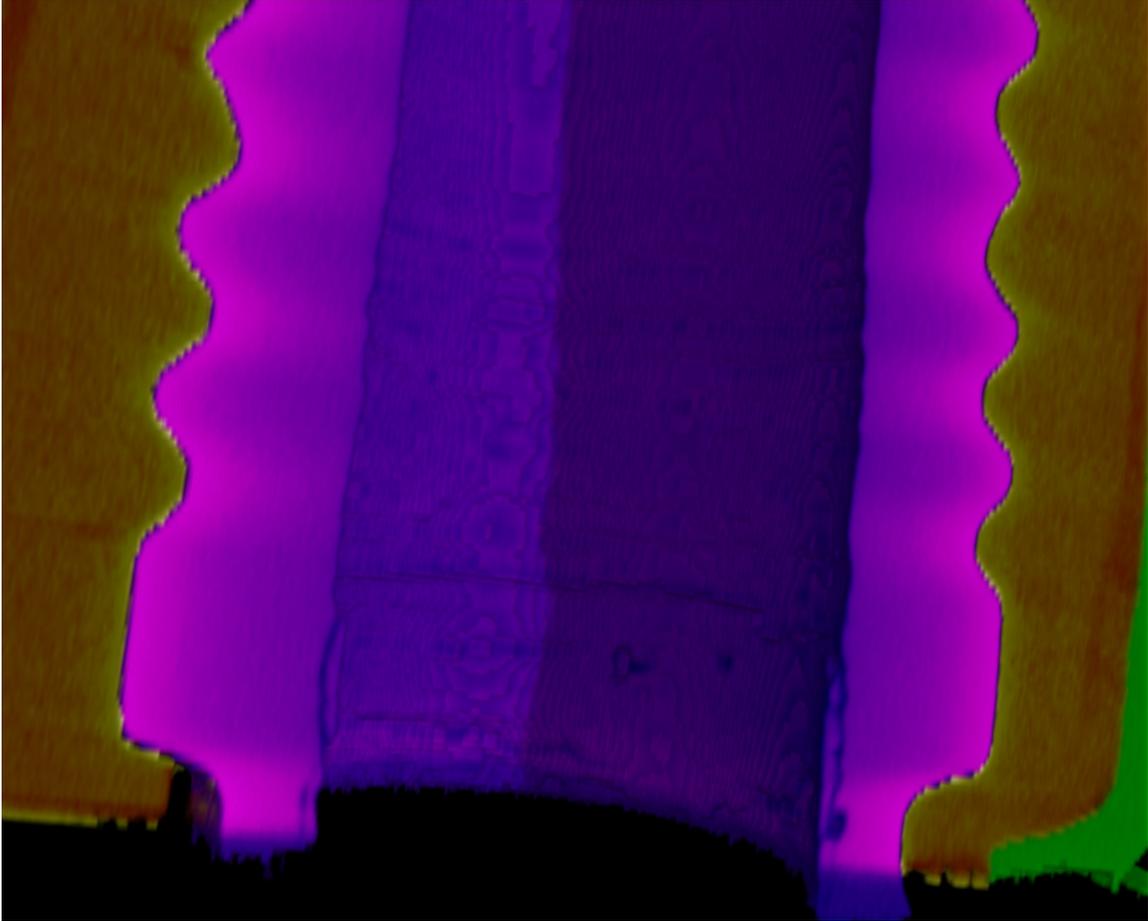
On hose end F, there was a cracked area noted on the lower section of the innermost layer of the hose end. This cracked area is shown in figure 15. An additional color (blue areas denote areas of relatively low density) were added to the three dimensional image to highlight these areas.

Figure 15
Hose End F – Cross Section With An Additional Color Digitally Added To
Highlight Suspected Cracked Areas
