NATIONAL TRANSPORTATION SAFETY BOARD

Computed Tomography and Aircraft Systems Specialist's Factual Report

CEN-14-LA-127

Operator: Mountain Aviation, Inc
Location: Abraham Lincoln Capital Airport (SPI), Springfield, Illinois
Date: January 31, 2014
Time: 1312 central standard time
Airplane: Piaggio model P180, N700FE

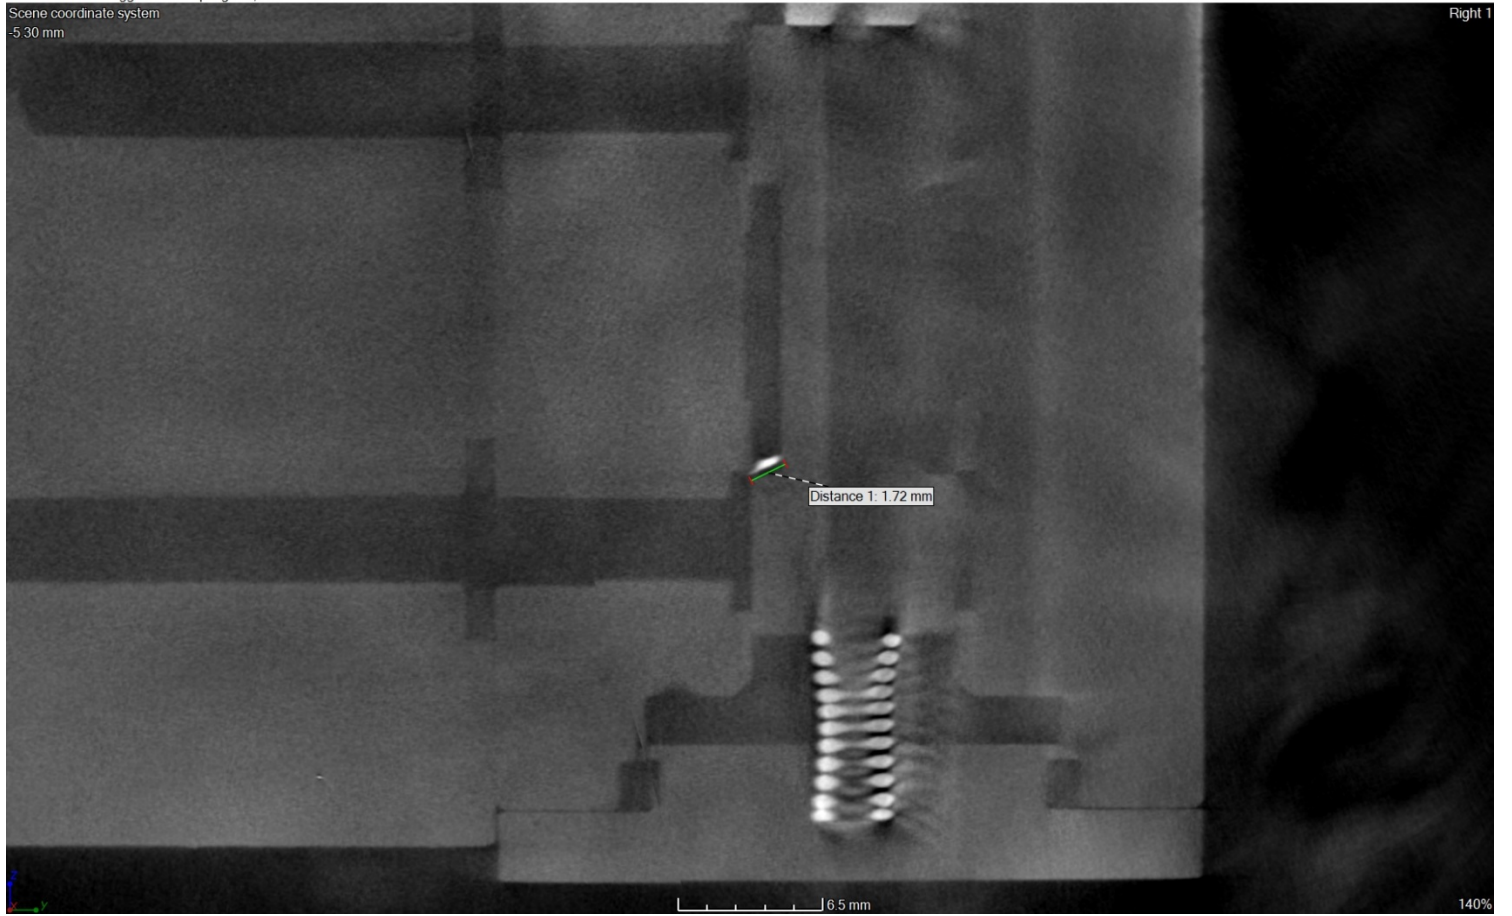
The computed tomography (CT) results for the DCV are shown in figures 1 through 11. Review of the images showed that there was a particle located between one of the spool lands and the DCV housing. The particle was approximately 3 mm long.

Figure 3
DCV – Particle between DCV spool land and housing

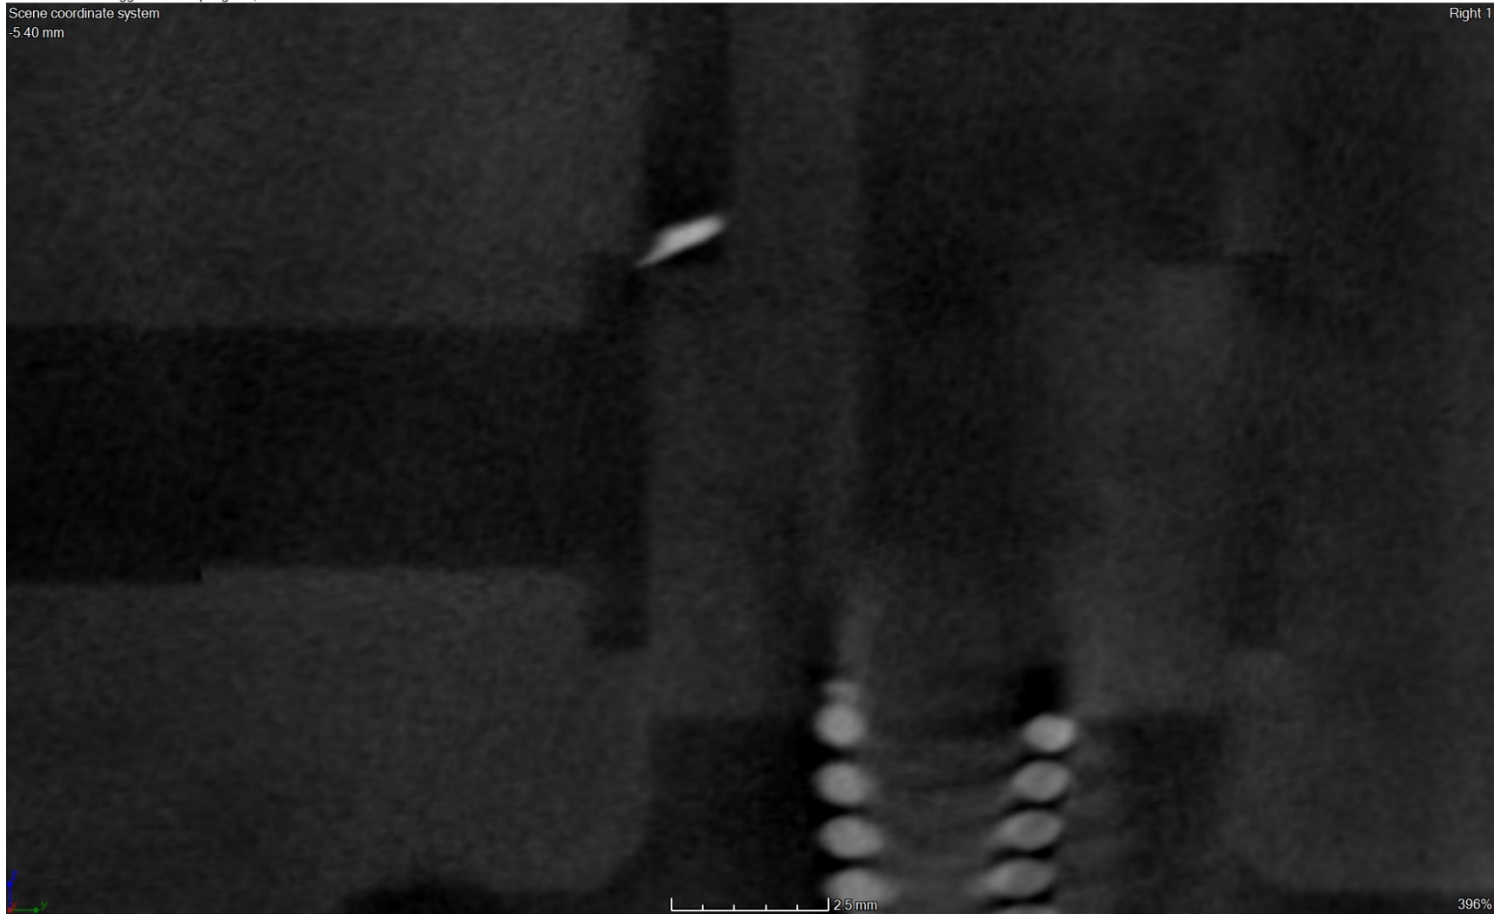
Figure 4
DCV – Particle between DCV spool land and housing (close up)

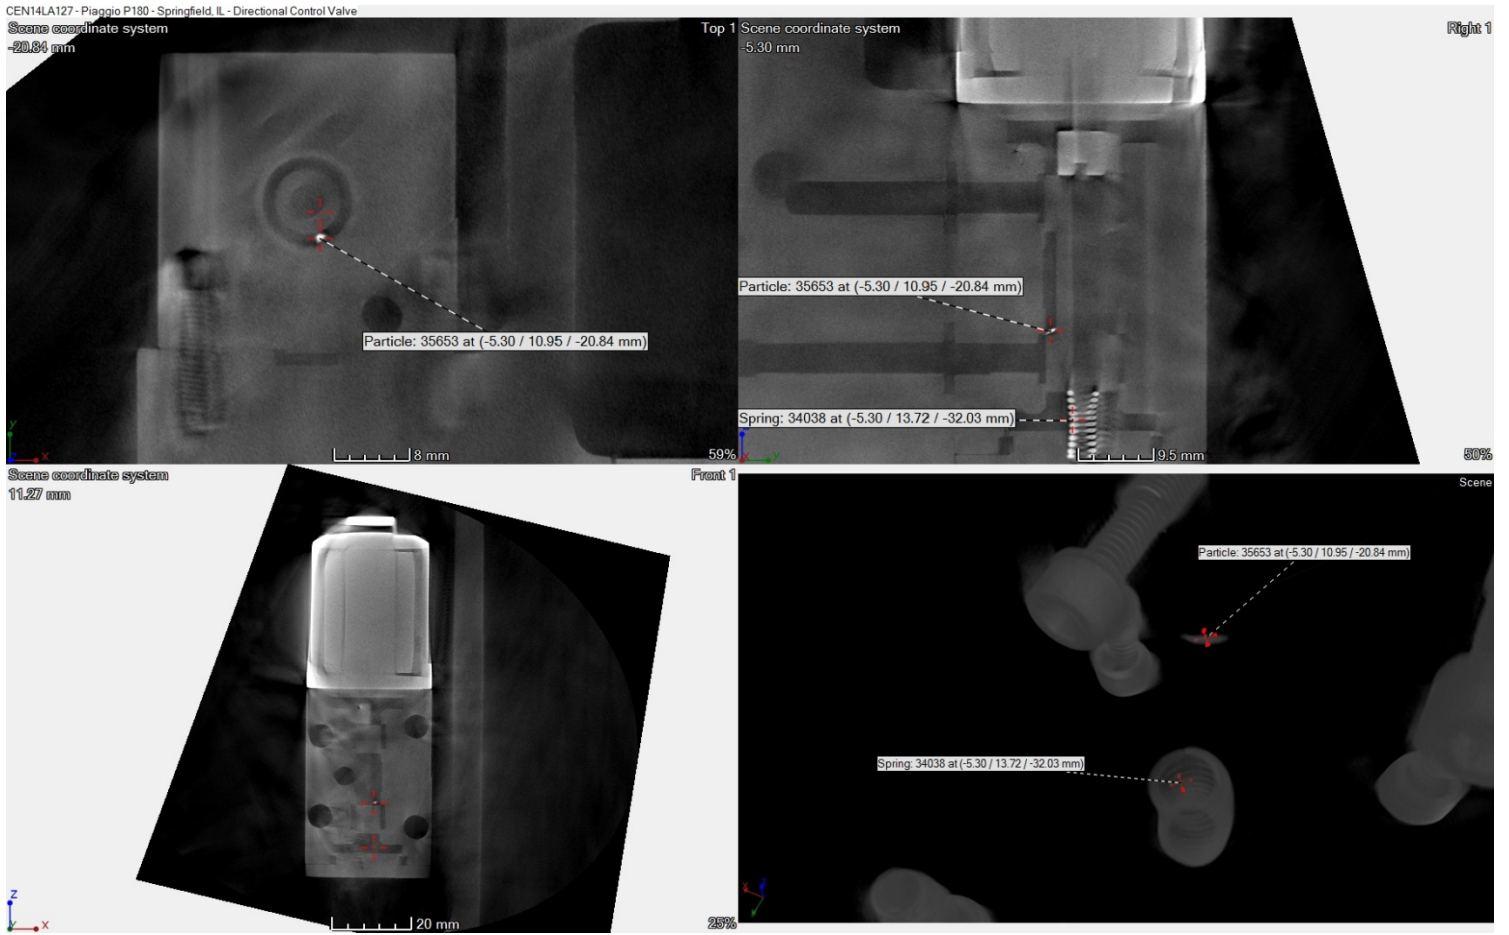
Figure 5

DCV – Particle between DCV spool land and housing oriented to show the maximum length of the particle

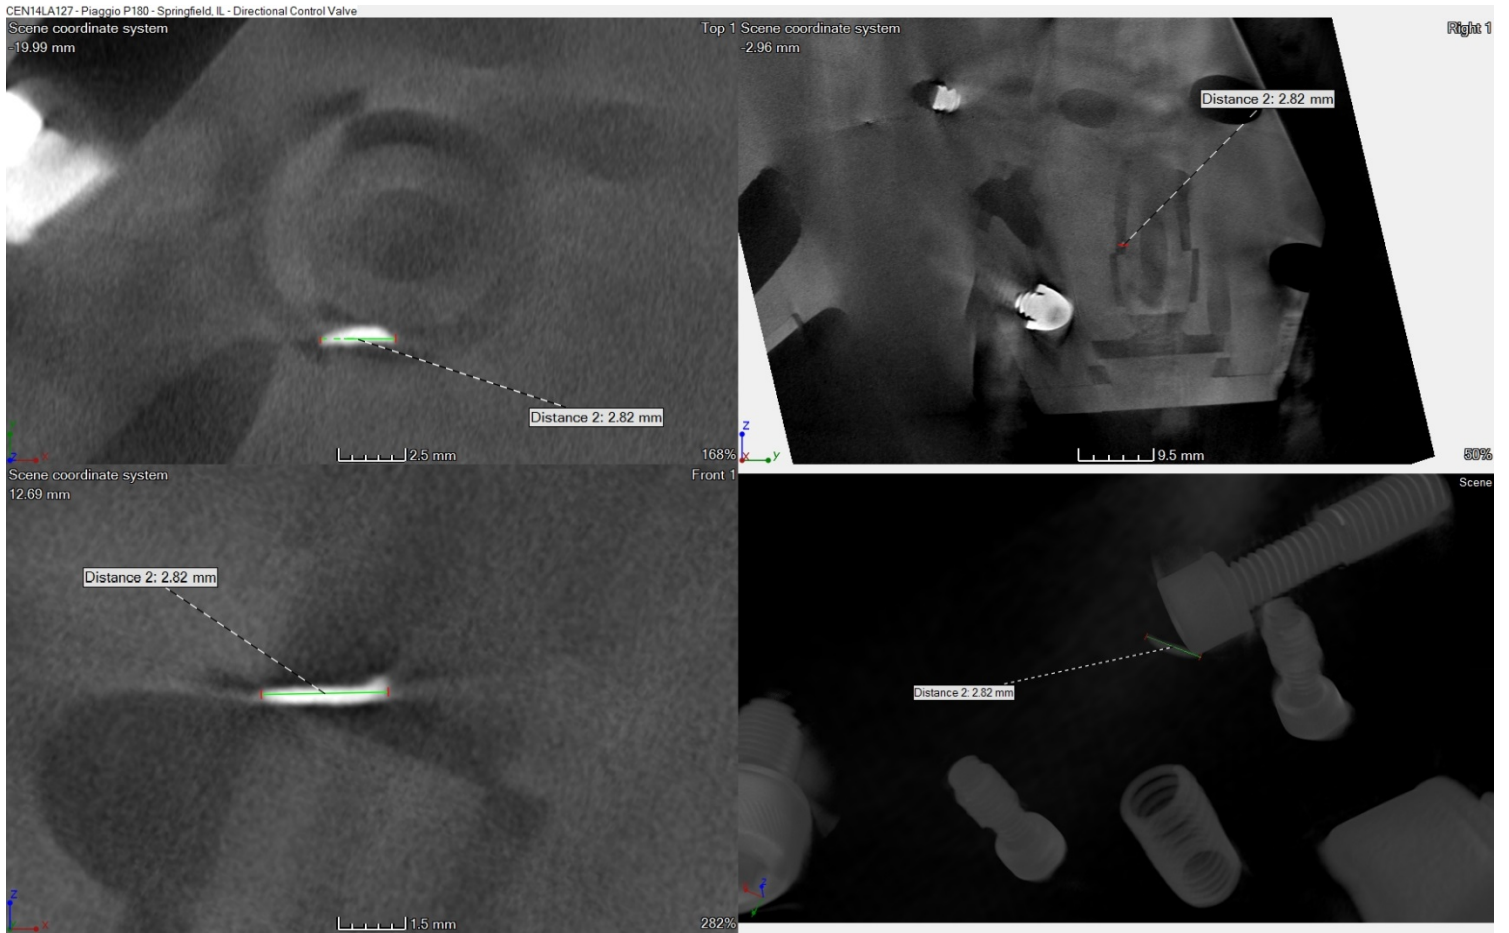
Figure 6

DCV – Particle between DCV spool land and housing oriented to show the maximum length of the particle (close up)

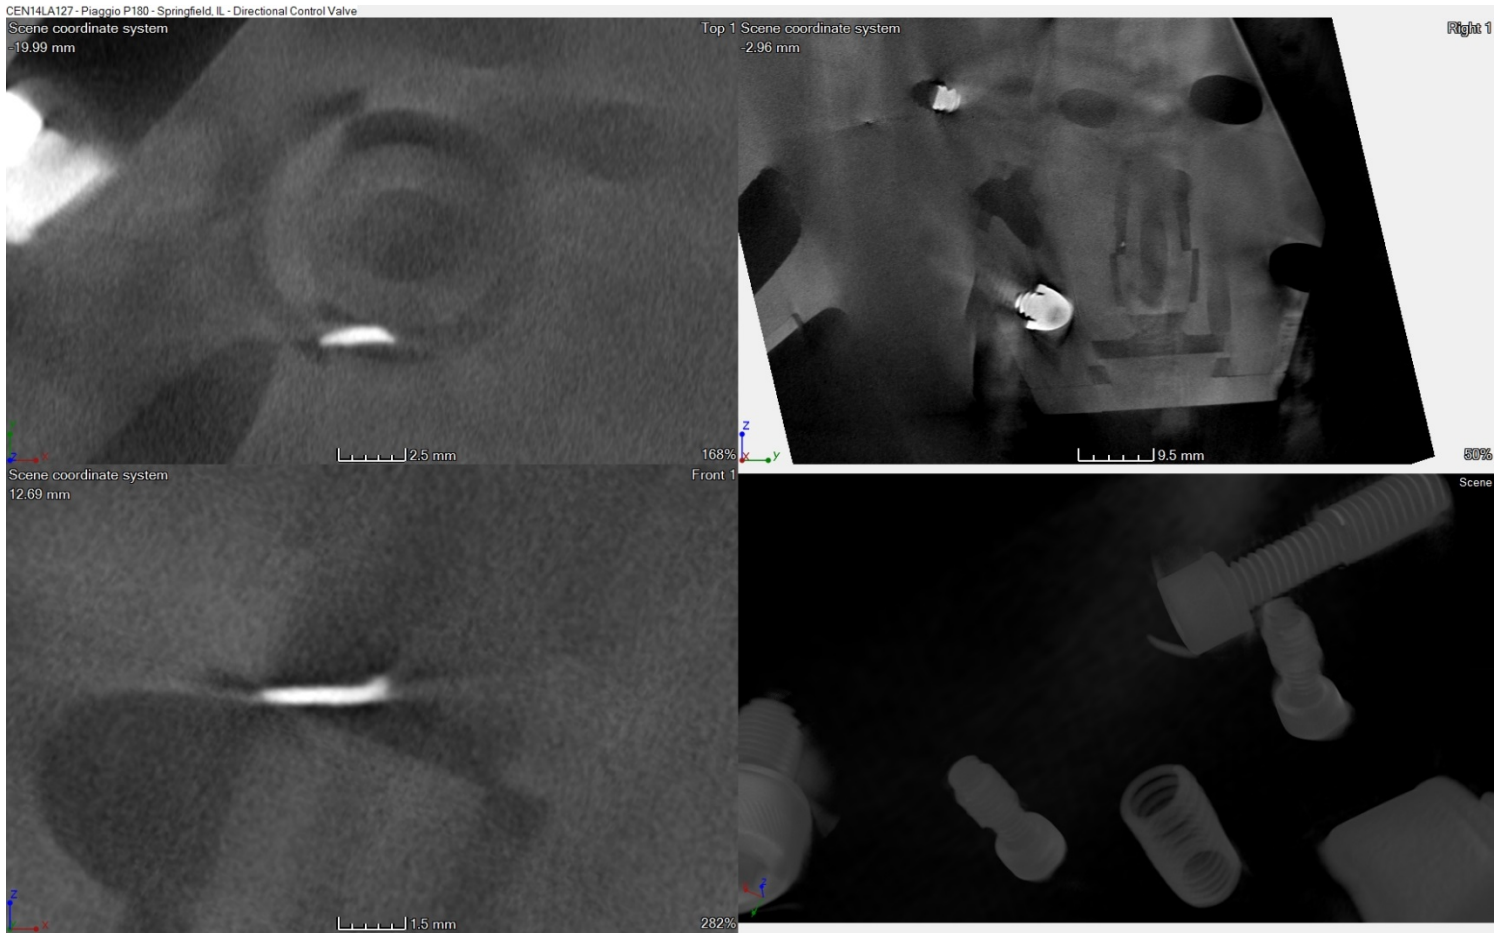
Figure 7

DCV – Particle between DCV spool land and housing oriented to show the maximum length of the particle (close up without indicators)

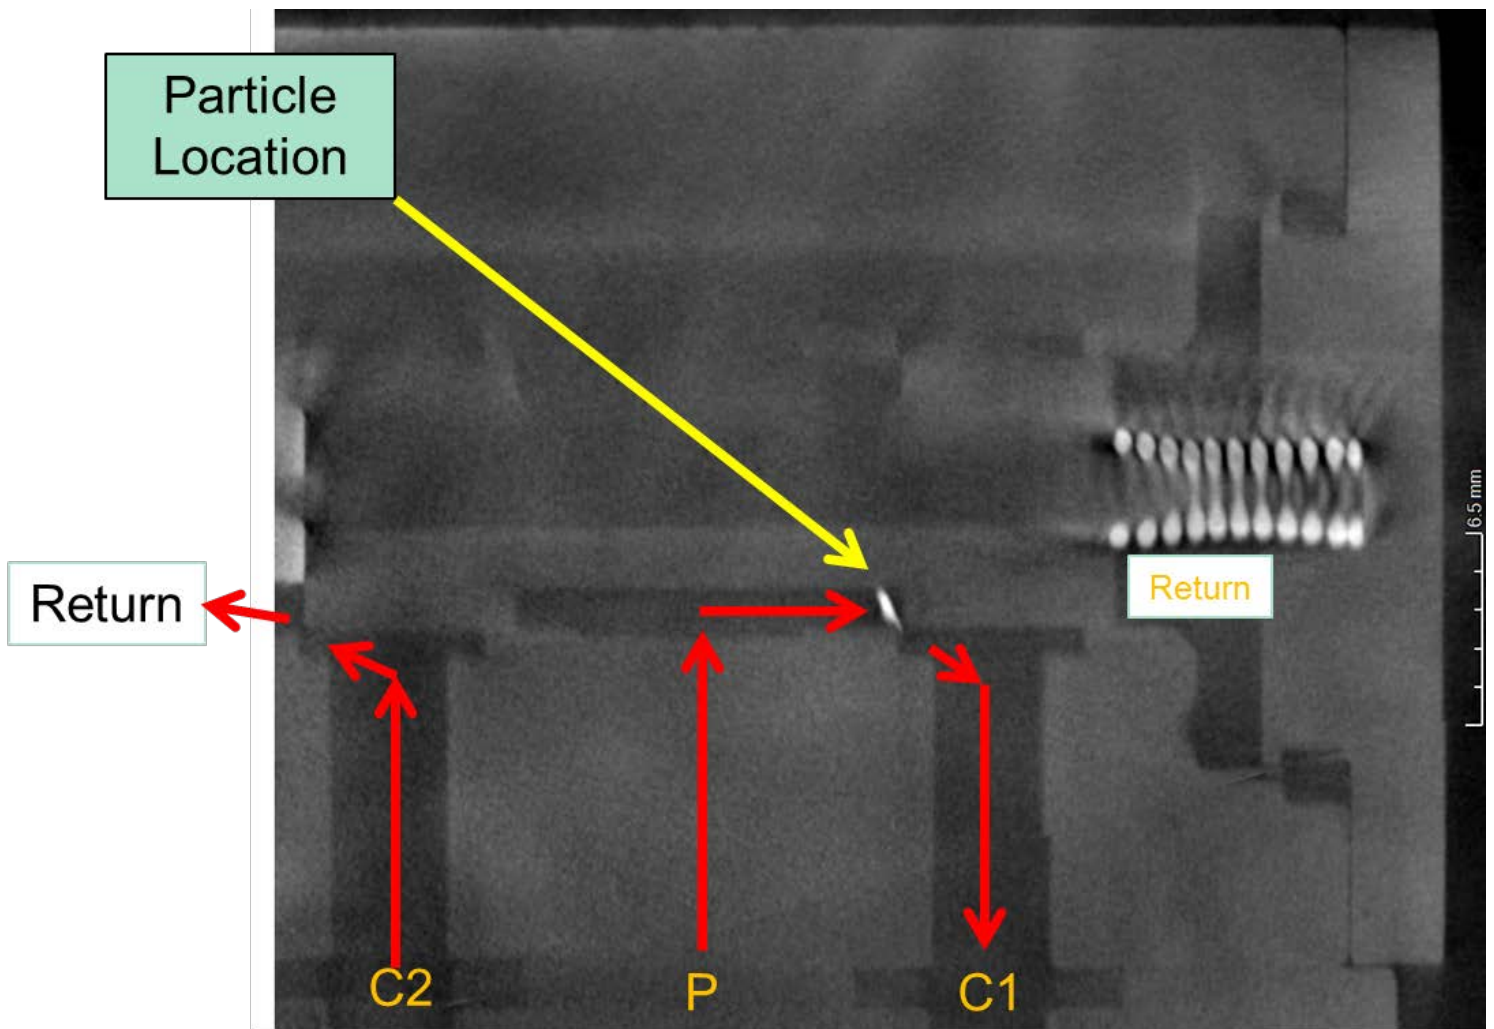
Figure 10

A review of the hydraulic system schematics was conducted, and the hydraulic ports associated with the DCV were identified. The ports are labeled in figures 8-11. The review indicated that the position of the DCV spool was consistent with a position where the pressure port would be connected to the C1 port.

Close up CT image of the DCV showing the pressure port (P), control ports (C1, C2), and return ports (Return). The arrows indicate the designed flow paths through the DCV in the “as-imaged” condition.

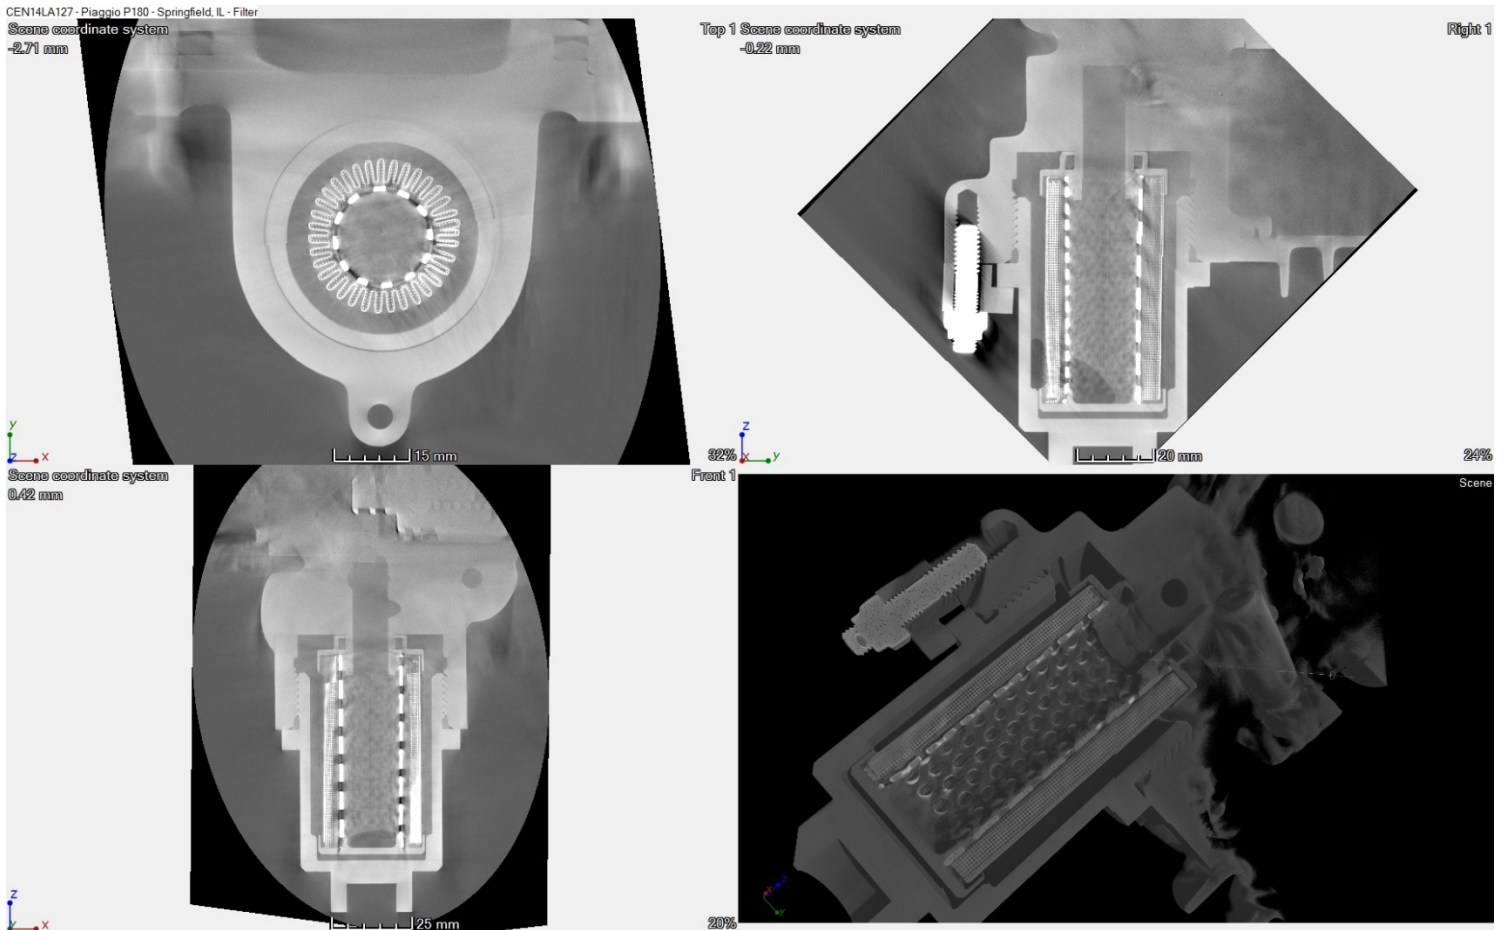
The computed tomography (CT) results for the hydraulic pump package filter are shown in figures 12 and 13. Review of the images did not show any radiographic indications of high density particles in the filter.

Figure 12
Hydraulic Pump Package Filter – Overall view

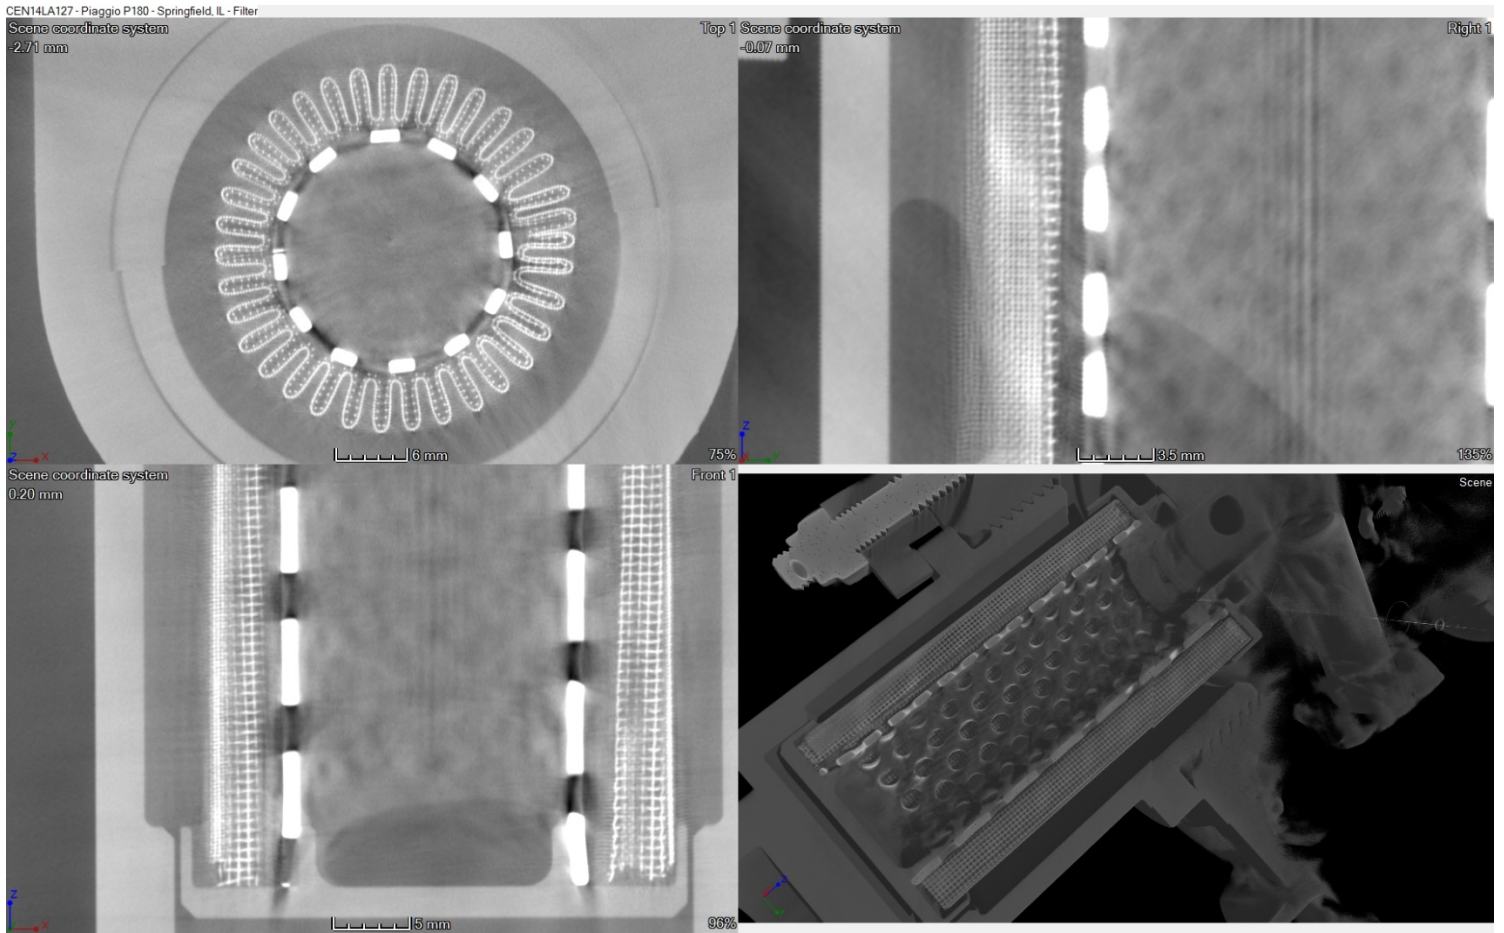
Figure 13
Hydraulic Pump Package Filter – Close up view showing multiple filter layers

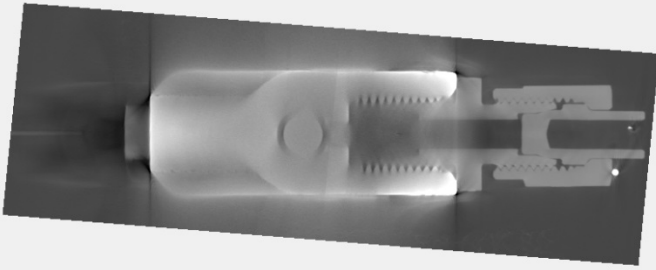
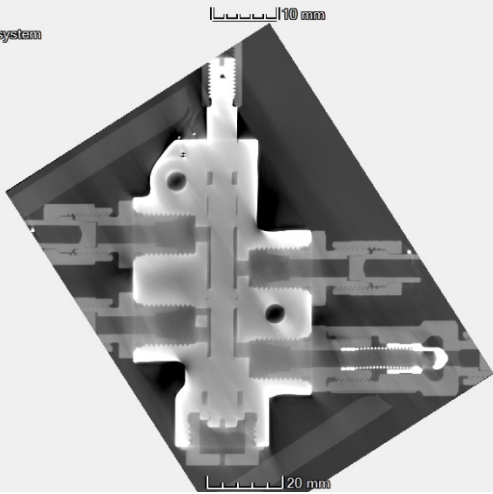
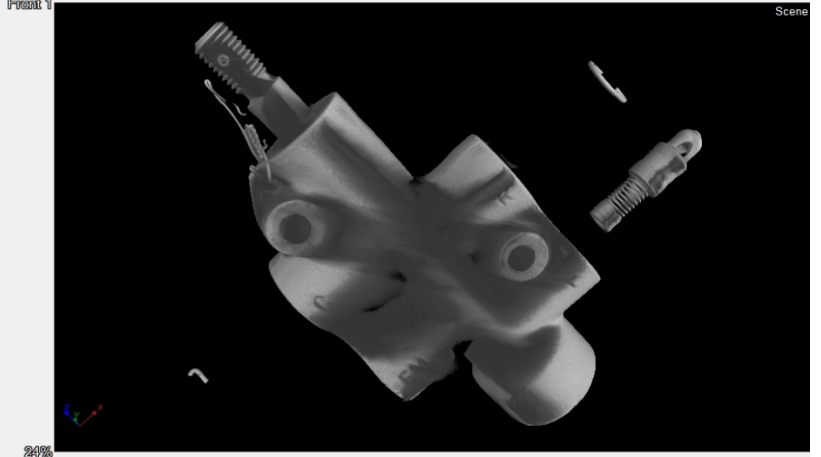
The computed tomography (CT) results for the ELGSV are shown in figures 14 through 18. Both the open and closed positions were imaged. Review of the images did not show any radiographic indications of high density particles in the valve, and the path for the valve spool did not appear to have any obstructions that would prevent the spool from moving to either the open or closed positions.

Figure 14
ELGSV – Open Position – Overall view

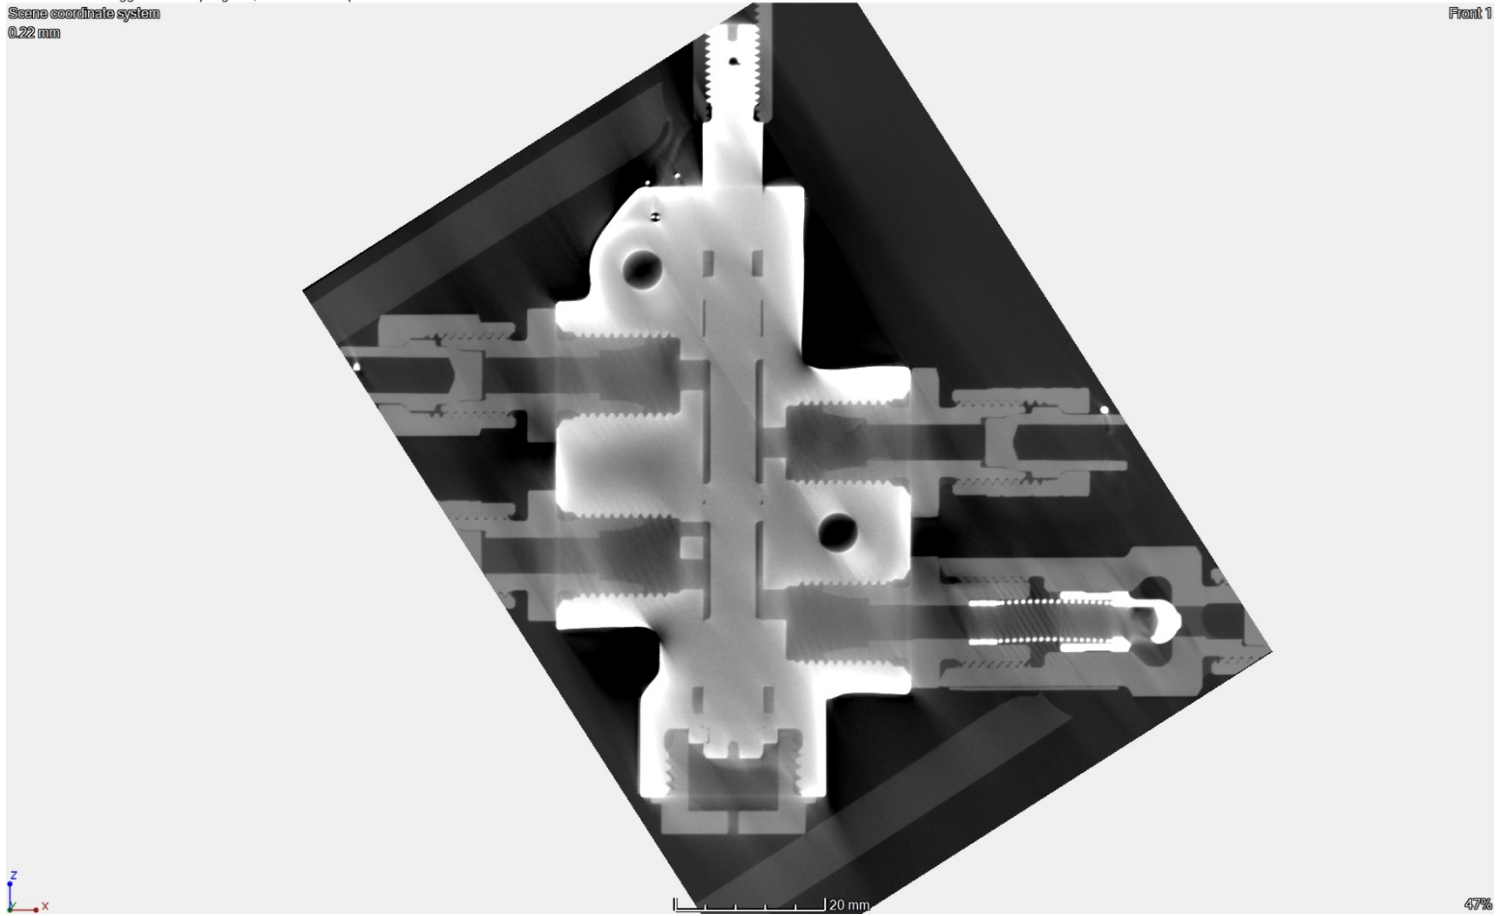
Figure 15
ELGSV – Open Position – Close up view

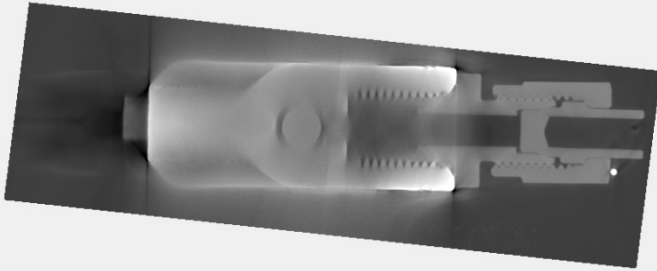
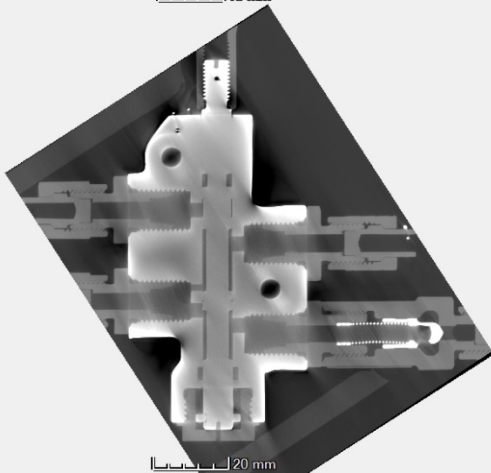
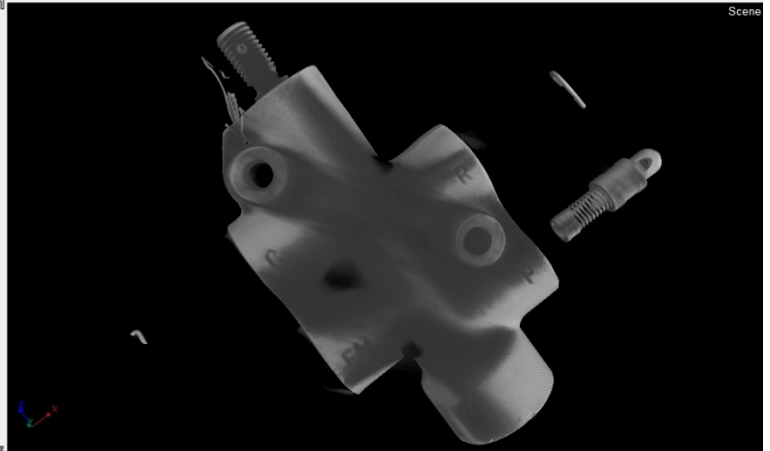
Figure 16
ELGSV – Closed Position – Overall view

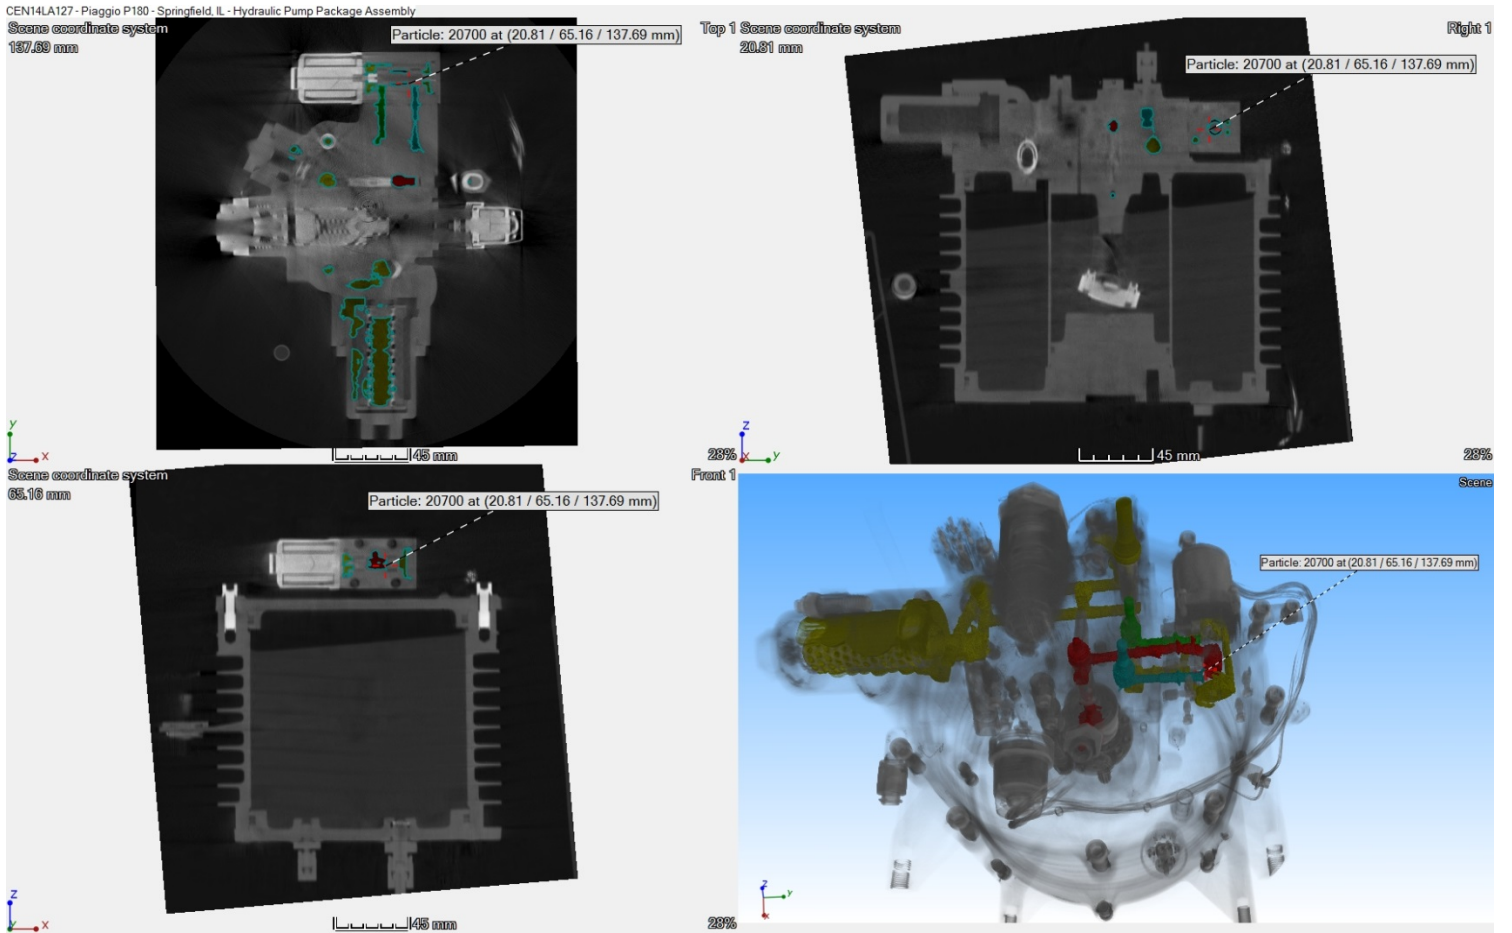
The computed tomography (CT) results for the hydraulic pump package are shown in figures 19 through 27. Review of the images did not show any radiographic indications of high density particles other than the particle in the DCV. The hydraulic flow paths within the pump package were digitally marked. Pressure was colored red, return was colored yellow, C1 was colored blue, and C2 was colored green.

Figure 20
Hydraulic Pump Package – Overall view showing particle location in DCV
