ENGINE FIELD INSPECTION REPORT

ENGINE MODEL	E-225
ENGINE SERIAL NUMBER	30057-D-3-4
AIRCRAFT MAKE & MODEL	Navion A
AIRCRAFT SERIAL NUMBER	NAV-4-1827
AIRCRAFT REGISTRATION	N4827K
FILE NUMBER	14-171

EXAMINATION		ACCIDENT DATA	
DATE	10/01/2014	NTSB ACCIDENT #	ANC14LA068
FACILITY	Arctic Aviation	NTSB INVESTIGATOR	Todd Gunther
ADDRESS	[REDACTED] Fairbanks, AK 99709	FAA INVESTIGATOR	Jason Major
		ACCIDENT DATE	08/24/2014
		ACCIDENT LOCATION	Coldfoot, Alaska

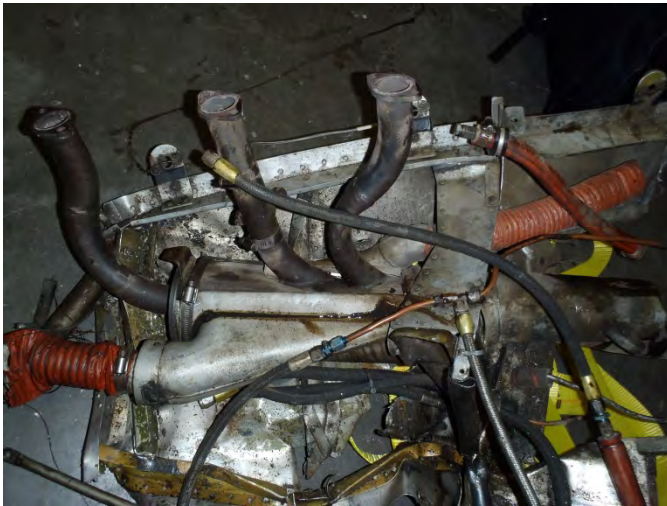
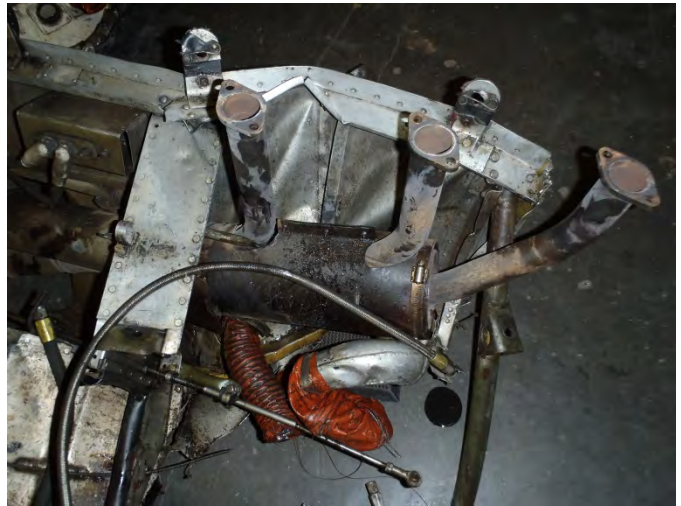
The exhaust system remained attached to the engine and to the airframe. The exhaust system sustained damage consistent with impact damage in the form of bending. There were no anomalies noted with the exhaust system.

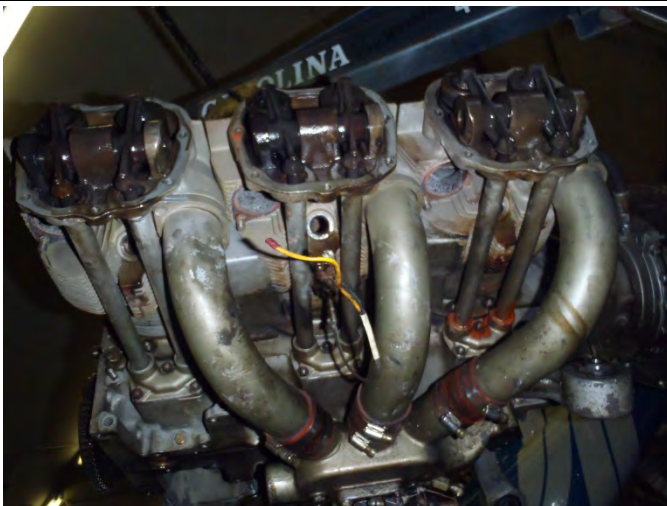
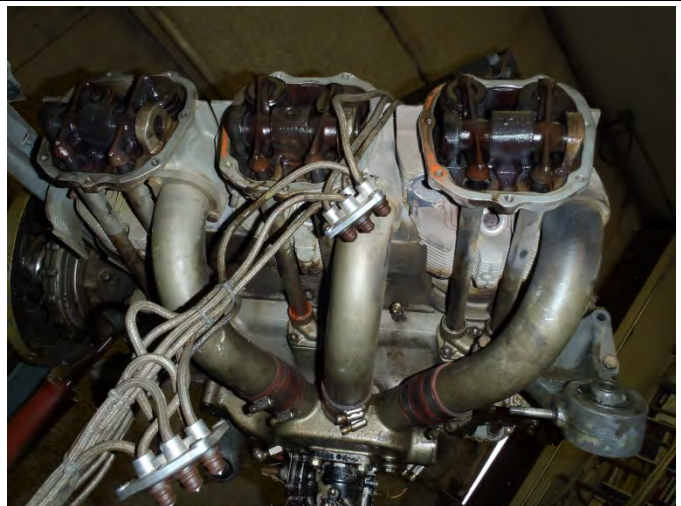
The induction system remained attached to the engine and to the carburetor. The carburetor airbox sustained damage consistent with impact damage. There were no anomalies noted with the intake system.

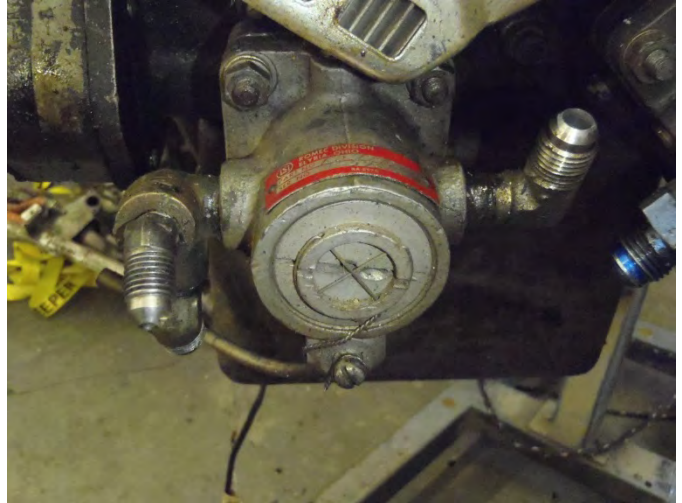
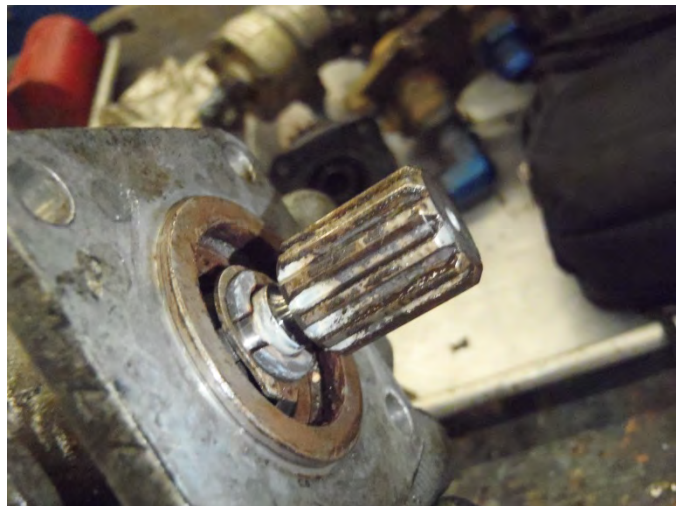
The fuel pump remained attached to its respective installation point and was undamaged. The fuel pump was removed and it was noted that the drive shaft remained intact and was capable of rotating by hand. There were no anomalies noted with the fuel pump.

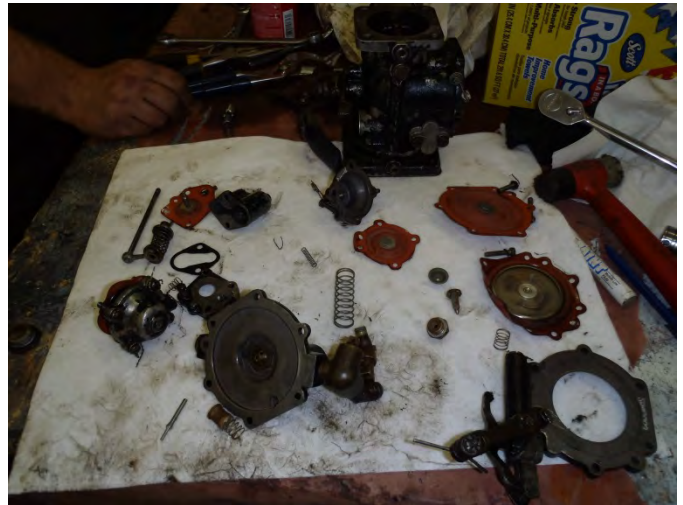
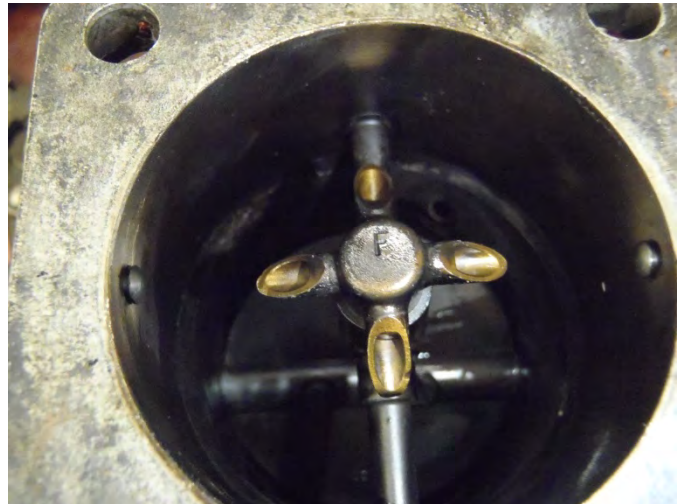
The carburetor remained attached to the engine and to the airbox. The carburetor sustained damage consistent with impact damage to the carburetor mixture control components. The carburetor was removed from the engine and disassembled for an internal examination. It was noted that the fuel inlet screen had a significant amount of material consistent with rubber and there was a significant amount of particulates noted in several of the carburetor chambers. It also noted that there was fuel present within several of the chambers of the carburetor. There were no further anomalies noted.

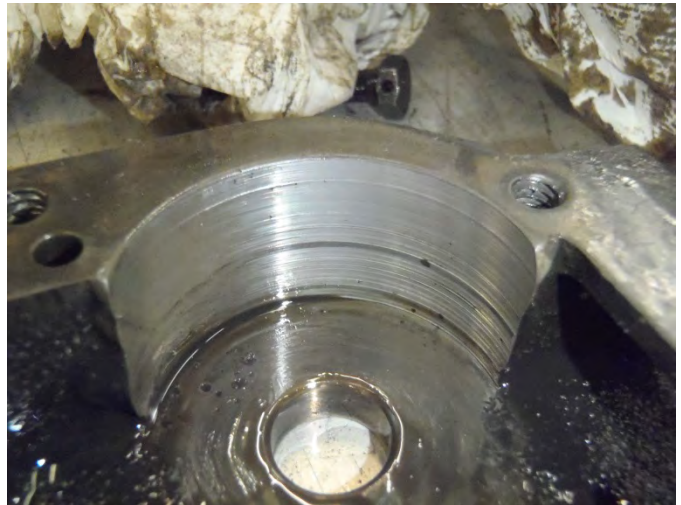
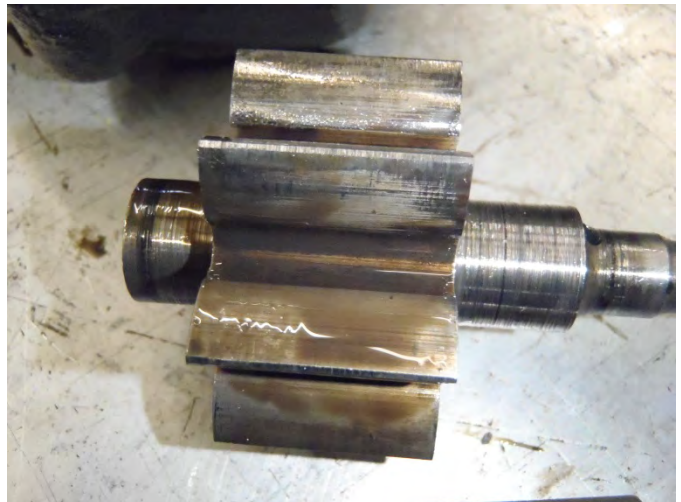
OIL SUMP	
Condition:	The oil sump remained attached to the engine and was undamaged. There were no anomalies noted with the oil sump.
OIL PICK-UP TUBE & SCREEN	
Condition:	The oil pick-up tube and screen remained installed to its respective installation point and was undamaged. The screen was clear of contaminants.
OIL PUMP	
Condition:	The oil pump remained installed in its respective installation point and was capable of normal rotation. The oil pump was disassembled and it was noted that the oil pump housing displayed scoring consistent with hard partical passage. The oil pump gears displayed small chips in several of the gear apexes consistent with hard partical passage. There were no further anomalies noted with the oil pump.

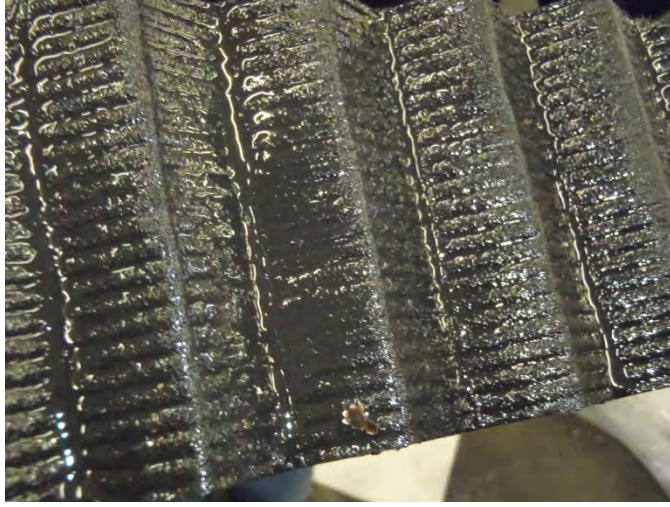
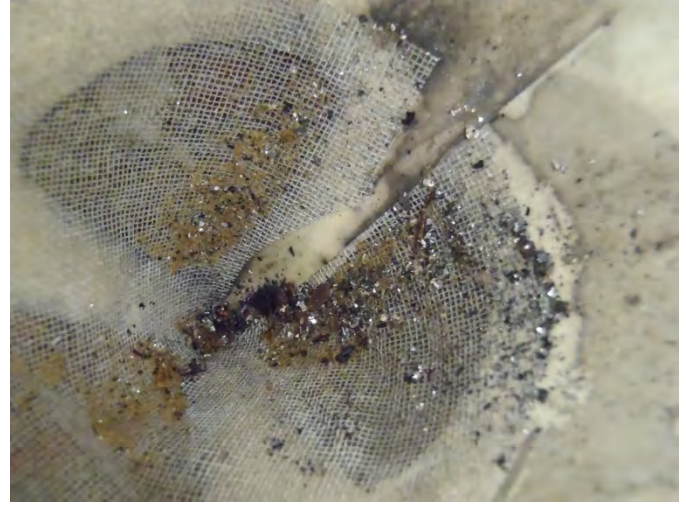
Condition: The oil filter remained attached to the oil filter adapter and was undamaged. The oil filter was removed and the filter housing was cut open for inspection of the filter element. The filter element displayed several large flakes and small metallic particulates within the oil filter pleats. The oil filter pleats were placed into solvent and then the solvent was poured through a paper filter; additional metallic particulates were noted in the filter. There were no further anomalies noted.

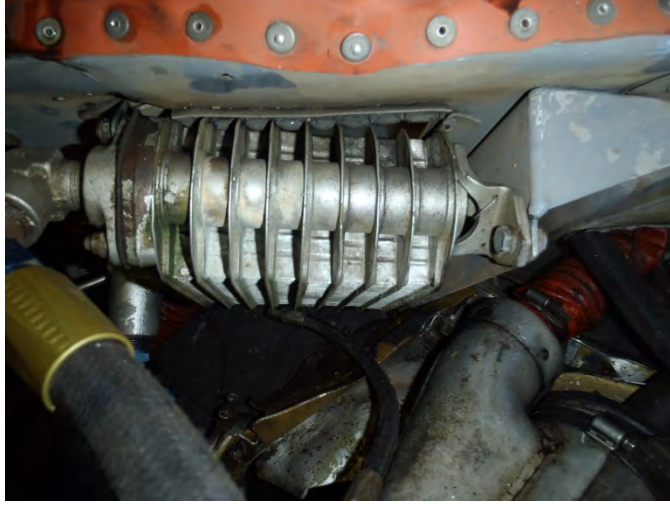
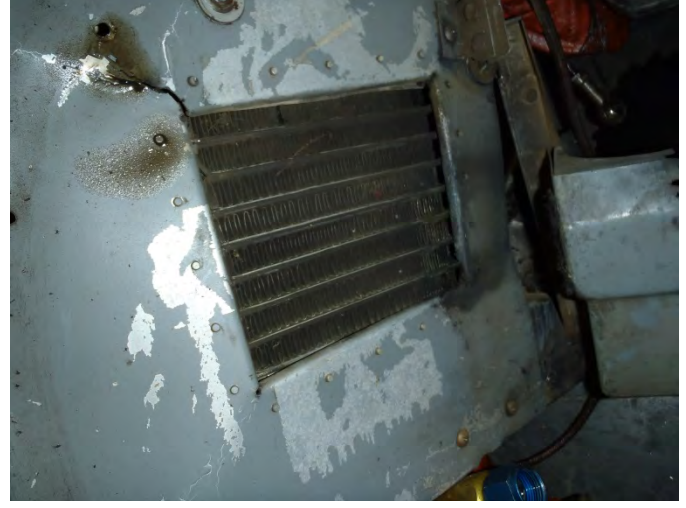
Condition: The oil cooler remained attached to its respective installation point and was undamaged. There were no anomalies noted with the oil cooler.

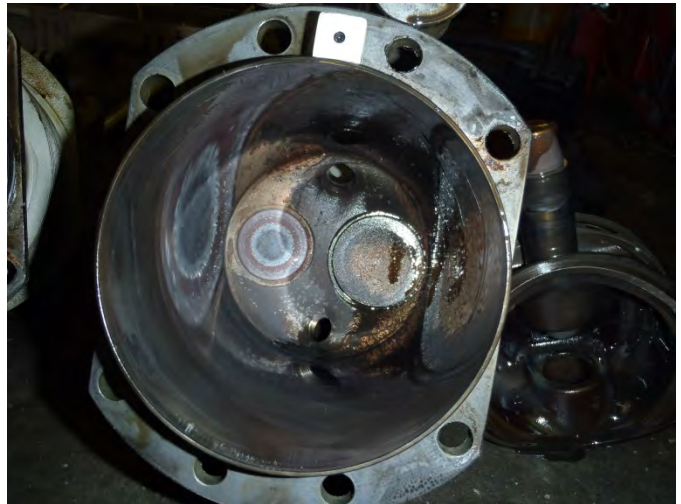
CYLINDER #1	P/N: Illegible	S/N: Illegible	
Condition:	The cylinder remained attached to the engine and there was no spot putty noted on the cylinder hold down nuts. The crankshaft was rotated and it was noted that the cylinder had good thumb compression and suction. The cylinder was removed from the engine and visually inspected. The external and internal components of the cylinder displayed normal operating signatures; there were no anomalies noted with the cylinder.

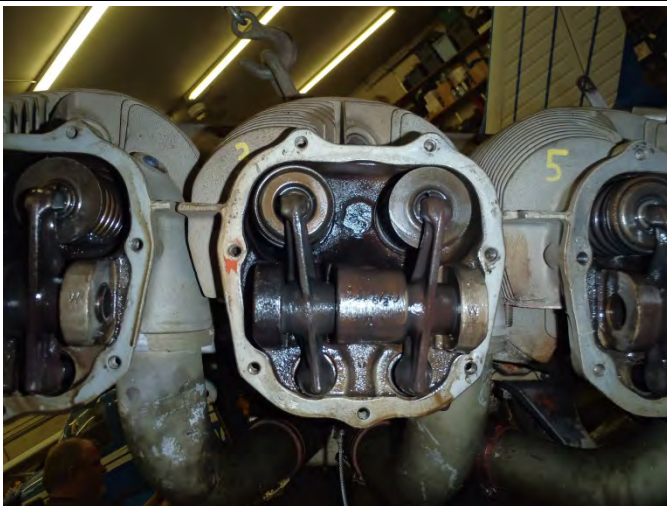
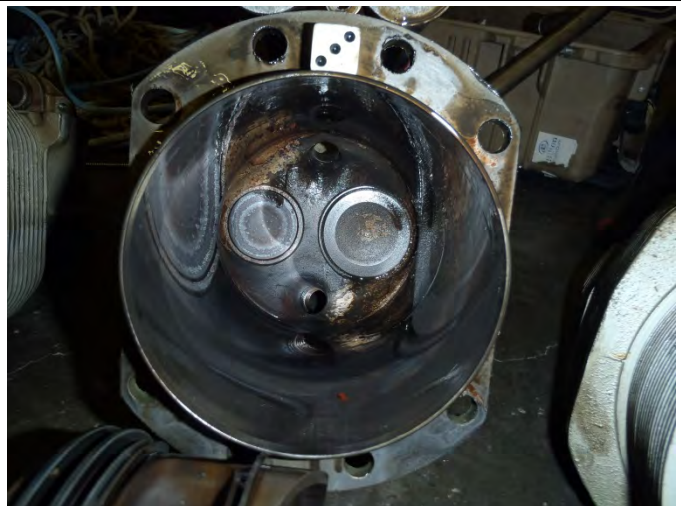
CYLINDER #3	P/N: Illegible	S/N: Illegible	
Condition:	The cylinder remained attached to the engine and there was no spot putty noted on the cylinder hold down nuts. The crankshaft was rotated and it was noted that the cylinder had good thumb compression and suction. The cylinder was removed from the engine and visually inspected. The external and internal components of the cylinder displayed normal operating signatures; there were no anomalies noted with the cylinder.

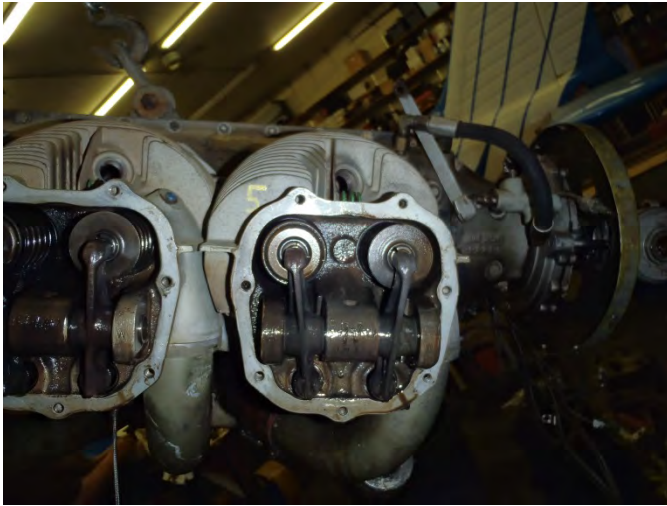
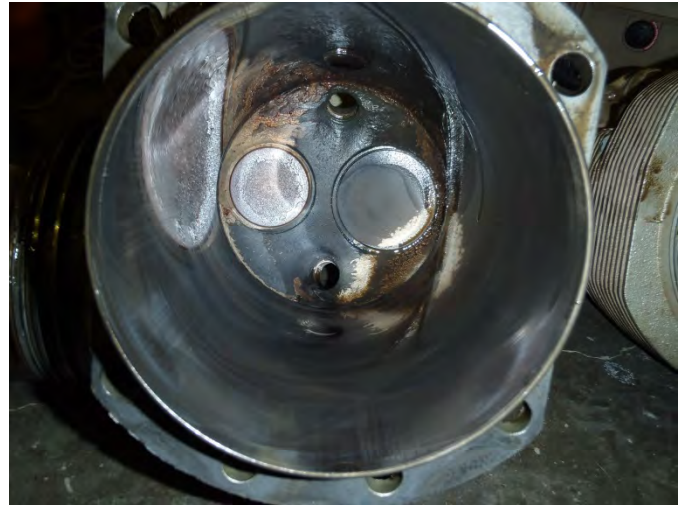
CYLINDER #5	P/N: Illegible	S/N: Illegible	
Condition:	The cylinder remained attached to the engine and there was no spot putty noted on the cylinder hold down nuts. The crankshaft was rotated and it was noted that the cylinder had good thumb compression and suction. The cylinder was removed from the engine and visually inspected. The external and internal components of the cylinder displayed normal operating signatures; there were no anomalies noted with the cylinder.

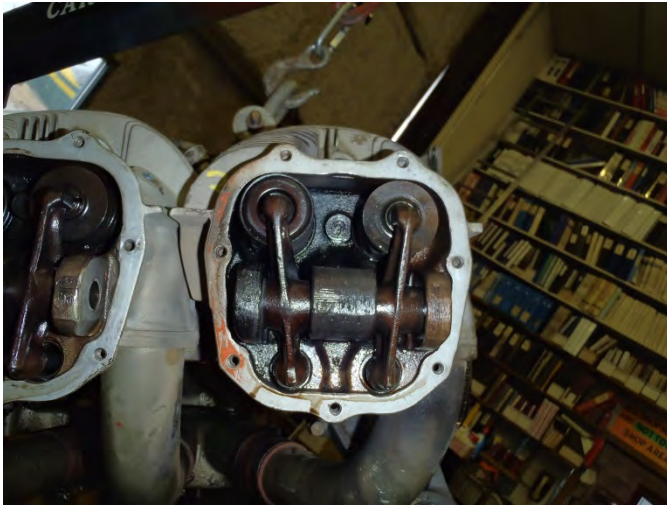
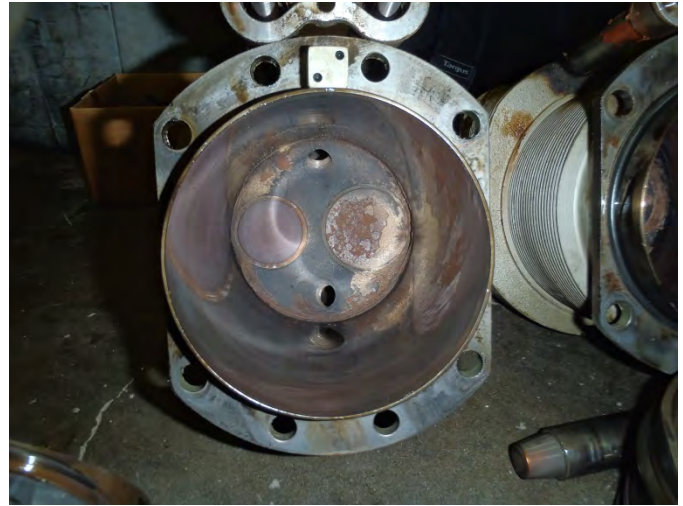
CYLINDER #2	P/N: Illegible	S/N: Illegible	
Condition:	The cylinder remained attached to the engine and there was no spot putty noted on the cylinder hold down nuts. The crankshaft was rotated and it was noted that the cylinder had good thumb compression and suction. The cylinder was removed from the engine and visually inspected. The external and internal components of the cylinder displayed normal operating signatures; there were no anomalies noted with the cylinder.

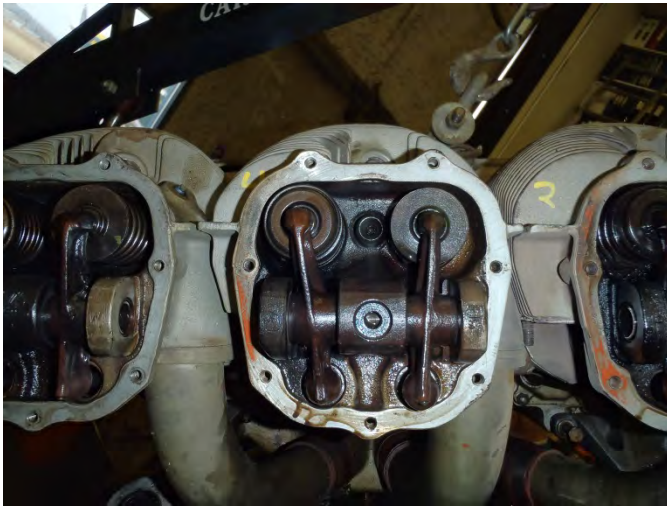
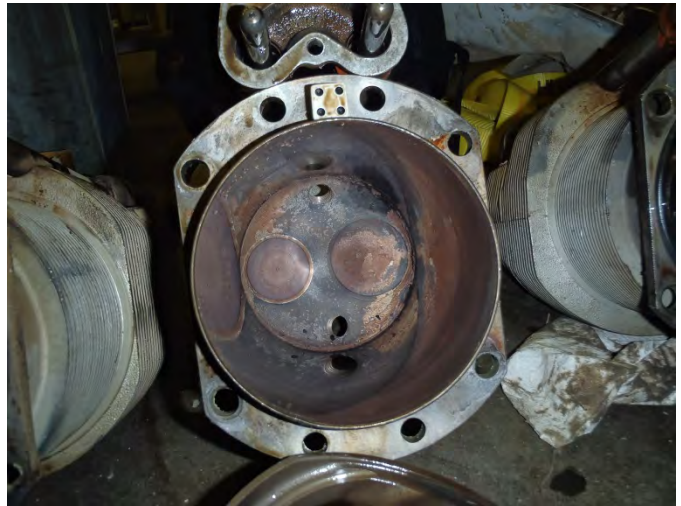
CYLINDER #4	P/N: Illegible	S/N: Illegible	
Condition:	The cylinder remained attached to the engine and there was no spot putty noted on the cylinder hold down nuts. The crankshaft was rotated and it was noted that the cylinder had good thumb compression and suction. The cylinder was removed from the engine and visually inspected. The external and internal components of the cylinder displayed normal operating signatures; there were no anomalies noted with the cylinder.

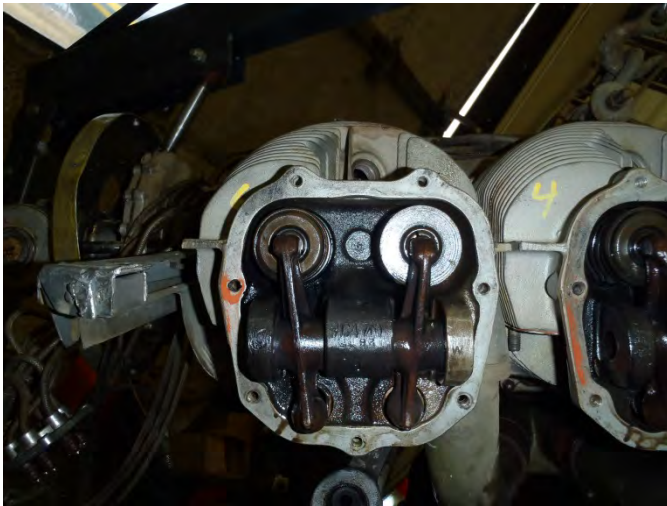
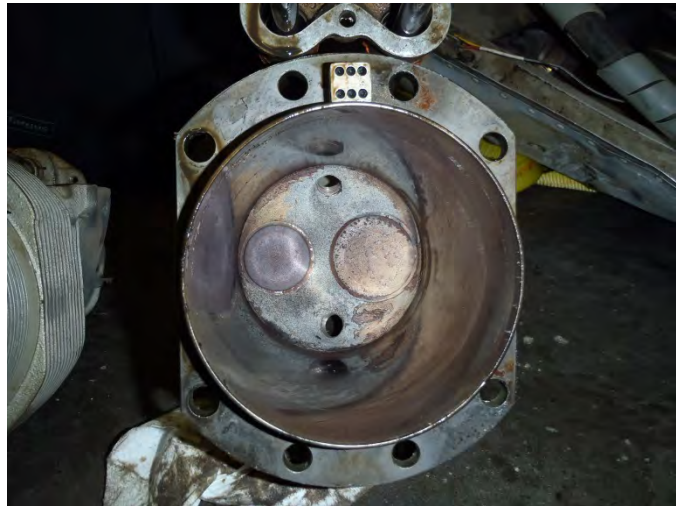
CYLINDER #6	P/N: Illegible	S/N: Illegible	
Condition:	The cylinder remained attached to the engine and there was no spot putty noted on the cylinder hold down nuts. The crankshaft was rotated and it was noted that the cylinder had good thumb compression and suction. The cylinder was removed from the engine and visually inspected. The external and internal components of the cylinder displayed normal operating signatures; there were no anomalies noted with the cylinder.

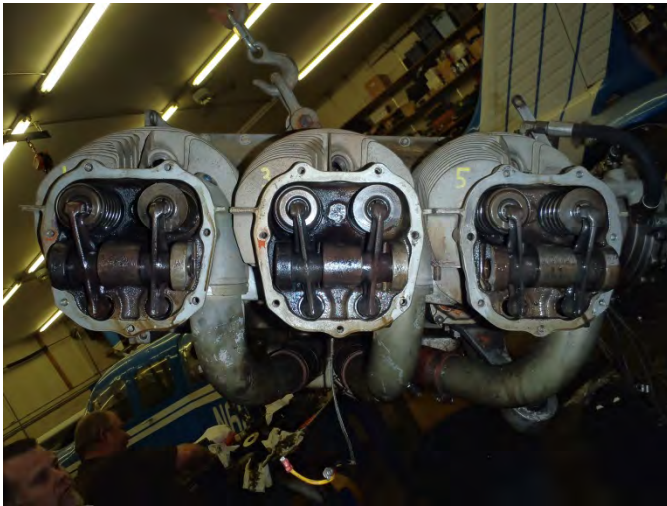
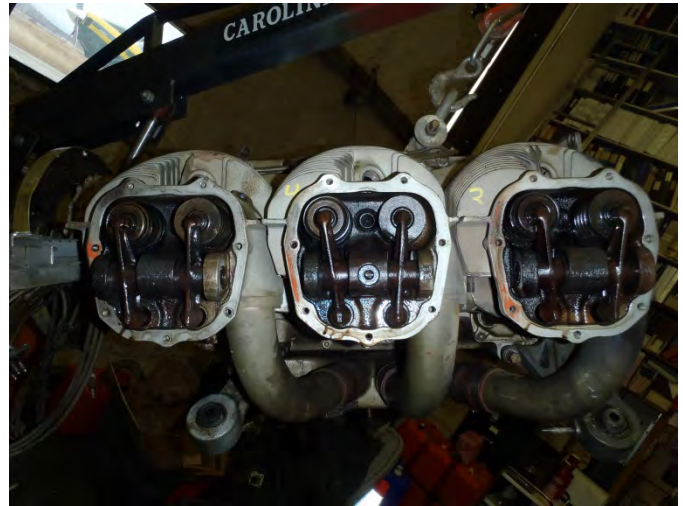
The valves remained installed in their respective cylinders and were undamaged. The intake and exhaust valve heads displayed normal operating and combustion signatures. During crankshaft rotation the valves operated normally.

All of the rocker arms displayed normal operating signatures. The rocker arms all operated normally during crankshaft rotation; there were no anomalies noted with the rocker arms.

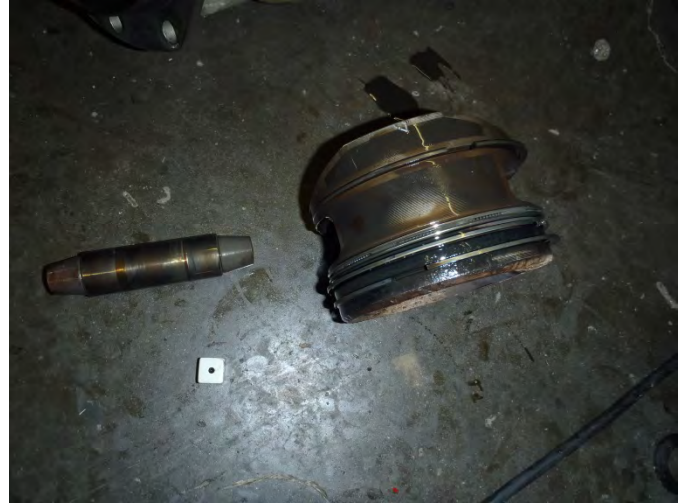
The piston displayed normal operating and combustion signatures. The piston rings were intact and free in their grooves. There were no anomalies noted with any of the pistons.

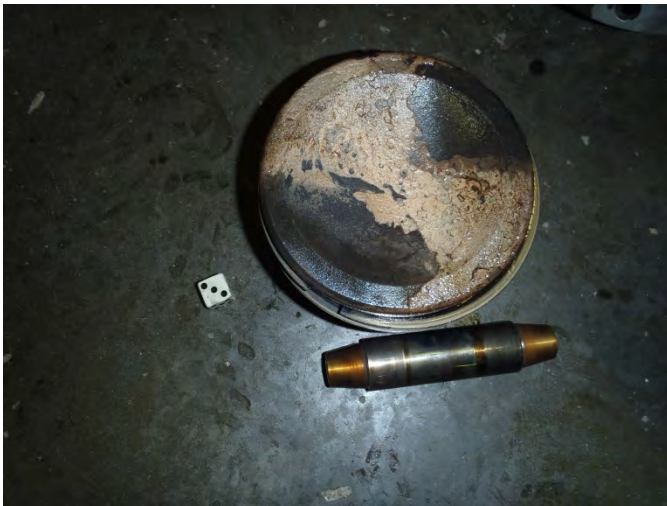
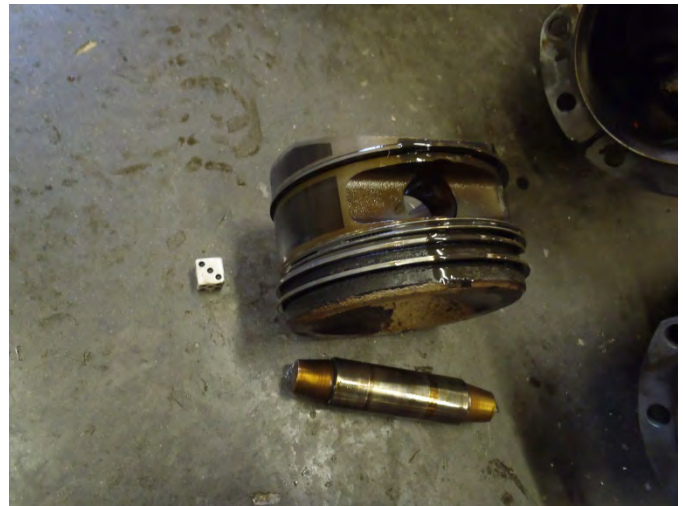
The piston displayed normal operating and combustion signatures. The piston rings were intact and free in their grooves. There were no anomalies noted with any of the pistons.

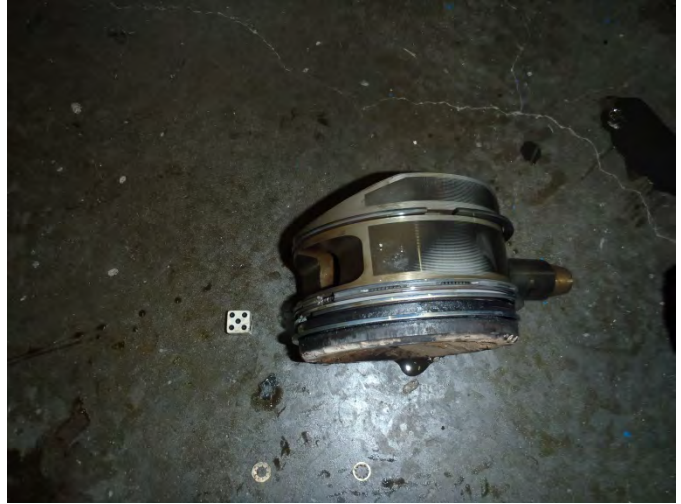
The piston displayed normal operating and combustion signatures. The piston rings were intact and free in their grooves. There were no anomalies noted with any of the pistons.

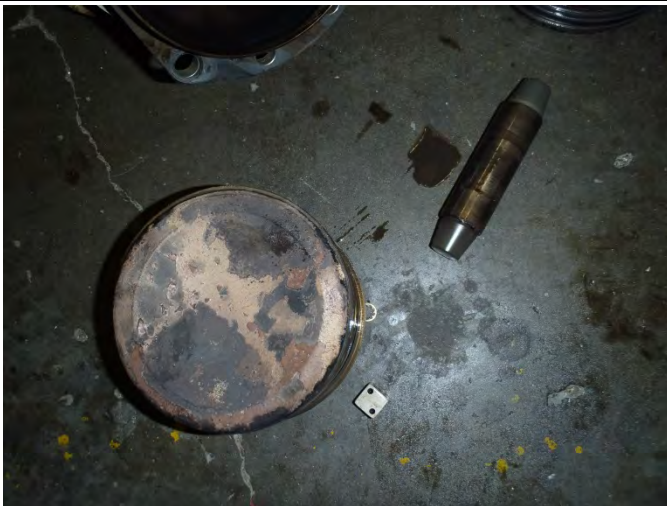
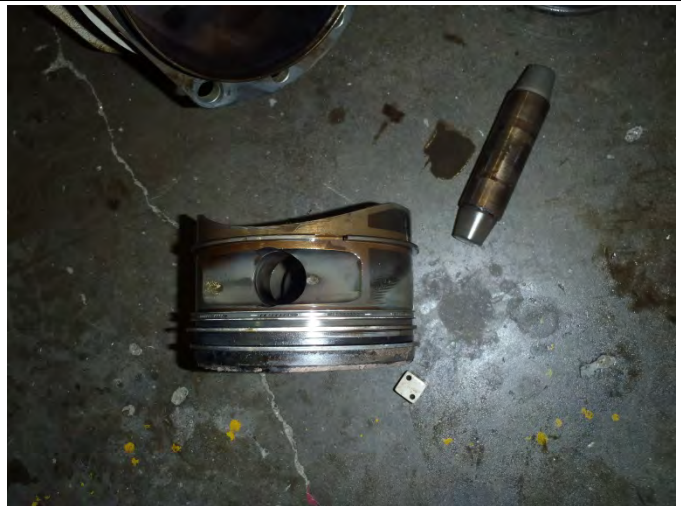
The piston displayed normal operating and combustion signatures. The piston rings were intact and free in their grooves. There were no anomalies noted with any of the pistons.

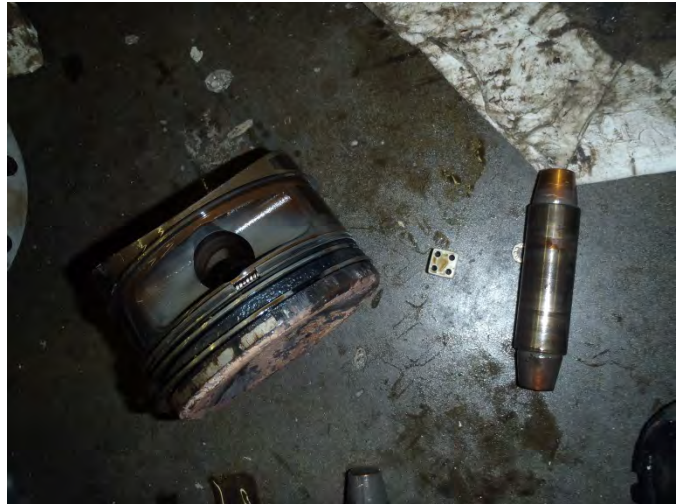
The piston displayed normal operating and combustion signatures. The piston rings were intact and free in their grooves. There were no anomalies noted with any of the pistons.

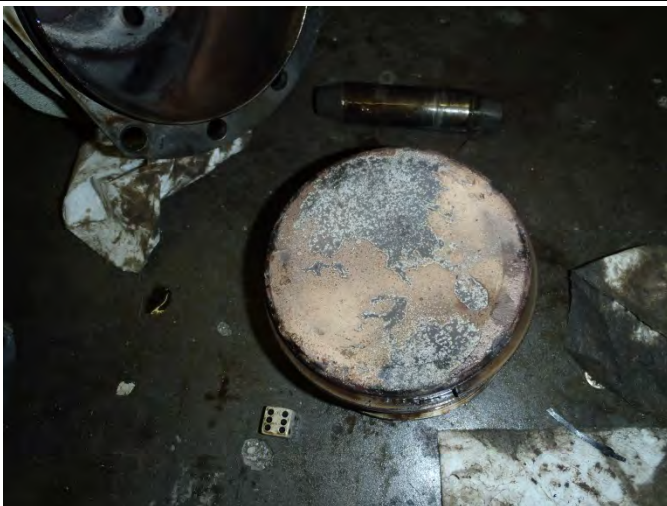
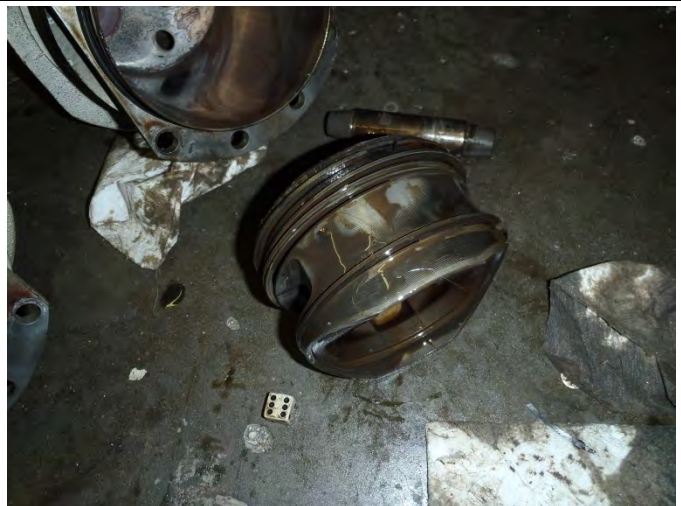
The piston displayed normal operating and combustion signatures. The piston rings were intact and free in their grooves. There were no anomalies noted with any of the pistons.

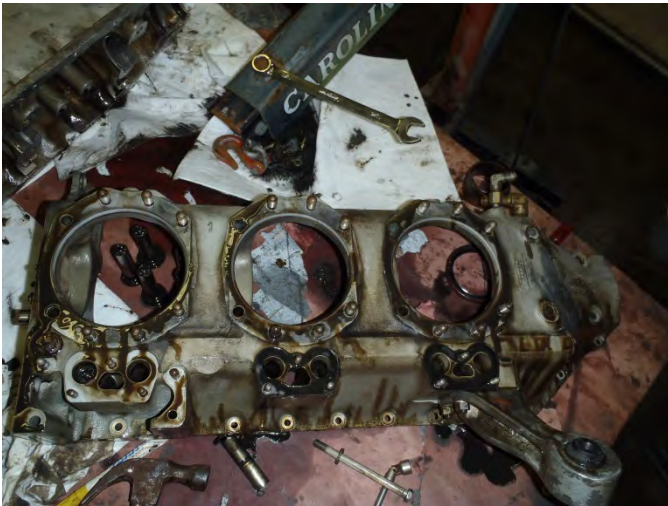
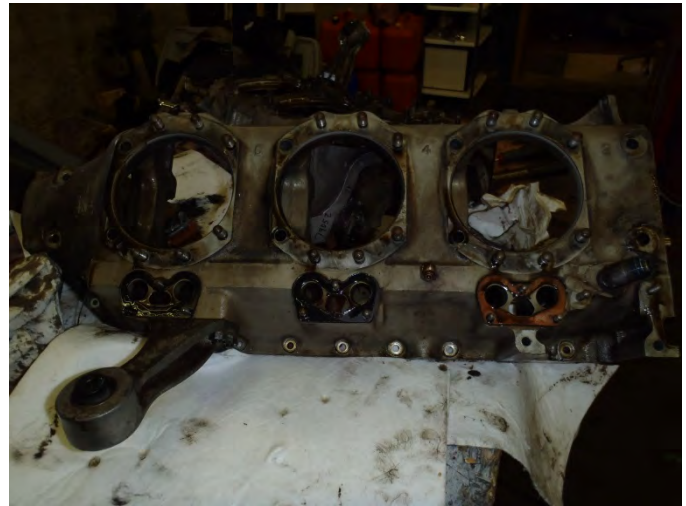
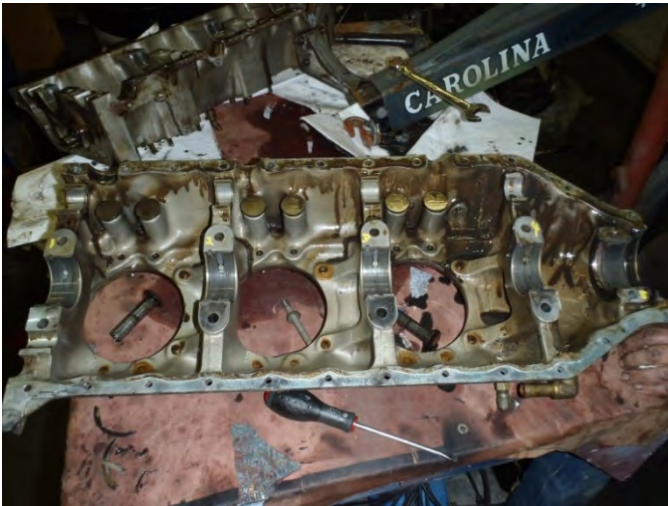
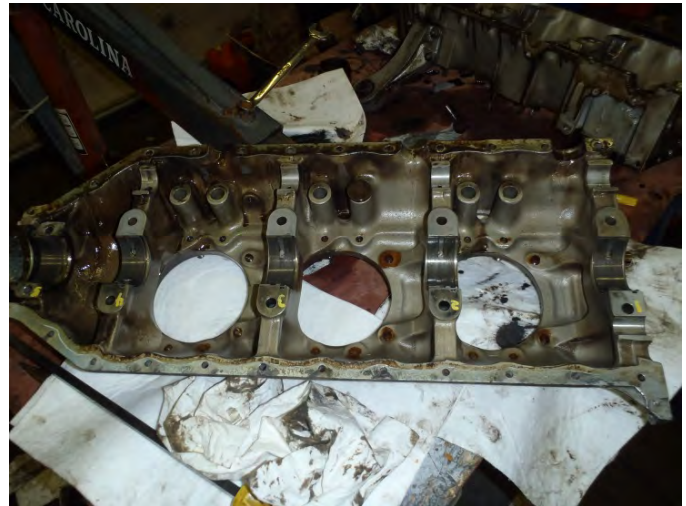
CRANKCASE	Casting Number:	1-3-5: 532271	2-4-6: 532272	S/N: 544
Condition:	The crankcase remained intact and there were no signs of impact damage. The engine was disassembled and the internal portions of the crankcase were inspected. It was noted that a small crack on both halves of the crankcase forward of the #5 main bearing at the nose seal area. There was wear noted on the #2, #3, and #4 main bearing bosses consistent with the crankshaft contacting the crankcase. There were no further anomalies noted.

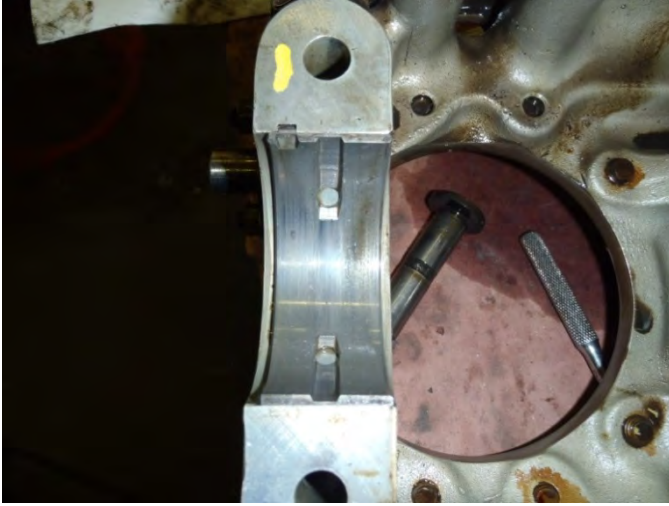
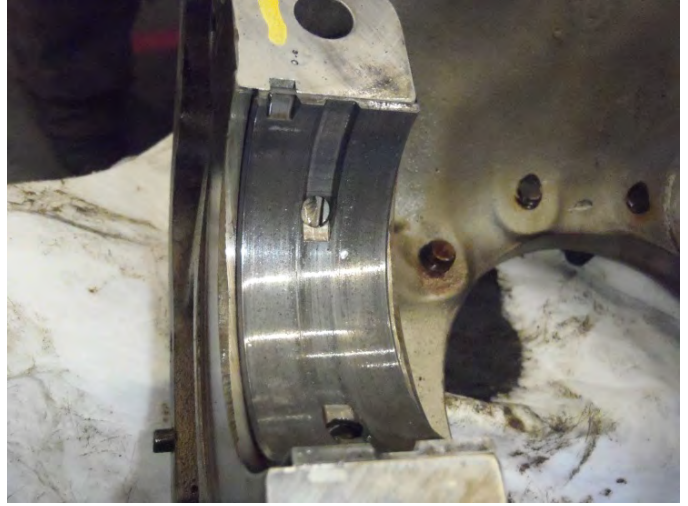
The bearing remained installed within its respective bearing saddle and there was no signs of bearing shift. The bearing displayed normal wear and lubrication signatures. There were no anomalies noted with the bearing.

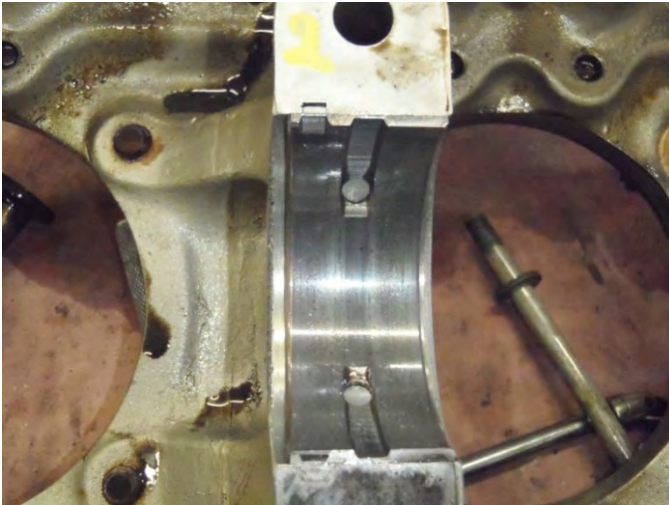
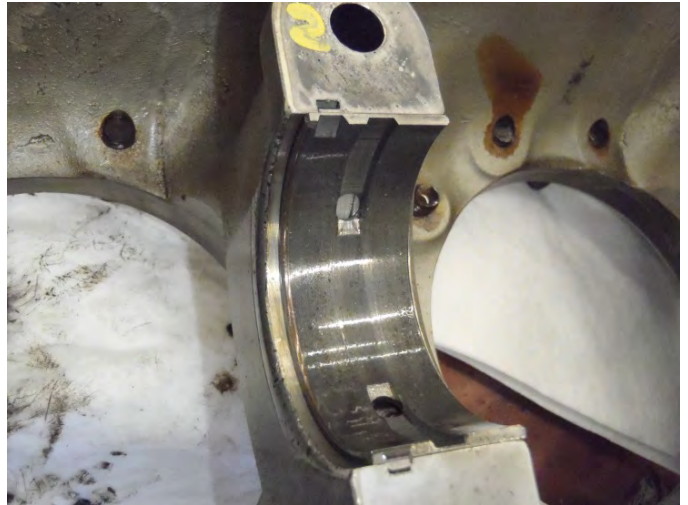
The bearing remained installed within its respective bearing saddle and there was no signs of bearing shift. The bearing displayed normal wear and lubrication signatures. There were no anomalies noted with the bearing.

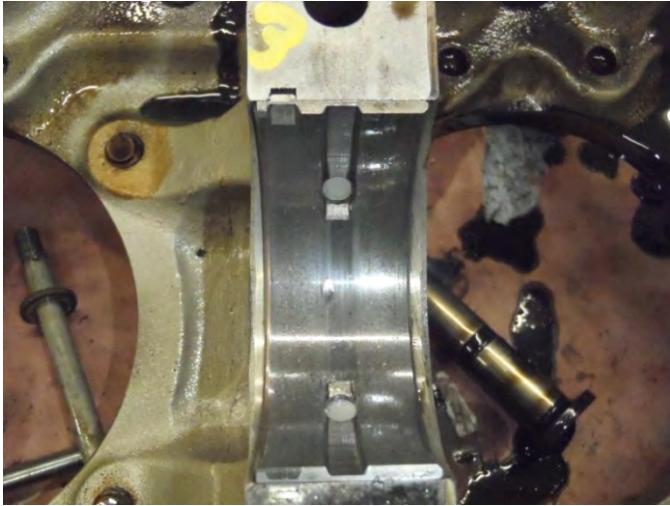
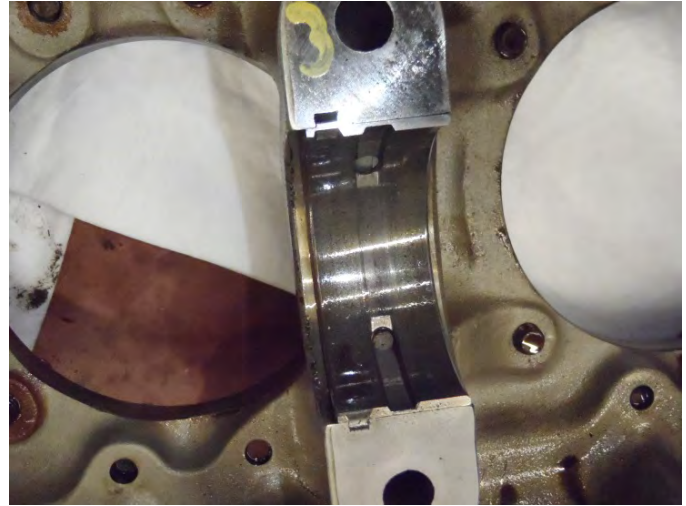
The bearing remained installed within its respective bearing saddle and there was no signs of bearing shift. The bearing displayed normal wear and lubrication signatures. There were no anomalies noted with the bearing.

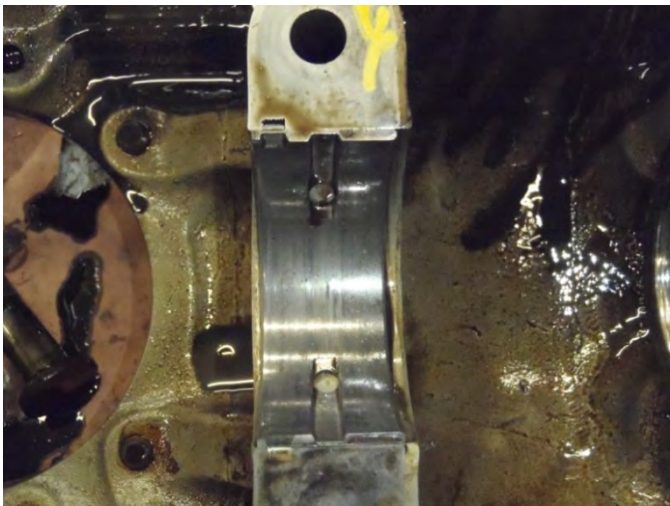
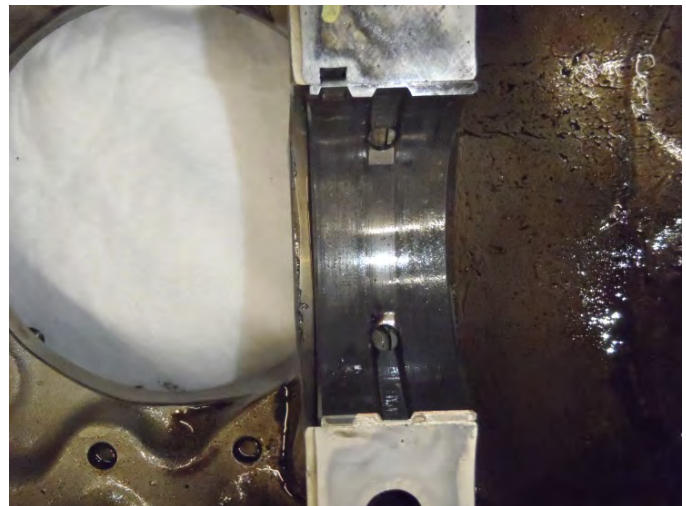
The bearing remained installed within its respective bearing saddle and there was no signs of bearing shift. The bearing displayed normal wear and lubrication signatures. There were no anomalies noted with the bearing.

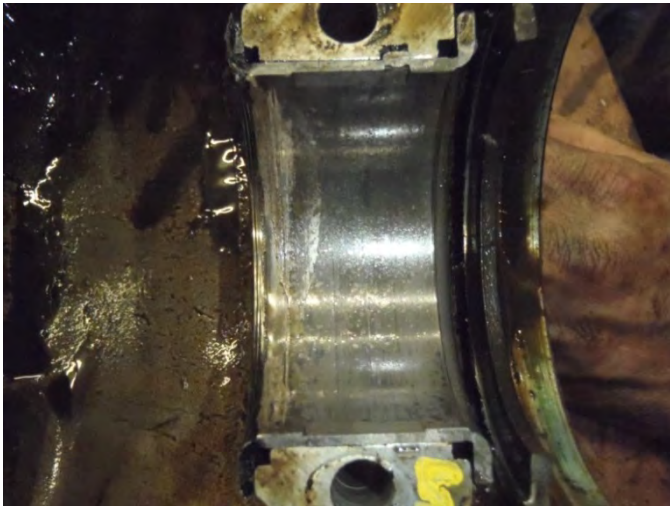
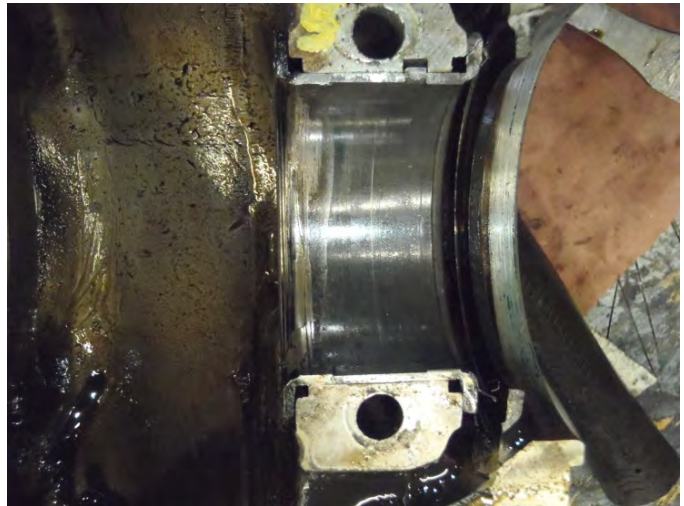
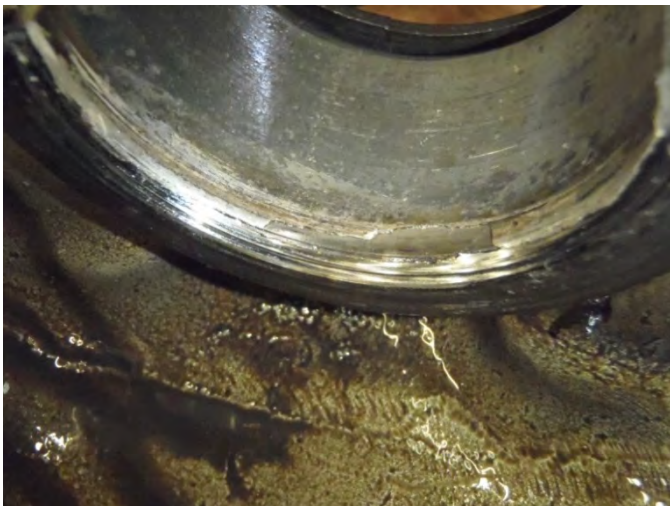
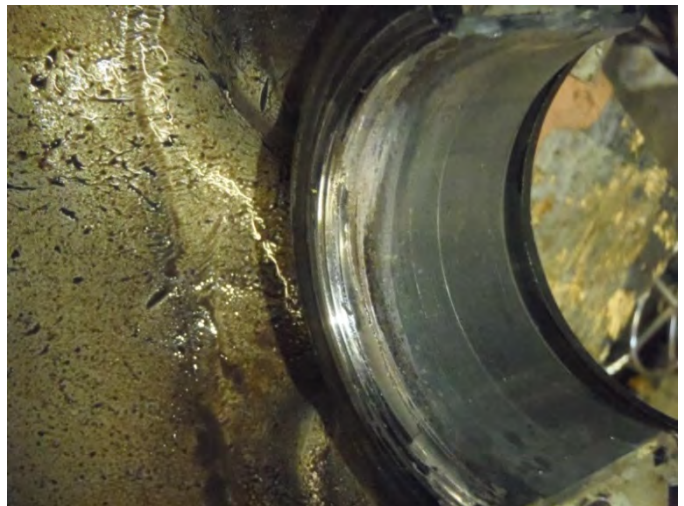
The engine was disassembled and it was noted that the #5 main crankshaft bearing displayed damage; several large flakes of material had broken off from the bearing and were located in the crankcase. The pressure carburetor fuel inlet filter contained a significant amount of material consistent with rubber; there was also a significant amount of particulates found within several of the pressure carburetor chambers.

The front bearing remained installed within its respective bearing saddle and there were no signs of bearing shift. The bearing displayed damage concentrated to the rear portion of the bearing; several large, flat portions of the bearing had broken free from the bearing. Several portions of the bearing were located in the crankcase. The bearing displayed normal lubrication signatures.

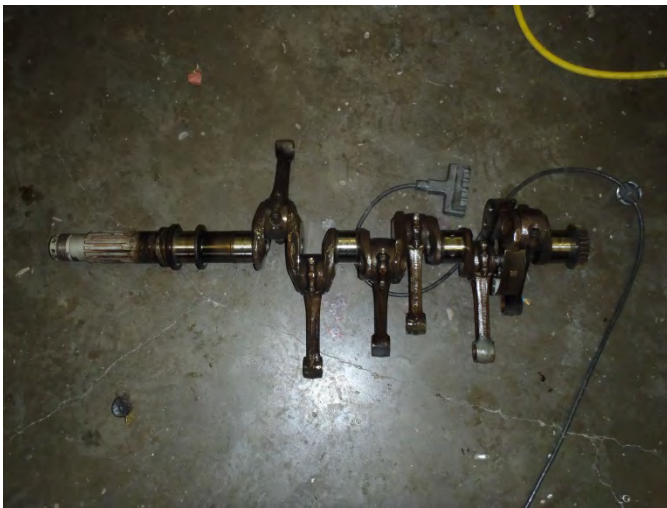
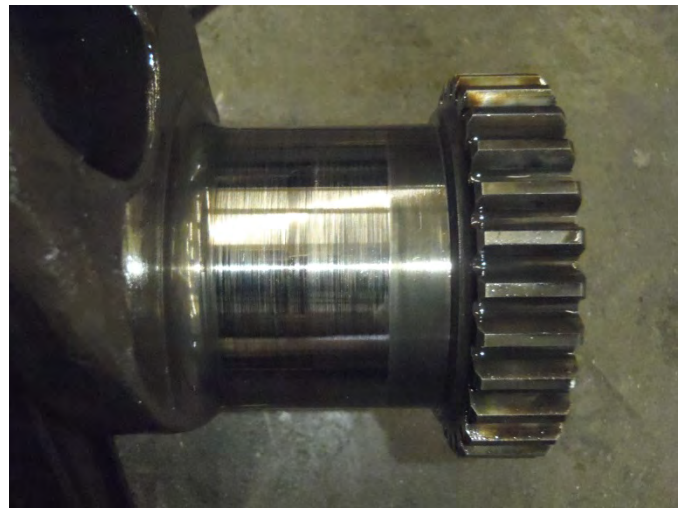
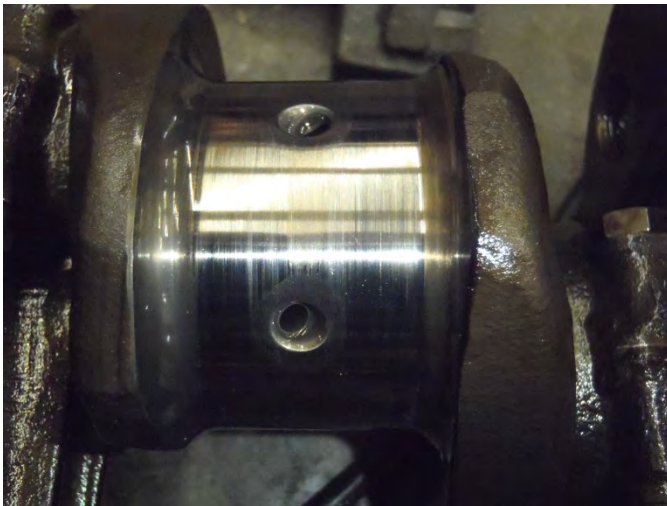
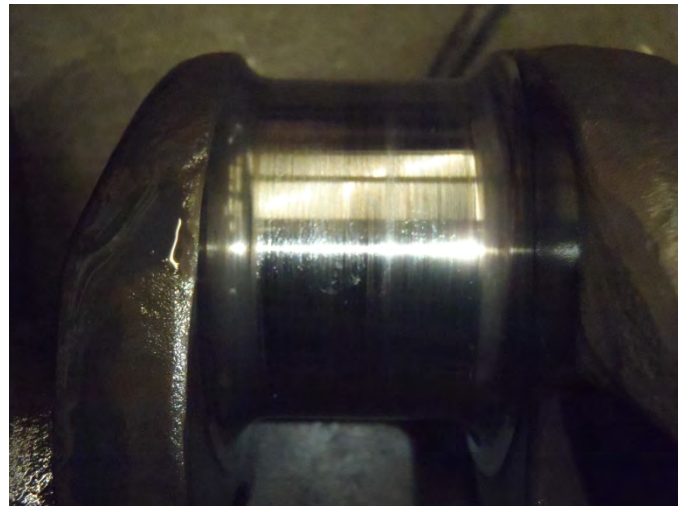
CRANKSHAFT	Forging Number: 50996	Identifying #: EC8858?-01	Heat code: L45
Condition:	The crankshaft remained intact and there were no signs of damage. The crankshaft gear was secure and the bolts were safety wired. The crankshaft spline shaft displayed normal operating signatures. The crankshaft main bearing journals displayed normal operating and lubrication signatures. All of the connecting rods were capable of rotating freely around their respective connecting rod journal. There were no anomalies noted with the crankshaft.

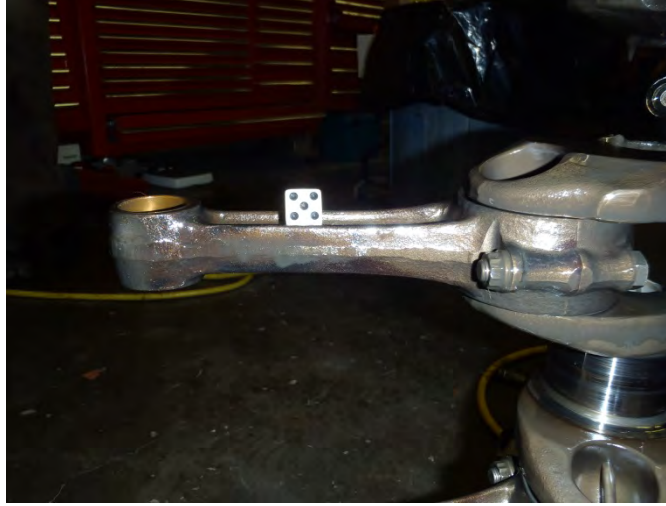
The connecting rod remained intact and was undamaged. The connecting rod bolts and nuts were secure. The connecting rod was rotating around the crankshaft connecting rod journal freely. There were no anomalies noted with the connecting rod.

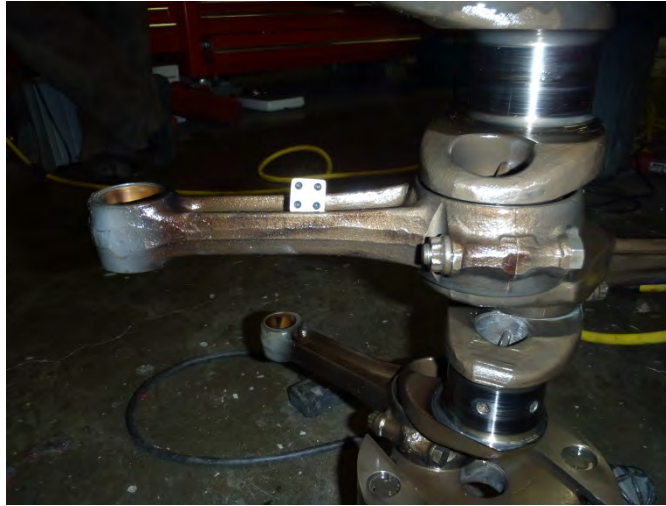
The connecting rod remained intact and was undamaged. The connecting rod bolts and nuts were secure. The connecting rod was rotating around the crankshaft connecting rod journal freely. There were no anomalies noted with the connecting rod.
