ENGINE FIELD INSPECTION REPORT

ENGINE MODEL	E-225
ENGINE SERIAL NUMBER	30057-D-3-4
AIRCRAFT MAKE & MODEL	Navion A
AIRCRAFT SERIAL NUMBER	NAV-4-1827
AIRCRAFT REGISTRATION	N4827K
FILE NUMBER	14-171

EXAMINATION		ACCIDENT DATA	
DATE	10/01/2014	NTSB ACCIDENT #	ANC14LA068
FACILITY	Arctic Aviation	NTSB INVESTIGATOR	Todd Gunther
ADDRESS	[REDACTED] Fairbanks, AK 99709	FAA INVESTIGATOR	Jason Major
		ACCIDENT DATE	08/24/2014
		ACCIDENT LOCATION	Coldfoot, Alaska

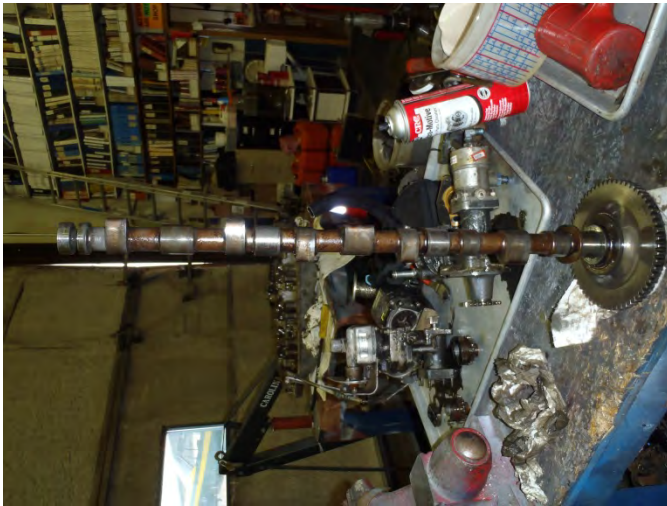
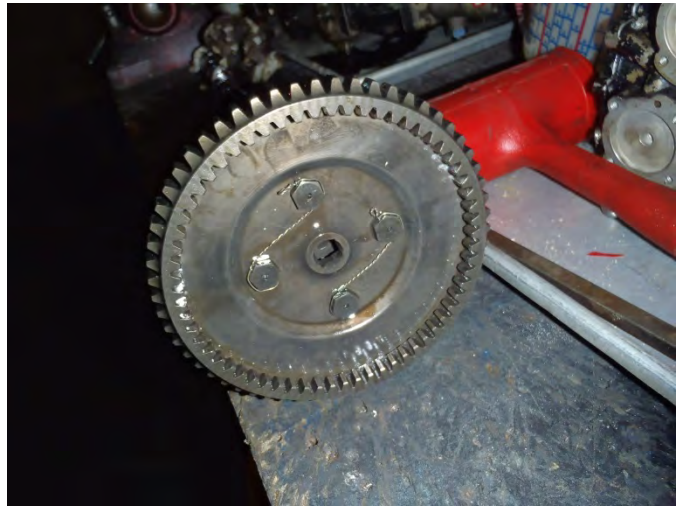
The camshaft remained intact and was undamaged. The camshaft gear was secure and the bolts were safety wired. The camshaft lobes and journals displayed normal operating signatures. There were no anomalies noted with the camshaft.

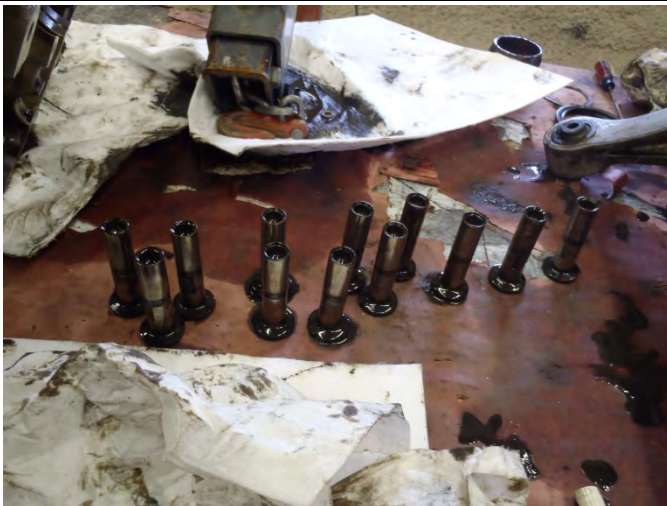
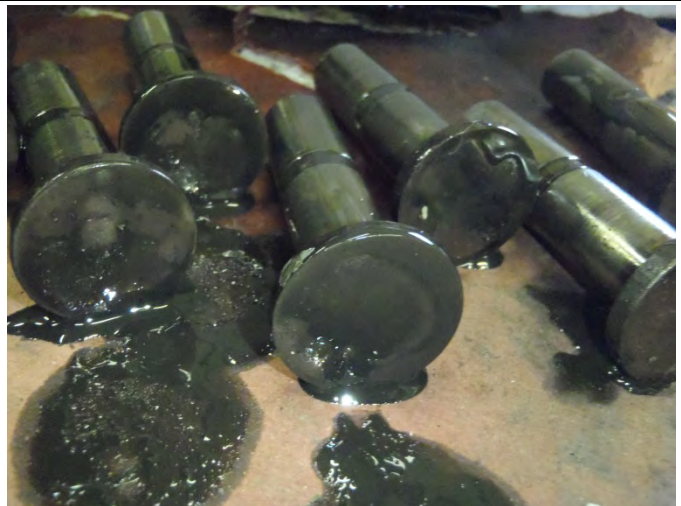
All of the lifters were intact and displayed normal operating signatures. There were no anomalies noted with the lifters.

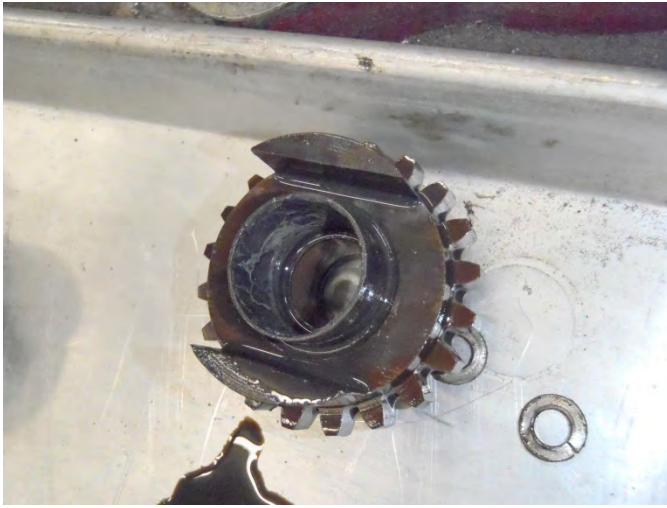
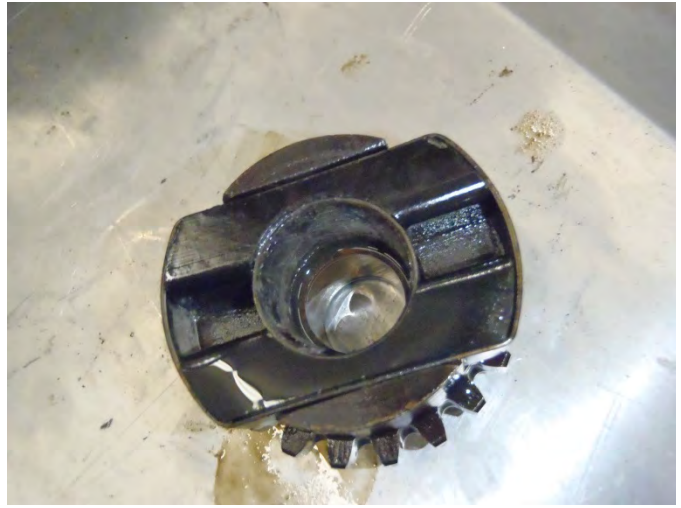
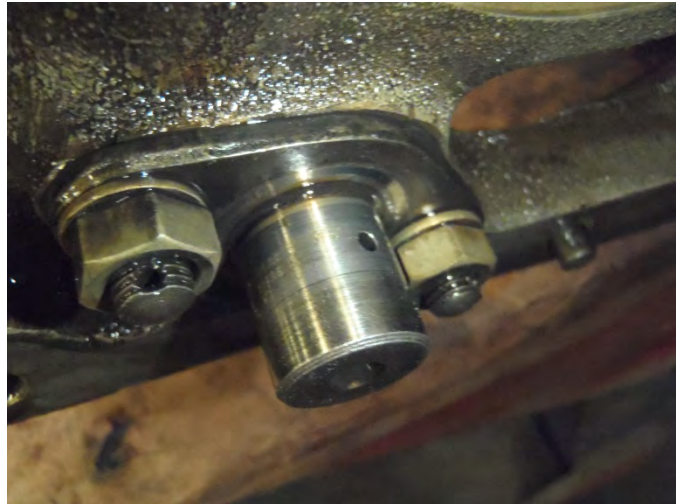
All of the accessory gears were secure and displayed normal operating signatures. It was noted that both of the magneto drive supports were secured with regular nuts; according to the E-225 parts catalog the drive supports are to be secured using a castellated nut and a cotter key.

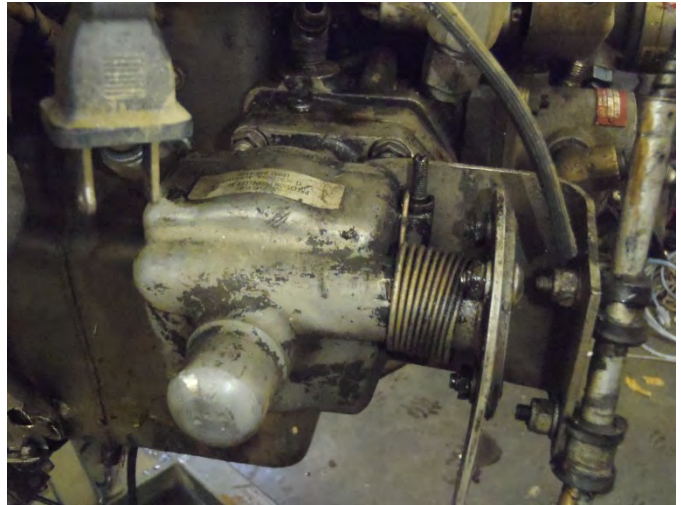
PROPELLER GOVERNOR	Manufacturer: Illegible	P/N: Illegible	S/N: Illegible
Condition:	The propeller governor remained attached to its respective installation point and was undamaged. There were no anomalies noted with the propeller governor.

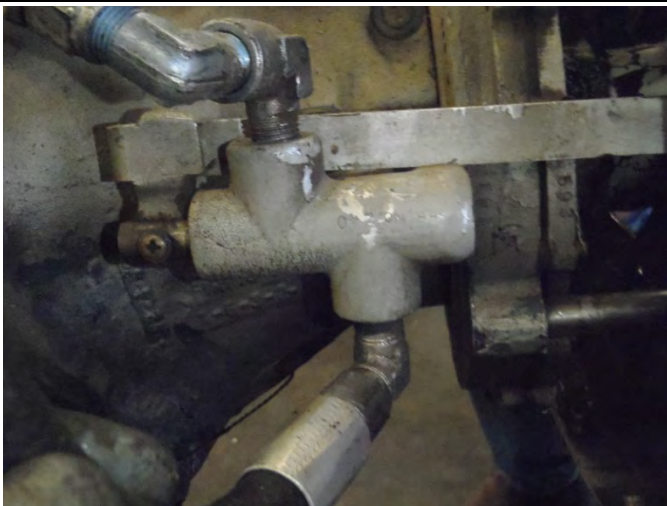
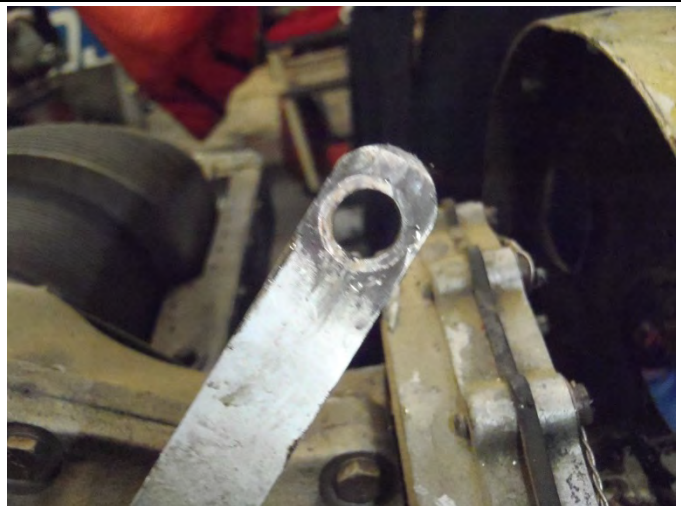
PROPELLER ACTUATOR	Manufacturer: Illegible	P/N: Illegible	S/N: Illegible
Condition:	The propeller actuator remained attached to its respective installation point and the oil lines remained secure. There were no anomalies noted with the actuator.
