## Continental Motors, Inc. Component Analysis Report

Exhibit #:	N/A	Analytical Date:	04/10/2014
Warranty Claim #:	N/A	RMA/AV-18 #:	N/A
Engine Model:	IO-550-B39	Engine S/N:	684677
Component P/N:	655469B	Component S/N:	AC04AB154
Engine:	Component: <input checked="" type="checkbox"/> New: <input type="checkbox"/>	Rebuilt: <input type="checkbox"/>	Overhaul: <input type="checkbox"/> Date: <input type="text"/>
Aircraft Make/Model:	Beech A36	Aircraft S/N:	E-3380 Reg. #: N999PK
Engine Position:	Single-Engine		
Engine Build Date:	11/22/2000	Date in Service:	03/06/2001 Date Removed: N/A
Date of Occurrence:	05/28/2013		Engine/Component Hours: 893.2
Inspection Performed By:	Phillip Grice, Greg Eastburn, and Nicole Charnon, with Ralph Hicks (NTSB)		Search Code: 59-01-34

**Components Returned:** #5 Cylinder

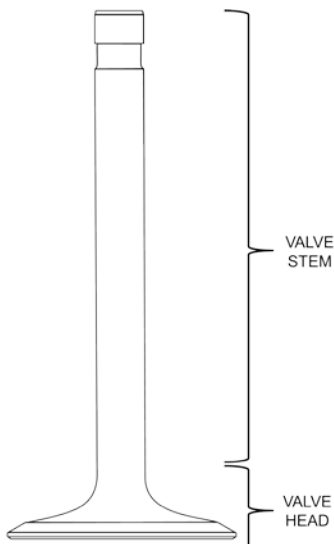
The visual examination of the cylinder revealed that the exhaust valve displayed a localized yellow-green discoloration on a 1/3<sup>rd</sup> of its circumference, indicative of a burnt valve condition. No other anomalies with the cylinder were visually noted. The dimensional examination of the cylinder revealed that the exhaust valve guide was wider than the new part limits toward the valve head (bell-mouthing). The exhaust valve stem was narrower than new part limits toward the valve head (necking). There were no anomalies noted with the valve tips or rocker faces. Some guide wear and valve necking is considered normal and the extent is usually dependent on total time and operating conditions.

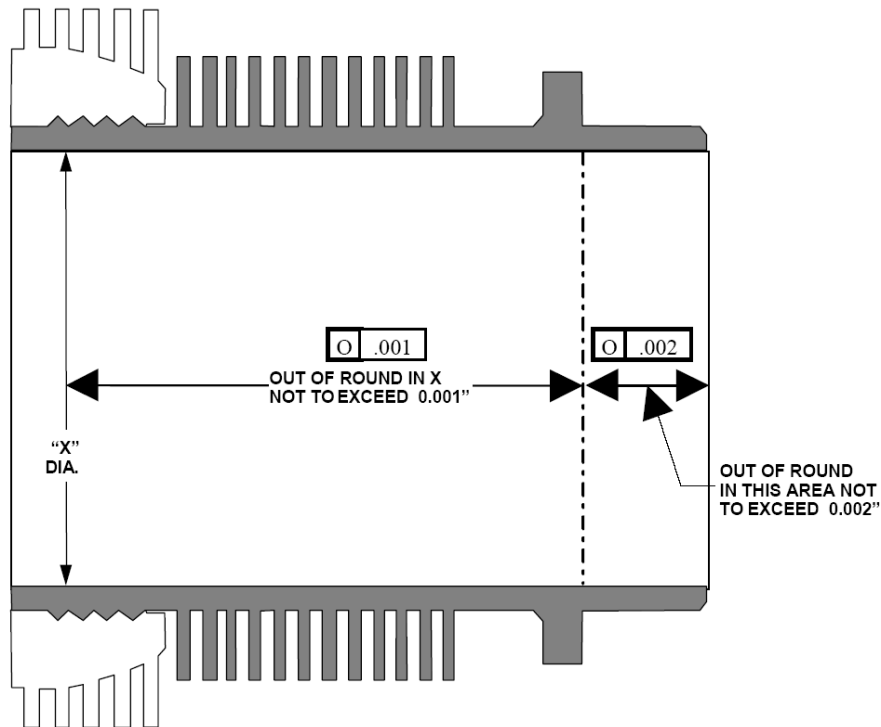
New Part Tolerances	Diameter Middle of Ring Travel	Diameter Top of Ring Travel
	5.247 - 5.250	5.244 - 5.247
Cylinder Bore Diameters – Cylinder #5		
Measurement Location	Vertical Plane - Inches	Horizontal Plane - Inches
Bottom of Ring Travel	5.2522	5.2516
Middle of Ring Travel	5.2525	5.2499
Top of Ring Travel	5.2523	5.2480
