ENGINE FIELD INSPECTION REPORT

ENGINE MODEL: IO-550-N (2)

AIRCRAFT MODEL: Velocity Super XLRG5

REGISTRATION: N444YP

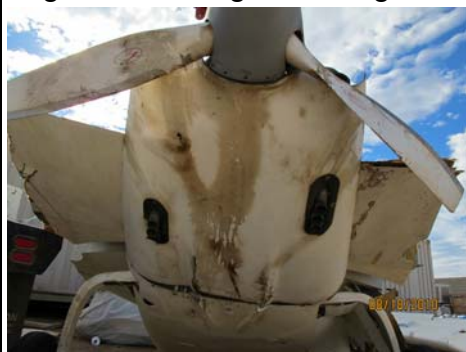
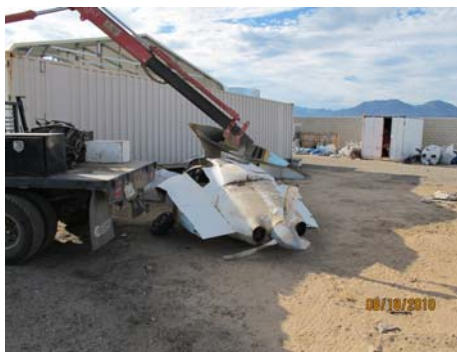
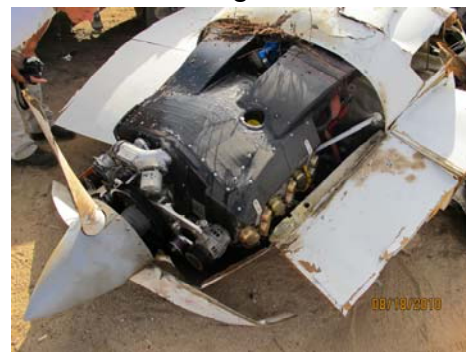
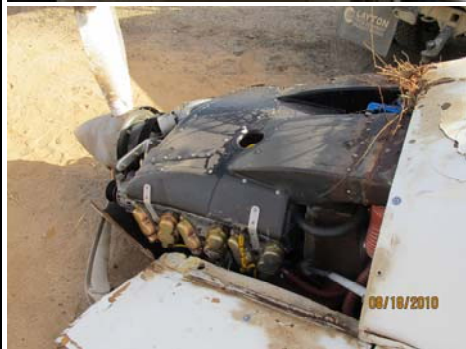
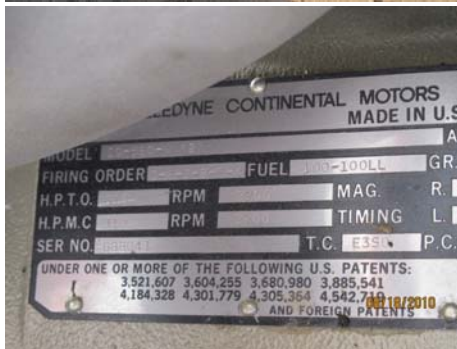
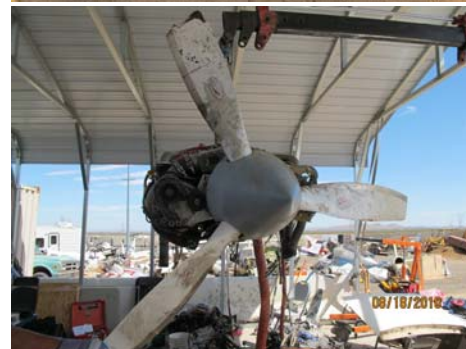
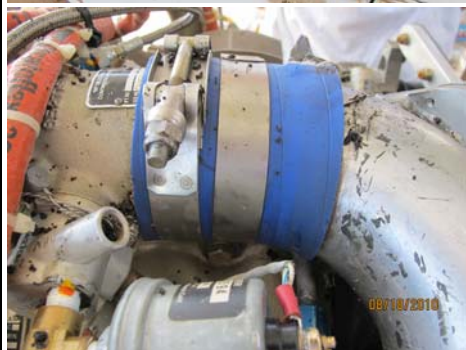
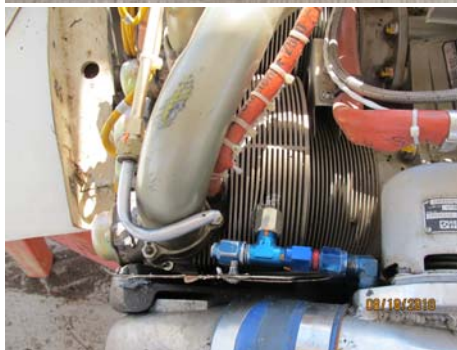
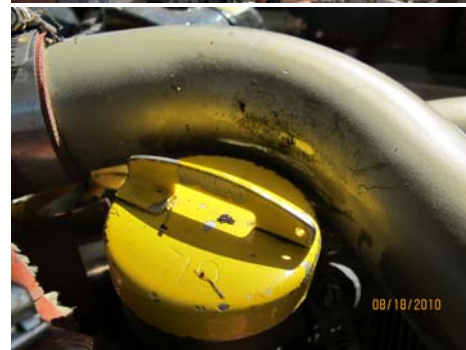
The engine inspection took place at Aircraft Recover Services in Pearblossom, California on 08-18-2010. The carbon fiber cooling shroud was removed from the top of the engine. The engine was removed from the airframe. The propeller assembly had impact damage and remained attached during the inspection. The cooling air exhaust ports and the propeller assembly including the extension shaft had black rubber marks. The aft positioned supercharger drive belt was missing from the engine. The forward drive belt separated from the engine and was found near the firewall area. The forward belt was intact and had damage. The supercharger upper deck reference line was loose at the supercharger and separated near a T-fitting. The number 5 cylinder upper cooling fins had impact damage and the T-fittings brass cap was in contact with the cylinder in that area. The throttlebody connection tube band clamps overlapped each other. The number 4 induction tube had rubbing marks near the oil filler cap area. The number 5 induction tube top side had wear marks. The number 3, 4 and 6 cylinder rocker covers had impact damage. The starter adapter drive pulley outer edge had damage. A belt guard was attached to the firewall and had rotational scoring.

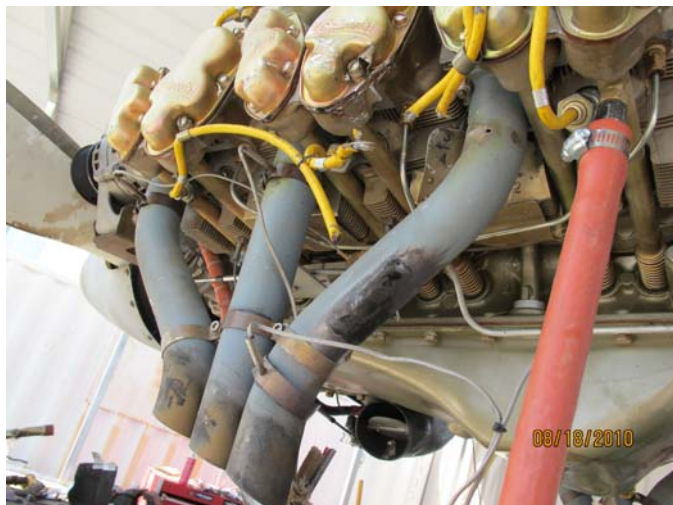
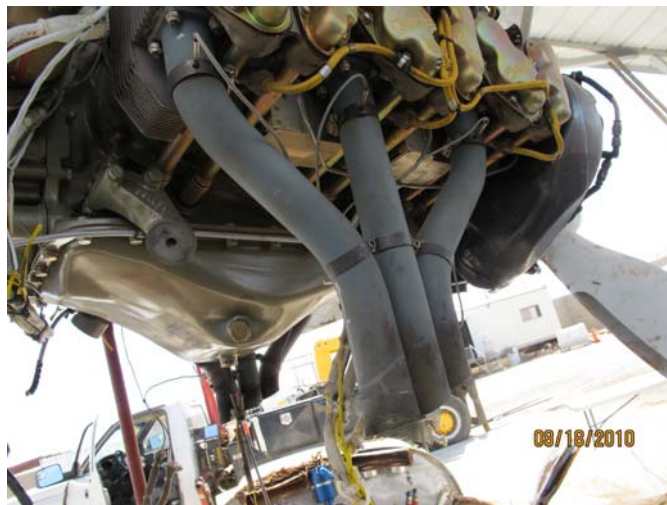
Exhaust assembly

Condition: The exhaust assembly was undamaged.

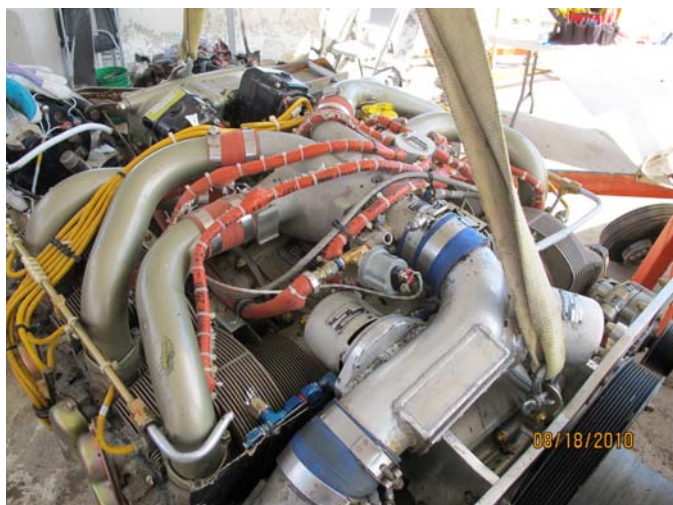
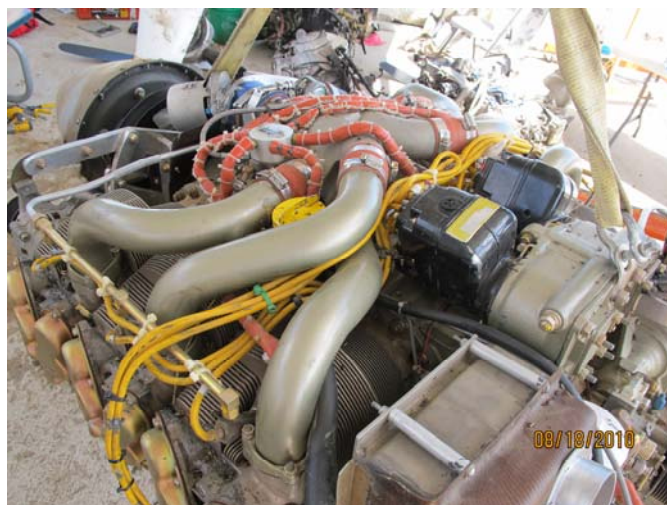
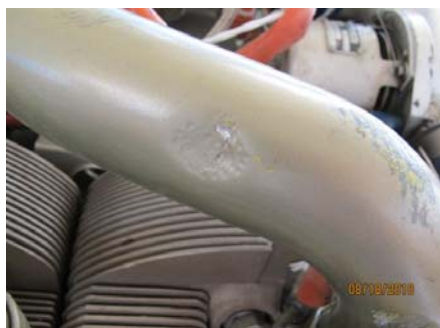
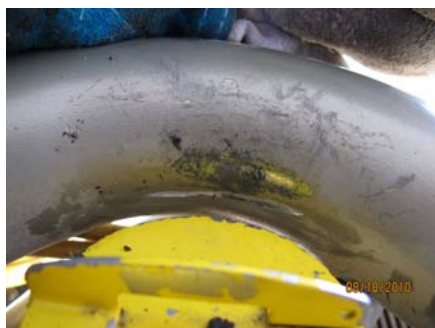
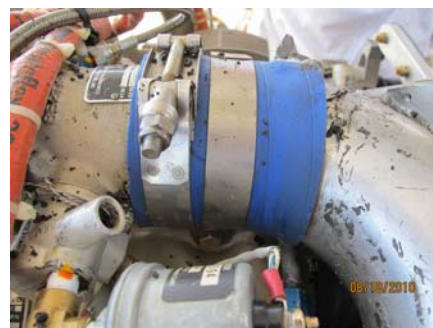
Induction assembly

Condition: The induction assembly was intact and had wear marks and scoring on two tubes. Wear marks were visible under paint near the wear mark on the number 5 induction tube. Two band clamps overlapped each other at the supercharger to throttle-body rubber coupling.

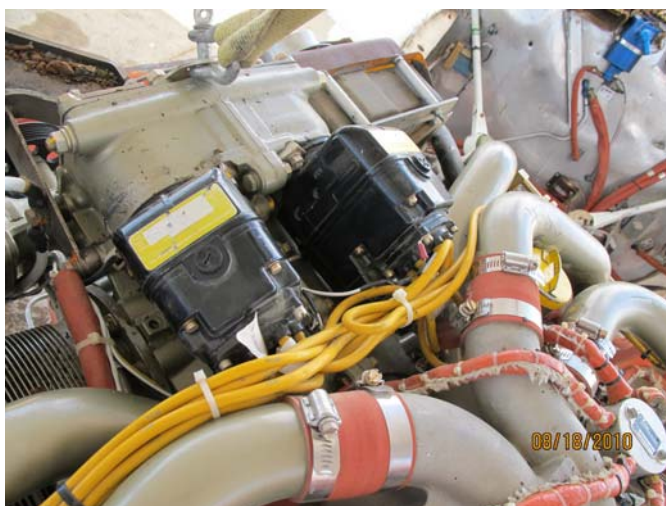
Condition: The magnetos were not removed during the inspection. The crankshaft was rotated by hand and impulse couplings engaged. Spark was visible from the ignition lead ends.

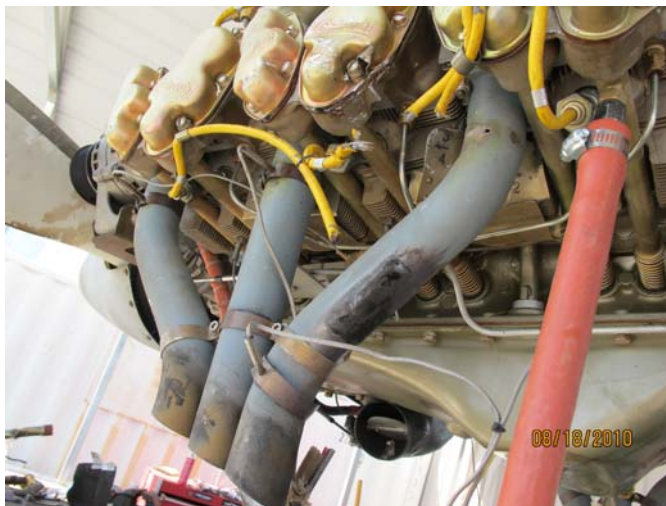
Condition: The ignition leads had impact damage at the lower positions of cylinders 4 and 6.

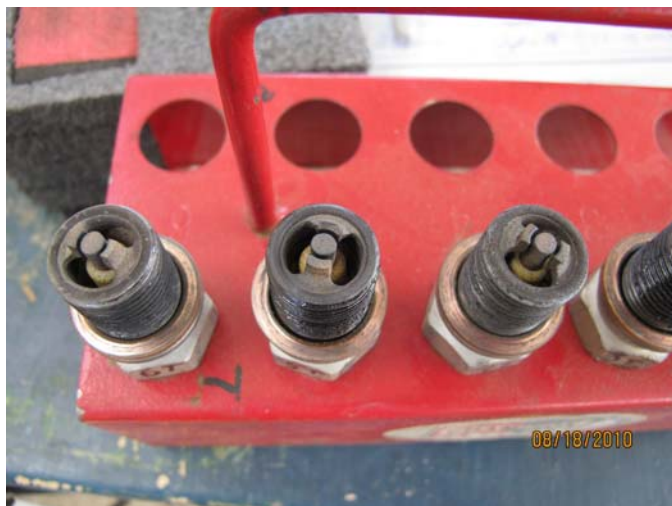
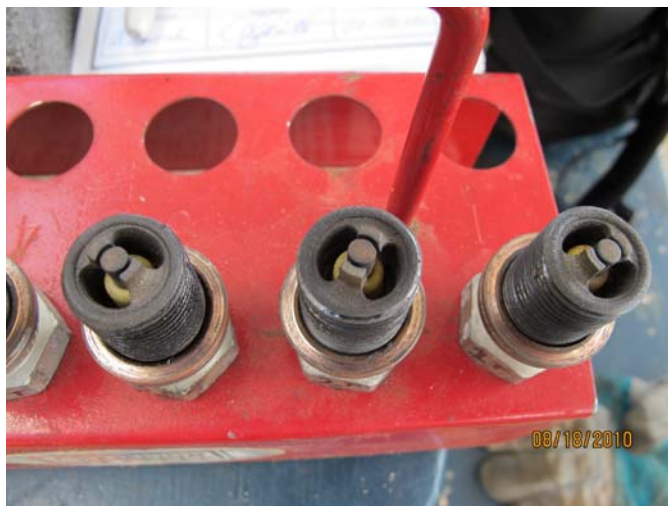
Condition: The spark plugs had (normal) wear signatures in accordance with the Champion AV-27 chart. The spark plug electrode areas had light gray deposits.

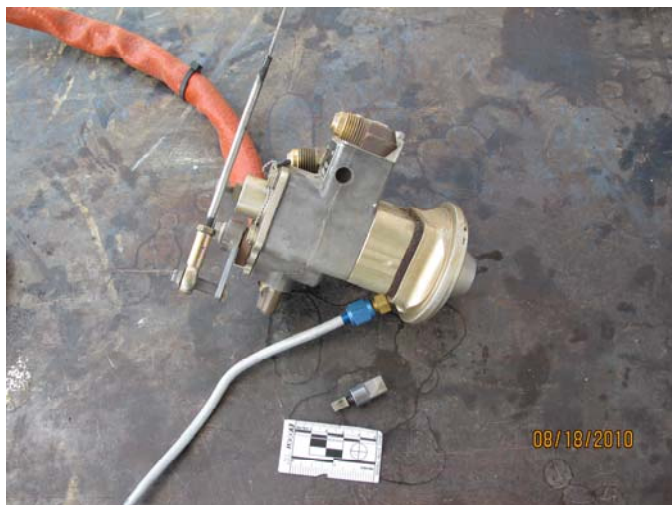
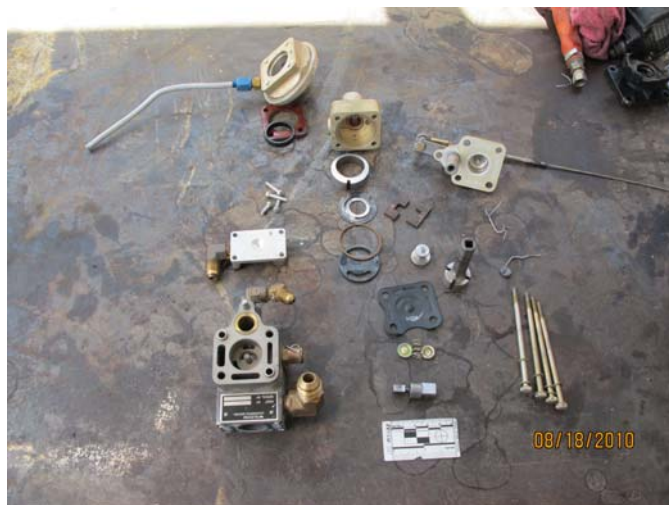
Condition: The fuel pump was removed from the engine and rotated freely by hand. Fuel was found in the pump and the fuel pump drive was intact and undamaged. Cabin control cable continuity was obtained to the mixture lever. The fuel pump was disassembled and no anomalies noted.

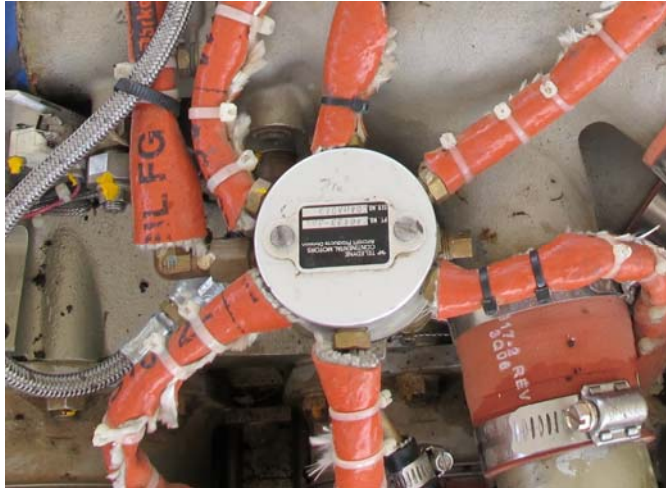
Condition: The fuel manifold valve was undamaged and not disassembled as designated by the NTSB.

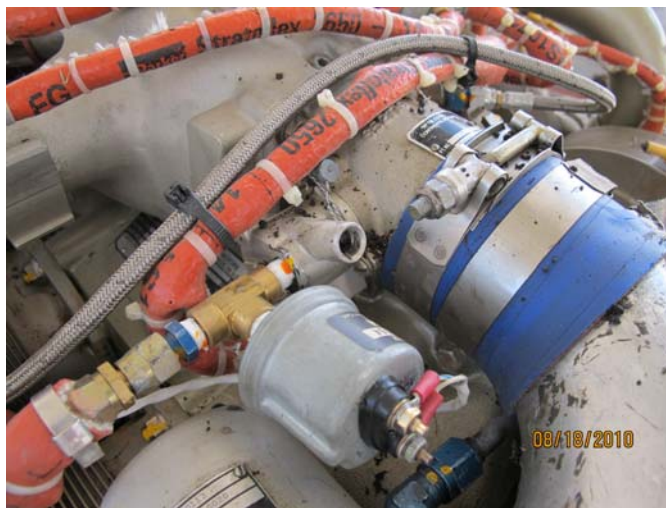
Condition: The throttle body fuel control linkage was undamaged and moved freely by hand. Cabin control cable continuity was obtained to the throttle valve linkage. The supercharger to throttlebody coupling band clamps overlapped each other.

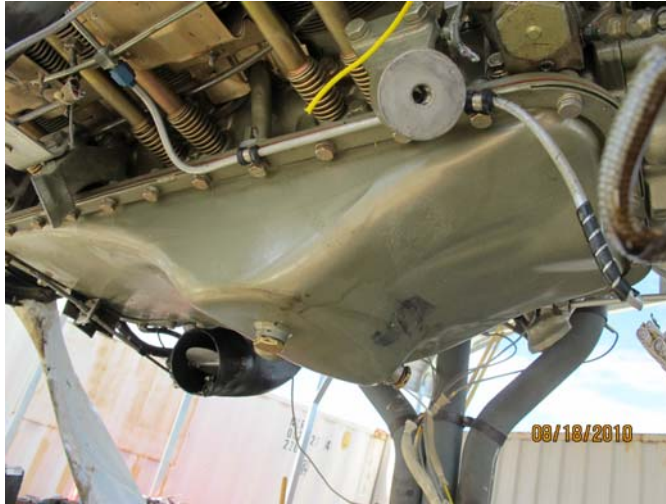
Oil Sump Condition: The oil sump was undamaged and not removed during the inspection. Approximately 8 quarts of oil was removed from the sump. The oil was dark in color.

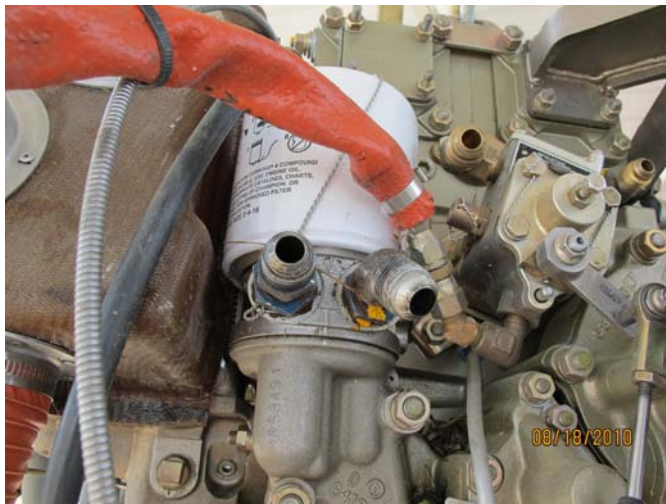
Oil Filter Condition: The oil filter was undamaged and safety wired. The filter was not removed during the inspection as designated by the NTSB.

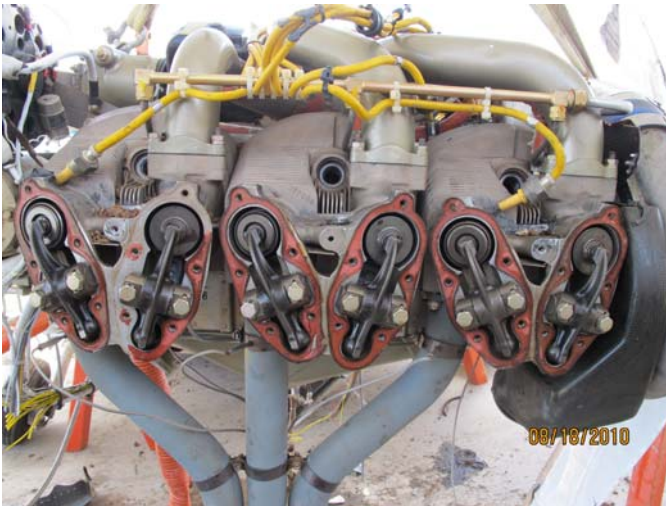
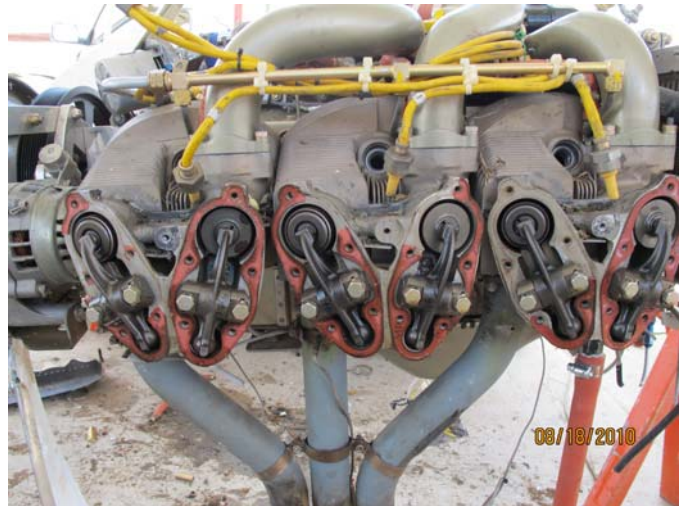
Condition: The cylinders were boroscoped and the piston heads and combustion areas had a light layer of gray deposits. The valves were undamaged and had no signs of abnormal thermal discoloration. The crankshaft was rotated by hand and cylinder compression and valve continuity was obtained. The cylinder overhead components were lubricated and undamaged.

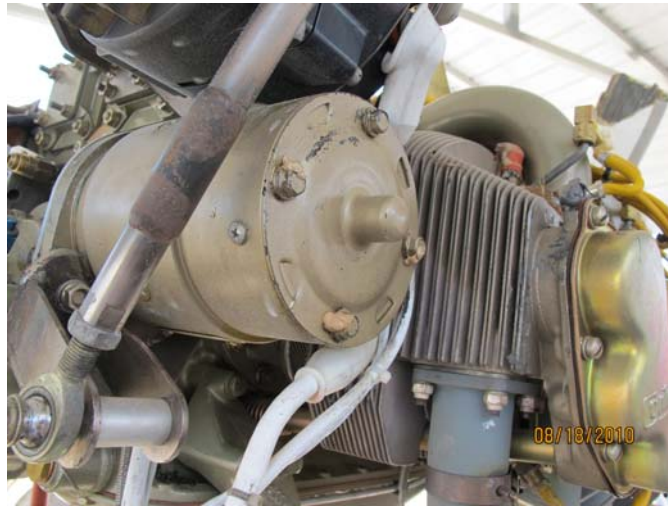
Starter

Condition: The starter was undamaged and not removed from the engine.

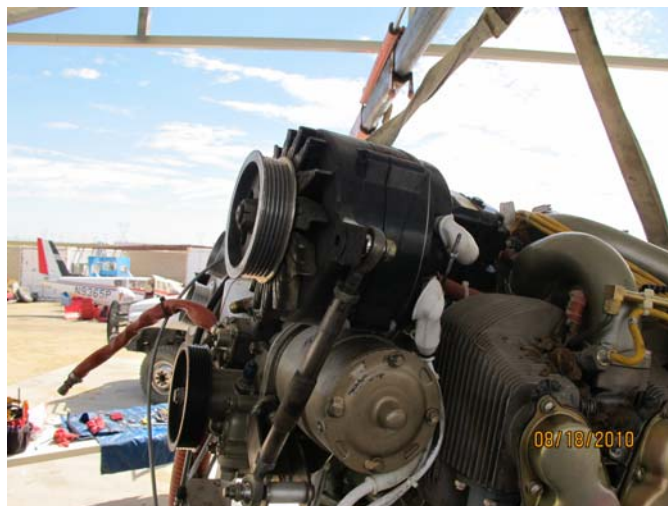
Alternator/Generator

Condition: The alternator was undamaged and was not removed from the engine during the inspection. The drive belt separated from the starter adapter drive pulley and alternator drive pulley and was found near the firewall area.

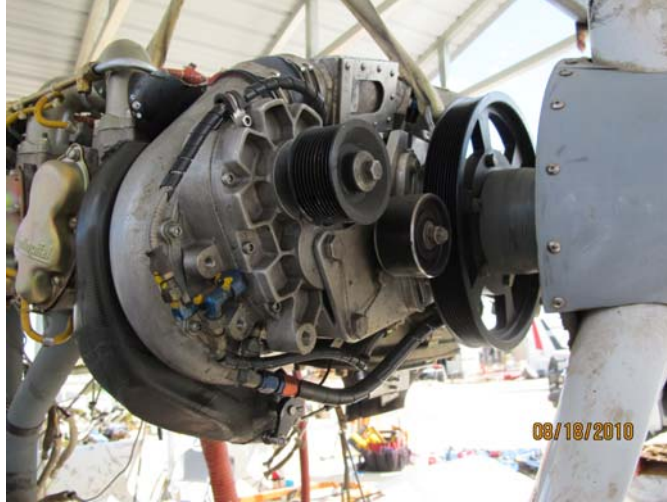
Supercharger

Condition: The supercharger was undamaged and not removed during the inspection. The drive belt was missing from the wreckage.

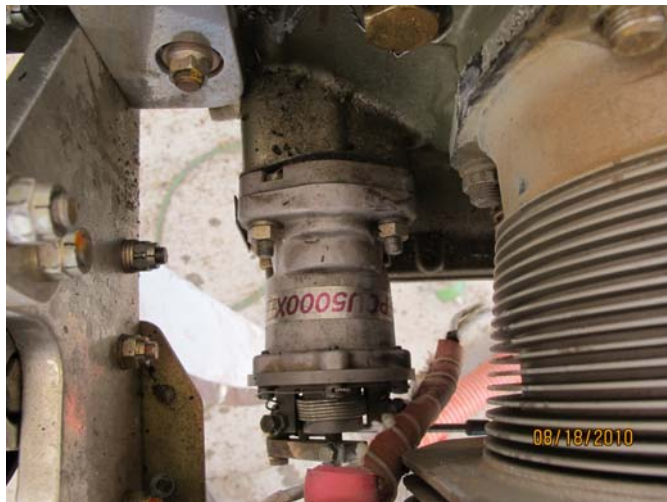
Propeller Governor

Condition: The propeller governor was not removed from the engine during the inspection.

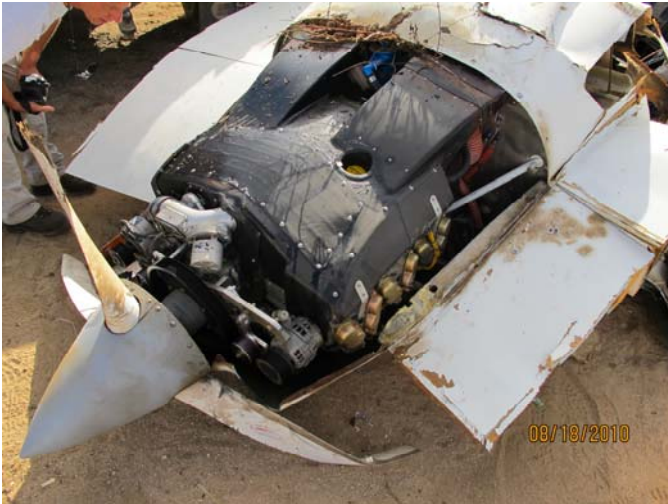
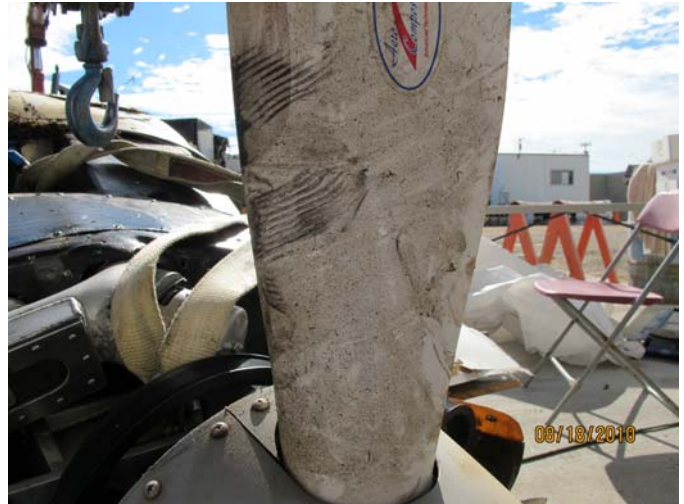
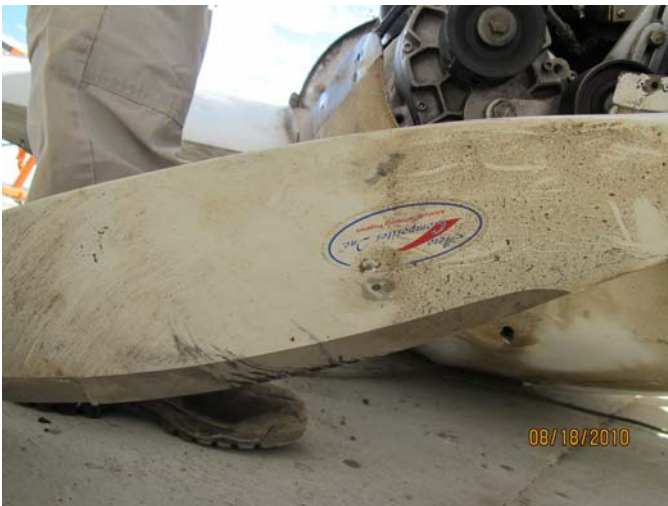
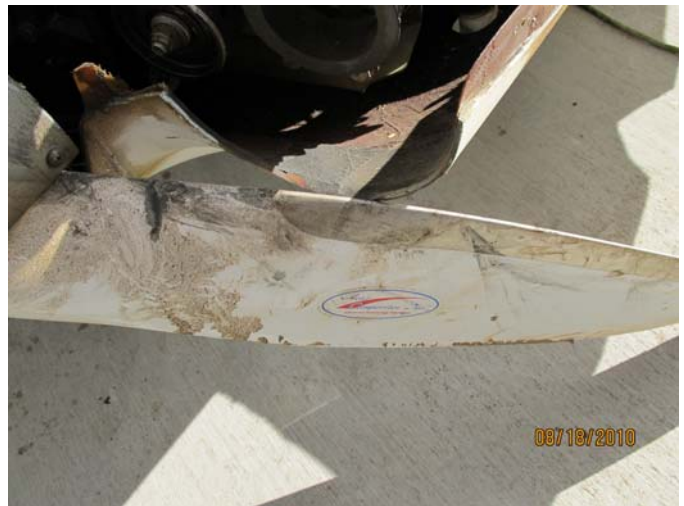
Condition: The propeller assembly had impact damage and remained attached to the engine during the inspection. The cambered surfaces of the blades had rubber impact marks. One of the blades had approximately 8 inches missing from the tip. The spinner was undamaged.
