Continental Motors

ENGINE FIELD INSPECTION REPORT

ENGINE MODEL	O-470-L1
ENGINE SERIAL NUMBER	66818-6-L
AIRCRAFT MAKE & MODEL	Cessna 182
AIRCRAFT SERIAL NUMBER	33816
AIRCRAFT REGISTRATION	N5816B
FILE NUMBER	14-077

EXAMINATION		ACCIDENT DATA	
DATE	07/16/2014	NTSB ACCIDENT #	WPR14FA286
FACILITY	AvTech Services LLC	NTSB INVESTIGATOR	Tom Little
ADDRESS	[REDACTED] Kent, WA 98042	FAA INVESTIGATOR	William Shin
		ACCIDENT DATE	07/08/2014
		ACCIDENT LOCATION	Fall City, WA

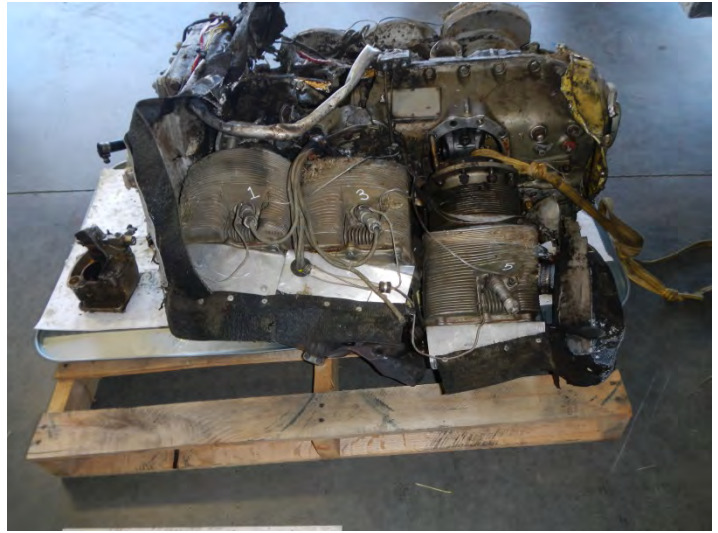
The engine was resting in an upright position on a pallet. The propeller was separated from the crankshaft's propeller flange. A portion of the propeller flange was fractured and displaced aft. All six propeller bolts remained with the propeller flange. The aft spinner bulkhead was deformed aft around the topside of the crankcase. The two-bladed propeller was lying on the floor adjacent to the engine. Both blades remained attached to the hub, both were twisted toward low pitch, and both displayed a polished erosion of the paint from the tips. One of the blades also displayed s-bending signatures. The threaded areas of the hub where the propeller bolts are normally positioned displayed distortion and elongation signatures. The propeller mounting dowels were also displaced.

The #4 and #5 cylinders were partially separated from the crankcase. The topside of the crankcase was fractured permitting a view inside the engine in the area of the four aft cylinders. Both magnetos were separated from the engine. Portions of the ignition leads remained with the engine. The carburetor was separated from the engine as was the oil cooler, starter motor, and vacuum pump. The exhaust system remained attached to the engine; however, it sustained deformation damage and flattening. The primer system and primer lines remained attached to the engine.

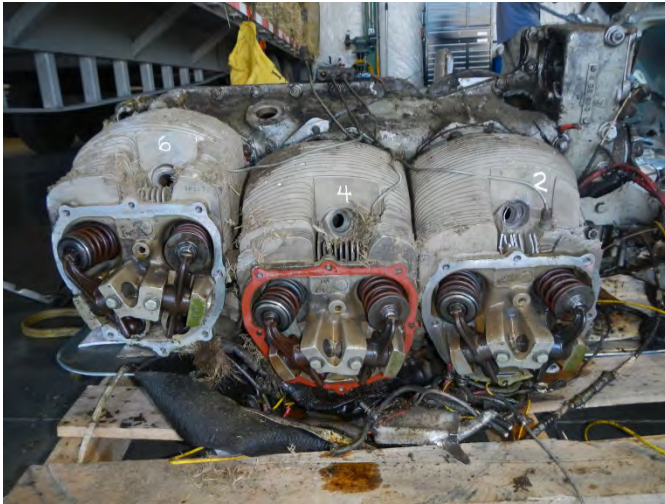
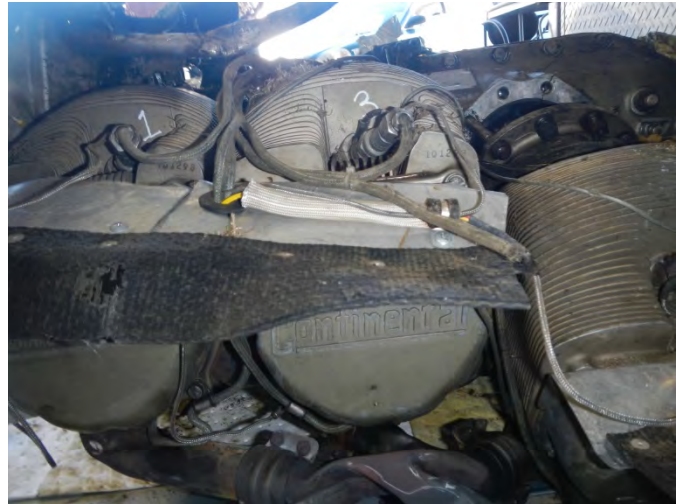
EXHAUST SYSTEM

The exhaust risers and manifold remained with the engine; however, they sustained deformation damage and were flattened.

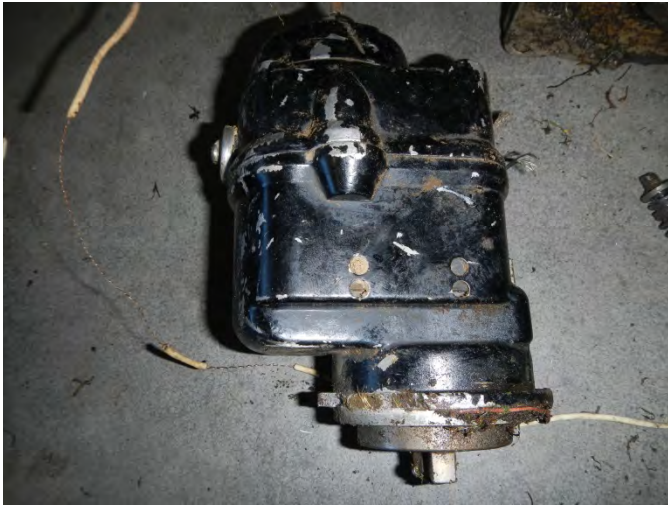
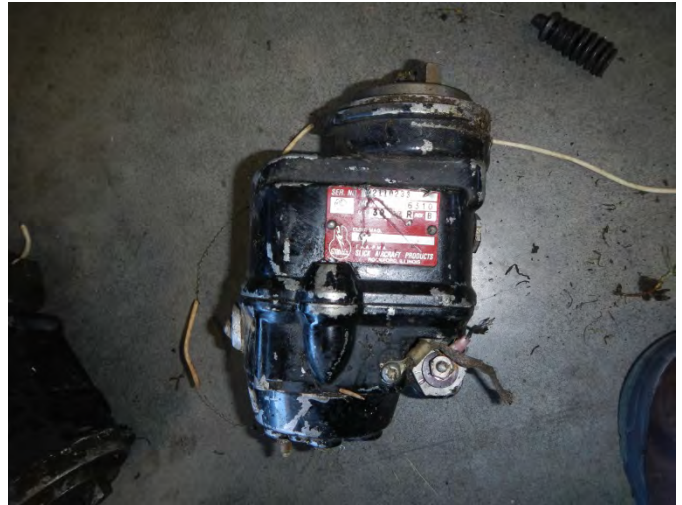
LEFT MAGNETO	Manufacturer: Slick	P/N: 6310	S/N: ?2110233
---------------------	---------------------	-----------	---------------

Condition: The left magneto was separated from the engine and was intact, though it sustained impact damage that separated all of the ignition leads and left mechanical deformation damage to the housing. The drive shaft could be manually rotated and the snap of the impulse coupling was audible.

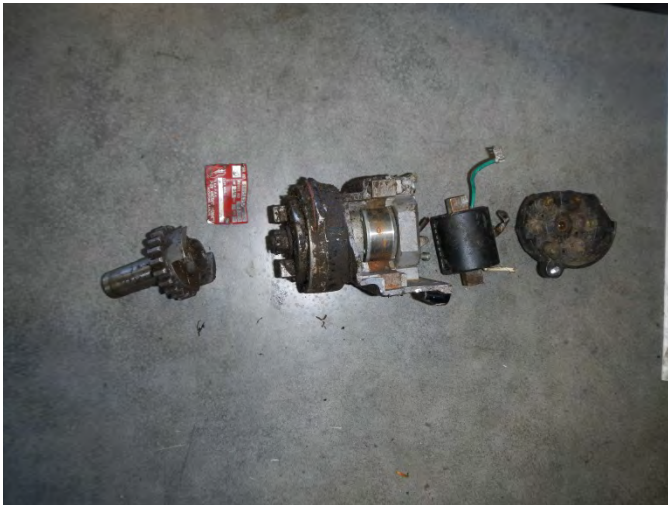
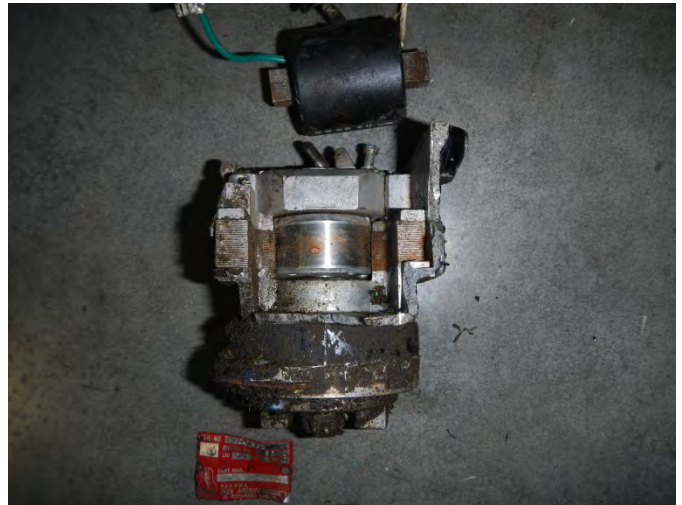
RIGHT MAGNETO	Manufacturer: Slick	P/N: 6310	S/N: 98041982
----------------------	---------------------	-----------	---------------

Condition: The right magneto was separated from the engine and was fractured. Examination of the identified components did not reveal any pre-impact anomalies.

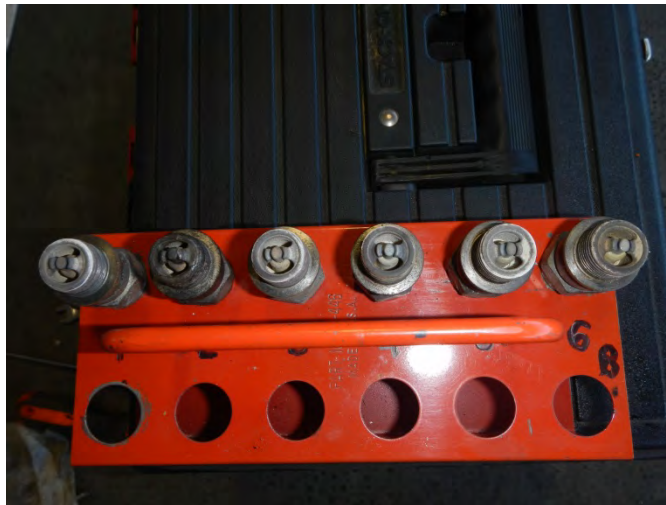
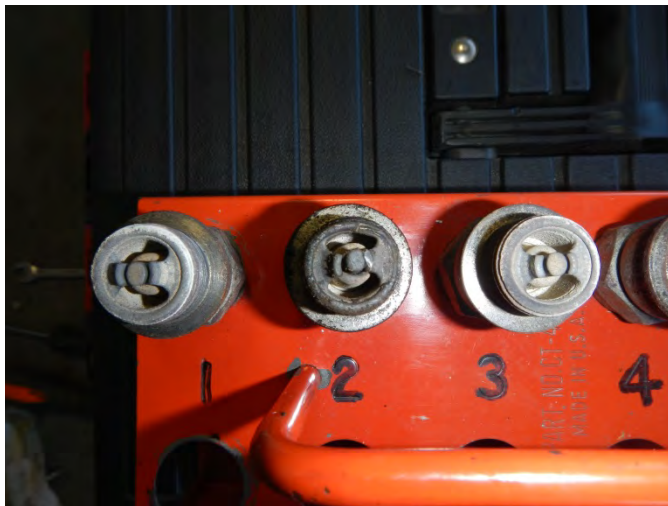
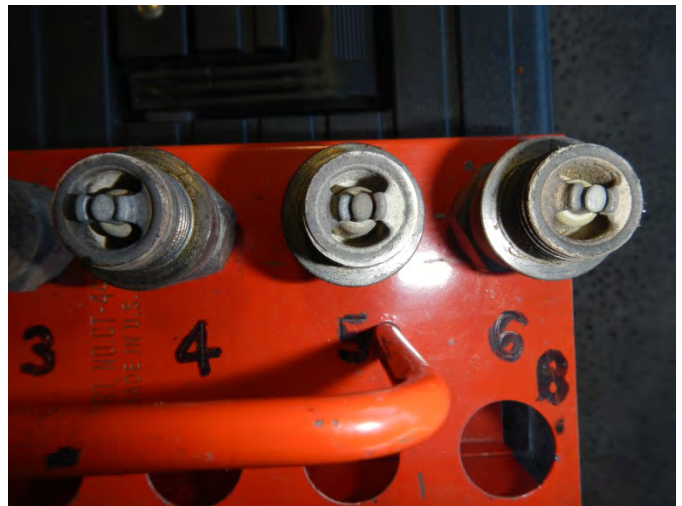
SPARK PLUGS	Manufacturer: Champion	P/N: REM40E
Condition:	The top sparkplugs were removed from their respective cylinders. The #2 top sparkplug sustained mechanical damage. Otherwise, they were unremarkable, showing normal wear and combustion signatures when compared to the Champion Service Manual AV6-R.

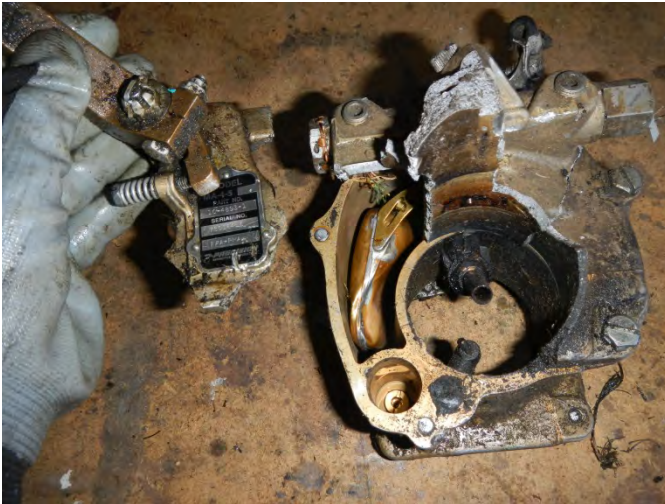
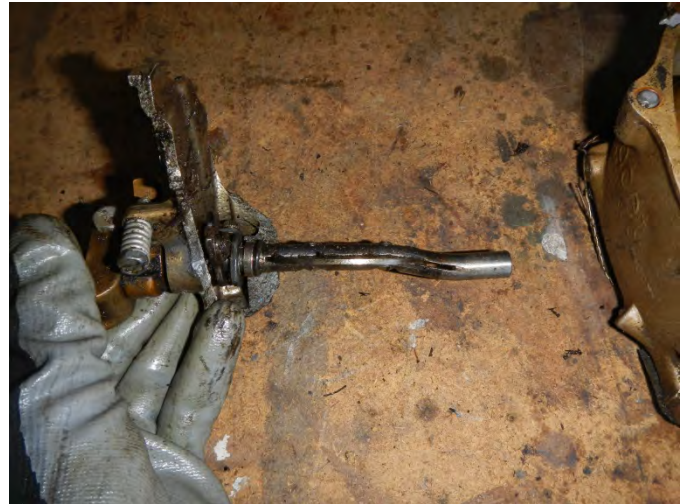
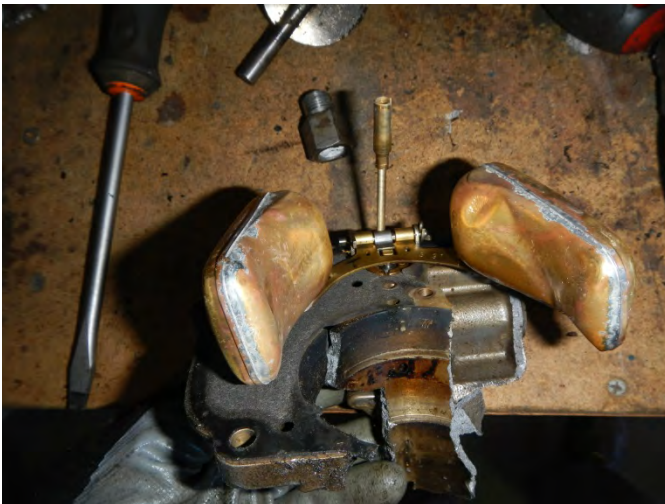
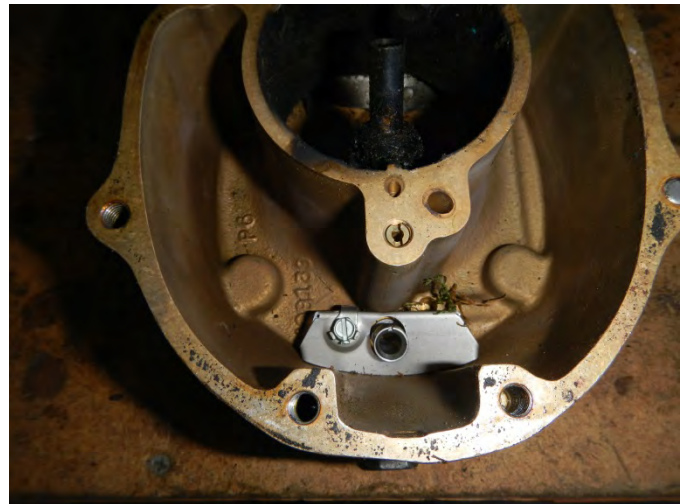
CARBURETOR

The carburetor was separated from the engine and the throttle valve was separated from the carburetor as was the accelerator pump. The mixture lever was separated from the carburetor. The throttle shaft was bent but remained attached to the throttle plate. The throttle lever remained attached to the shaft. The carburetor housing was fractured permitting a view into the carburetor bowl. Disassembly of the carburetor revealed that the inlet screen was clean, and the floats, though deformed, were intact.

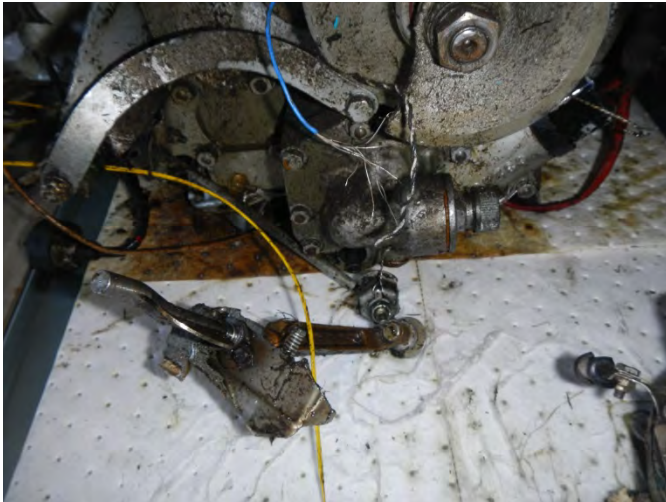
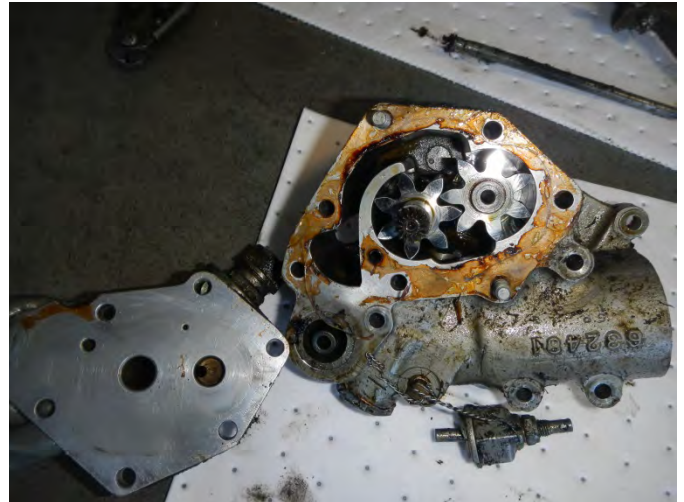
OIL PUMP

The oil pump remained secured to the backside of the engine. It was removed and disassembled. Some light scoring and corrosion was noted on the pump housing walls. There were no signs of operational distress with the oil pump housing or gears.

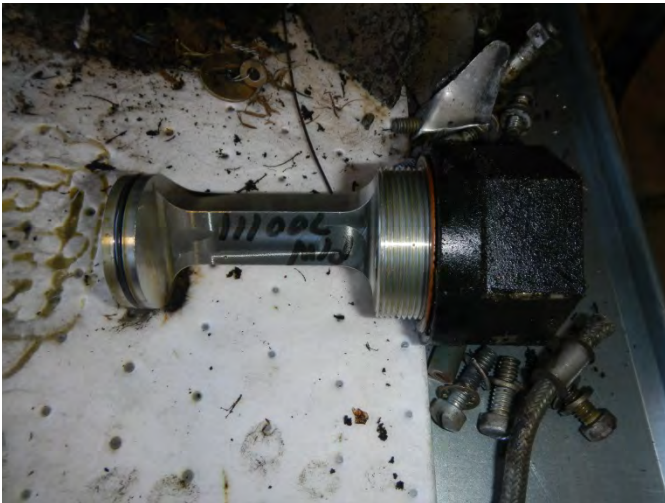
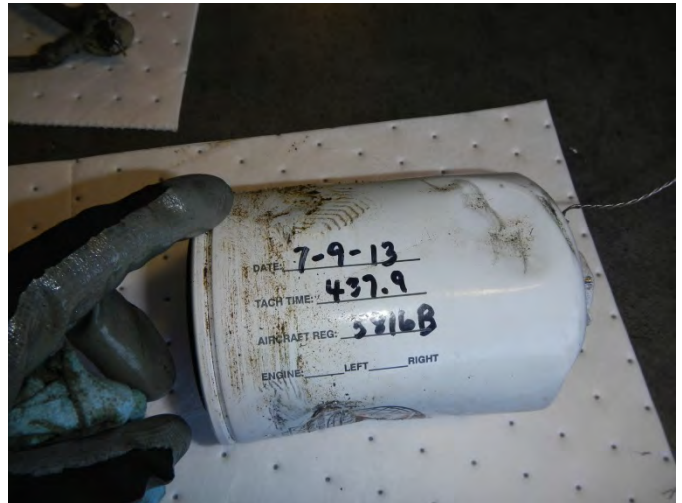
OIL FILTER

The engine was modified using a remote, disposable, oil filter. The oil filter supply and return lines were separated from the adapter. The oil filter was located and cut open. There were no visible signs of contamination.

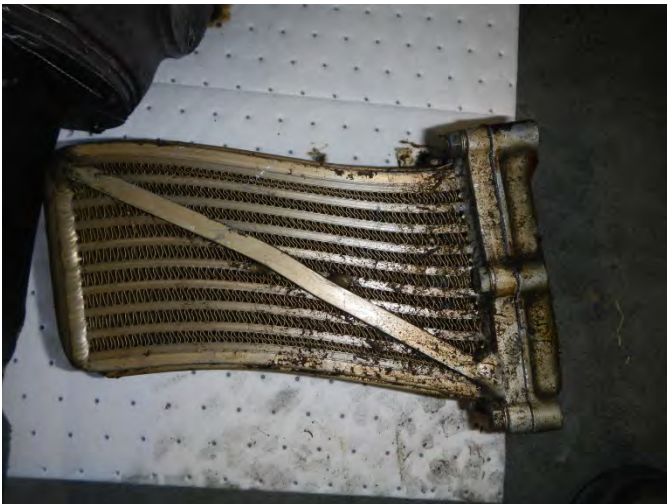
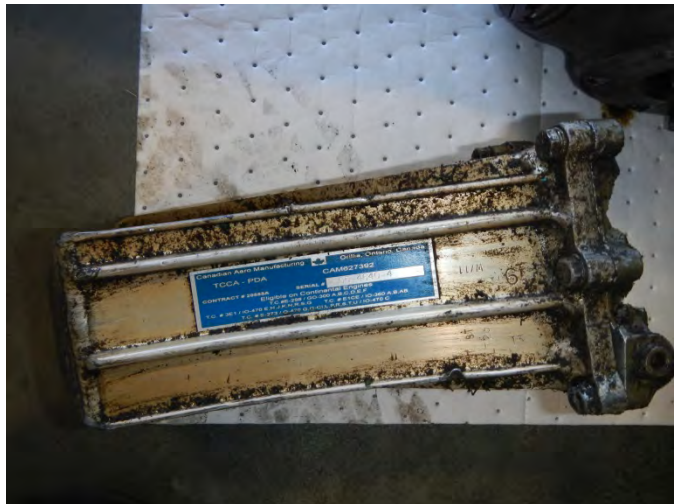
OIL COOLER

Condition: The oil cooler was separated from the engine and sustained deformation damage. There were no signs of operational distress with the unit.

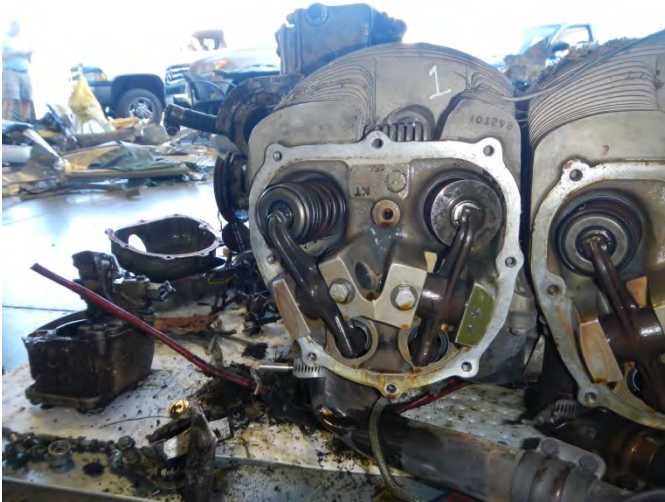
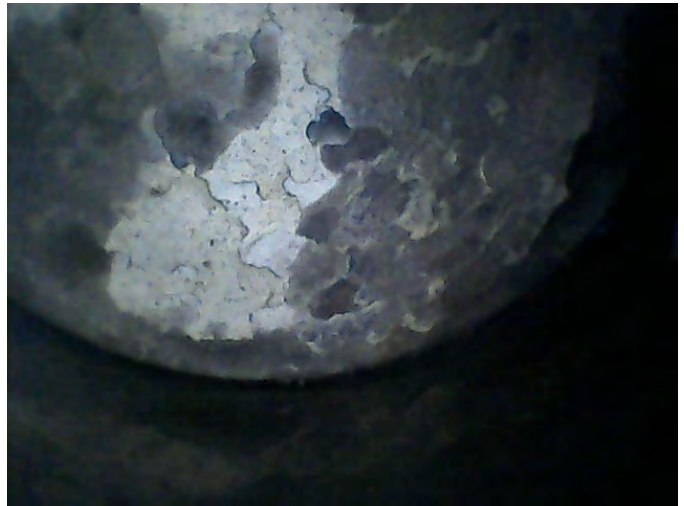
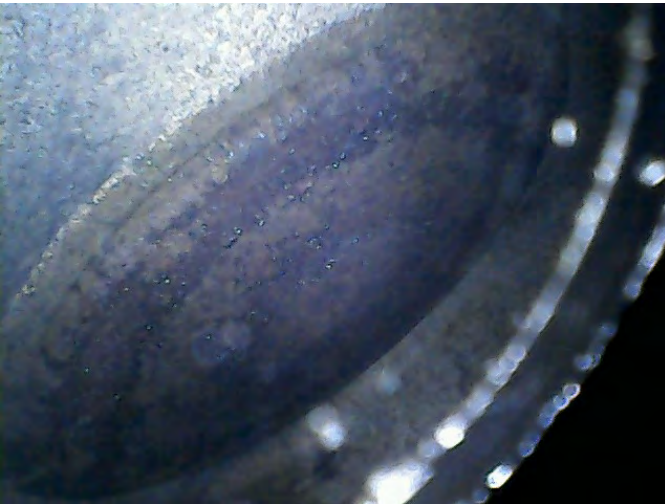
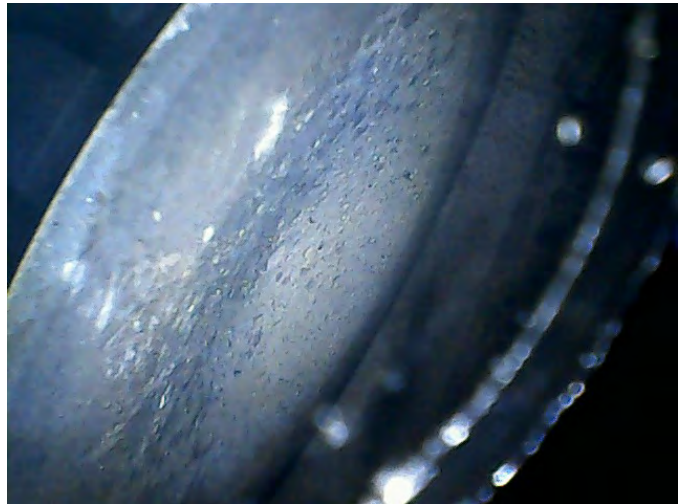
CYLINDER #1	P/N: 654959A1	S/N: Unknown	Head Date: 10-98
Condition:	The cylinder remained attached to the crankcase. No anomalies were noted with the rockers or valve springs. Borescope examination of the cylinder revealed no anomalies with the piston, barrel, cylinder head, valves or valve seats.

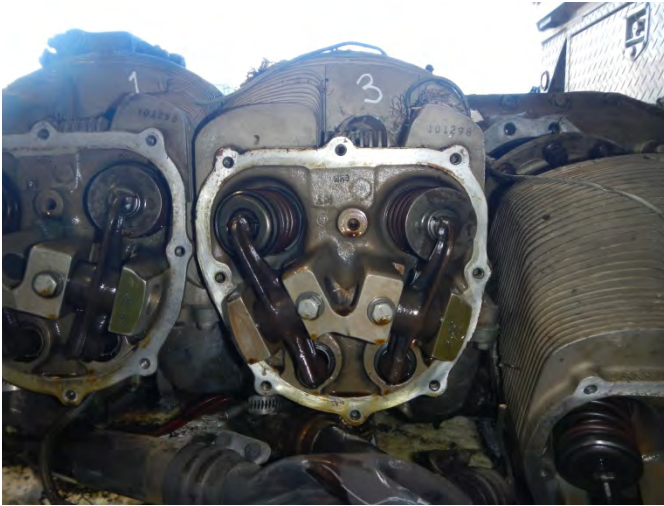
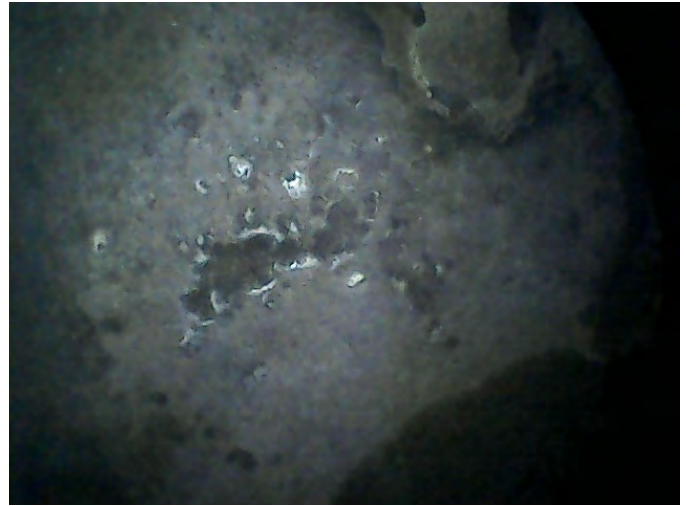
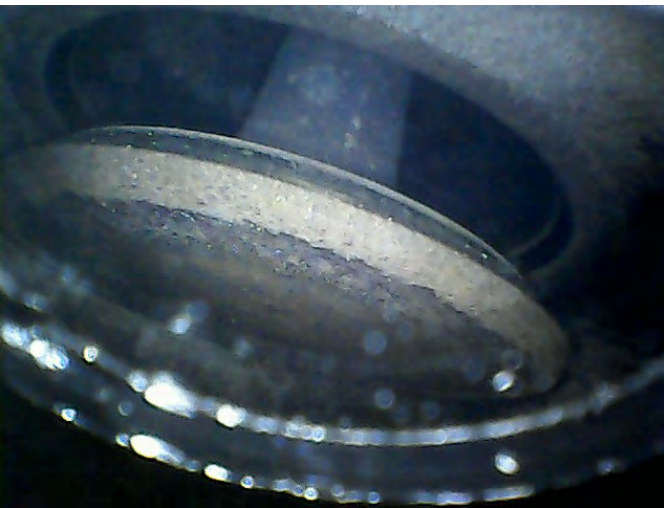
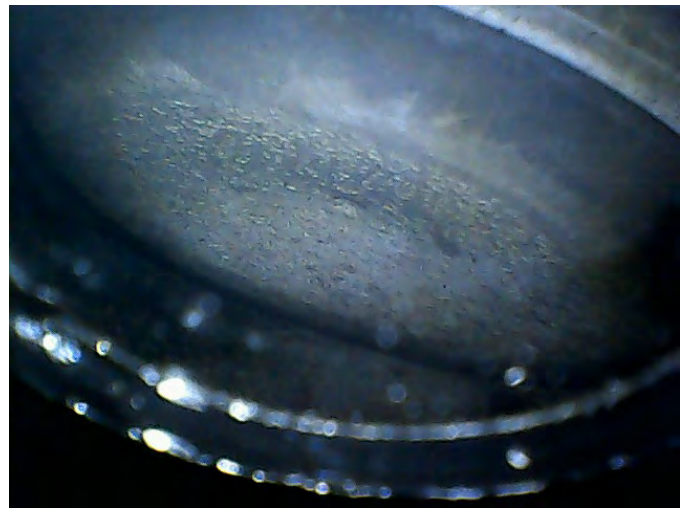
CYLINDER #3

The cylinder remained attached to the crankcase, though some of the deck studs were displaced due to the crankcase damage. No anomalies were noted with the rockers or valve springs. Borescope examination of the cylinder revealed no anomalies with the piston, barrel, cylinder head, valves or valve seats.

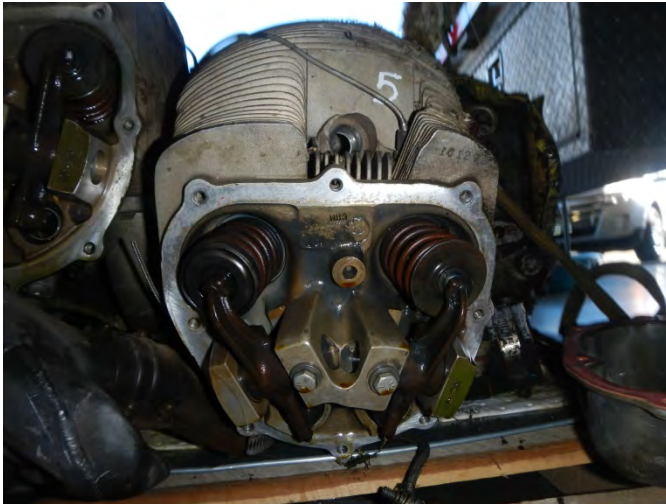
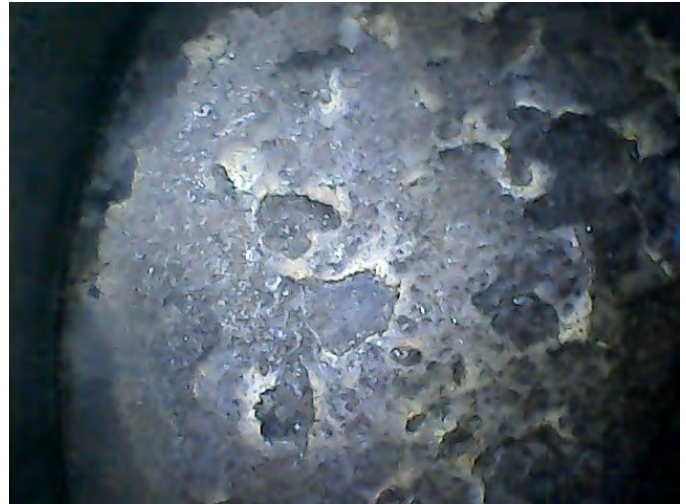
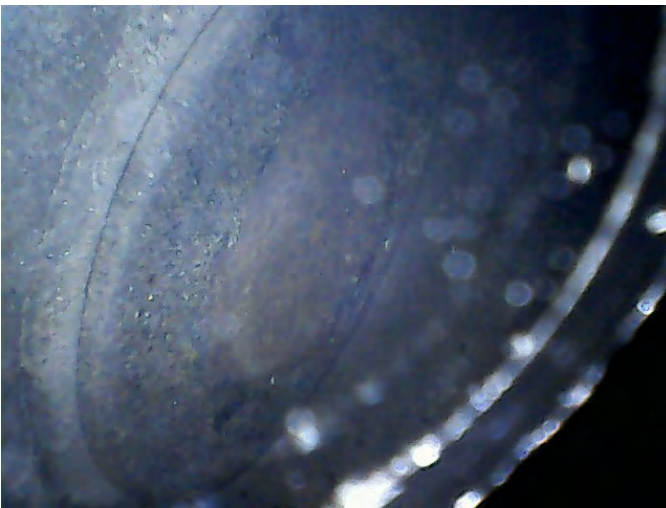
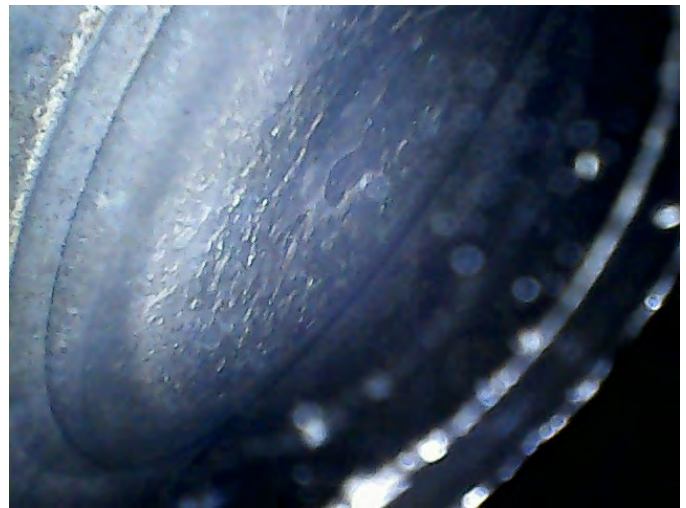
CYLINDER #5

The cylinder was partially separated from the crankcase exposing the connecting rod and backside of the piston. No anomalies were noted with the rockers or valve springs. Borescope examination of the cylinder revealed no anomalies with the piston, barrel, cylinder head, valves or valve seats.

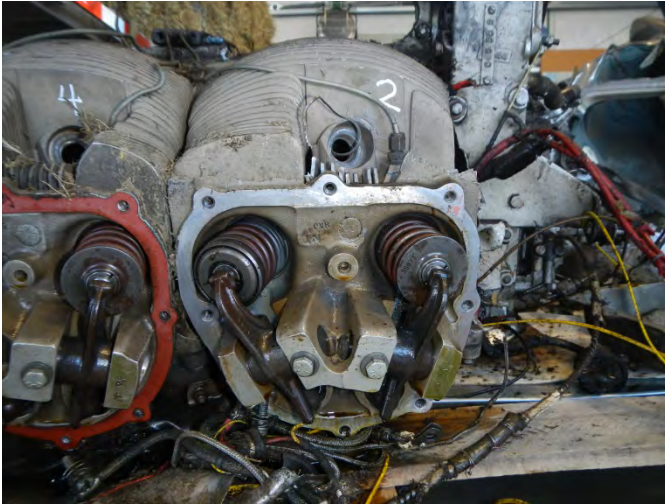
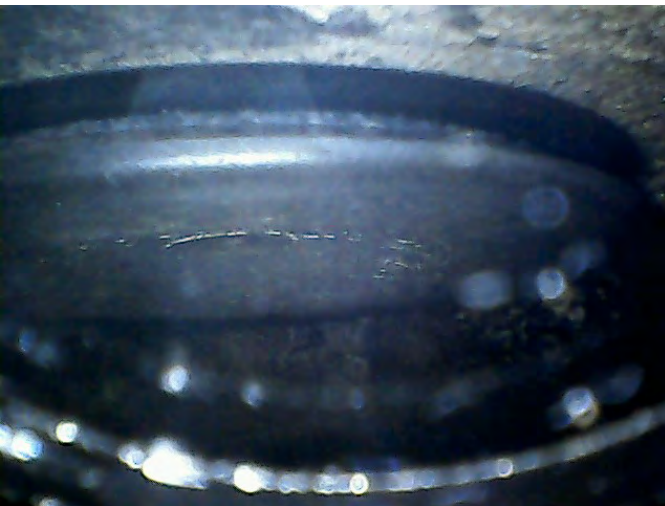
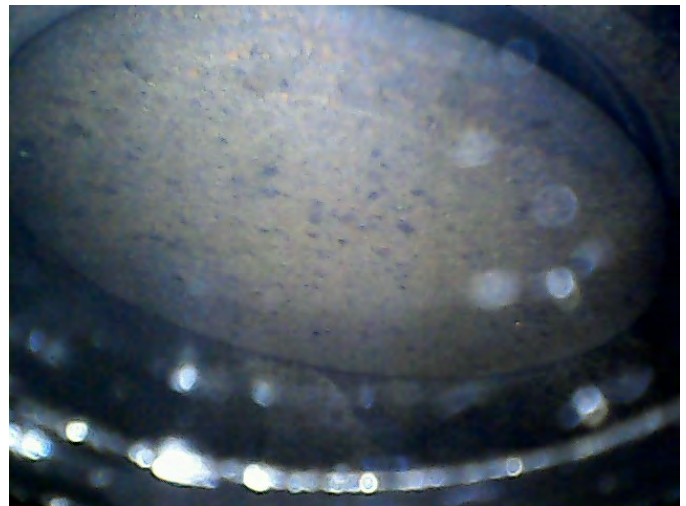
CYLINDER #2

The cylinder had broken cooling fins around the tops sparkplug. A hole was punctured in the rocker cover. The cylinder remained attached to the crankcase. No anomalies were noted with the rockers or valve springs. Borescope examination of the cylinder revealed no anomalies with the piston, barrel, cylinder head, valves or valve seats.

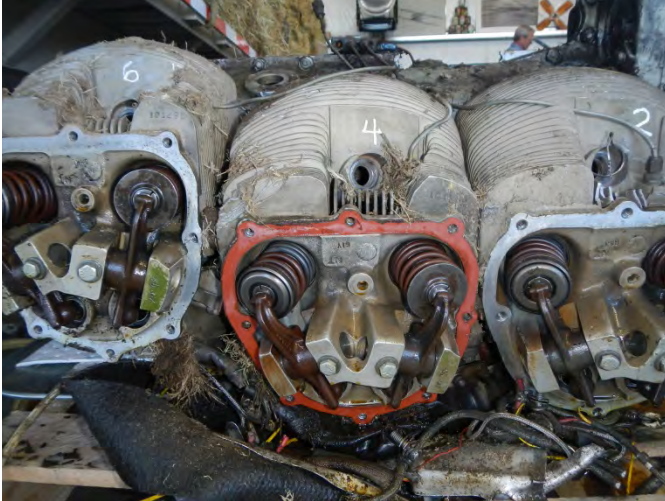
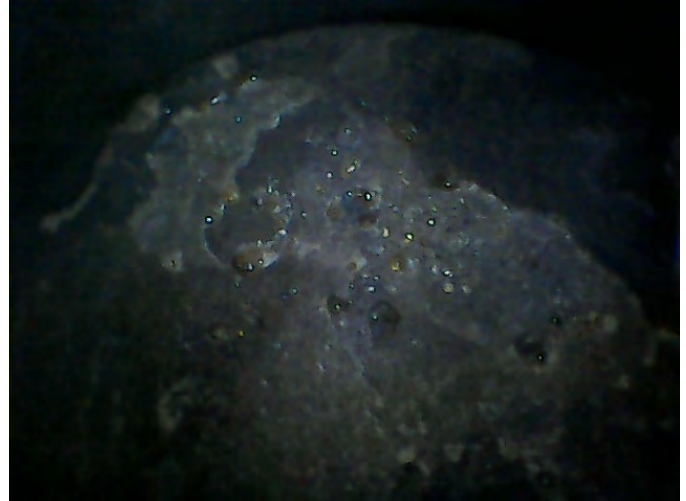
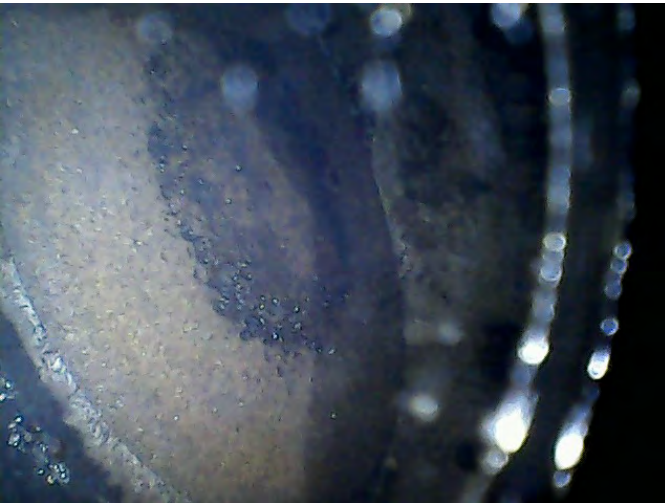
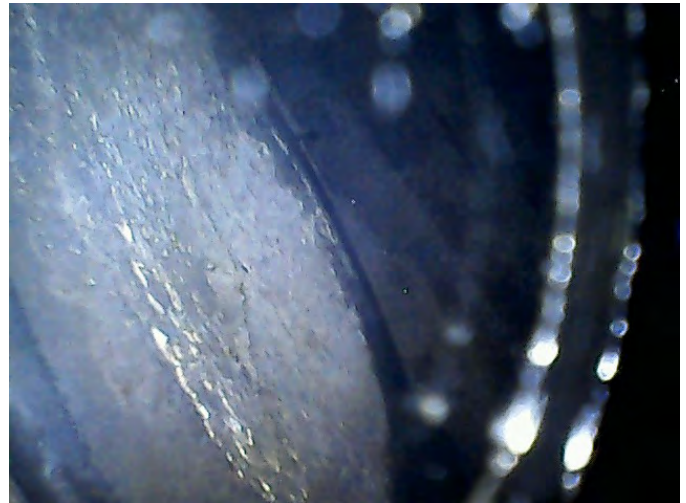
CYLINDER #4

The cylinder was partially separated from the crankcase. No anomalies were noted with the rockers or valve springs. Borescope examination of the cylinder revealed no anomalies with the piston, barrel, cylinder head, valves or valve seats.

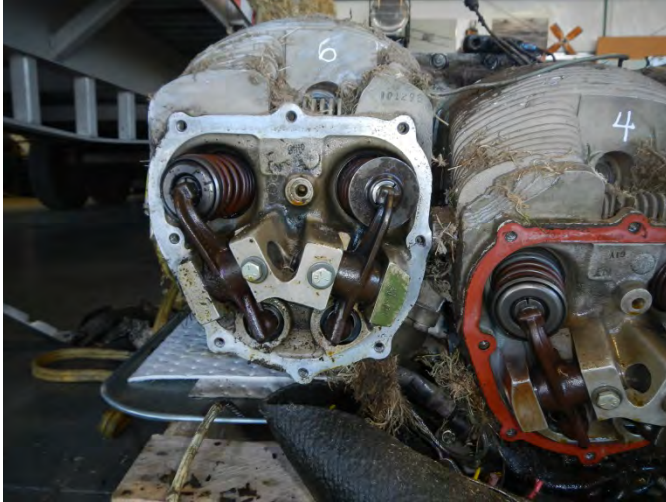
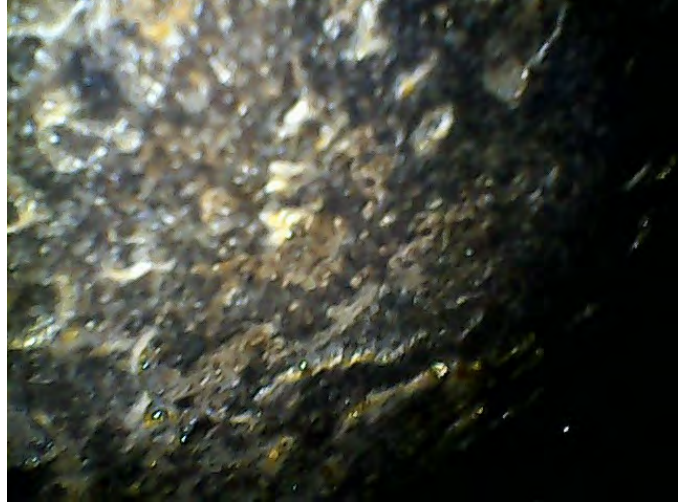
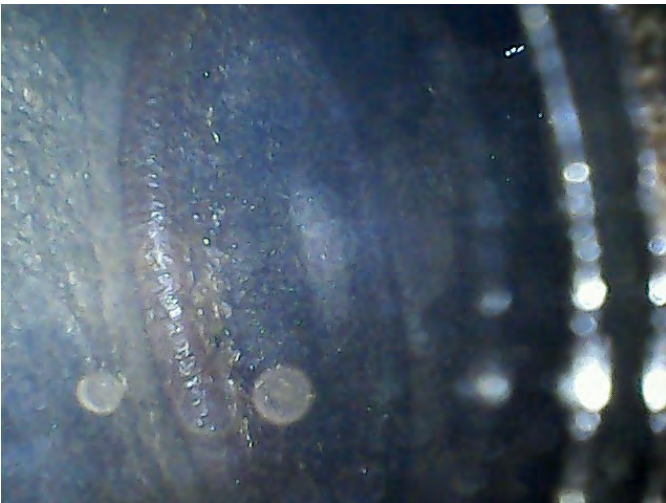
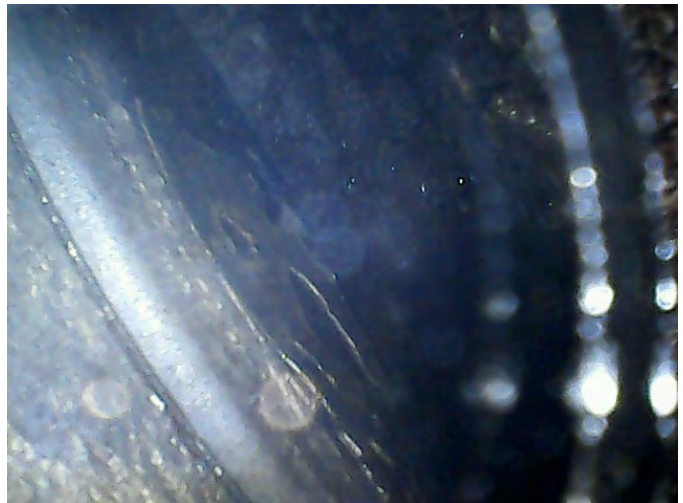
CYLINDER #6

The cylinder remained attached to the crankcase. No anomalies were noted with the rockers or valve springs. Borescope examination of the cylinder revealed no anomalies with the piston, barrel, cylinder head, valves or valve seats.

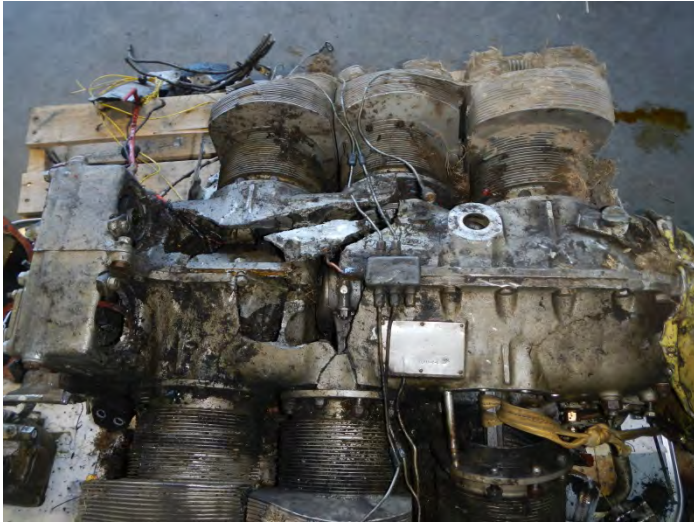
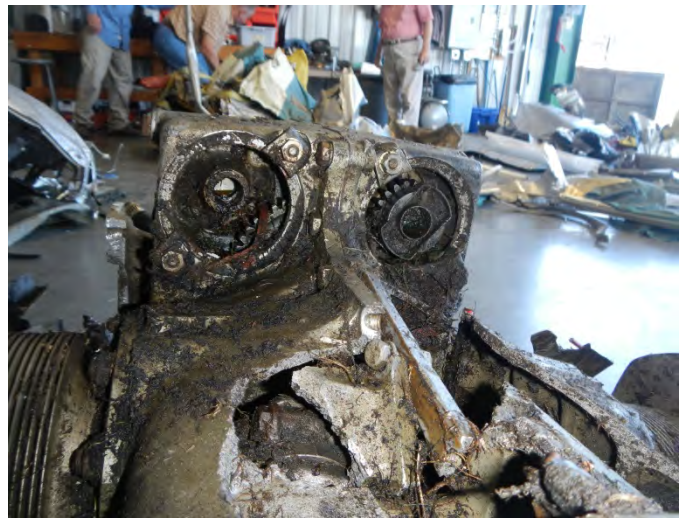
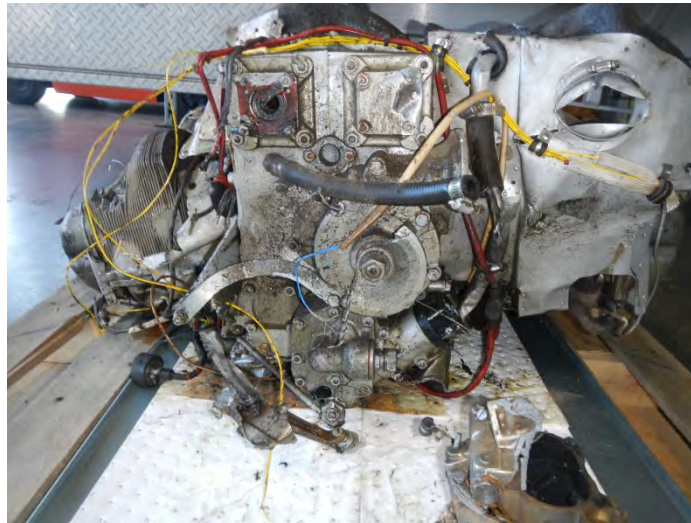
CRANKCASE	Casting Number	1-3-5: Unknown	2-4-6: Unknown	S/N: Unknown
Condition:	The crankcase was fractured exposing the internal components on the aft end of the engine. There was no evidence of any pre-existing anomalies with the crankcase.

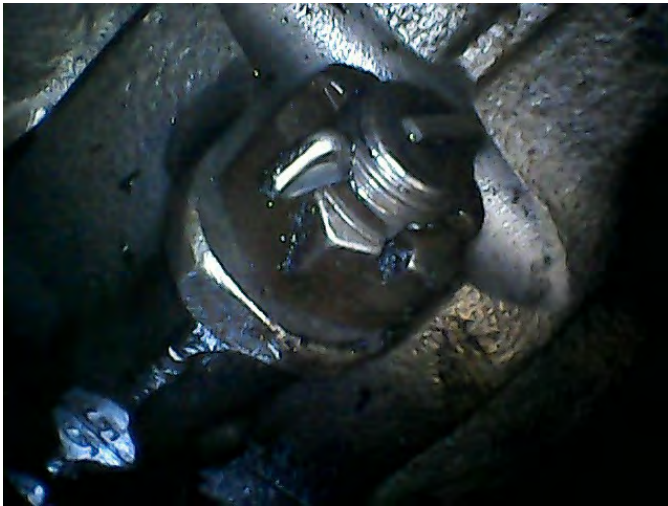
#5 CONNECTING ROD

Condition: Examination of the connecting rod through the partially separated cylinder revealed that it remained intact and the rod bolts were secured. The connecting rod did not display any evidence of operational or heat distress.

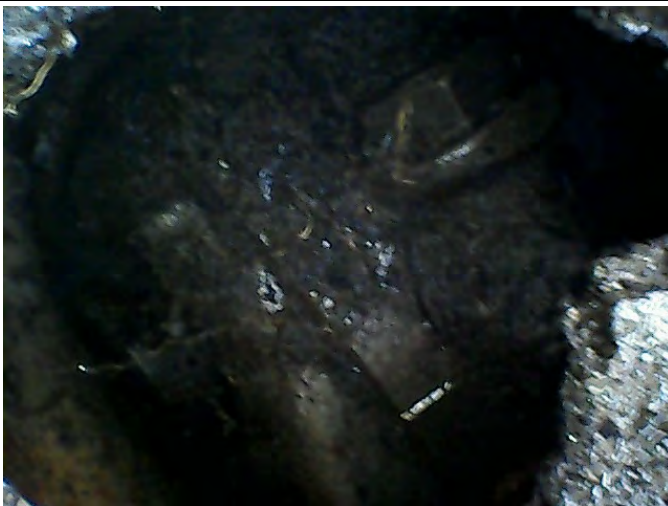
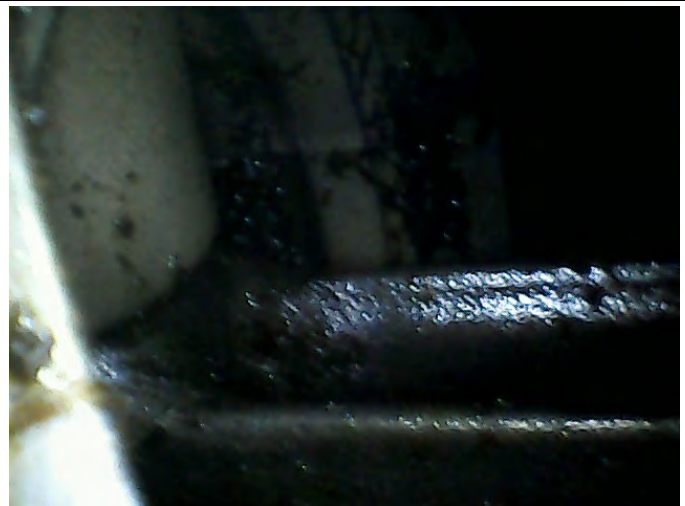
#2 CONNECTING ROD

Condition: Examination of the connecting rod through the fractured crankcase halves revealed that it remained intact and the rod bolts were secured. The connecting rod did not display any evidence of operational or heat distress.

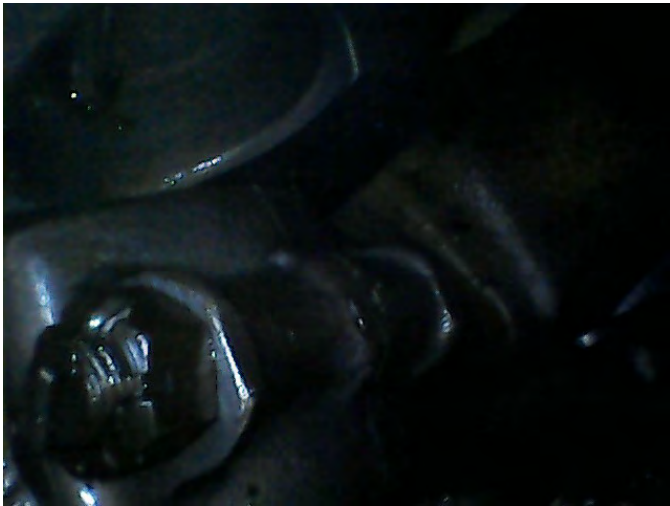
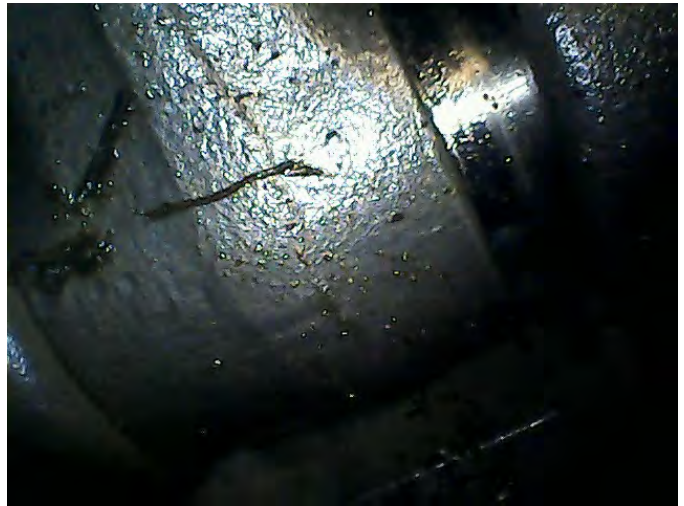
**#4 CONNECTING
ROD**

Condition: Examination of the connecting rod through the fractured crankcase halves revealed that it remained intact and the rod bolts were secured. The connecting rod did not display any evidence of operational or heat distress.

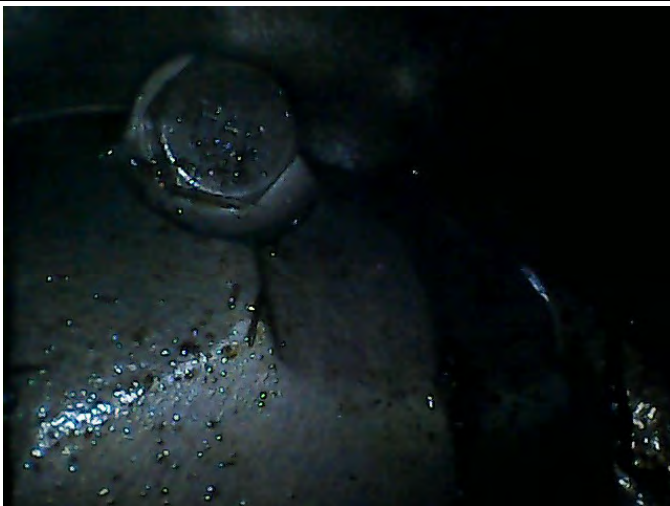
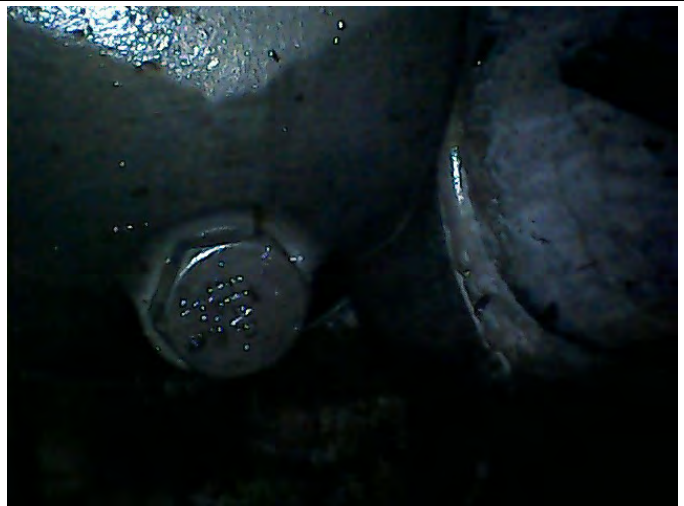
**#6 CONNECTING
ROD**

Condition: Examination of the connecting rod through the partially separated #5 cylinder revealed that it remained intact and the rod bolts were secured. The connecting rod did not display any evidence of operational or heat distress.

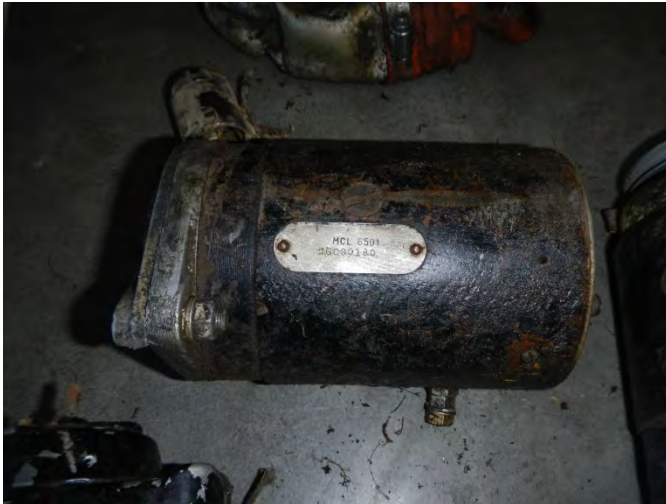
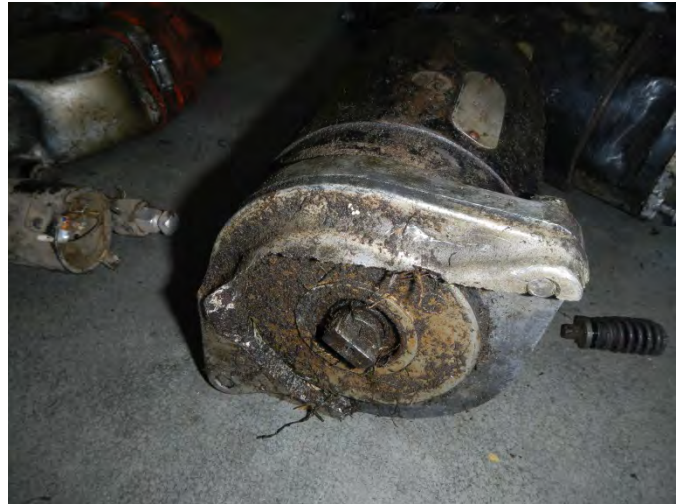
STARTER	Manufacturer: Unknown	P/N: MCL 6501	S/N: G000180
Condition:	The starter motor was separated from the engine. Rotation of the starter shaft did not reveal and anomalies or binding.

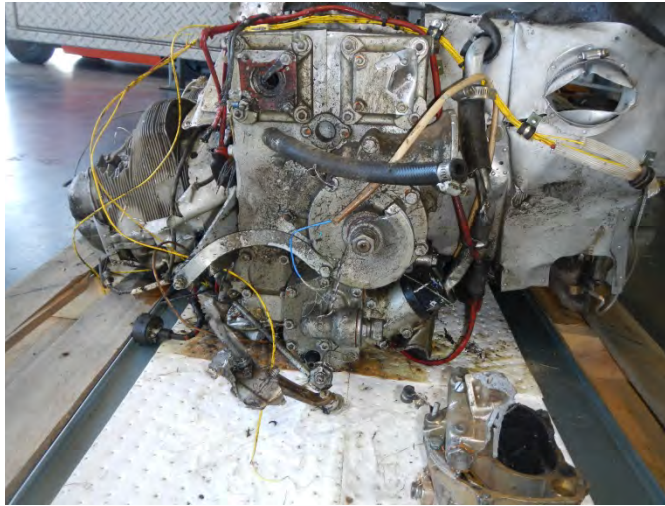
STARTER ADAPTER	P/N: Unknown
------------------------	--------------

Condition: The starter adapter remained attached to the aft end of the engine; however it sustained impact damage that fractured a portion of the starter motor mount and the adapter cap.

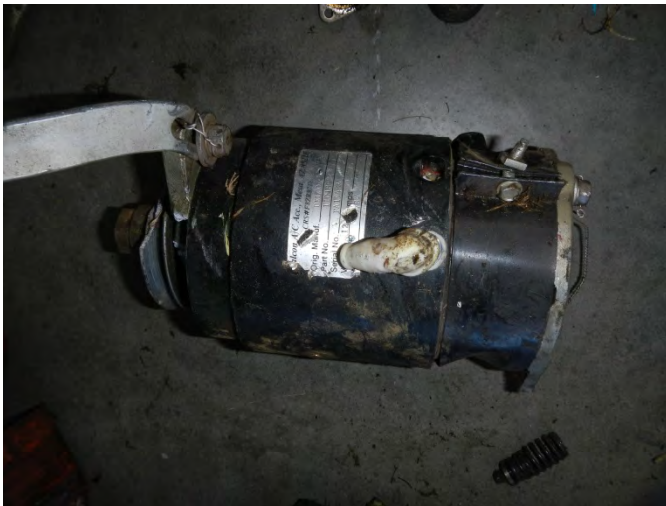
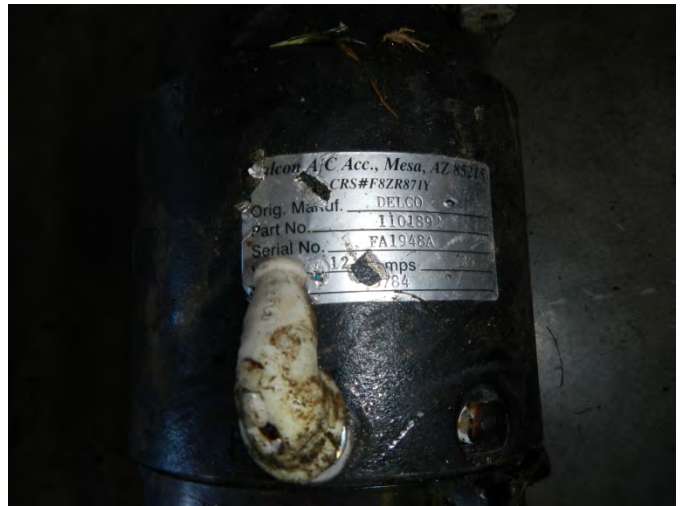
ALT/GEN #1	Manufacturer: Delco	P/N: 1101892	S/N: FA1948A
-------------------	---------------------	--------------	--------------

Condition: The 12 Volt generator was separated from the engine and sustained impact damage. A portion of the generator mount remained with the generator and a portion remained attached to the engine; both of which sustained deformation damage.

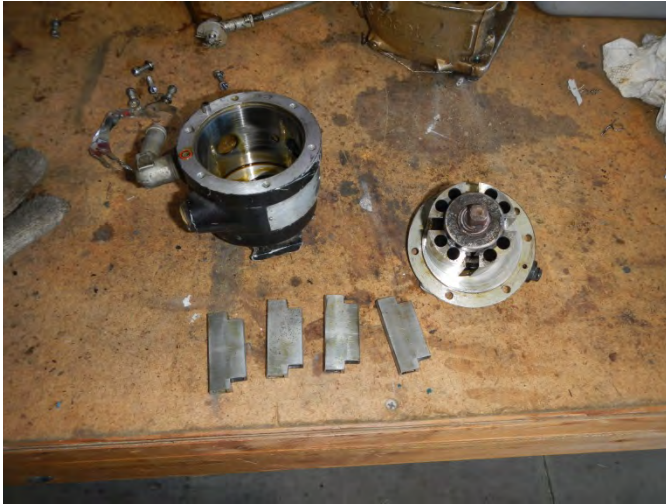
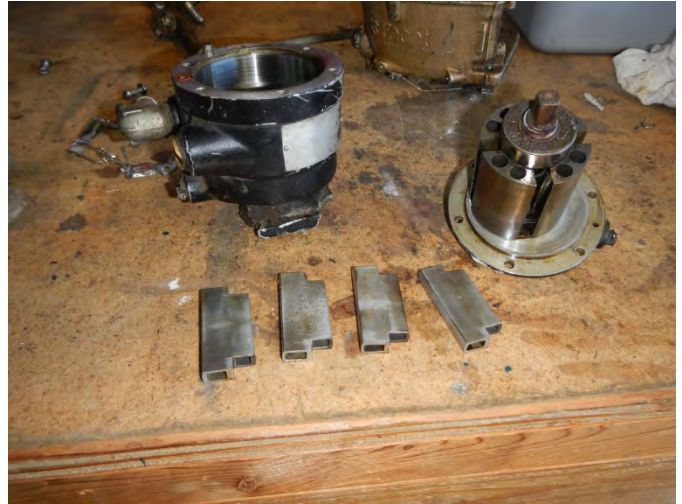
**VACUUM
PUMP**

The wet pump was separated from the engine. It was disassembled and no anomalies were noted with the rotor or vanes. All components displayed normal wear patterns.
