Continental Motors

ENGINE FIELD INSPECTION REPORT

ENGINE MODEL	O-470-L1
ENGINE SERIAL NUMBER	66818-6-L
AIRCRAFT MAKE & MODEL	Cessna 182
AIRCRAFT SERIAL NUMBER	33816
AIRCRAFT REGISTRATION	N5816B
FILE NUMBER	14-077

EXAMINATION		ACCIDENT DATA	
DATE	07/16/2014	NTSB ACCIDENT #	WPR14FA286
FACILITY	AvTech Services LLC	NTSB INVESTIGATOR	Tom Little
ADDRESS	[REDACTED] Kent, WA 98042	FAA INVESTIGATOR	William Shin
		ACCIDENT DATE	07/08/2014
		ACCIDENT LOCATION	Fall City, WA

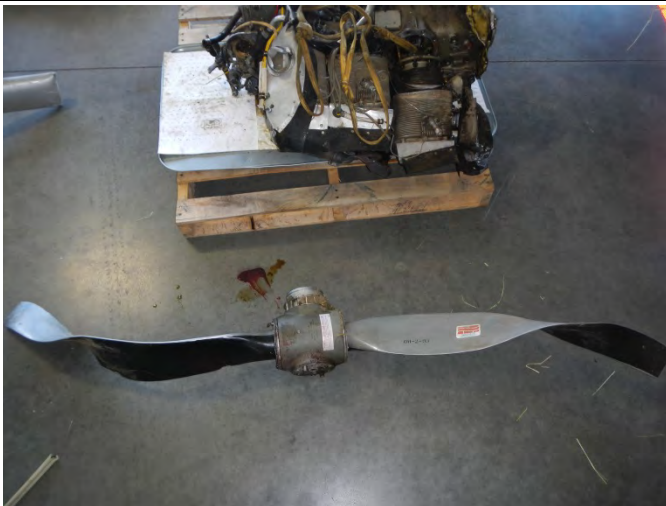
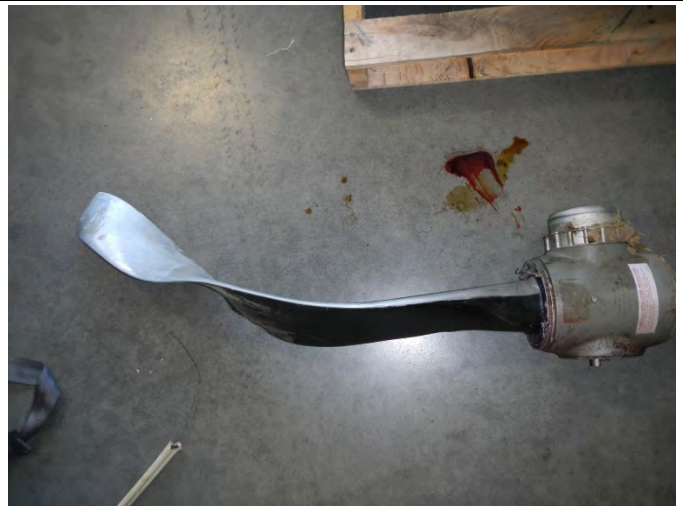
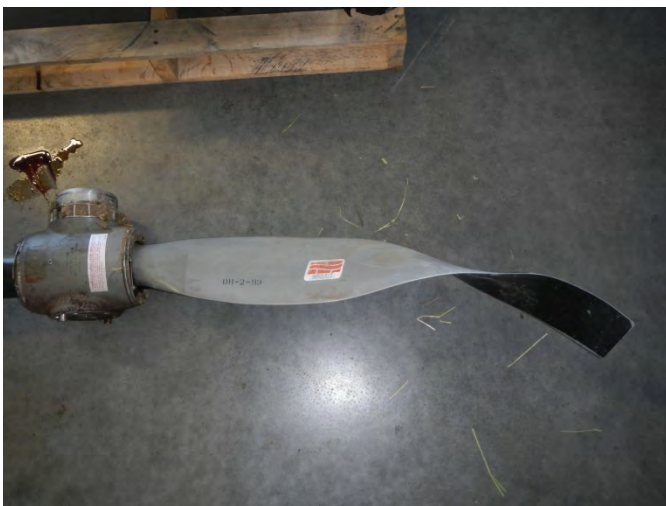
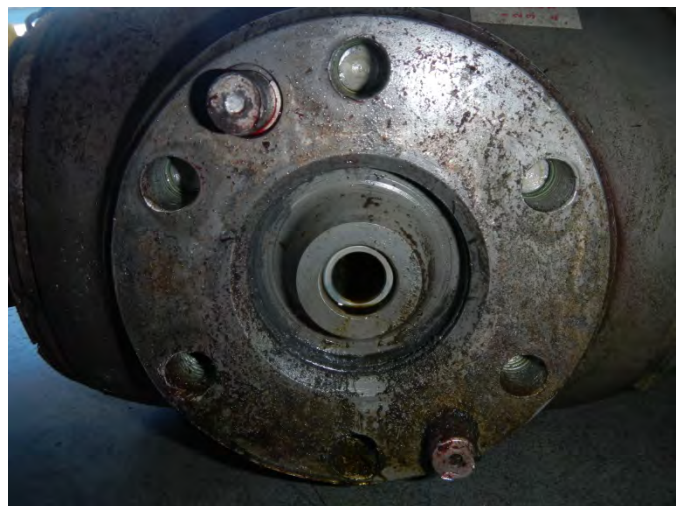
PROPELLER GOVERNOR	Manufacturer: Not observed	P/N: Not observed	S/N: Not observed
Condition:	The propeller governor was not observed during the examination.		
PROPELLER	Manufacturer: McCauley	P/N: 2A34C66-0P	S/N: 806983
Condition:	The propeller was separated from the crankshaft's propeller flange. A portion of the propeller flange was fractured and displaced aft. All six propeller bolts remained with the propeller flange. The aft spinner bulkhead was deformed aft around the topside of the crankcase. The two-bladed propeller was lying on the floor adjacent to the engine. Both blades remained attached to the hub, both were twisted toward low pitch, and both displayed a polished erosion of the paint from the tips. One of the blades also displayed s-bending signatures. The threaded areas of the hub where the propeller bolts are normally positioned displayed distortion and elongation signatures. The propeller mounting dowels were also displaced.
