Continental Motors, Inc.

ENGINE FIELD INSPECTION REPORT

ENGINE MODEL: IO-550-N (16)

REGISTRATION: N137MP

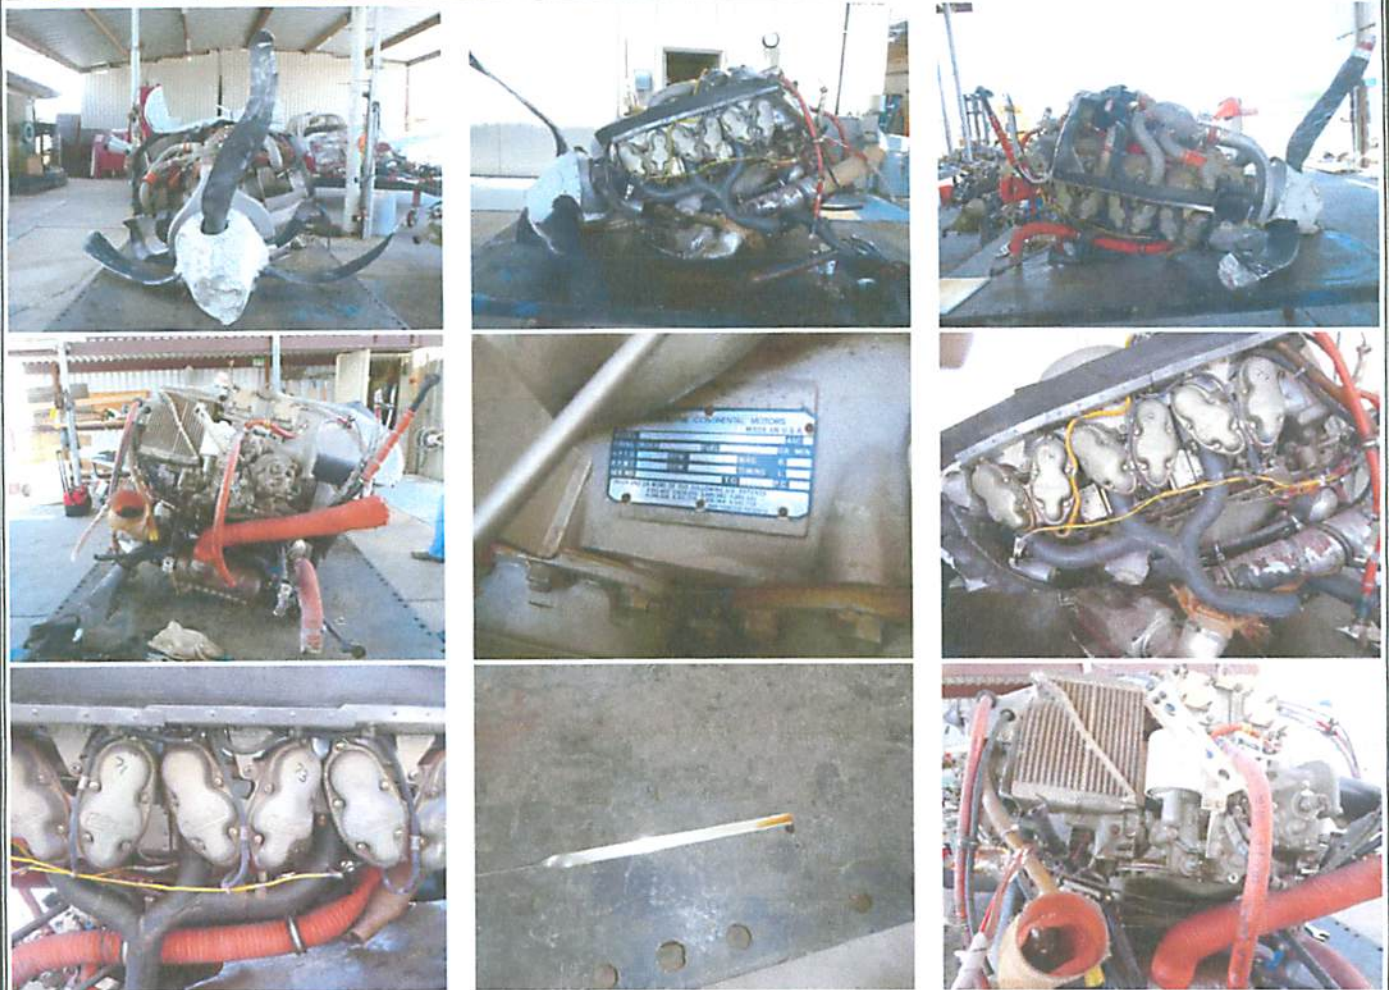
The engine broke free from its mounts during the impact sequence. The engine was placed on an examination table at the salvage yard. The propeller hub remained attached to the engine crankshaft, and the three propeller blades remained attached to the propeller hub. All three propeller blades displayed significant s-bending and heavy leading edge gouging. The outboard tip of two blades was torn off and all three blades were loose in the hub (broken free from their pitch change links).

The engine's oil sump was punctured from the outside in and oil had leaked out over the intake shroud. Removal of the engine oil dipstick revealed that some residual oil remained in the sump. The oil was coffee colored and appeared clear. The propeller governor remained intact and attached to the engine. The oil cooler sustained impact-related deformation and its mount was broken, but it remained in place. The magnetos remained in place and secured to the engine. The throttle, mixture, and propeller control cables remained secured to their respective engine controls, though they had been separated (post-accident) from the cockpit controls at the firewall junction. Examination of the top and sides of the engine did not reveal any evidence of pre-impact fuel or oil leaks.

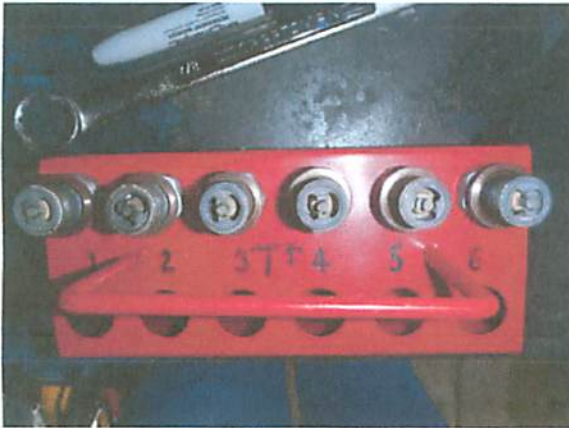
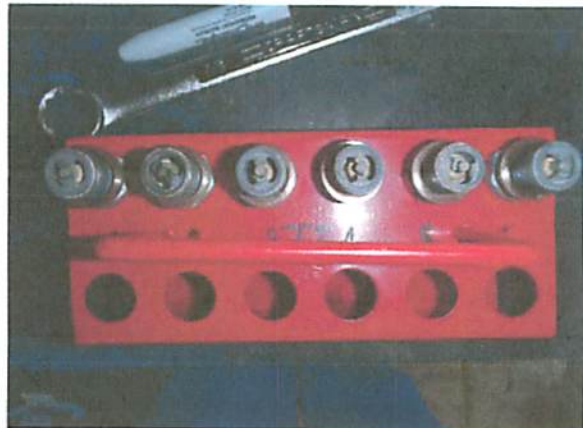
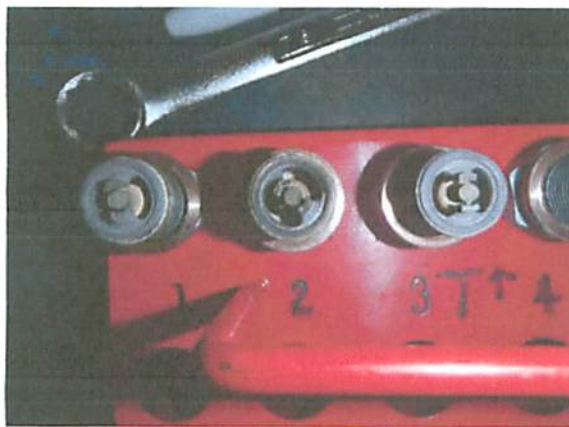
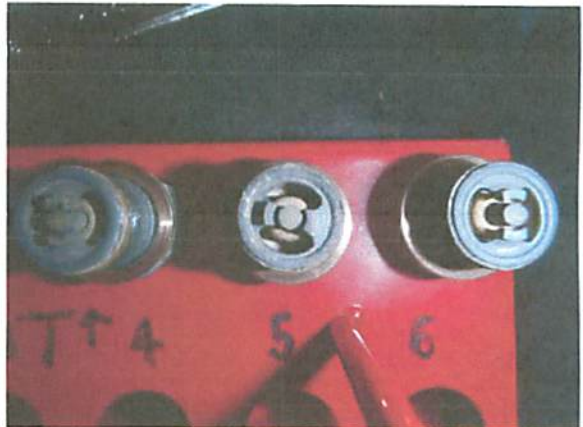
Spark Plugs Manufacturer: Part number:

Condition: All six spark plugs displayed normal wear conditions when compared to the Champion AV6-R Aviation Service Manual. The #2 top spark plug was lightly coated with black soot. None of the electrodes appeared to be fouled or compromised.

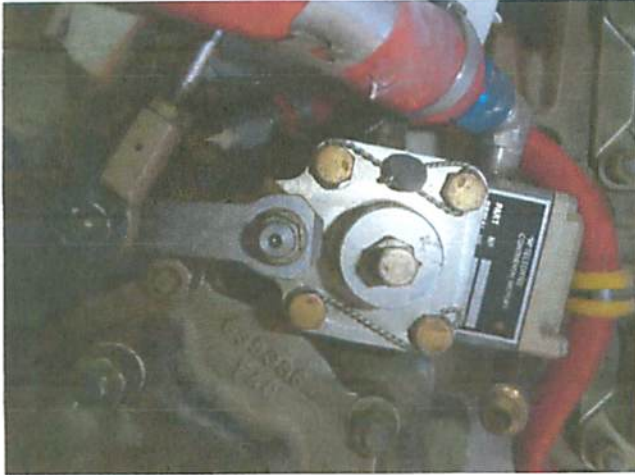
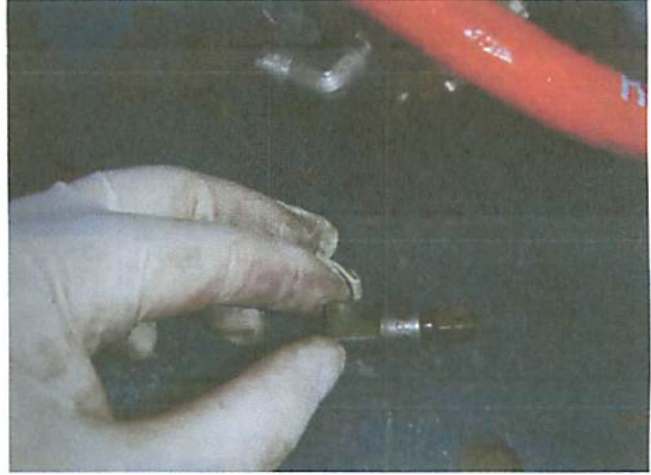
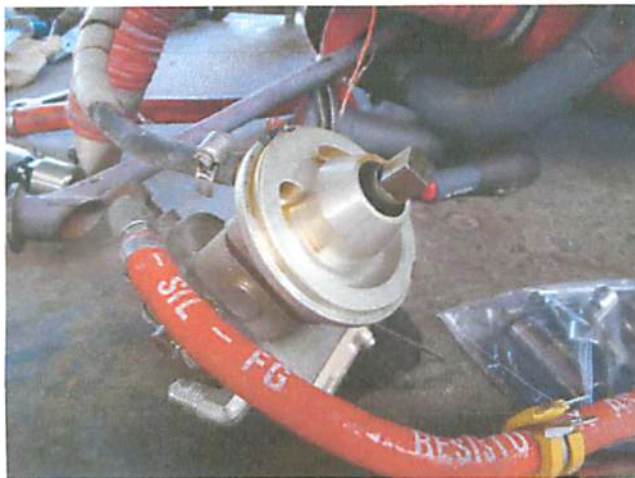
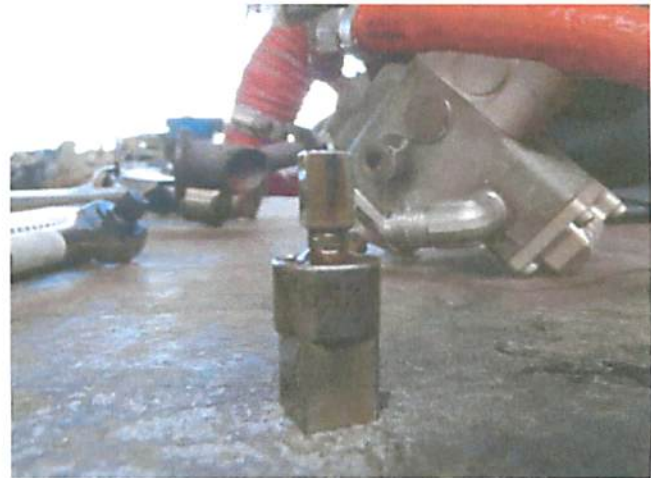
Fuel Pump Manufacturer: TCM Part Number: 655921-1A5 Serial #: B03HA142

Condition: The fuel pump was removed from its mounting pad on the backside of the engine crankcase. Upon removal, fuel poured from the lines. The fuel pump's drive coupling was intact and in place. Installation of the drive coupling into the drive shaft and manual rotation revealed no evidence of drive shaft binding.

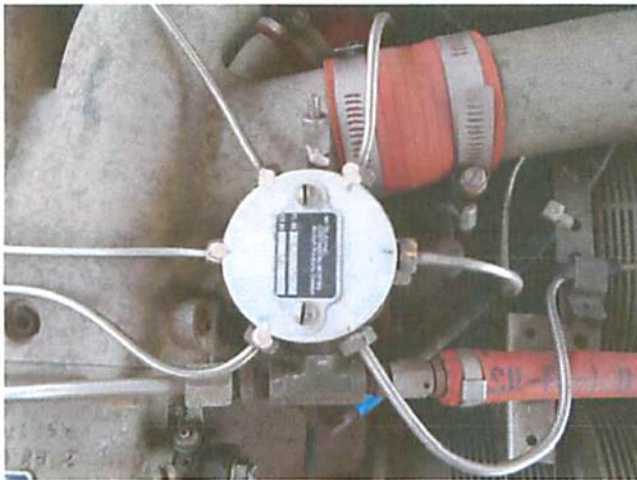
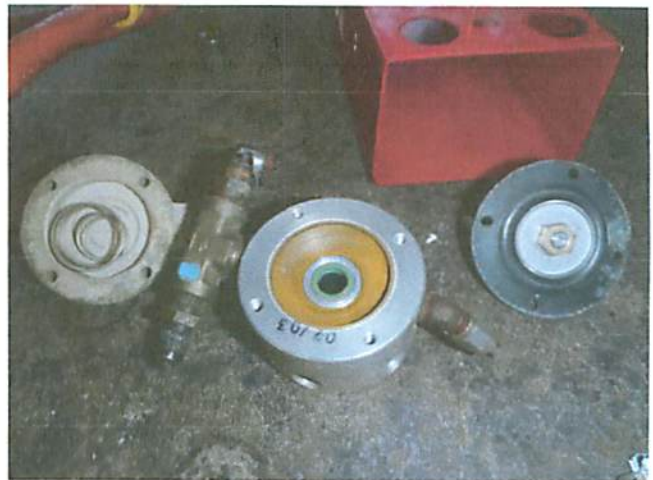
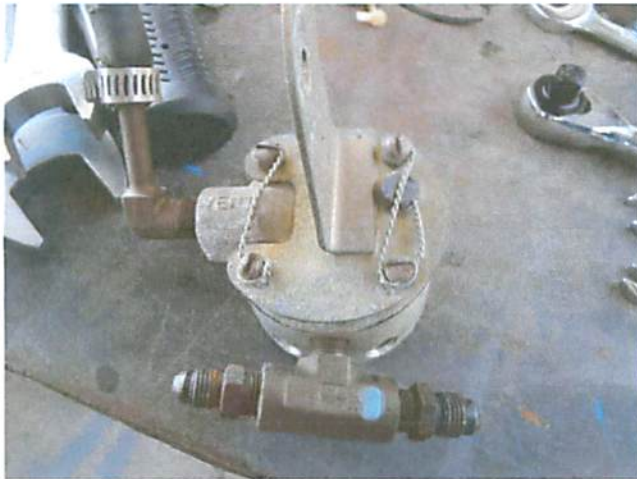
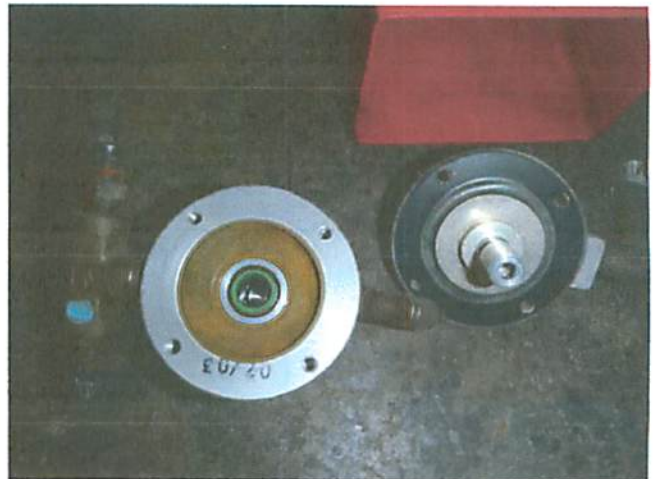
Fuel Manifold Valve Manufacturer: TCM Part Number: Not Legible Serial #: Not Legible

Condition: The fuel manifold remained attached to its mount on the topside of the engine. All but two of the fuel injector line nuts retained their original torque putty seals. The injector lines were removed as was the inlet line. Fuel poured from the inlet line upon its removal. Disassembly of the fuel manifold valve revealed that the screen was clean and free from debris and fuel was present in the valve. The plunger was in place and intact as was the gasket. Visual inspection of the gasket did not reveal any anomalies.

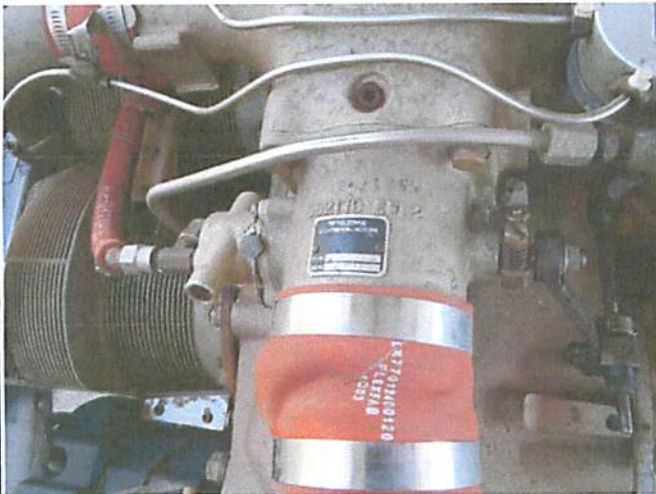
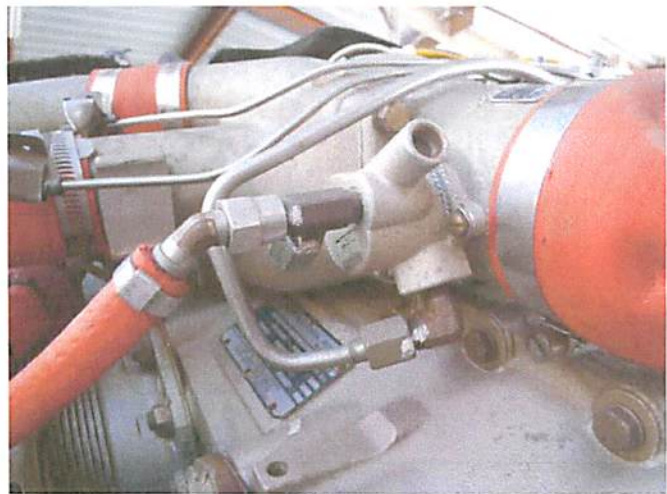
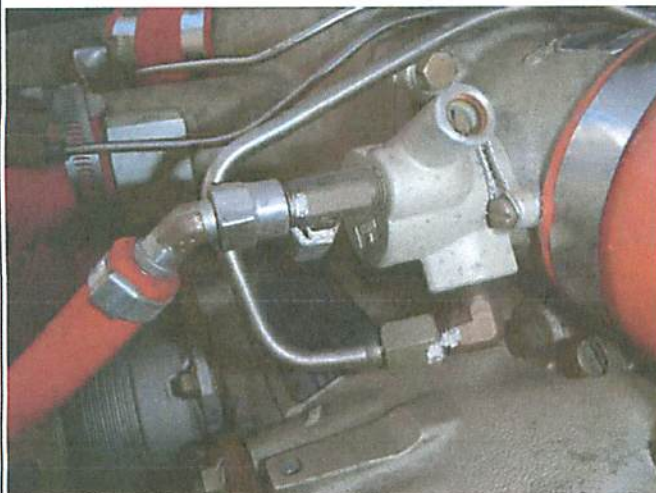
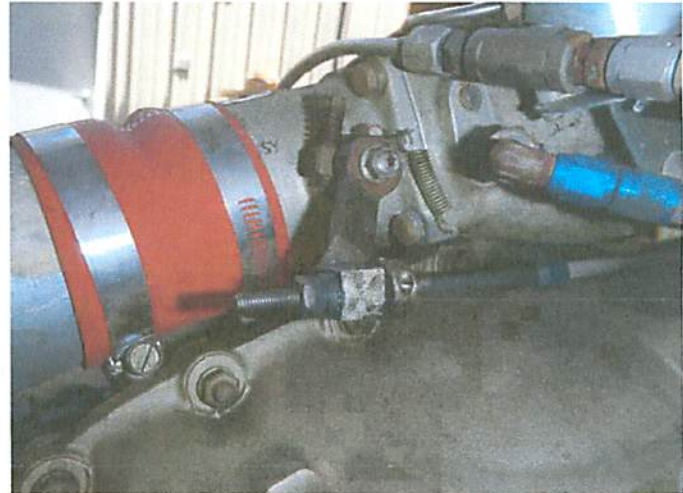
Throttle Body / Metering Unit Manufacturer: TCM Part Number: 653353-5A1 Serial #: A03HA144

Condition: The fuel injector lines and nozzles were in place and intact. None of the lines appeared to be damaged. The base of the fuel injector nozzle screens (beneath their shrouds) appeared to be clear. There were no signs of pre-impact leakage. The fuel nozzles were not removed from their respective cylinders.

Condition: The throttle body/metering unit remained intact and attached to the topside of the engine. The attachment screws were safety wired in place. The fuel inlet and outlet lines from the metering unit remained intact and attached. There were no visible signs of fuel leakage prior to the accident.

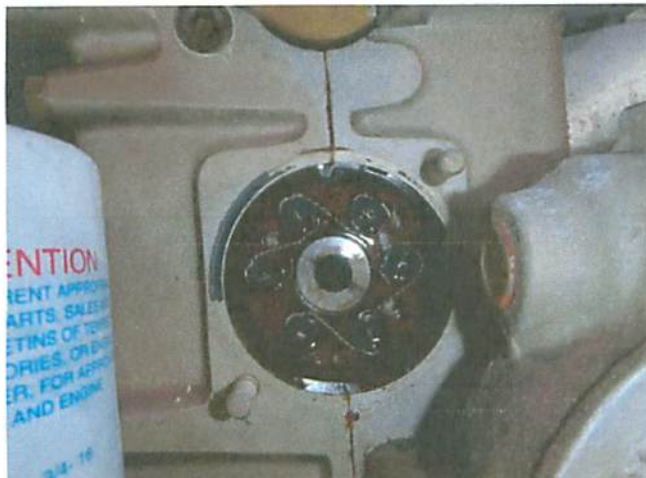
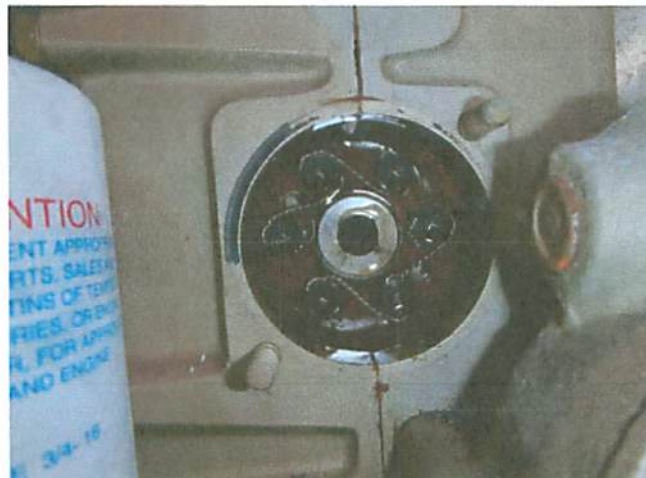
Crankshaft Forging number: Serial number: Heat code:

Condition: The only portion of the crankshaft that was visually observed was the crankshaft gear when the fuel pump was removed from its mounting pad. The crankshaft gear was intact, in place, and safety wired. There were no signs of operational distress and the crankshaft gear was observed to rotate with manual rotation of the propeller.

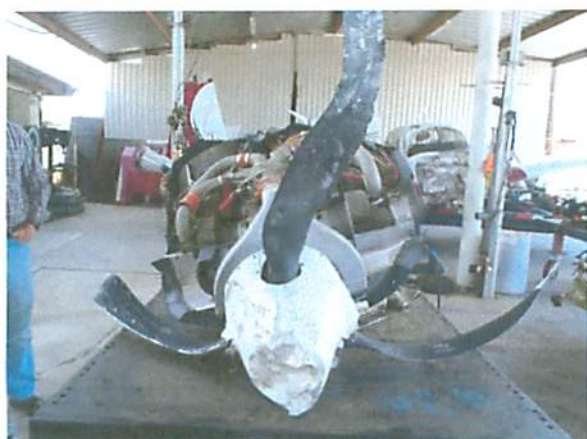
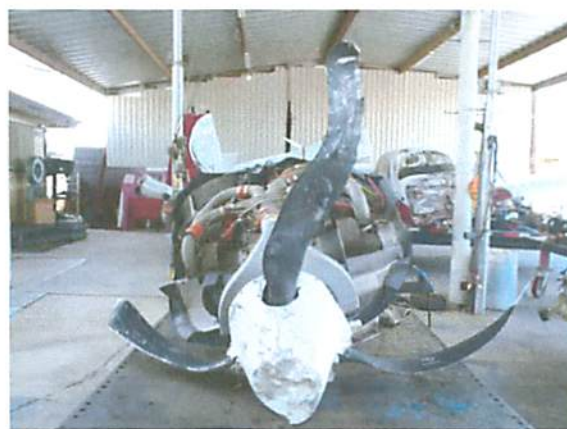
Propeller: MFG/Model: McCauley
3A32C418-1C

Condition: The propeller hub remained attached to the engine crankshaft, and the three propeller blades remained attached to the propeller hub. All three propeller blades displayed significant s-bending and heavy leading edge gouging. The outboard tip of two blades was torn off and all three blades were loose in the hub (broken free from their pitch change links).
