Continental Motors

ENGINE OPERATIONAL TEST

REPORT

DATE	December 02, 2014
REGISTRATION #	N147MP
ENGINE MODEL	IO-550-N16B
ENGINE SERIAL	687928
INSPECTOR	Phillip Grice
SEARCH CODE	15-12-68

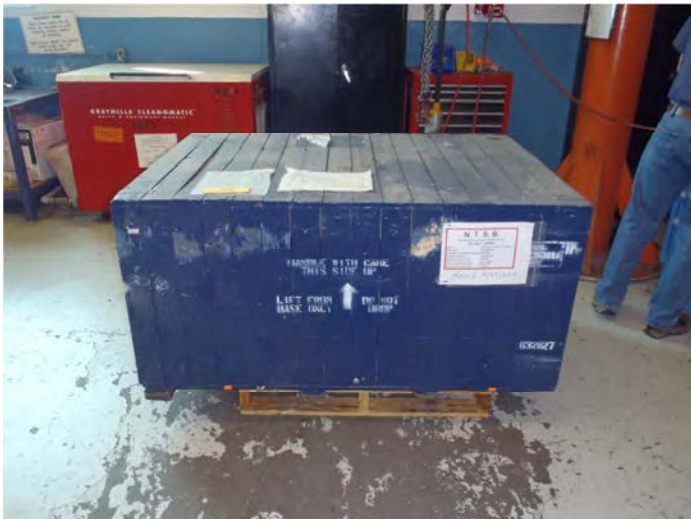
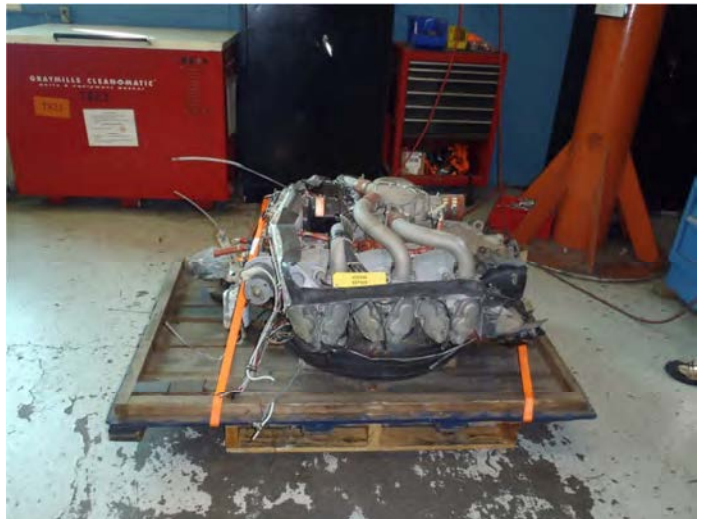
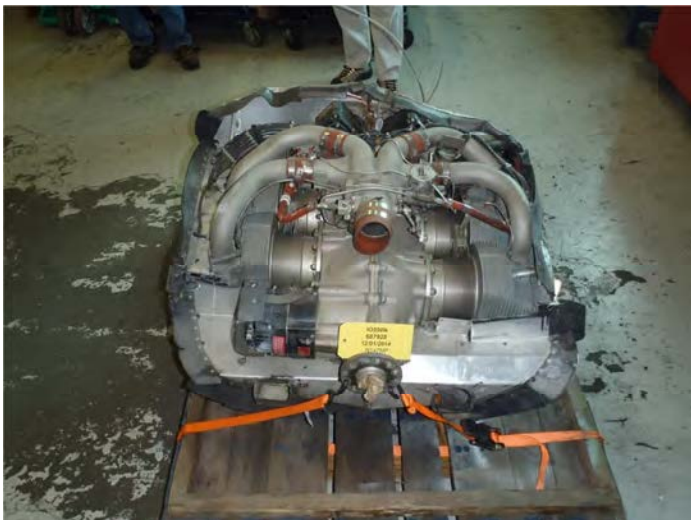
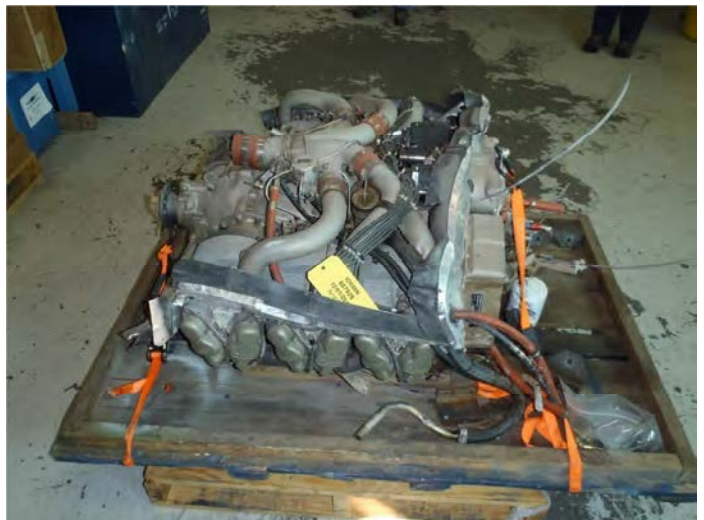
The engine exhibited impact damage concentrated at the bottom of the engine. The oil sump was crushed and breached, the oil filter had broken free from the oil filter adapter, three of the four engine mounts were broken, the exhaust was bent and crushed, the #2 intake push rod housing was bent, and the oil cooler was dented.

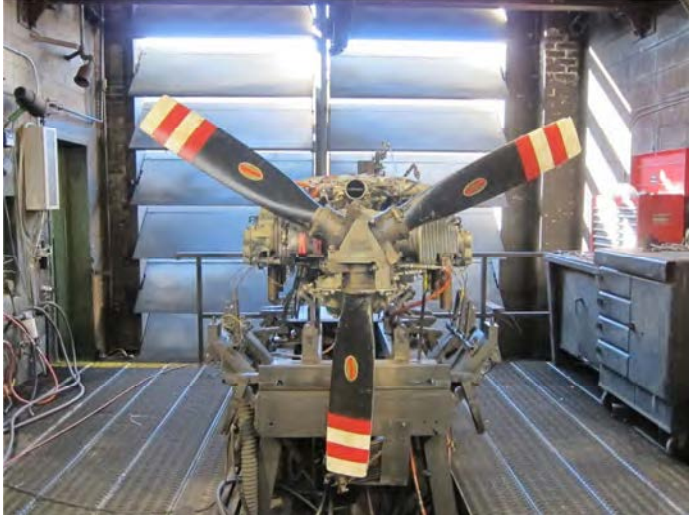
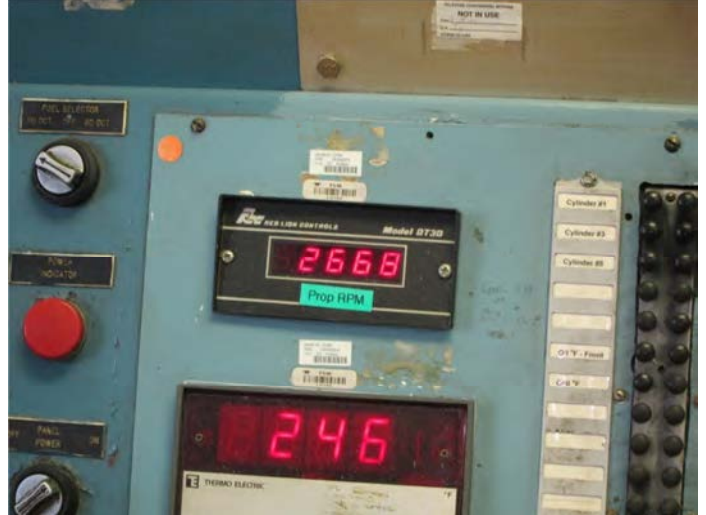
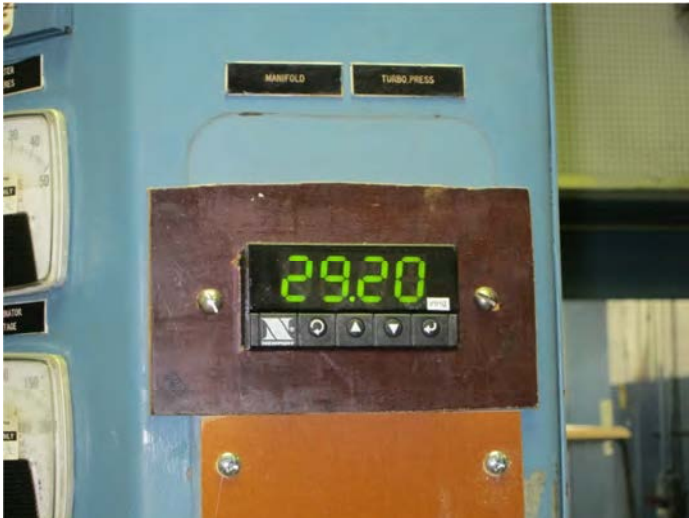
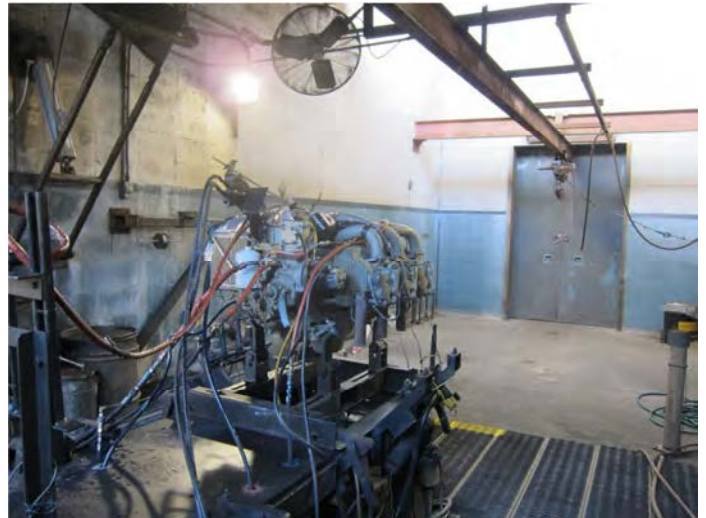
The operation of this engine was normal and did not reveal any abnormalities that would have prevented normal operation and production of rated horsepower.
