Continental Motors

ENGINE FIELD INSPECTION REPORT

ENGINE MODEL	TSIO-520-B12B
ENGINE SERIAL NUMBER	176760-R
AIRCRAFT MAKE & MODEL	Cessna T310Q
AIRCRAFT SERIAL NUMBER	T310Q-0611
AIRCRAFT REGISTRATION	N310JA
FILE NUMBER	15-199

EXAMINATION		ACCIDENT DATA	
DATE	09/27 and 28/2015	NTSB ACCIDENT #	CEN15FA425
FACILITY	Accident Site	NTSB INVESTIGATOR	Courtney Leidler
ADDRESS	410 S. Wetmore Wichita, KS 67209	FAA INVESTIGATOR	Bobby Warren
		ACCIDENT DATE	09/25/2015
		ACCIDENT LOCATION	Wichita, Kansas

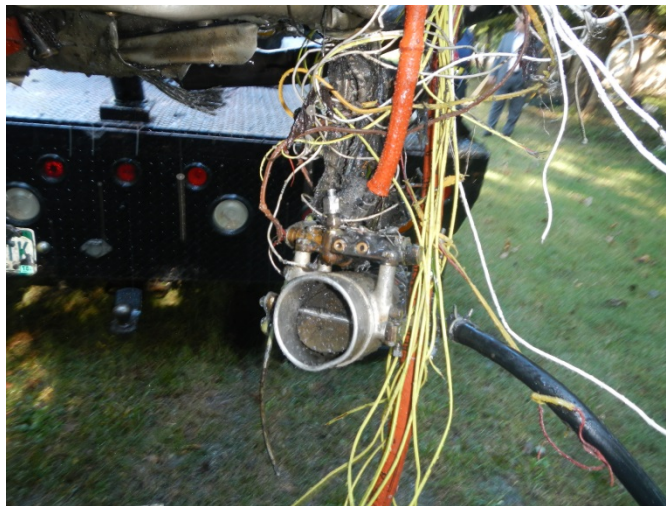
INDUCTION SYSTEM

The intake risers were fractured and separated from their respective cylinders. Portions of the intake system were found in the wreckage. The throttle body remained attached to the engine via a fuel line. A majority of the induction system was not observed during the wreckage examination.

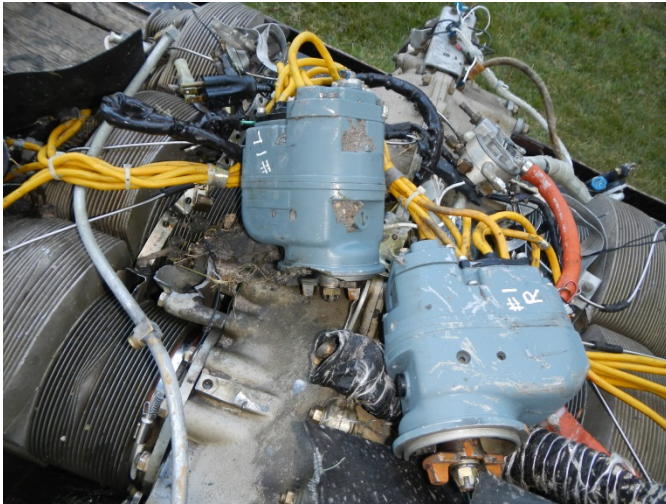
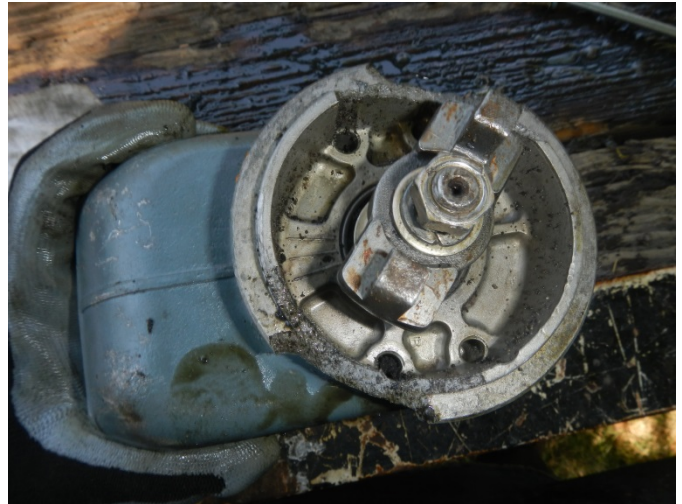
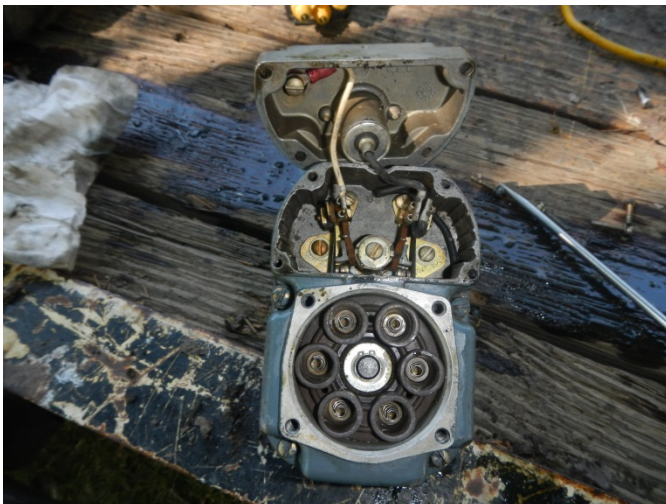
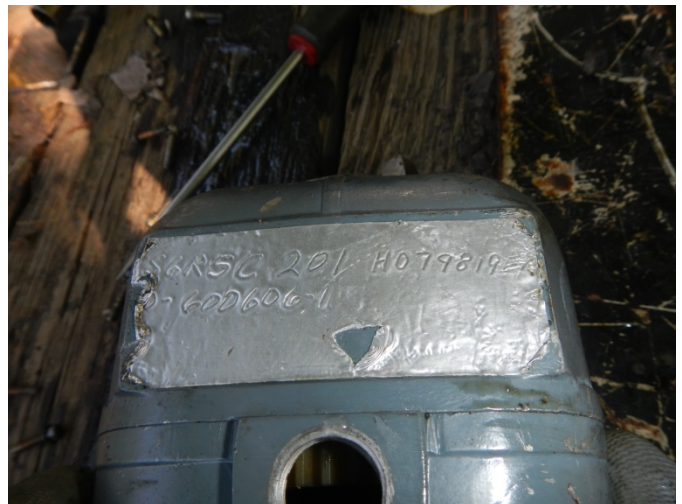
**LEFT
MAGNETO**

Condition: The left magneto was separated from its mounting pad but remained attached to the engine via the ignition harness. The mounting flange was fractured in an area that coincided with the attach washers. The drive shaft was manually rotated with no binding noted. The distributor gear shaft rotated with manual rotation of the drive shaft; however, no spark was noted as there was no impulse coupling for either magneto. The housing plug was removed and water/mud was drained from the magneto. The point/capacitor cover was removed and the magneto was permitted to dry for an hour. The point/capacitor cover was reinstalled and the drive shaft was rotated using a hand drill. Spark was observed emitting from the left magneto's distributor block. No internal, pre-accident anomalies, besides water emersion and mud contamination, were observed with the magneto.

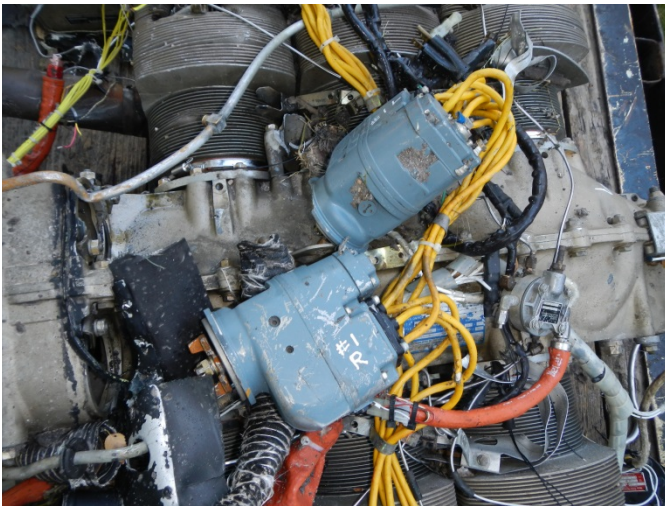
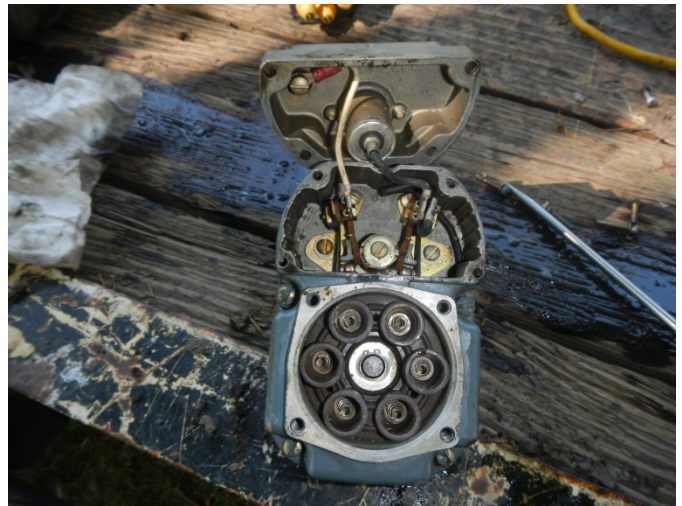
**RIGHT
MAGNETO**

The right magneto was separated from its mounting pad but remained attached to the engine via the ignition harness. The mounting flange was fractured in an area that coincided with the attach washers. The drive shaft was manually rotated with no binding noted. The distributor gear shaft rotated with manual rotation of the drive shaft; however, no spark was noted as there was no impulse coupling for either magneto. The housing plug was removed and water/mud was drained from the magneto. The point/capacitor cover was removed and the magneto was permitted to dry for an hour. The point/capacitor cover was reinstalled and the drive shaft was rotated using a hand drill. No spark was observed from the right magneto's distributor block; however, a significant amount of water and mud contamination remained. No internal, pre-accident anomalies, besides water emersion and mud contamination, were observed with the magneto.

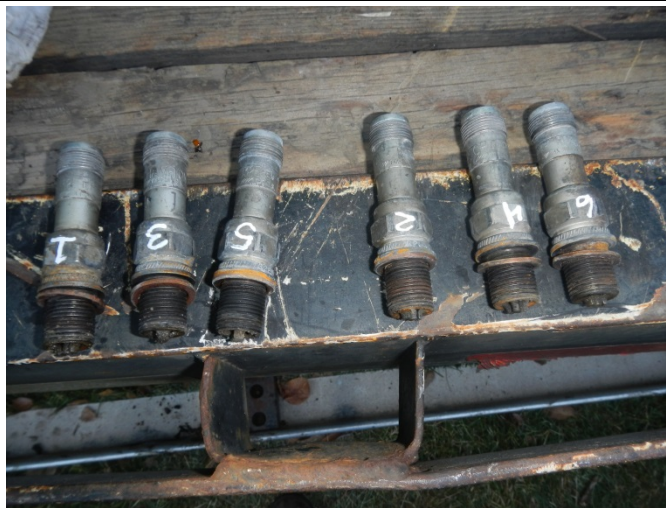
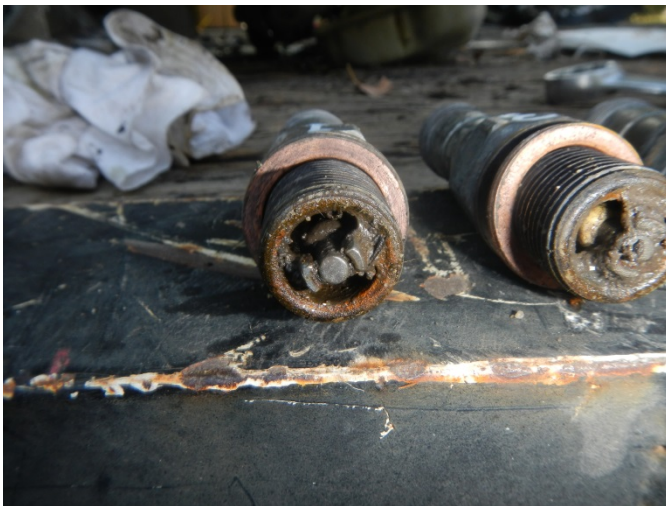
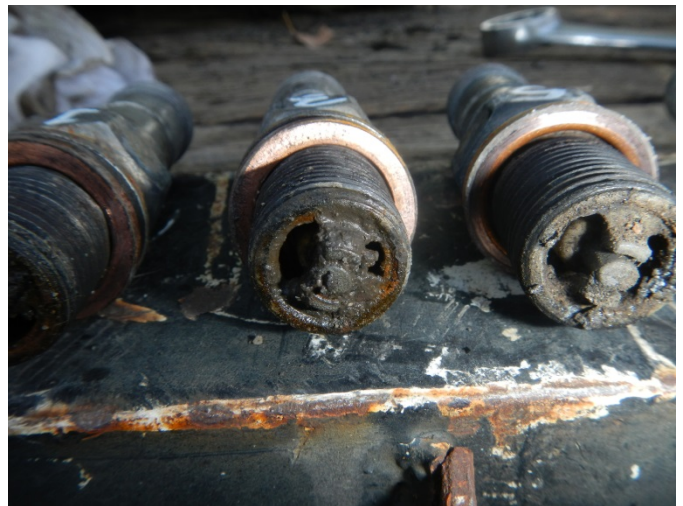
IGNITION HARNESS	Manufacturer: CMI	P/N: Unknown	S/N: Unknown
Condition:	The ignition harness remained attached to the magnetos, but a number of the leads were damaged. All of the terminal ends remained attached to their respective sparkplugs.		
SPARK PLUGS	Manufacturer: Champion	P/N: RHB32E	
Condition:	The top sparkplugs were covered with mud, water, and oil. All electrodes displayed a normal worn condition when compared to the Champion Aviation Service Manual (AV6-R).

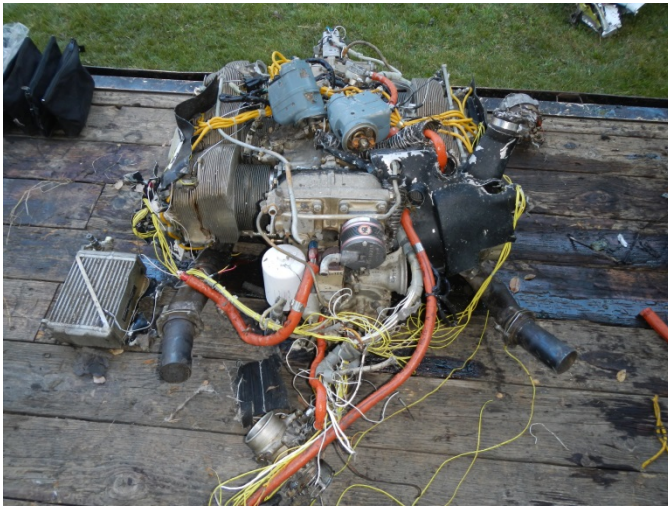
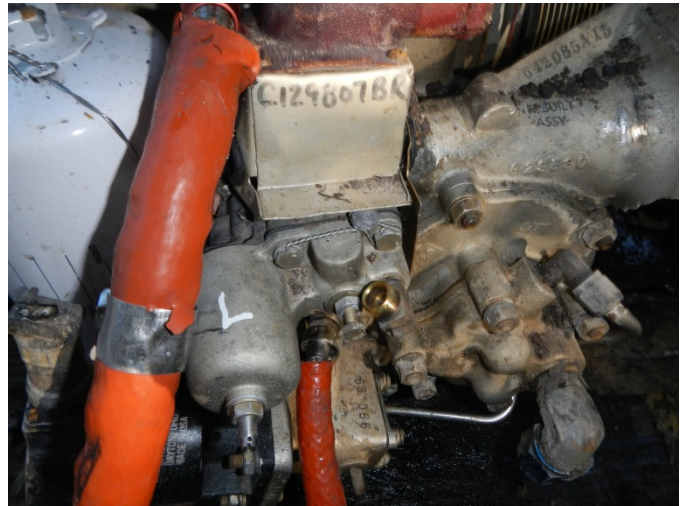
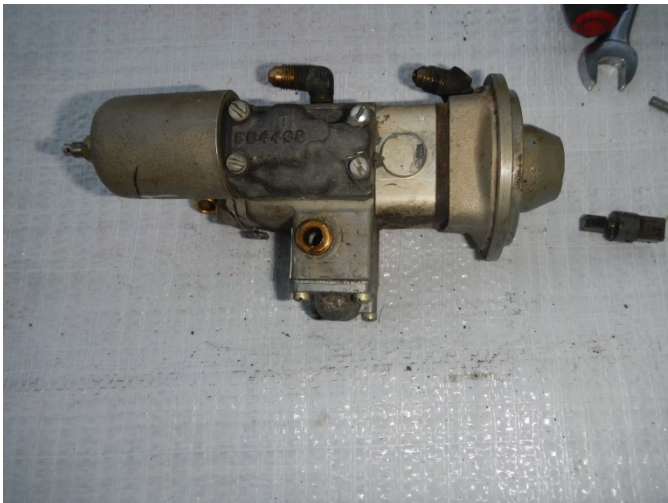
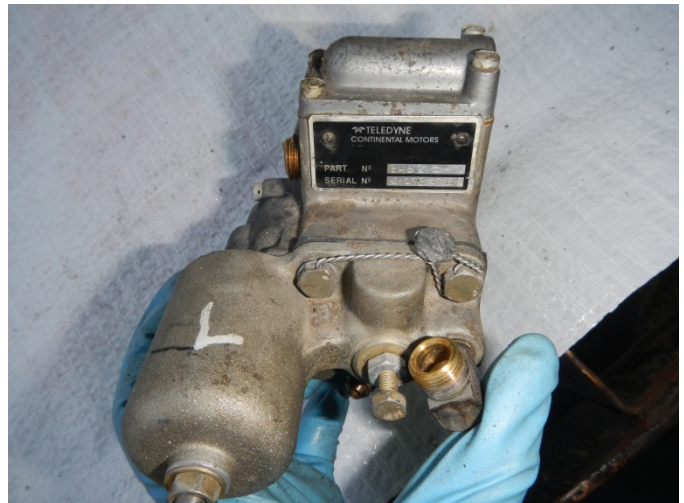
FUEL PUMP

The engine-driven fuel pump was attached to the backside of the engine. The fuel line from the pump to the metering unit was attached and intact. Removal of the fuel line resulted in fuel, water, and mud pouring from the fittings. The engine-driven fuel pump was removed from the backside of the engine and fuel poured from the housing fittings. The drive coupling was intact and rotation of the drive coupling while installed in the driveshaft resulted in rotation of the driveshaft with a gritty feel to the rotation, but no binding noted. The fuel pump was disassembled and no pre-accident anomalies were noted with any of the internal components.

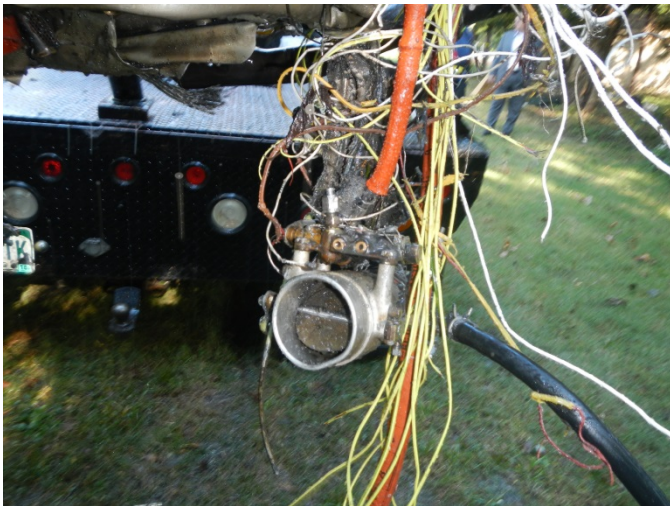
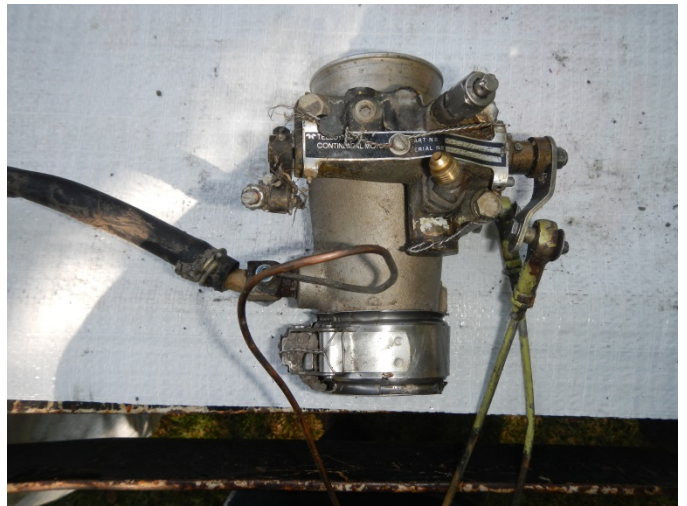
THROTTLE BODY METERING UNIT	Manufacturer: CMI	P/N: 632916-8	S/N: H129818AR
	<p>Condition: The throttle body/fuel metering unit remained attached to the engine via the fuel line between the fuel pump and the metering unit. The throttle and mixture cables remained attached to the throttle body and metering unit levers, which remained attached to their respective shafts. Rotation of the levers resulted in a coinciding rotation of the shafts with no binding noted. The metering unit fuel inlet filter was removed and no obstructions or blockage was noted, but mud and dirty water was observed. The metering unit was disassembled and besides water and dirt contamination, no pre-accident anomalies were noted with the internal components.</p>

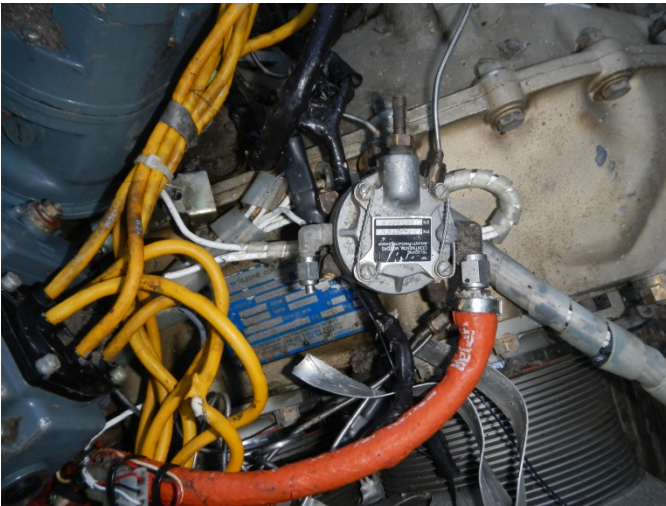
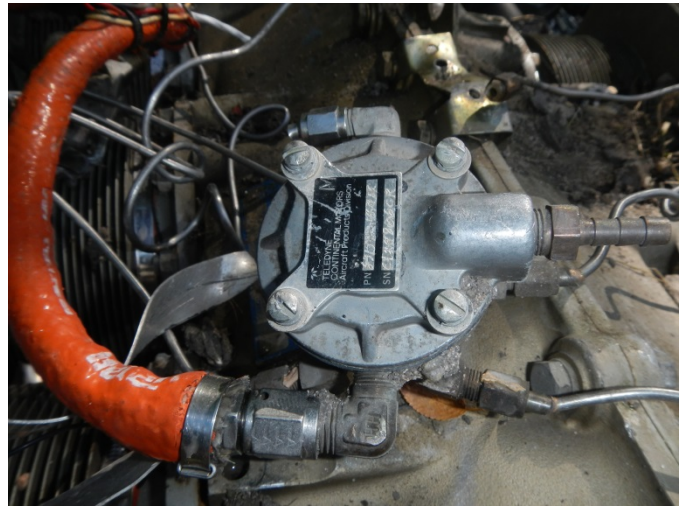
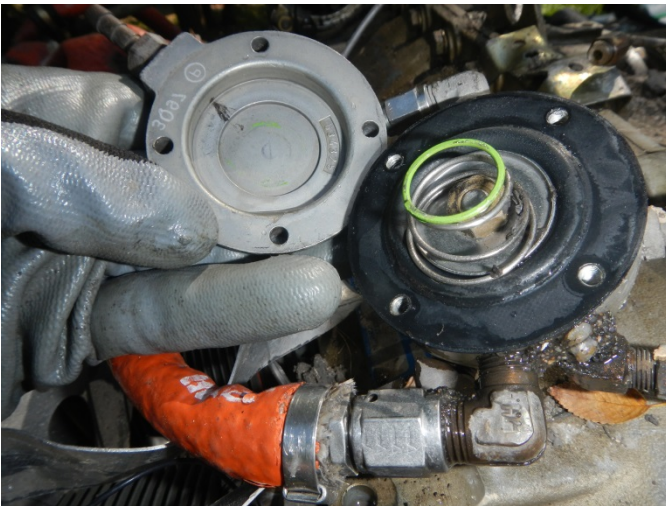
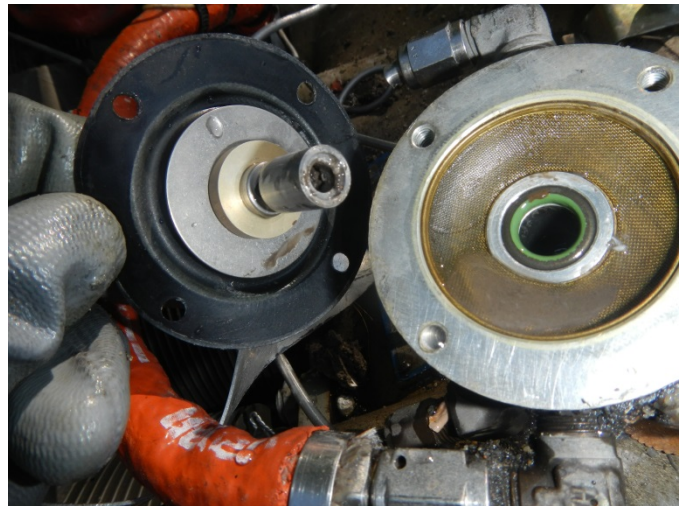
FUEL MANIFOLD VALVE

The fuel manifold valve remained attached to the topside of the engine; however, some of the fuel injection lines were fractured and it was separated from its mount. The cap was secured to the body with safety-wire. The fuel manifold valve was disassembled and aviation gasoline, mud and water were noted in the manifold. No pre-accident anomalies were noted with the diaphragm, plunger, spring, or screen.

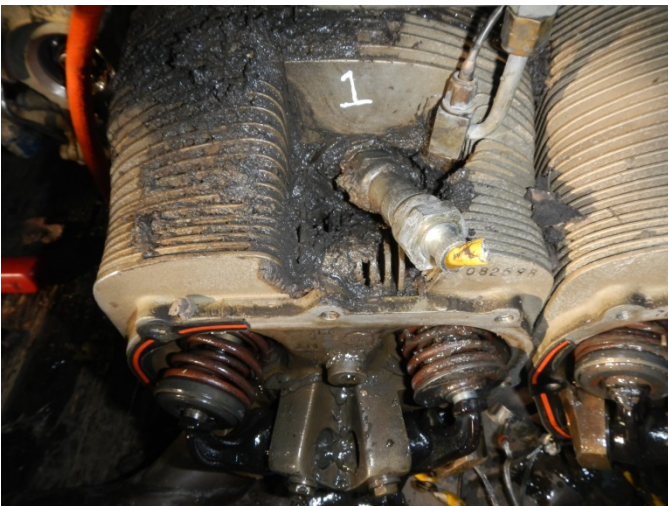
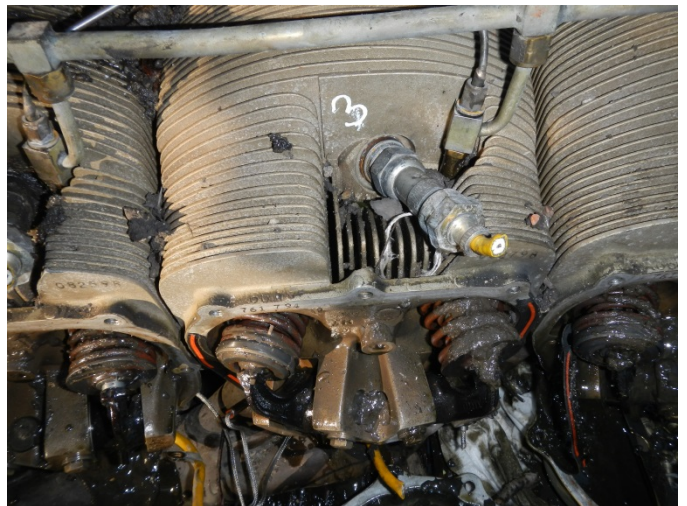
FUEL NOZZLES AND LINES

The upper deck reference (UDR) lines remained attached to the fuel injector nozzles with the exception of the #2 nozzle. The #2 nozzle was bent and its UDR shroud remained in place, but the UDR manifold line was separated. The fuel lines remained secured to their respective nozzles.

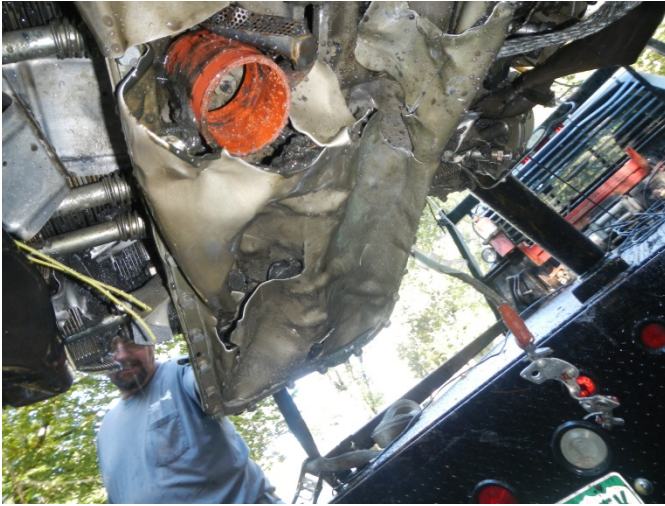
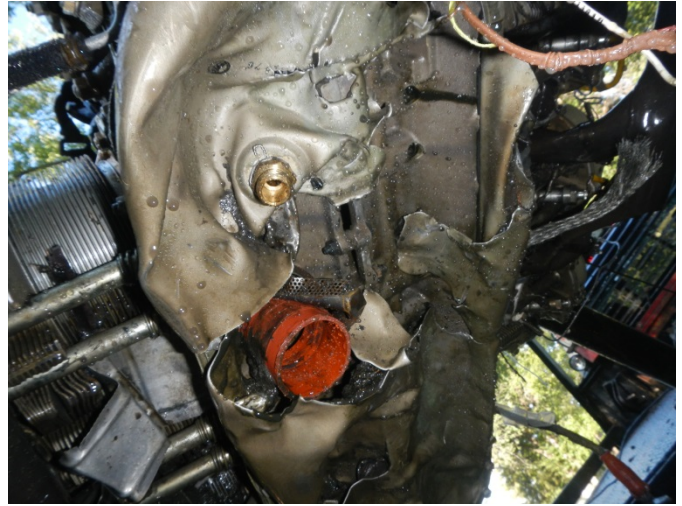
OIL SUMP

Condition: The oil sump was crushed upward toward the bottom side of the engine and sections were torn permitting a view of the oil pickup tube/screen. No pre-accident anomalies were noted with the observed portions of the oil sump.

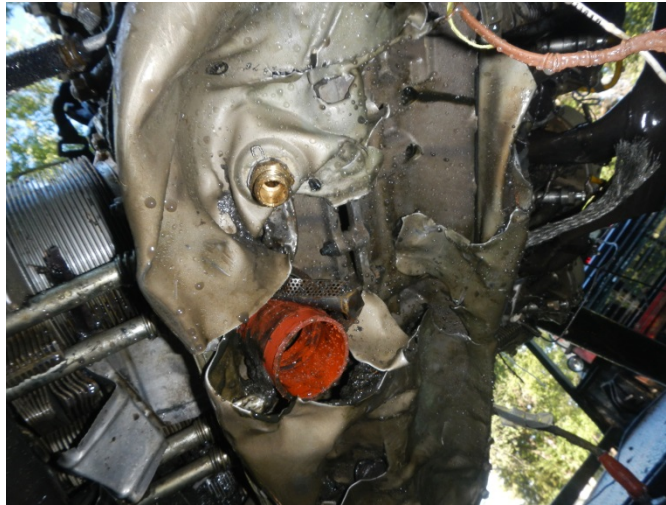
OIL PICKUP TUBE & SCREEN

Condition: The oil pickup tube/screen was visible through the fractured oil sump. No pre-accident anomalies were noted.

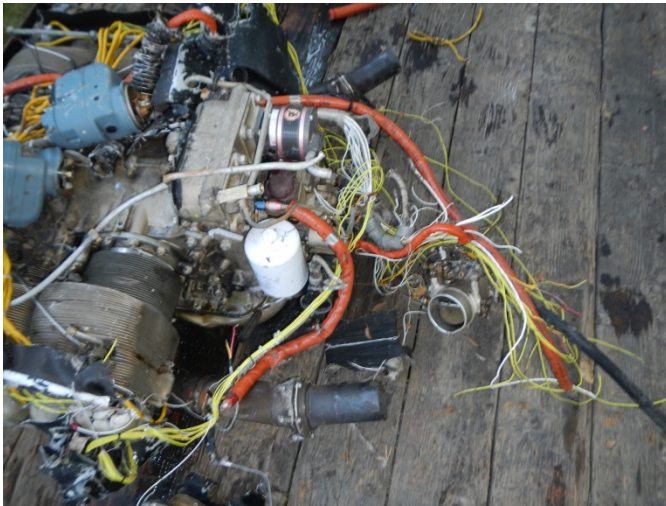
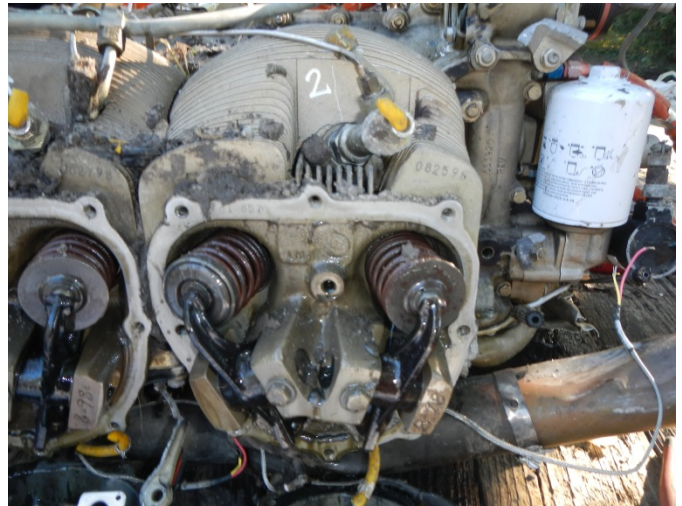
OIL FILTER

The oil filter remained secured and safety-wired to the engine. There were no signs of pre-accident anomalies with the oil filter.

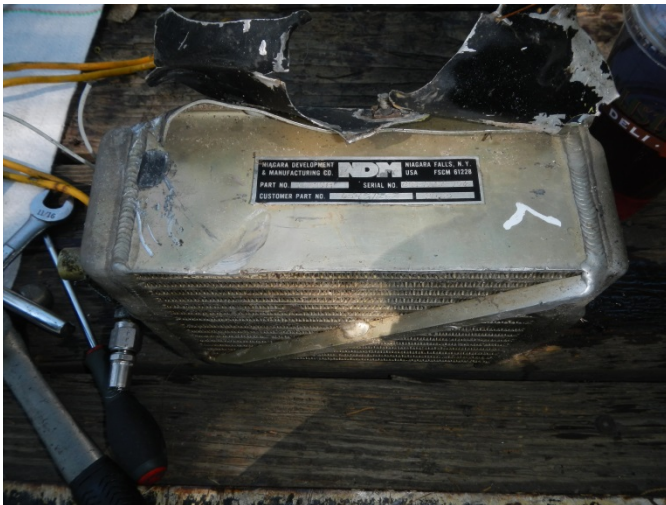
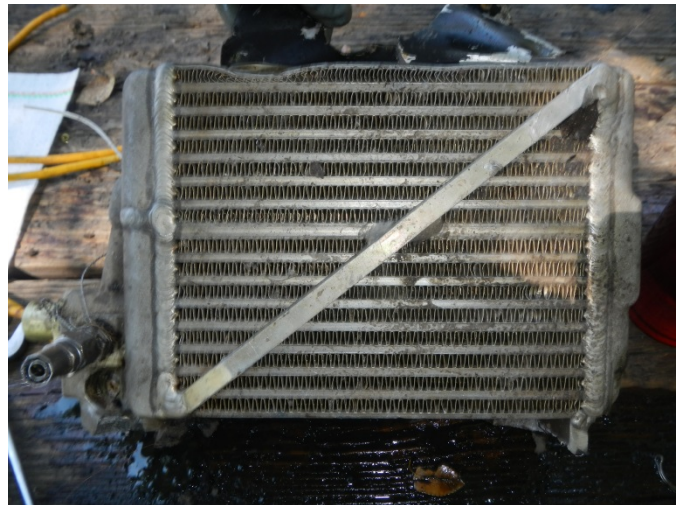
OIL COOLER

The oil cooler was separated from its mounting pad on the engine, but remained attached via two electrical wires. Besides impact-related damage, no pre-accident anomalies were noted with the oil cooler and residual oil flowed from the unit.

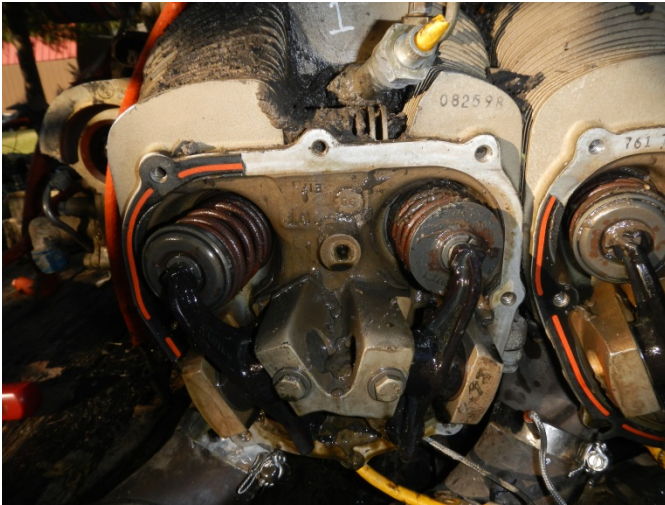
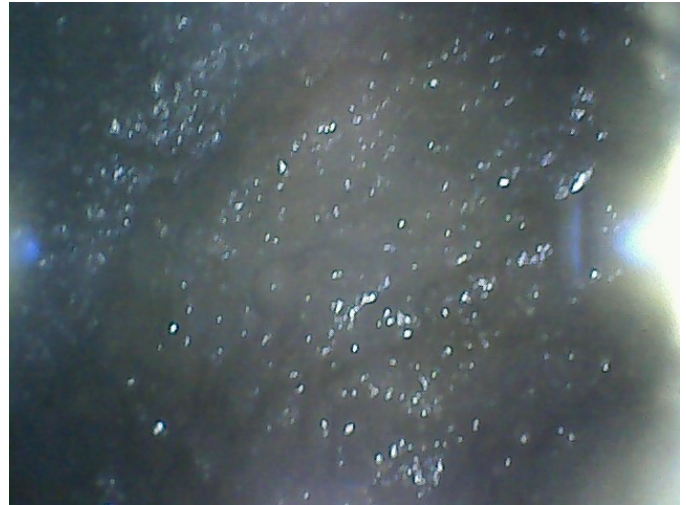
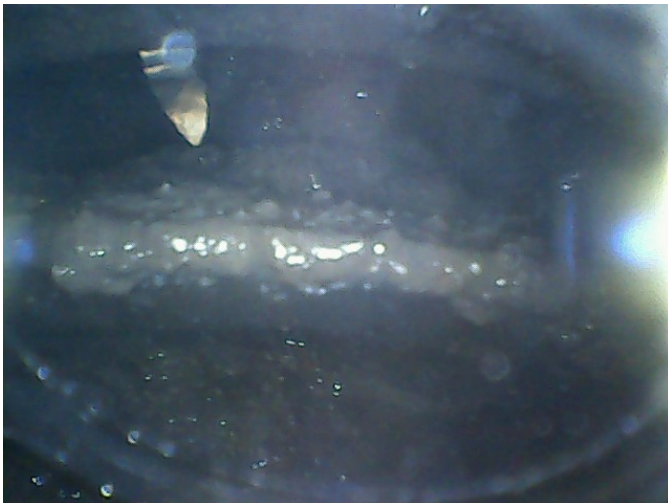
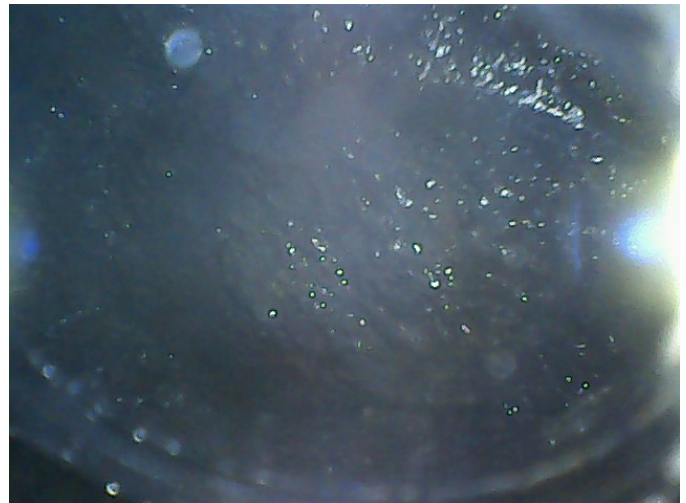
CYLINDER #1	P/N: 658552A1	S/N: Unknown	Head Date: 8-98
Condition:	The cylinder remained attached to the engine and torque putty from the last overhaul was evident on the cylinder flange hardware. No pre-accident anomalies were noted externally. The top sparkplug was removed from the engine and the cylinder was inspected using a lighted borescope. Mud and water were observed in the cylinder. The crankshaft was rotated and the rockers, valves, and valve springs functioned properly and piston movement was observed. No pre-accident anomalies were noted with the cylinder components.

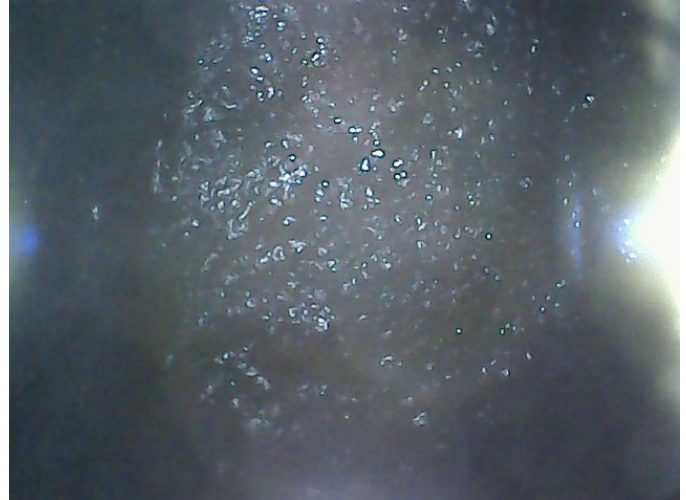
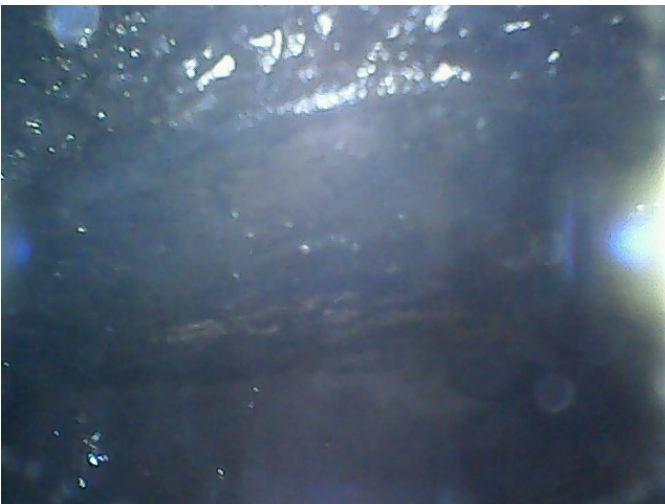
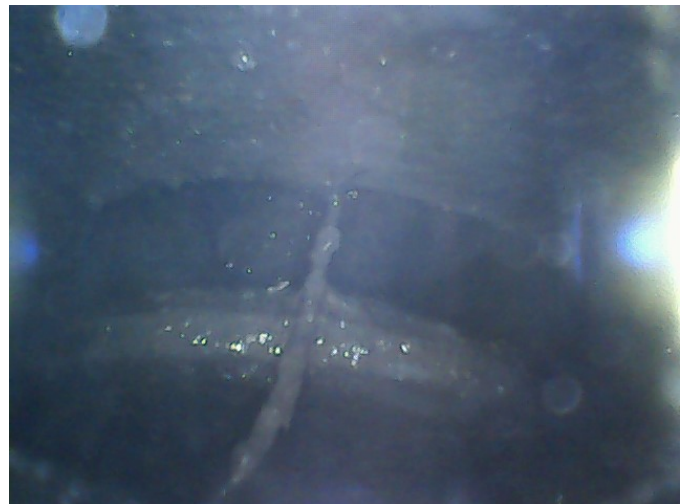
CYLINDER #3

The cylinder remained attached to the engine and torque putty from the last overhaul was evident on the cylinder flange hardware. No pre-accident anomalies were noted externally. The top sparkplug was removed from the engine and the cylinder was inspected using a lighted borescope. Mud and water were observed in the cylinder. The crankshaft was rotated and the rockers, valves, and valve springs functioned properly and piston movement was observed. No pre-accident anomalies were noted with the cylinder components.

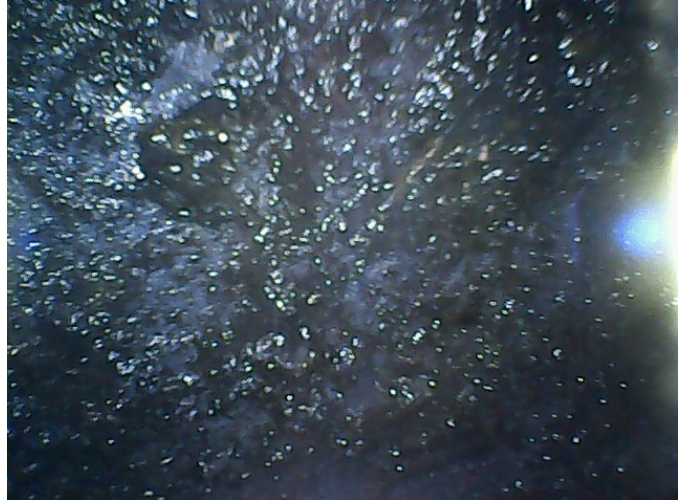
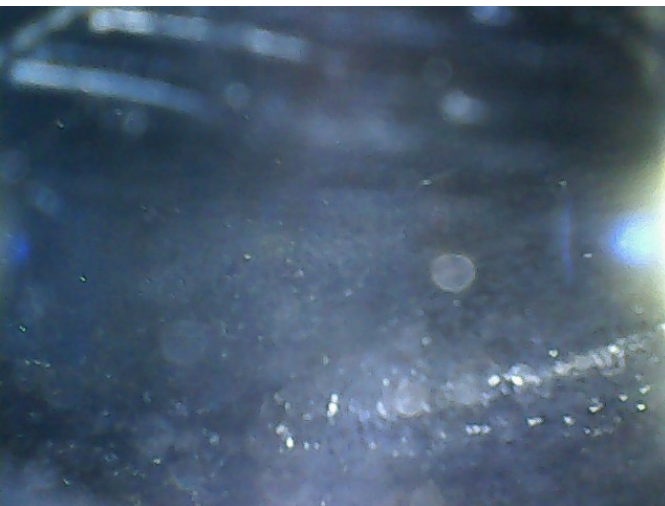
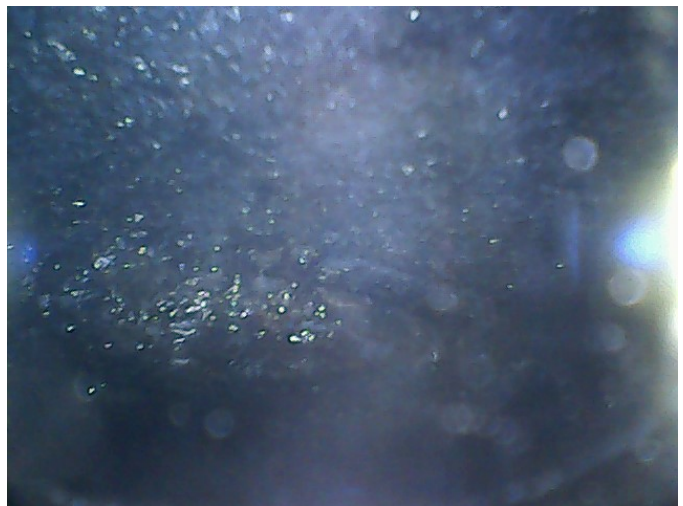
CYLINDER #5

The cylinder remained attached to the engine and torque putty from the last overhaul was evident on the cylinder flange hardware. No pre-accident anomalies were noted externally. The top sparkplug was removed from the engine and the cylinder was inspected using a lighted borescope. Mud and water were observed in the cylinder. The crankshaft was rotated and the rockers, valves, and valve springs functioned properly and piston movement was observed. No pre-accident anomalies were noted with the cylinder components.

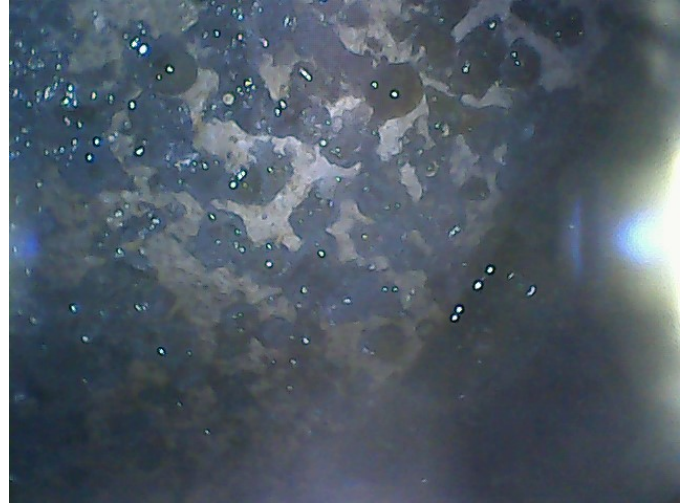
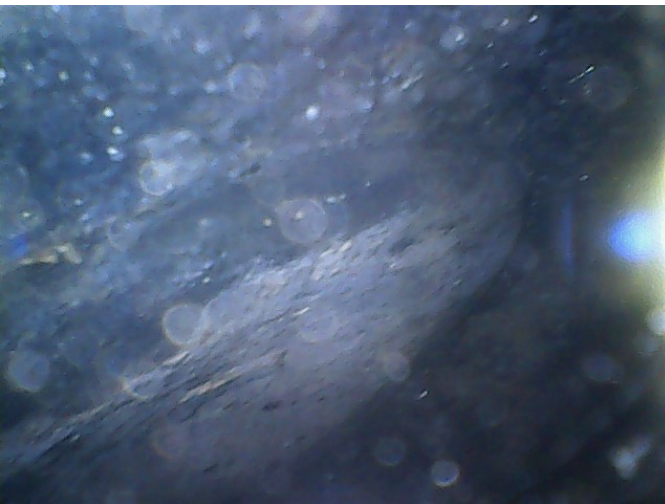
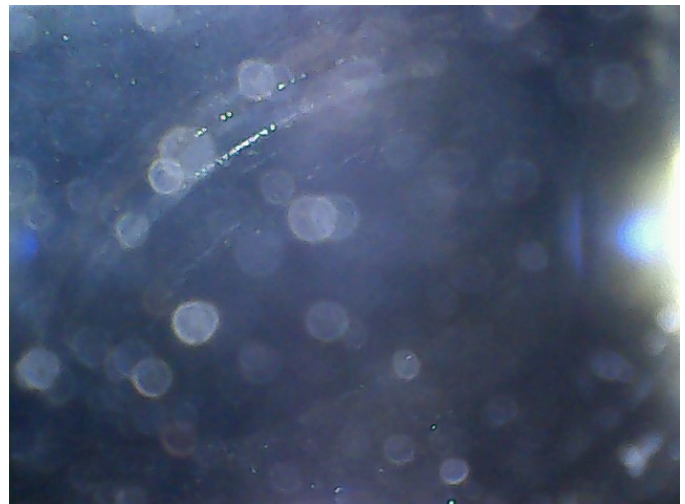
CYLINDER #2

The cylinder remained attached to the engine and torque putty from the last overhaul was evident on the cylinder flange hardware. No pre-accident anomalies were noted externally. The top sparkplug was removed from the engine and the cylinder was inspected using a lighted borescope. Mud and water were observed in the cylinder. The crankshaft was rotated and the rockers, valves, and valve springs functioned properly and piston movement was observed. No pre-accident anomalies were noted with the cylinder components.

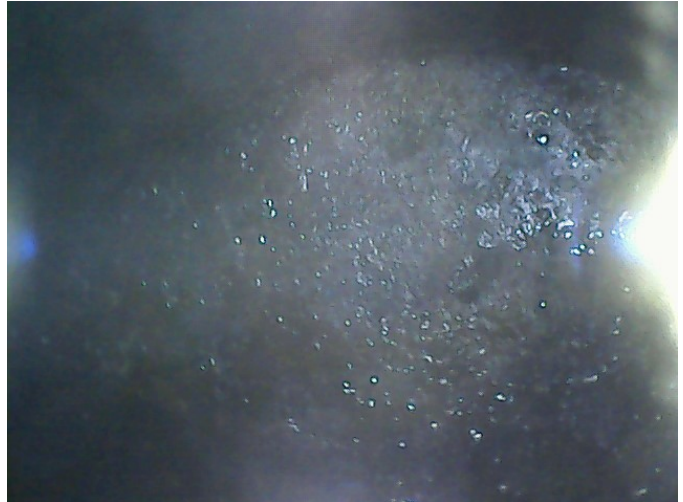
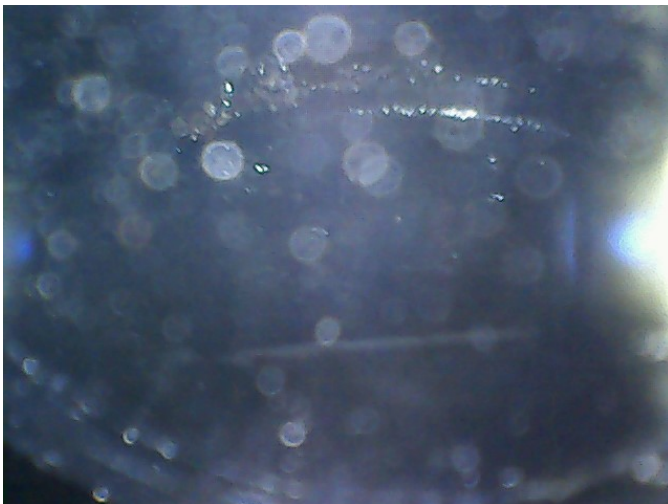
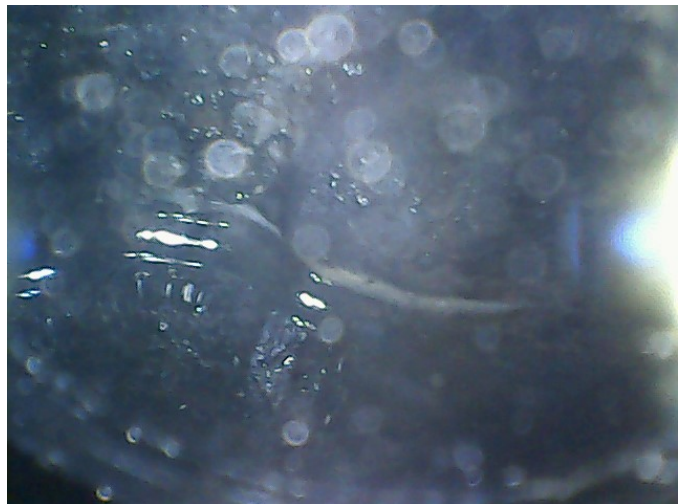
CYLINDER #4

The cylinder remained attached to the engine and torque putty from the last overhaul was evident on the cylinder flange hardware. No pre-accident anomalies were noted externally. The top sparkplug was removed from the engine and the cylinder was inspected using a lighted borescope. Mud and water were observed in the cylinder. The crankshaft was rotated and the rockers, valves, and valve springs functioned properly and piston movement was observed. No pre-accident anomalies were noted with the cylinder components.

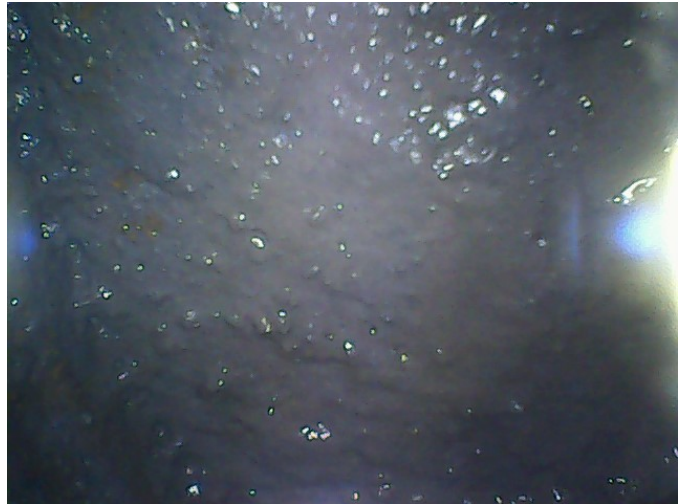
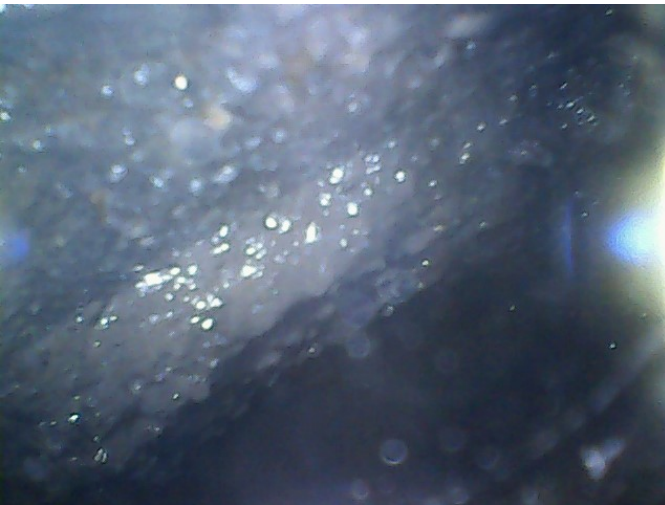
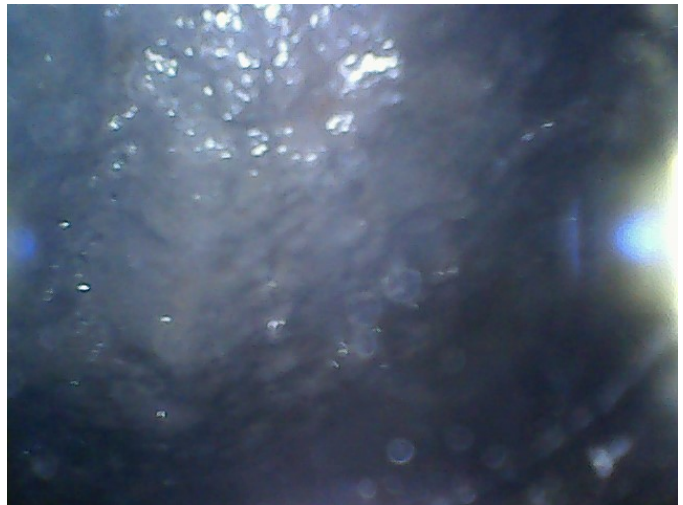
CYLINDER #6

The rocker cover was fractured and the majority was missing. The cylinder remained attached to the engine and torque putty from the last overhaul was evident on the cylinder flange hardware. No pre-accident anomalies were noted externally. The top sparkplug was removed from the engine and the cylinder was inspected using a lighted borescope. Mud and water were observed in the cylinder. The crankshaft was rotated and the rockers, valves, and valve springs functioned properly and piston movement was observed. No pre-accident anomalies were noted with the cylinder components.

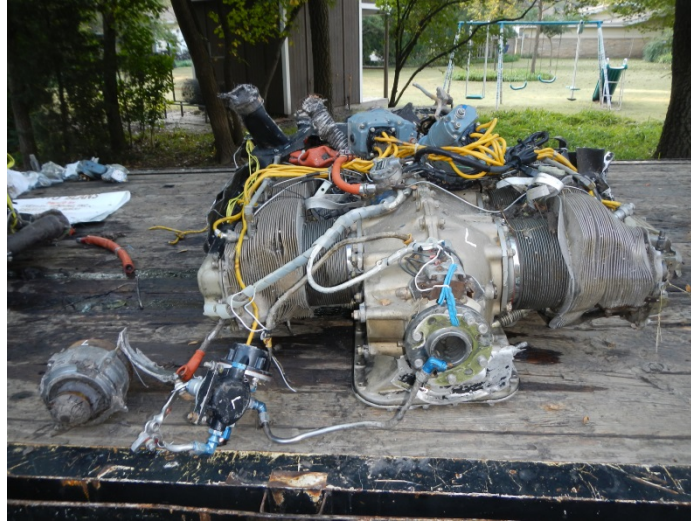
CRANKCASE	Casting Number:	1-3-5: Not Recorded	2-4-6: Not Recorded	S/N: H219814R
Condition:	The crankcase remained intact with no pre-accident anomalies noted.

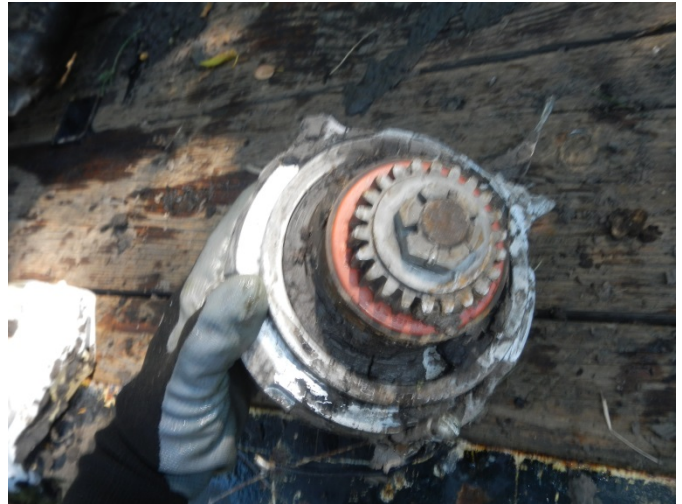
ALT/GEN #1	Manufacturer: Unknown	P/N: Unknown	S/N: Unknown
Condition:	The alternator was separated from the front right side of the engine. No pre-accident anomalies were noted with the alternator drive gear.

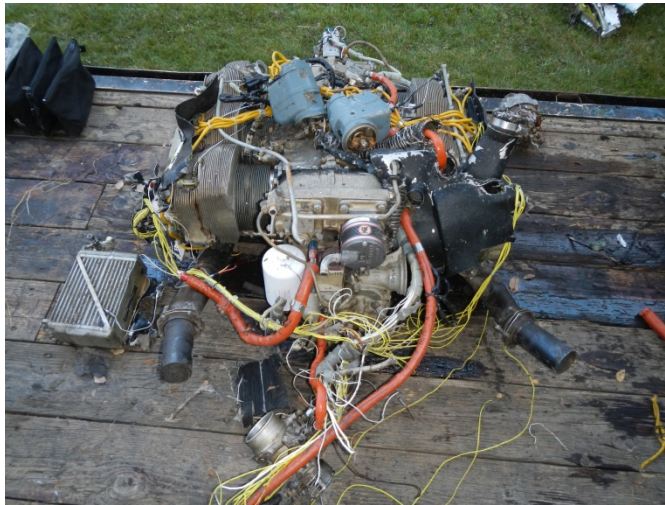
VACUUM PUMP	Manufacturer: Tempest	P/N: Unknown	S/N: Unknown
Condition:	The vacuum pump remained secured to the backside of the engine. One of the mount studs was bent and removal of the pump could not be facilitated.

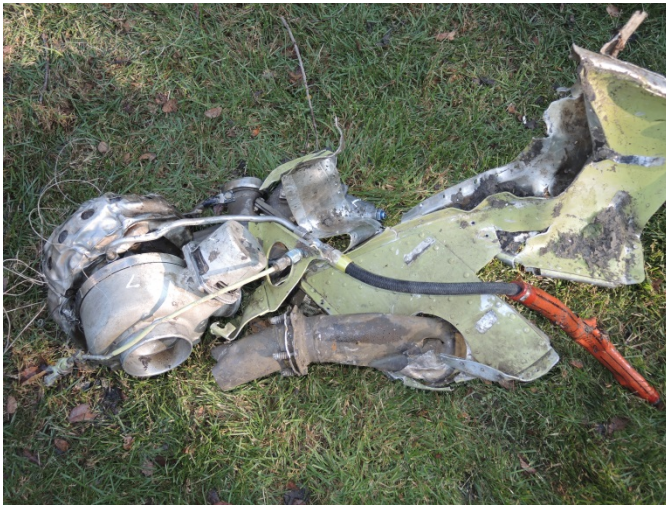
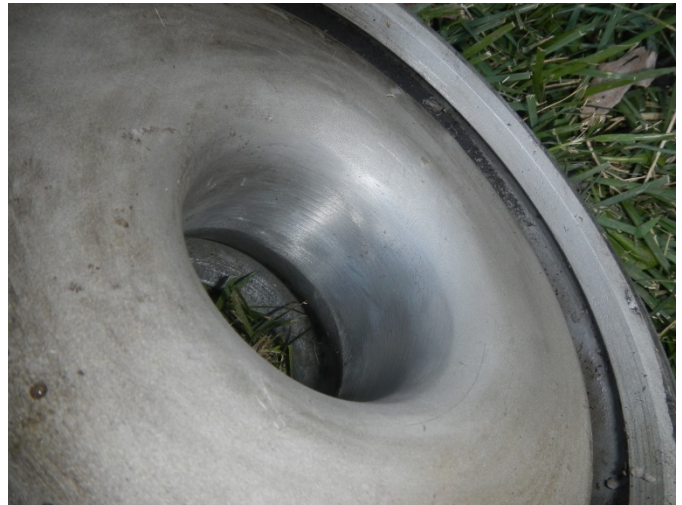
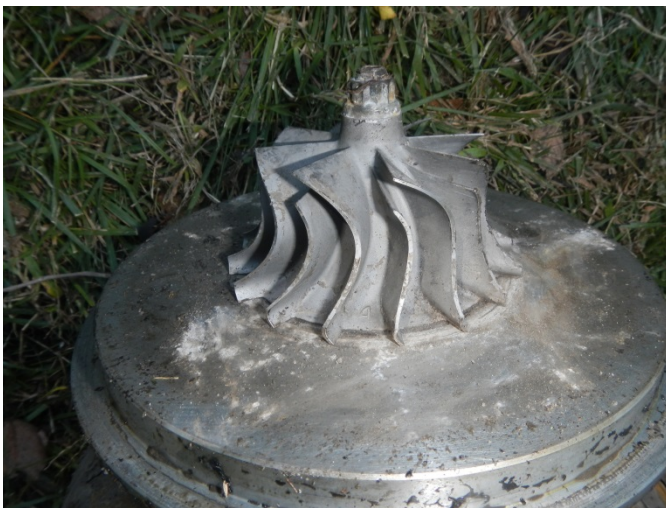
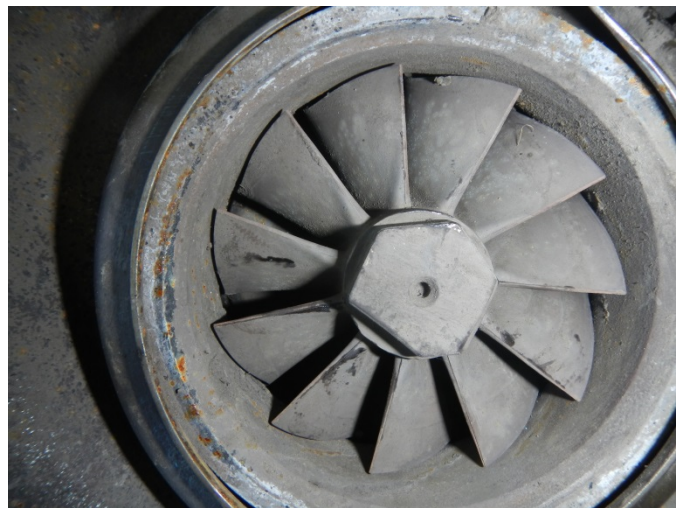
TURBO

The turbocharger, wastegate, overboost valve and controller were separated from the aircraft and the engine. The left turbocharger remained attached to a portion of fractured airframe which also retained a portion of exhaust manifold. Dirt and mud were observed in both the impeller and turbine sections of the turbocharger. Removal of the turbocharger impeller shroud revealed that the impeller was intact and the shaft to the turbine was intact and capable of rotation.

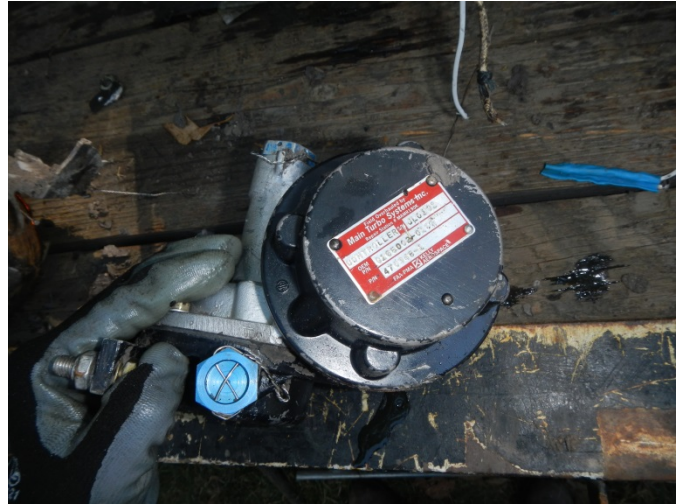
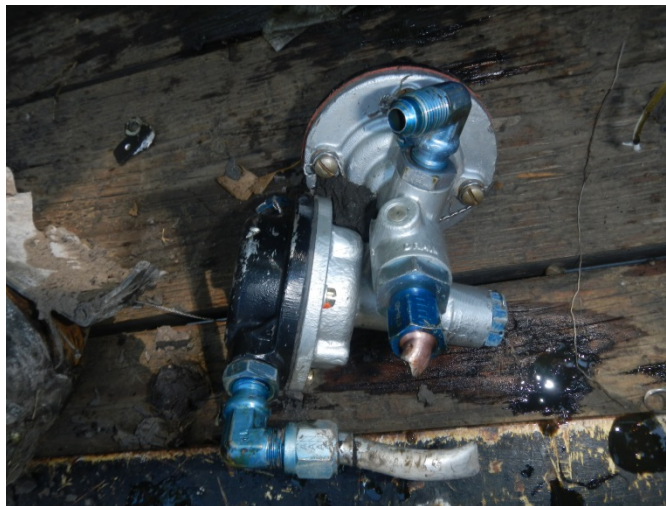
**TURBO
CONTROLLER**

The controller was separated from the aircraft and engine. The controller was intact with no external signs of operational distress. Residual oil poured from the controller during the examination.

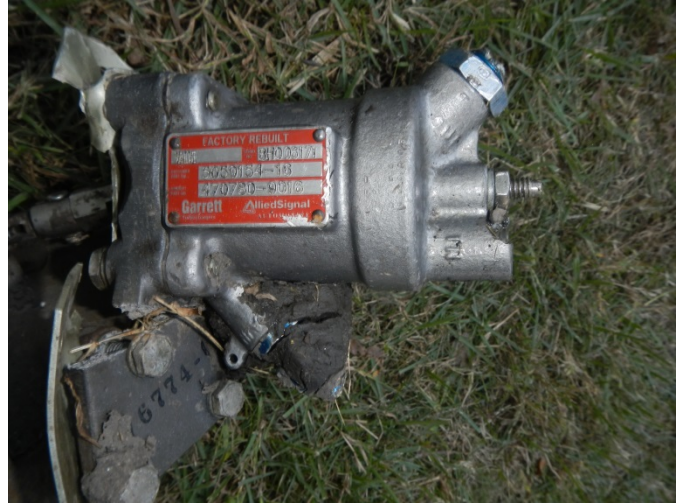
Condition: The wastegate actuator remained attached to the wastegate linkage and no pre-accident anomalies or disconnects were noted.
