Continental Motors

ENGINE FIELD INSPECTION REPORT

ENGINE MODEL	TSIO-520-B12B
ENGINE SERIAL NUMBER	176760-R
AIRCRAFT MAKE & MODEL	Cessna T310Q
AIRCRAFT SERIAL NUMBER	T310Q-0611
AIRCRAFT REGISTRATION	N310JA
FILE NUMBER	15-199

EXAMINATION		ACCIDENT DATA	
DATE	09/27 and 28/2015	NTSB ACCIDENT #	CEN15FA425
FACILITY	Accident Site	NTSB INVESTIGATOR	Courtney Leidler
ADDRESS	410 S. Wetmore Wichita, KS 67209	FAA INVESTIGATOR	Bobby Warren
		ACCIDENT DATE	09/25/2015
		ACCIDENT LOCATION	Wichita, Kansas

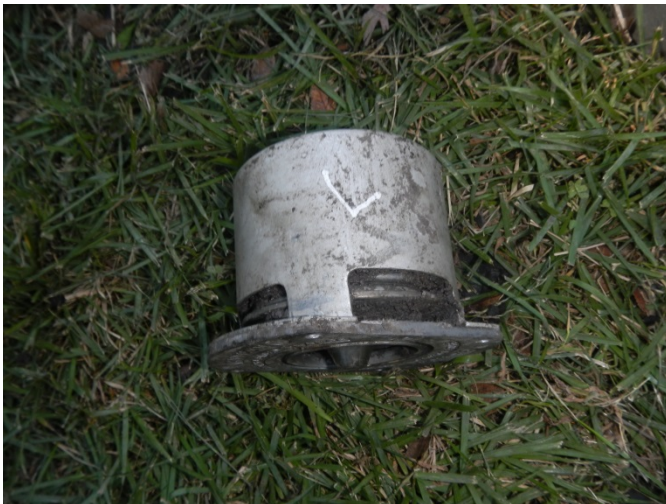
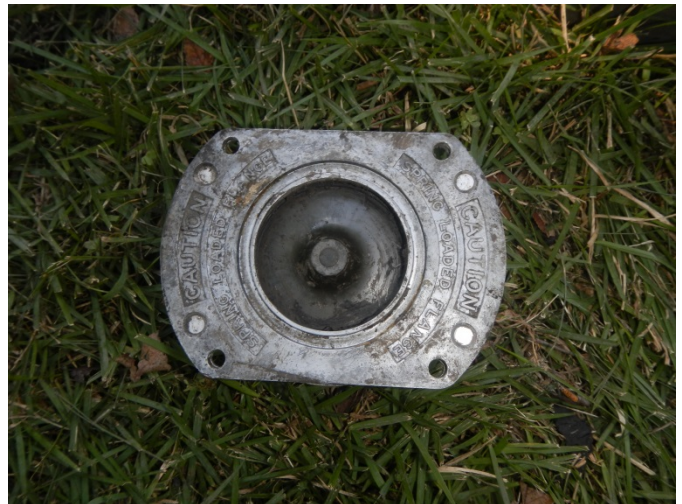
Condition: The overboost valve was intact and its poppet valve could be opened and the spring was intact.

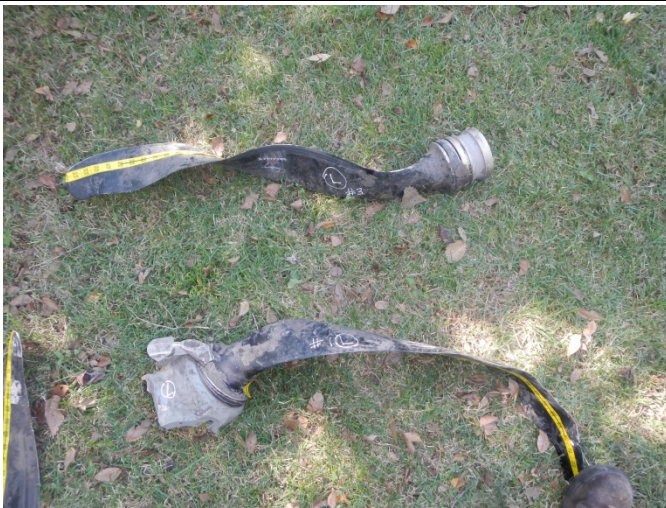
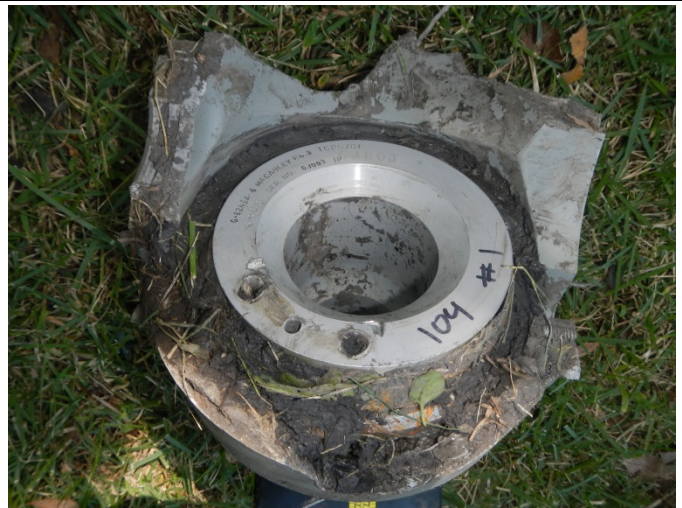
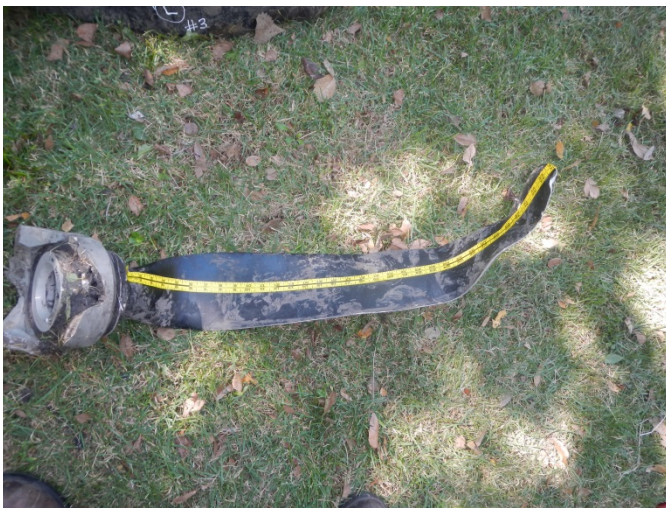
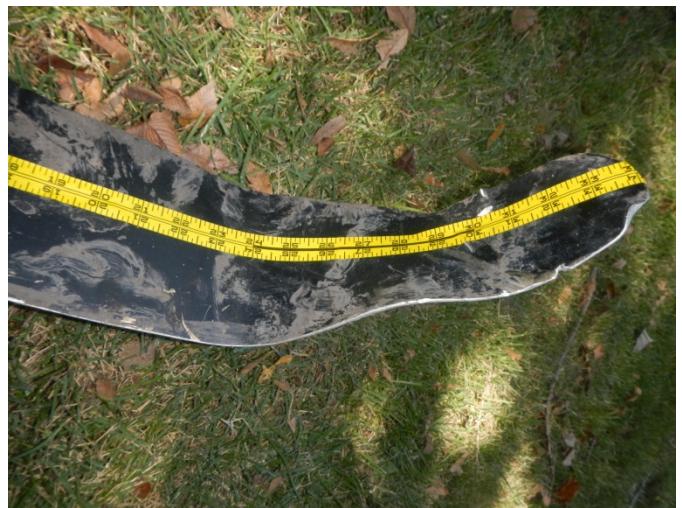
PROPELLER GOVERNOR	Manufacturer: Unknown	P/N: Unknown	S/N: Unknown
Condition:	The propeller governor was separated from the engine and was not located or observed during the examination.		
PROPELLER	Manufacturer: McCauley	P/N: Unknown	S/N: Unknown
Condition:	The left propeller hub was fractured and only two of the three blades were recovered with only remnant of the hub remaining attached to one of the blades. The two blades displayed s-bending, and both were twisted toward low pitch. The pitch change link was fractured from the blade shanks.
