ENGINE FIELD INSPECTION REPORT

ENGINE MODEL	TSIO-520-B11B
ENGINE SERIAL NUMBER	176759-R
AIRCRAFT MAKE & MODEL	Cessna T310Q
AIRCRAFT SERIAL NUMBER	T310Q-0611
AIRCRAFT REGISTRATION	N310JA
FILE NUMBER	15-199

EXAMINATION		ACCIDENT DATA	
DATE	09/27 and 28/2015	NTSB ACCIDENT #	CEN15FA425
FACILITY	Accident Site	NTSB INVESTIGATOR	Courtney Leidler
ADDRESS	410 S. Wetmore Wichita, KS 67209	FAA INVESTIGATOR	Bobby Warren
		ACCIDENT DATE	09/25/2015
		ACCIDENT LOCATION	Wichita, Kansas

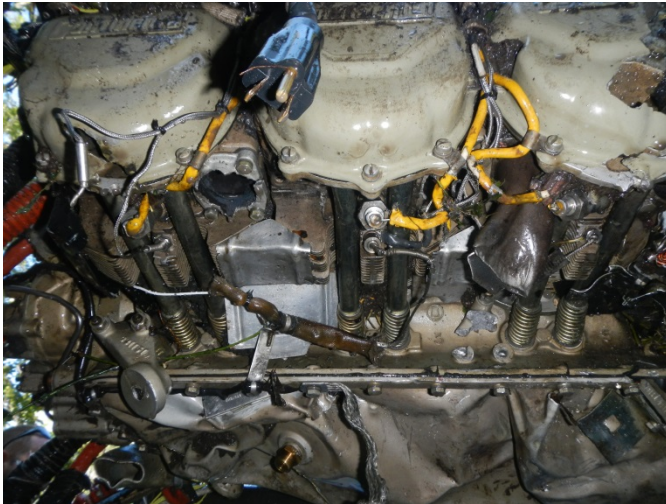
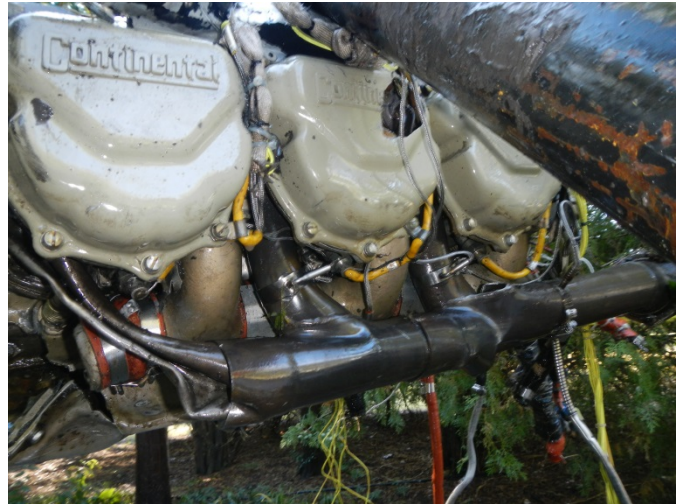
The exhaust risers remained attached to their respective cylinders and the exhaust manifolds remained in place on the left side of the engine; however, they sustained deformation damage and were filled with mud and debris. The right side exhaust system was separated from the engine. The turbocharger exhaust system was separated from the exhaust manifold. No pre-accident anomalies were noted with the observed exhaust system components.

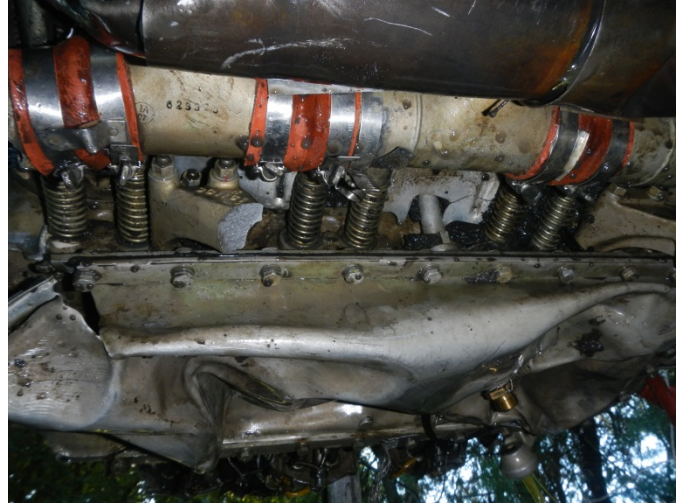
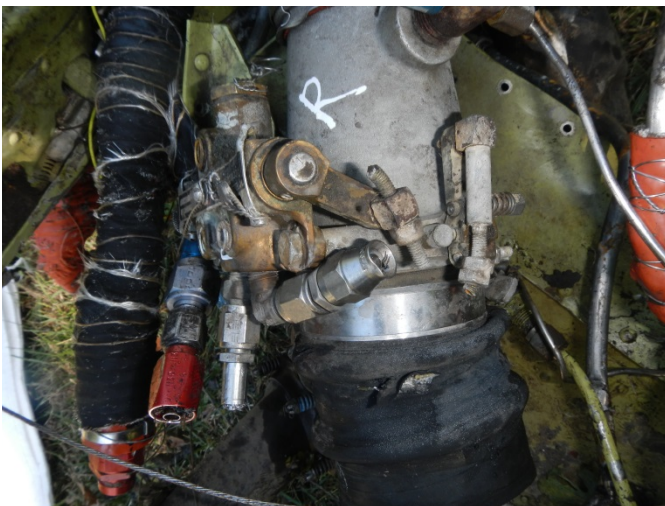
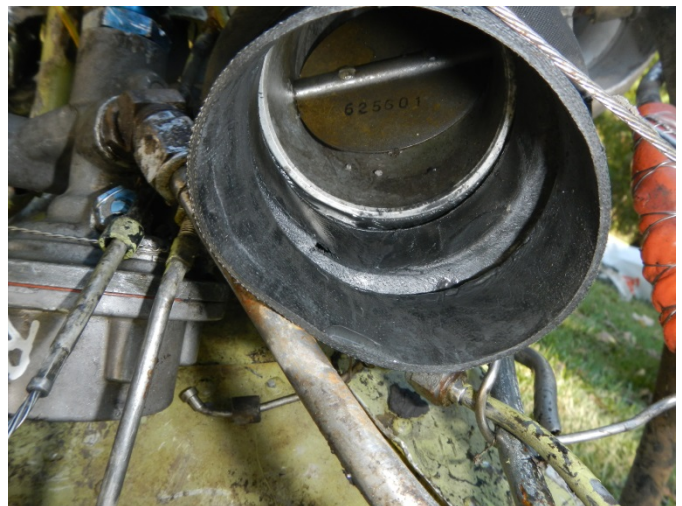
The left side intake risers and manifold remained in place and attached to the engine. The right side intake risers and manifold was separated and not observed. The throttle body was attached to turbocharger section of the engine nacelle.

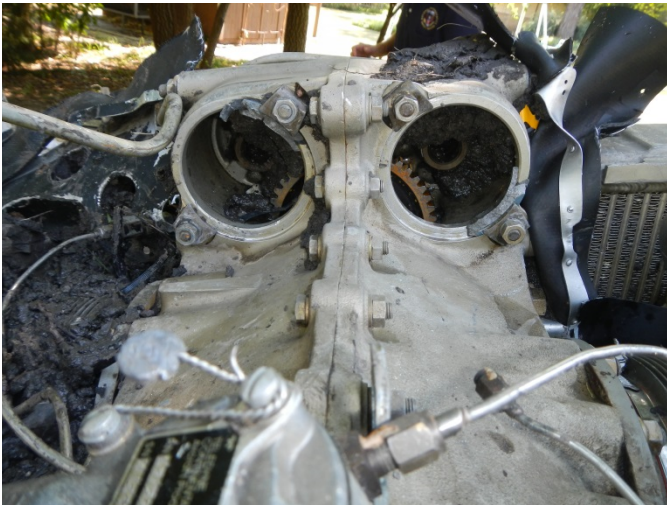
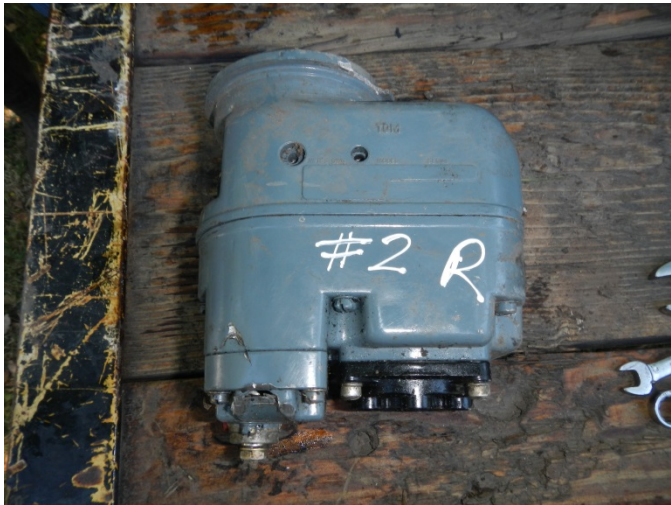
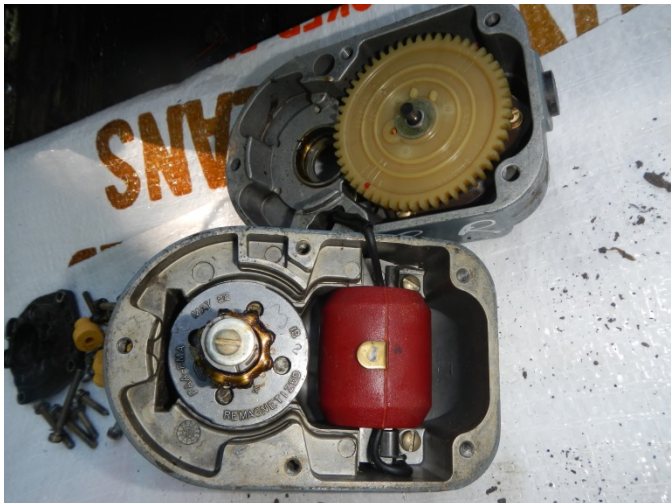
LEFT MAGNETO	Manufacturer: Unknown	P/N: Unknown	S/N: Unknown
Condition:	The magneto was separated from the engine and was not located during the examination.		
RIGHT MAGNETO	Manufacturer: CMI S6RSC-205	P/N: 10-600656-1	S/N: H299806ER
Condition:	The magneto was separated from the engine. The mounting flange of the right magneto was fractured in an area that coincided with the attach washers. The ignition harness cap was removed from the right magneto. The drive shaft was rotated with some binding noted. The magneto was disassembled and when the housing was removed the drive shaft rotated with some binding noted at the drive end. The distributor gear rotated freely. The points were intact and opened/closed with driveshaft rotation. No internal, pre-accident anomalies, besides water emersion and mud contamination, were observed with the magneto.

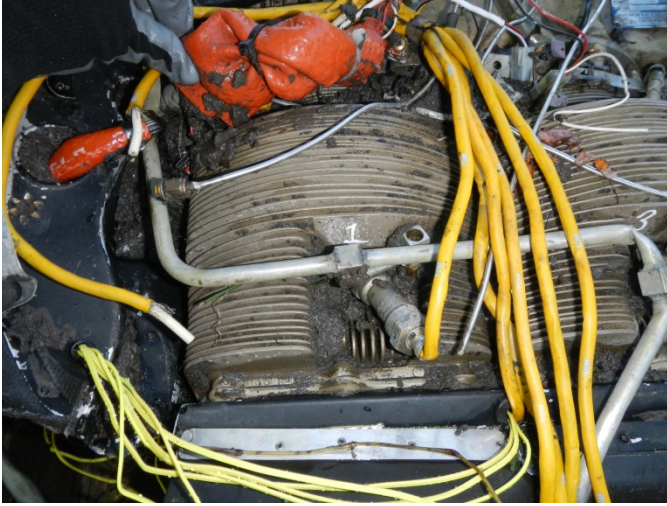
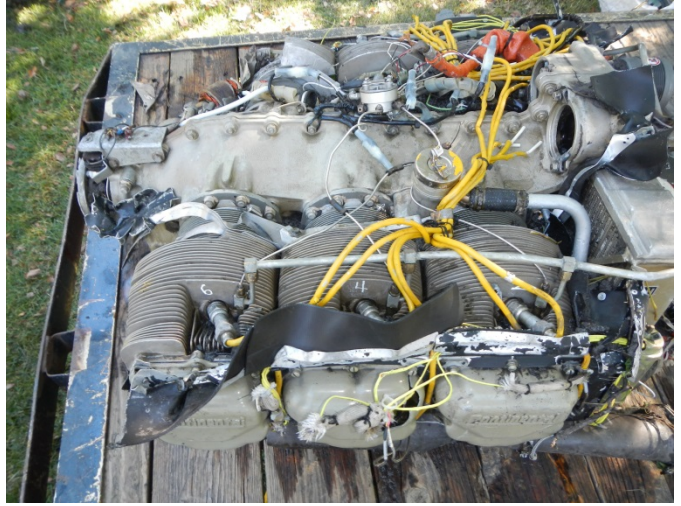
Condition: All of the ignition terminal ends remained attached to their respective sparkplugs though some displayed some accident-related damage.

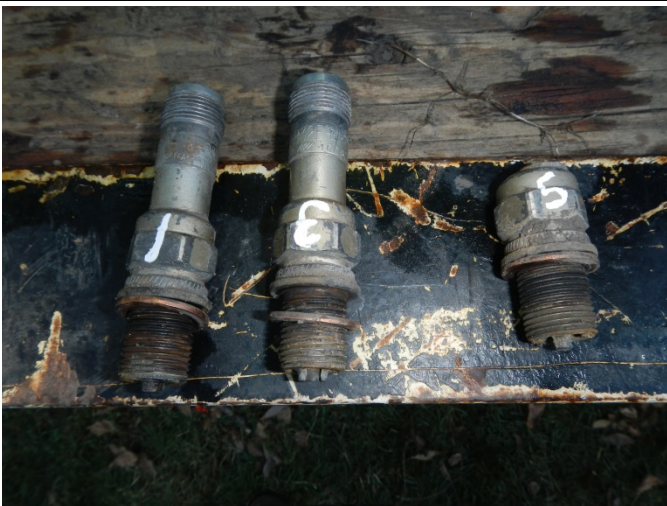
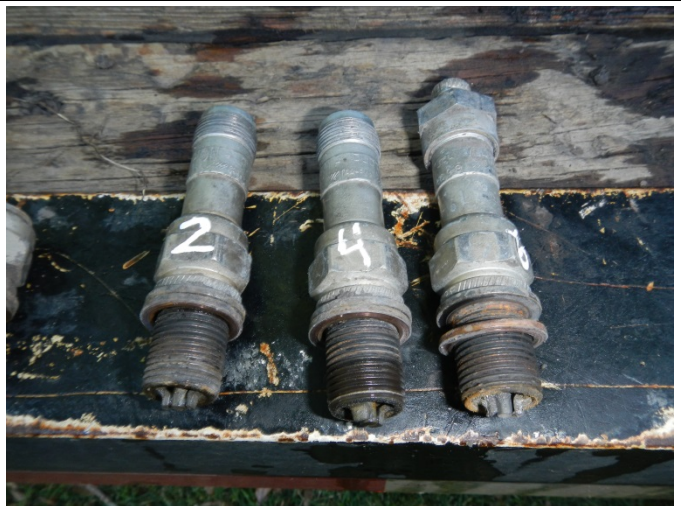
Condition: All of the sparkplugs remained secured to their respective cylinders. Removal of the top sparkplugs revealed that they were covered with mud, water, and oil. All electrodes displayed a normal worn condition when compared to the Champion Aviation Service Manual (AV6-R).

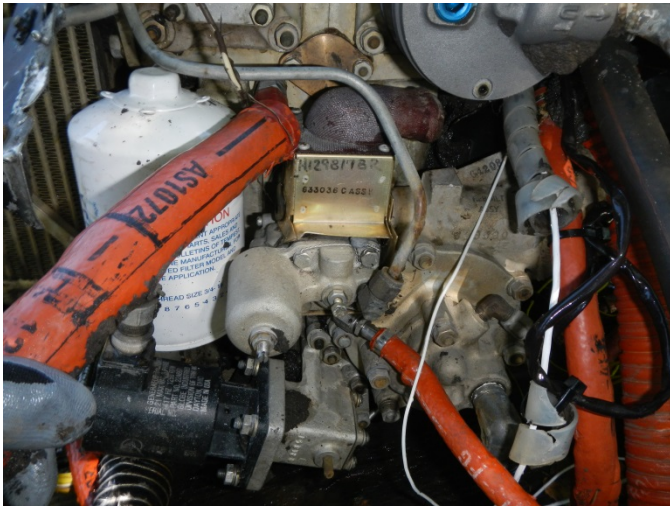
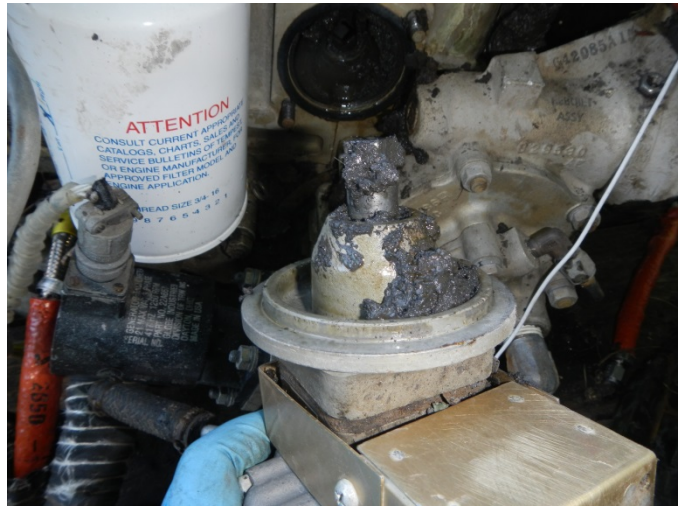
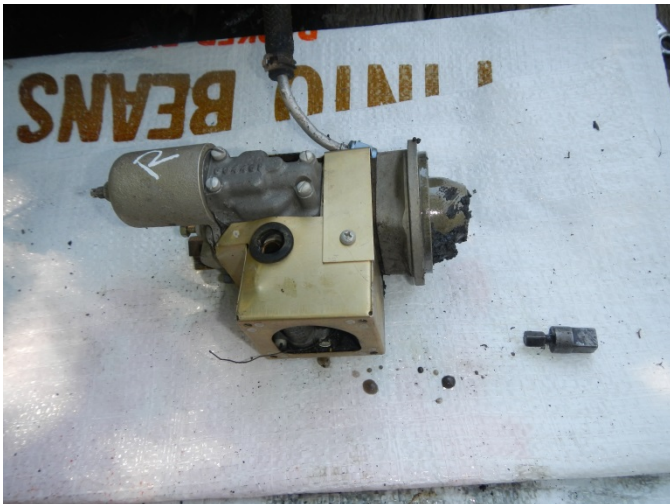
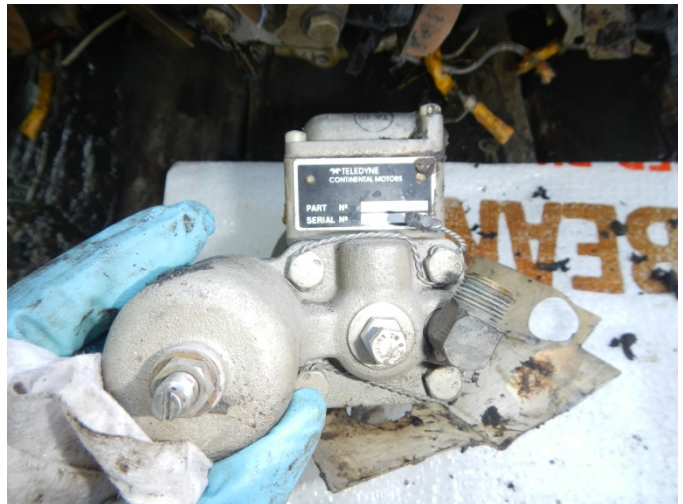
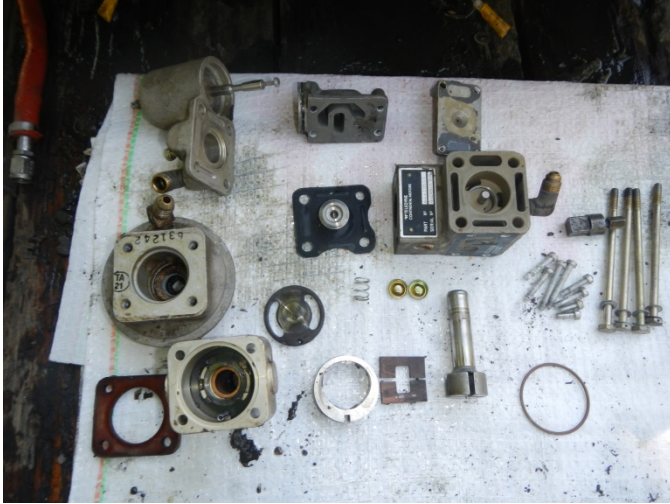
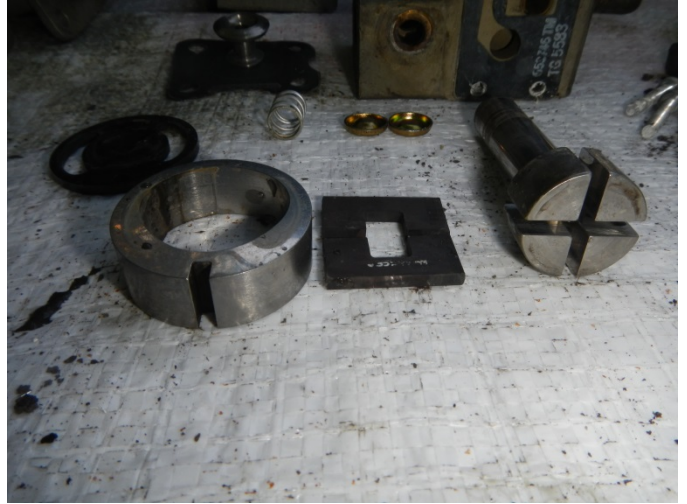
The engine-driven fuel pump was attached to the backside of the engine. The engine-driven fuel pump was removed from the backside of the engine and fuel poured from the housing fittings. The drive coupling was intact and rotation of the drive coupling while installed in the driveshaft resulted in rotation of the driveshaft with no binding noted. The fuel pump was disassembled and no pre-accident anomalies were noted with any of the internal components.

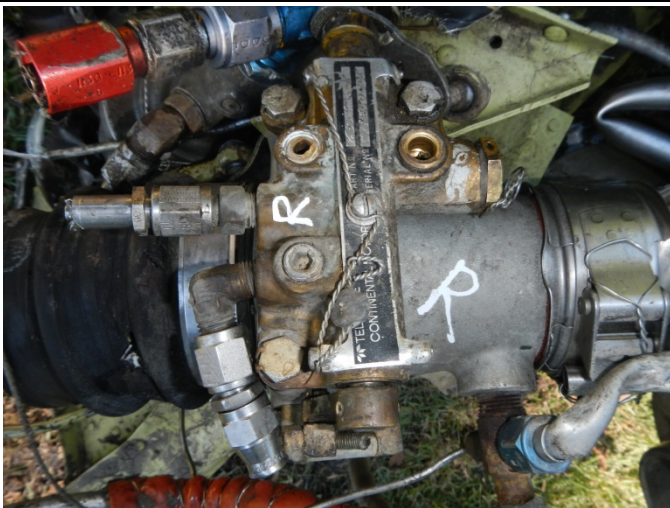
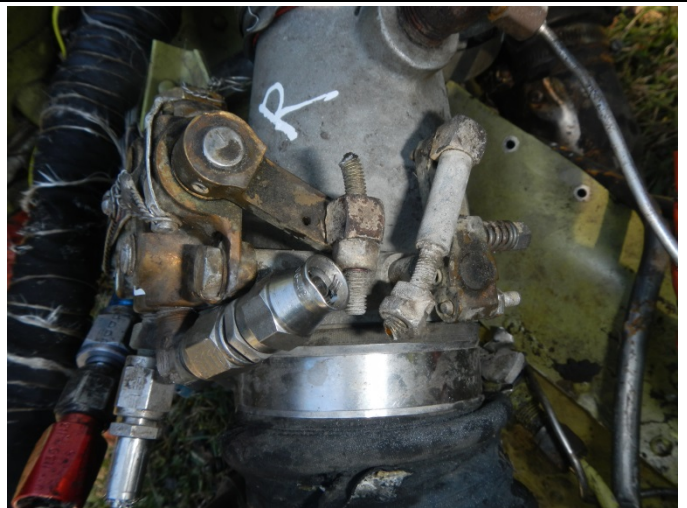
THROTTLE BODY METERING UNIT	Manufacturer: CMI	P/N: 632916-8	S/N: C129804AR
Condition:	<p>The throttle body/fuel metering unit remained attached to the engine nacelle. The throttle and mixture cables remained attached to the throttle body and metering unit levers, which remained attached to their respective shafts. The linkage between the throttle valve shaft and the metering unit's throttle cam shaft was fractured and bending deformation was noted at the fracture. Rotation of the levers resulted in a coinciding rotation of the shafts with no binding noted. The metering unit fuel inlet filter was removed and no obstructions or blockage was noted, but mud and dirty water was observed. The metering unit was disassembled and besides water and dirt contamination, no pre-accident anomalies were noted with the internal components.</p>

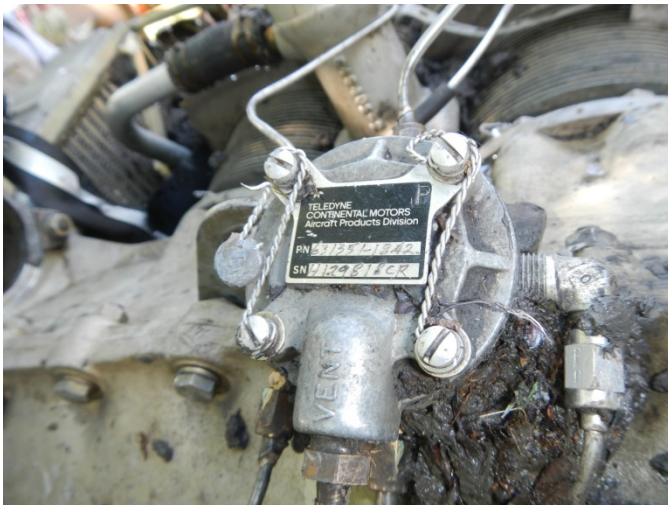
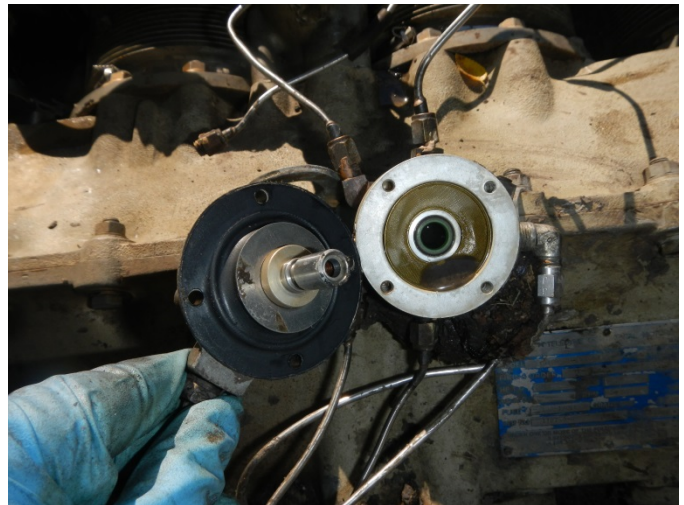
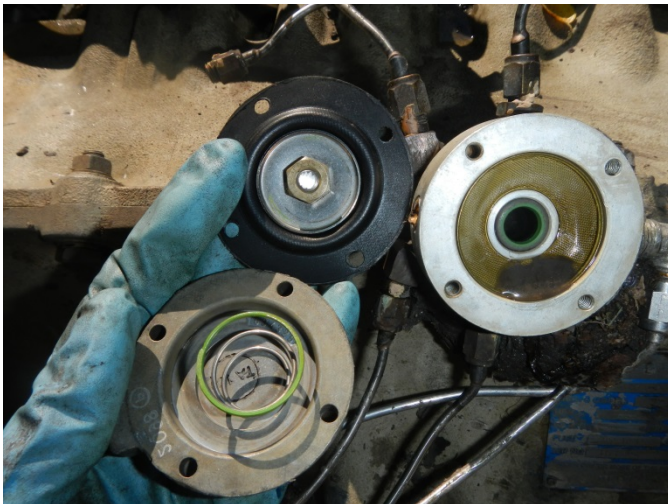
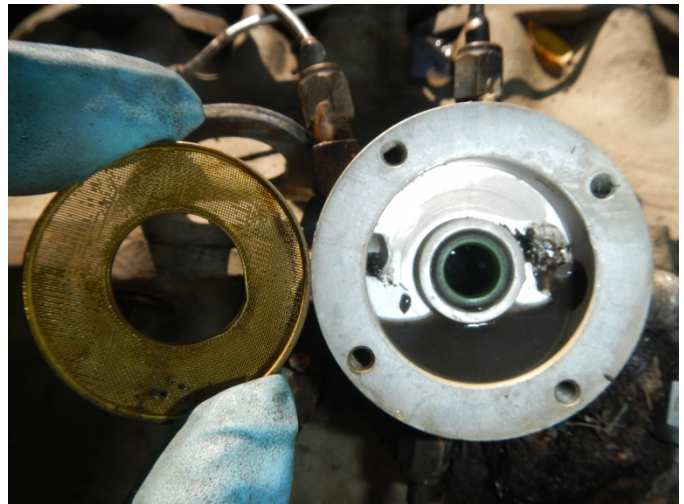
The fuel manifold valve remained attached to the topside of the engine; however, some of the fuel injection lines were fractured and it was separated from its mount. The cap was secured to the body with safety-wire. The fuel manifold valve was disassembled and aviation gasoline, mud and water were noted in the manifold. No pre-accident anomalies were noted with the diaphragm, plunger, spring, or screen.

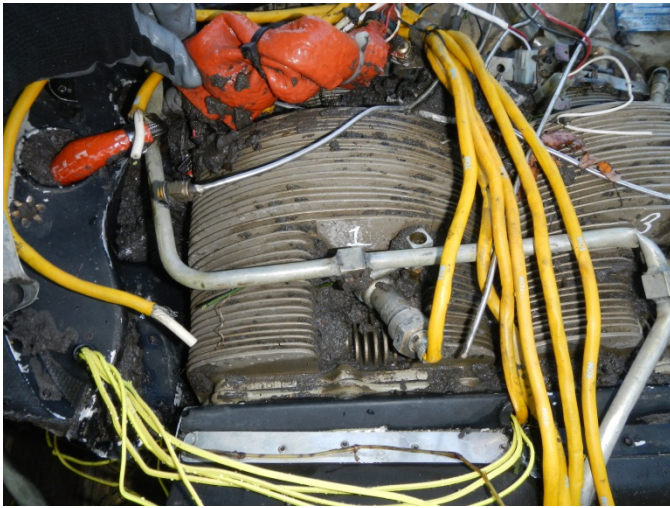
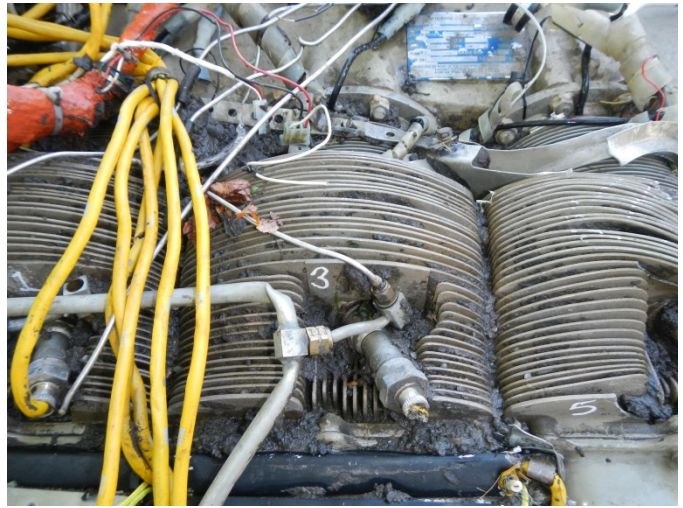
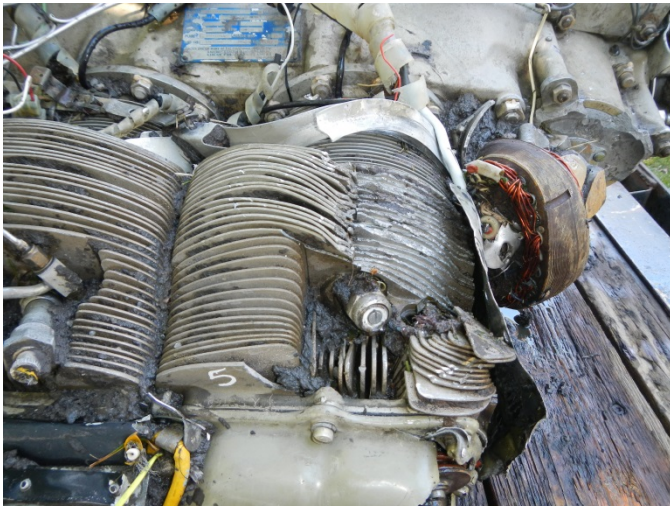
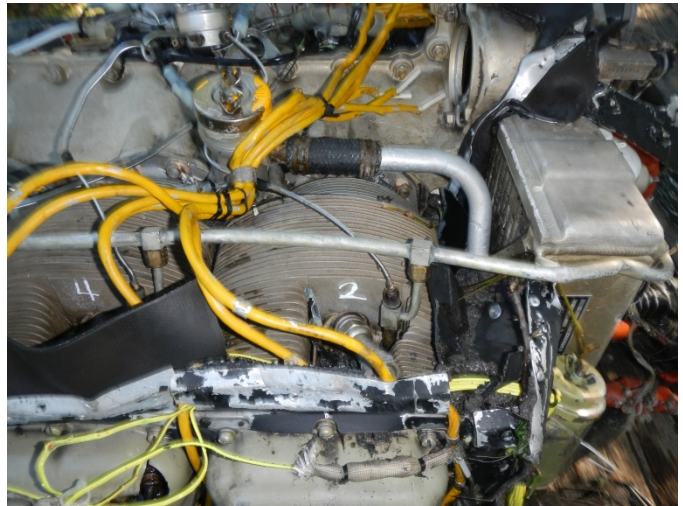
The #5 fuel injector nozzle was separated from its cylinder and its line was displaced aft toward the #1 cylinder. The #1 fuel injector line was separated from the #1 fuel nozzle. The upper deck reference line was attached to the right side fuel nozzles, but the #5 upper deck reference line, with nozzle installed, was bent aft toward the #3 cylinder. The #6 fuel injector line was separated from the fuel manifold valve but the nozzles and upper deck reference lines remained attached to the left side cylinders.

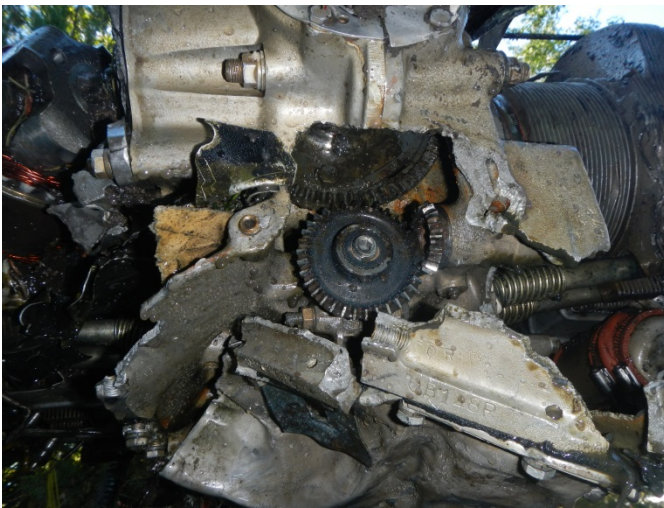
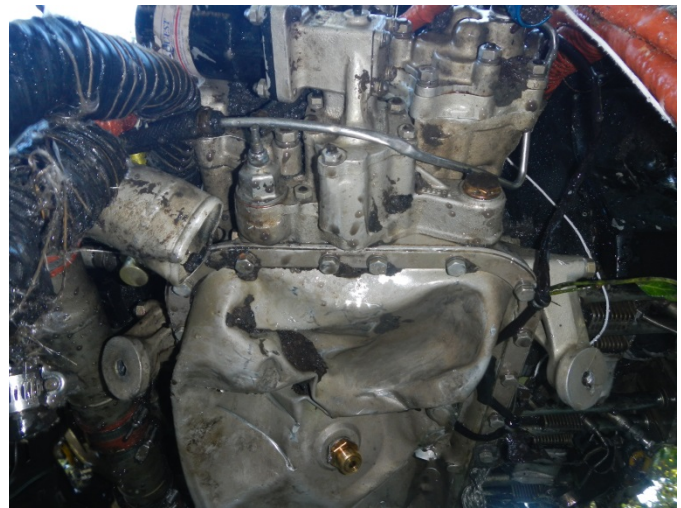
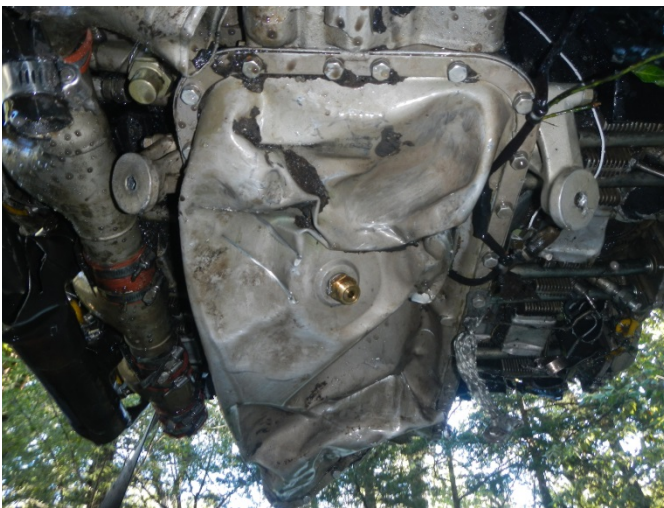
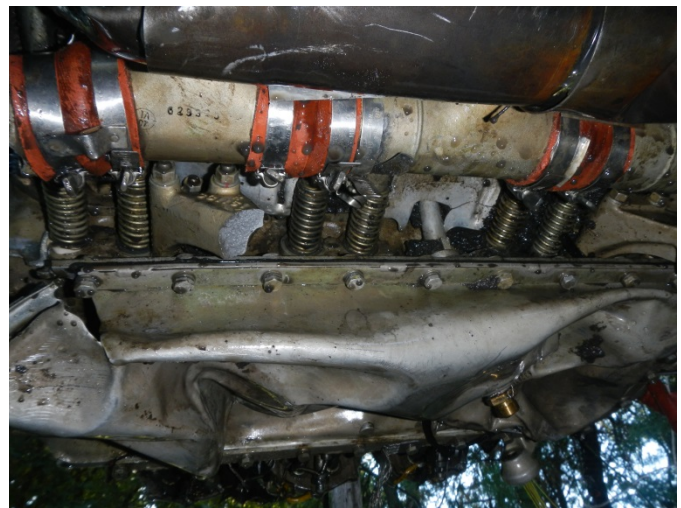
The oil sump was displaced up around the bottom side of the engine. It remained attached to its bottom side of the engine, but the bottom front end of the engine was fractured and the oil sump was displaced aft. No pre-accident anomalies were noted with the oil sump.

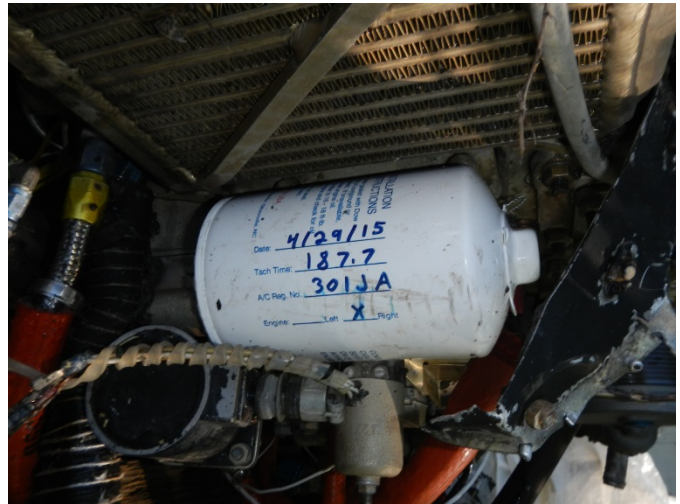
The oil filter remained secured with safety-wire to the engine. There were no signs of pre-accident anomalies with the oil filter. The date of 4/29/15 was written on the oil filter with a tachometer time listed as 187.7. The filter indicated that it was utilized on the right engine.

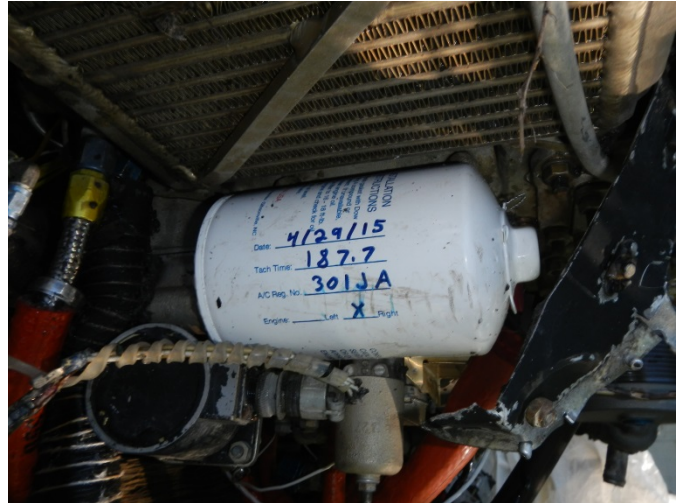
The oil cooler remained attached to the engine and no pre-accident anomalies were noted.

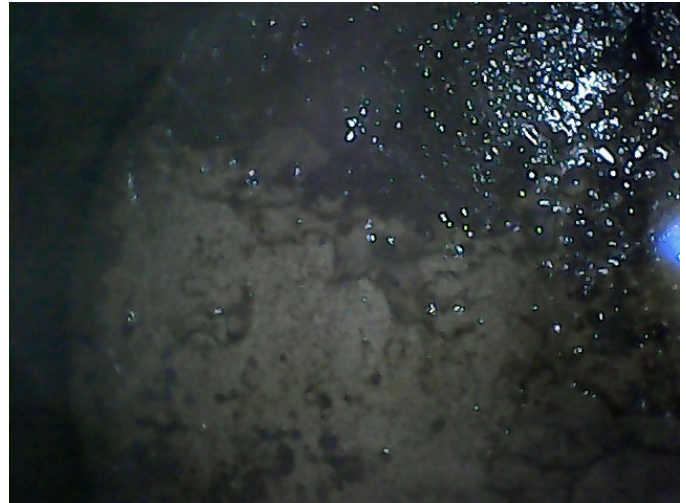
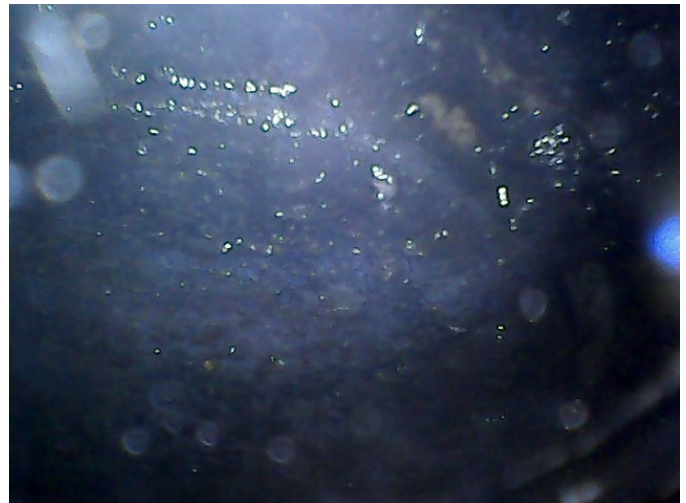
CYLINDER #1	P/N: 658552A1	S/N: Unknown	Head Date: 8-98
Condition:	The cylinder remained attached to the engine and torque putty from the last overhaul was evident on the cylinder flange hardware. No pre-accident anomalies were noted externally. The top sparkplug was removed from the engine and the cylinder was inspected using a lighted borescope. Mud and water were observed in the cylinder. The crankshaft was rotated and the rockers, valves, and valve springs functioned properly and piston movement was observed. No pre-accident anomalies were noted with the cylinder components.

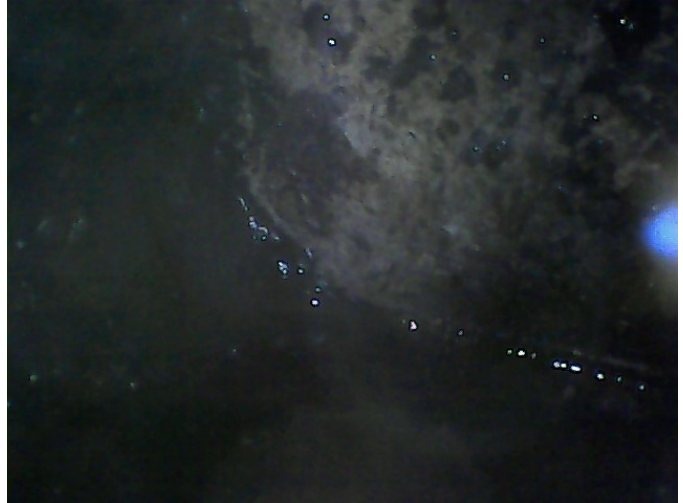
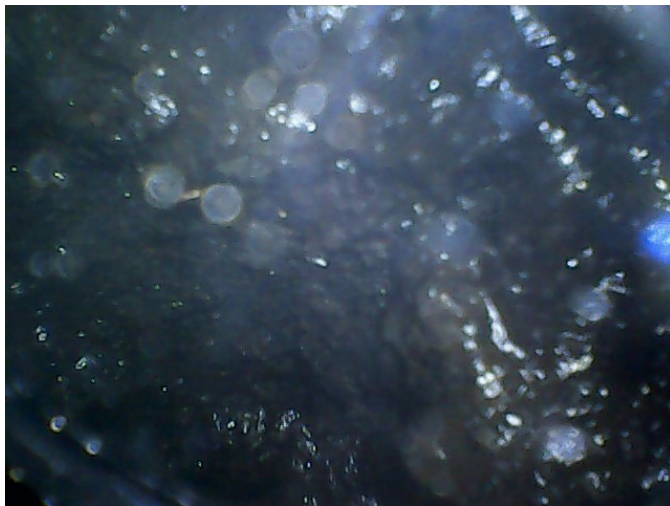
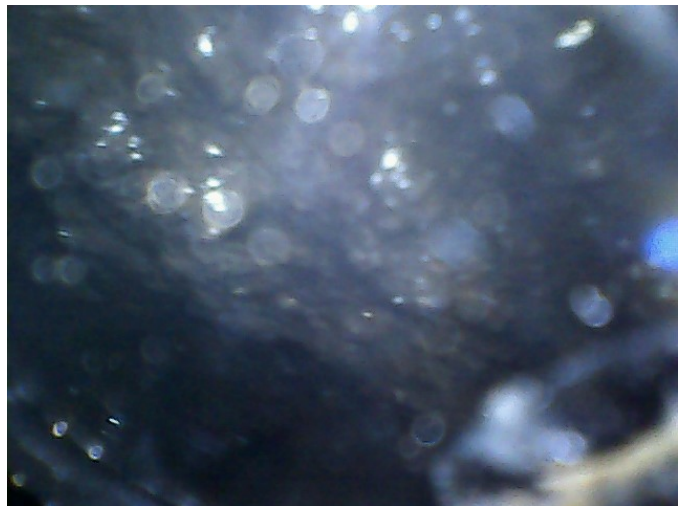
CYLINDER #3

The cylinder remained attached to the engine and torque putty from the last overhaul was evident on the cylinder flange hardware. No pre-accident anomalies were noted externally. The top sparkplug was removed from the engine and the cylinder was inspected using a lighted borescope. Mud and water were observed in the cylinder. The crankshaft was rotated and the rockers, valves, and valve springs functioned properly and piston movement was observed. No pre-accident anomalies were noted with the cylinder components.

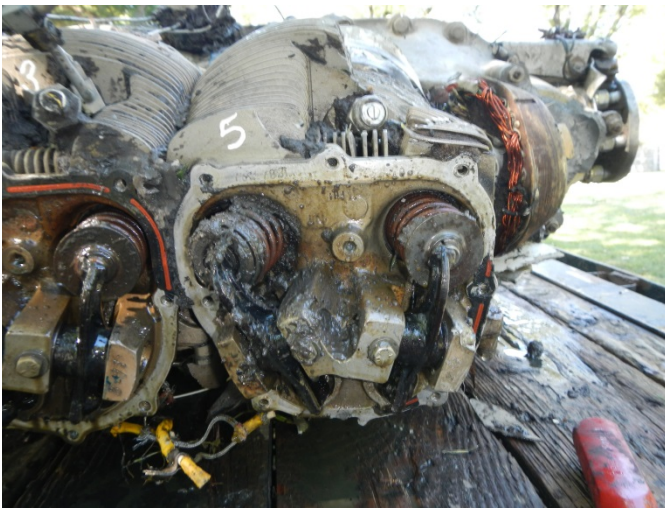
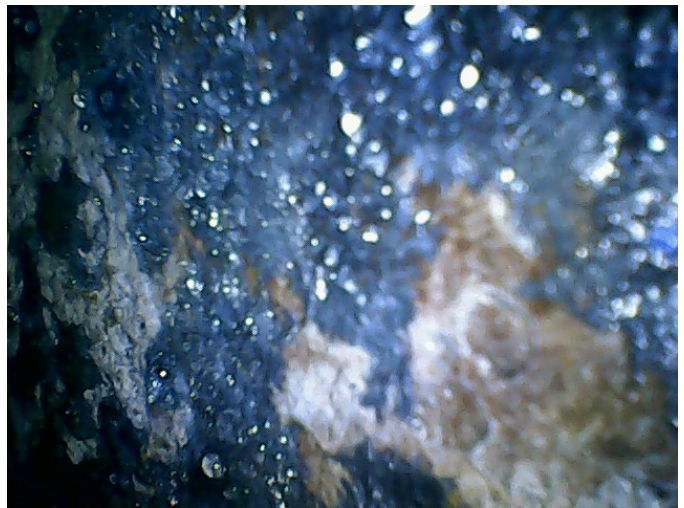
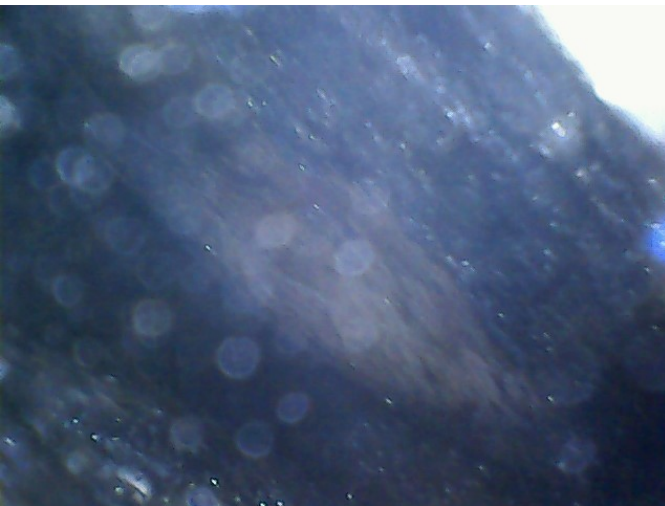
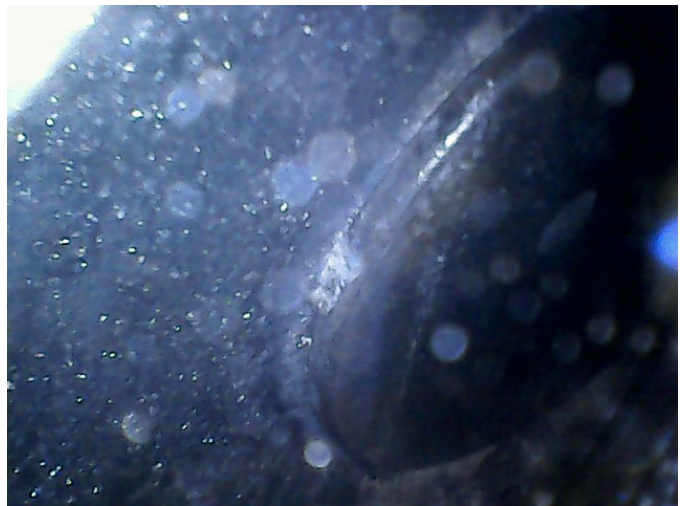
Condition: The cylinder remained attached to the engine and torque putty from the last overhaul was evident on the cylinder flange hardware. The cooling fins on the top front side of the cylinder were fractured and the fuel injector nozzle was separated. No pre-accident operational anomalies were noted externally. The top sparkplug was removed from the engine and the cylinder was inspected using a lighted borescope. Mud and water were observed in the cylinder. The crankshaft was rotated and the rockers, valves, and valve springs functioned properly and piston movement was observed. A line of discoloration was noted on the exhaust valve and a piece of debris was noted in the circumference of the valve in the area of the discoloration. Besides the valve signatures, no other pre-accident anomalies were noted with the cylinder components.

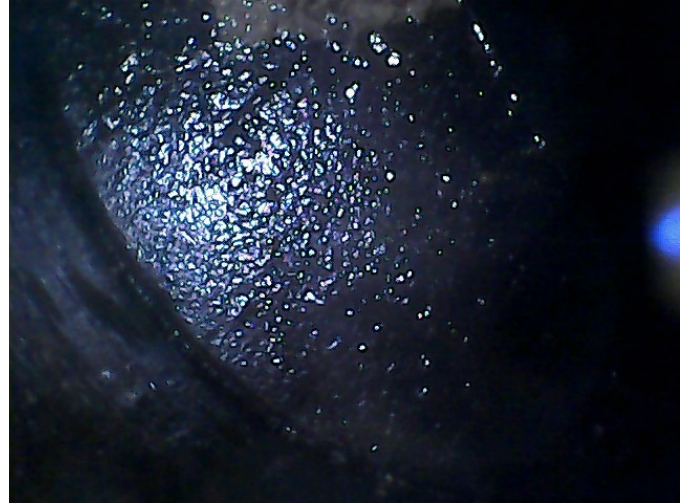
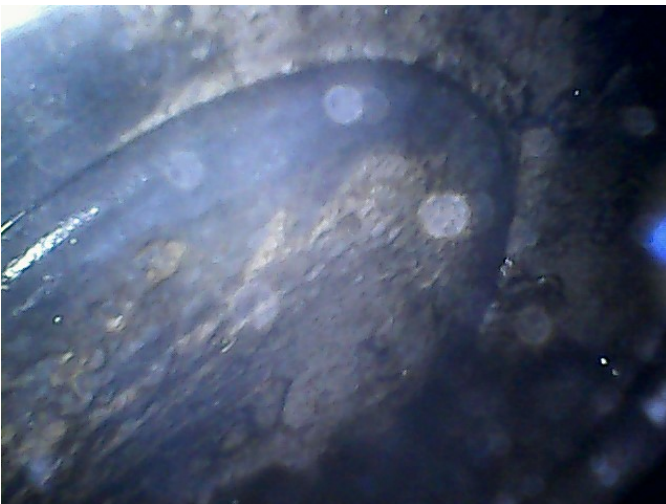
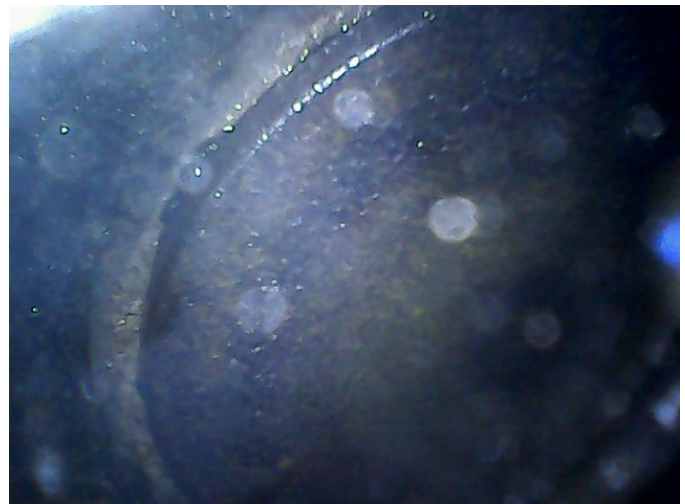
CYLINDER #2

The cylinder remained attached to the engine and torque putty from the last overhaul was evident on the cylinder flange hardware. No pre-accident anomalies were noted externally. The top sparkplug was removed from the engine and the cylinder was inspected using a lighted borescope. Mud and water were observed in the cylinder. The crankshaft was rotated and the rockers, valves, and valve springs functioned properly and piston movement was observed. No pre-accident anomalies were noted with the cylinder components.

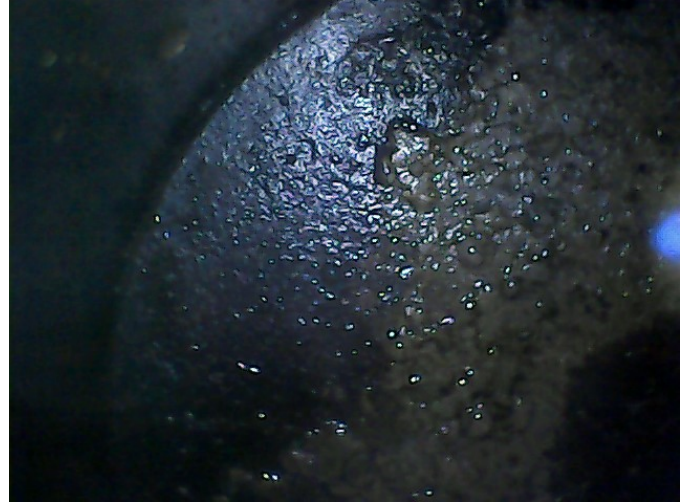
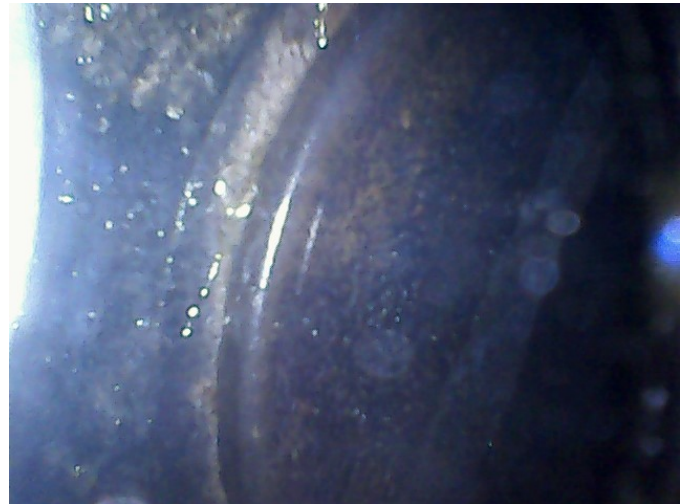
CYLINDER #4

The cylinder remained attached to the engine and torque putty from the last overhaul was evident on the cylinder flange hardware. No pre-accident anomalies were noted externally. The top sparkplug was removed from the engine and the cylinder was inspected using a lighted borescope. Mud and water were observed in the cylinder. The crankshaft was rotated and the rockers, valves, and valve springs functioned properly and piston movement was observed. No pre-accident anomalies were noted with the cylinder components.

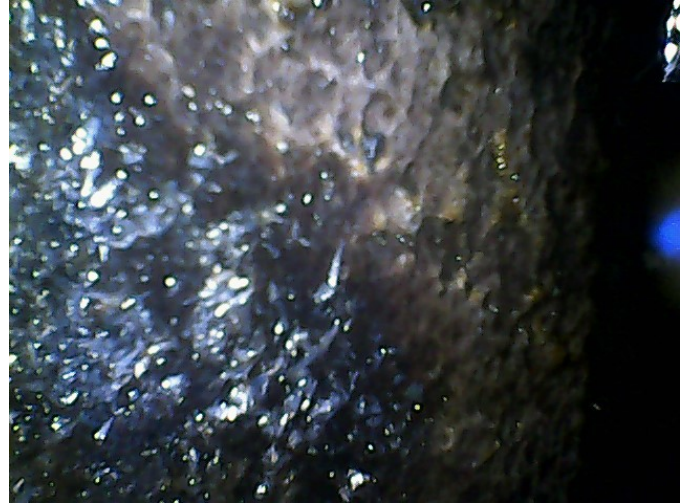
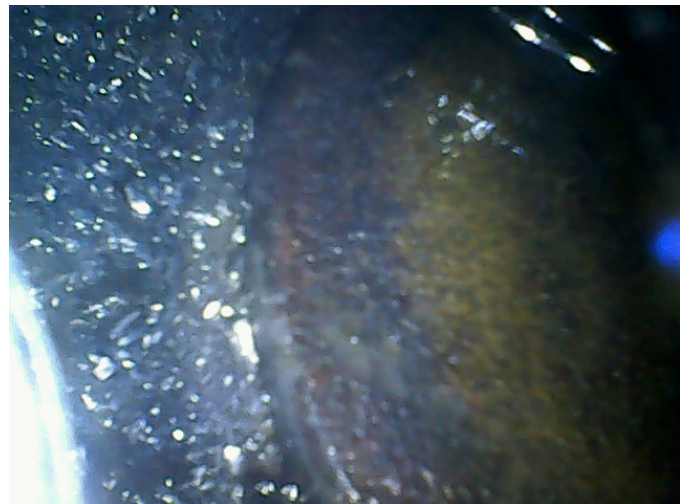
CYLINDER #6

The cylinder remained attached to the engine and torque putty from the last overhaul was evident on the cylinder flange hardware. No pre-accident anomalies were noted externally. The top sparkplug was removed from the engine and the cylinder was inspected using a lighted borescope. Mud and water were observed in the cylinder. The crankshaft was rotated and the rockers, valves, and valve springs functioned properly and piston movement was observed. No pre-accident anomalies were noted with the cylinder components.

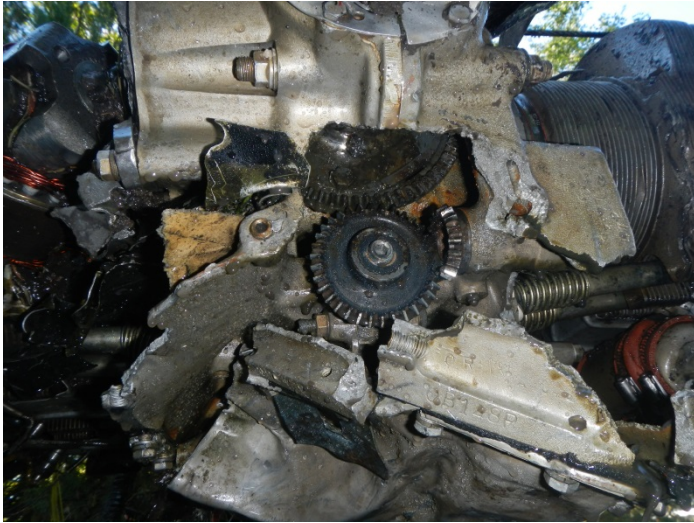
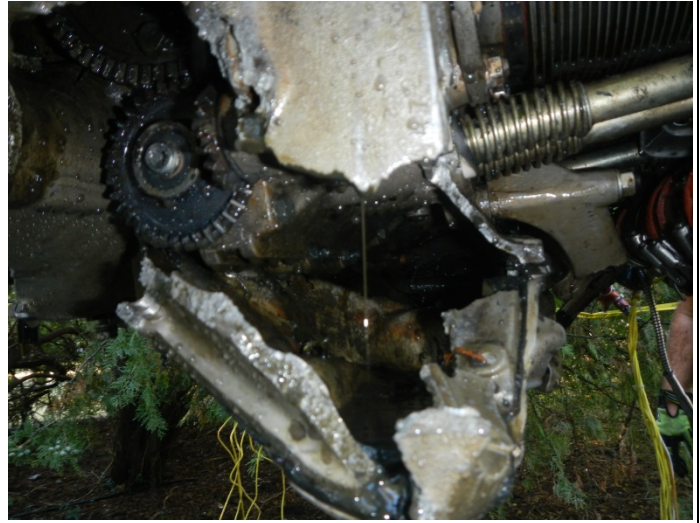
CRANKCASE	Casting Number:	1-3-5: Not Observed	2-4-6: Not Observed	S/N: OB148P
Condition:	The crankcase was fractured on the bottom front end which permitted visible examination of the alternator face gear, the camshaft bevel gear, and the propeller governor drive gear. No pre-accident anomalies were noted with the crankcase.

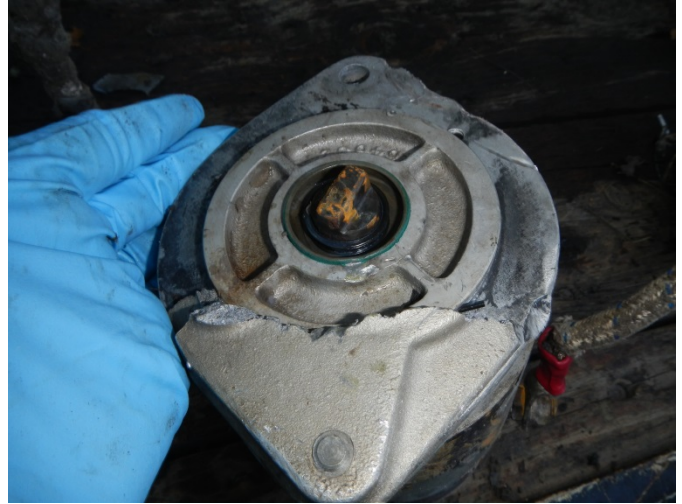
STARTER	Manufacturer: Unknown	P/N: Unknown	S/N: Unknown
Condition:	The starter motor was separated from its mounting pad. Only one starter motor (Energizer 24 PN: 646275 SN: A08269806) was recovered from the pond. No pre-accident anomalies were noted with the recovered motor.

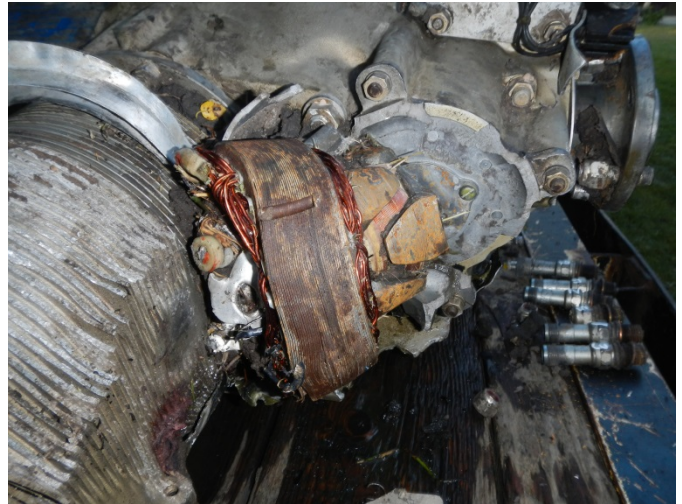
ALT/GEN #1	Manufacturer: Unknown	P/N: Unknown	S/N: Unknown
Condition:	The alternator remained attached to the engine, but its housing was destroyed and the remaining portions were displaced aft into the #5 cylinder barrel.

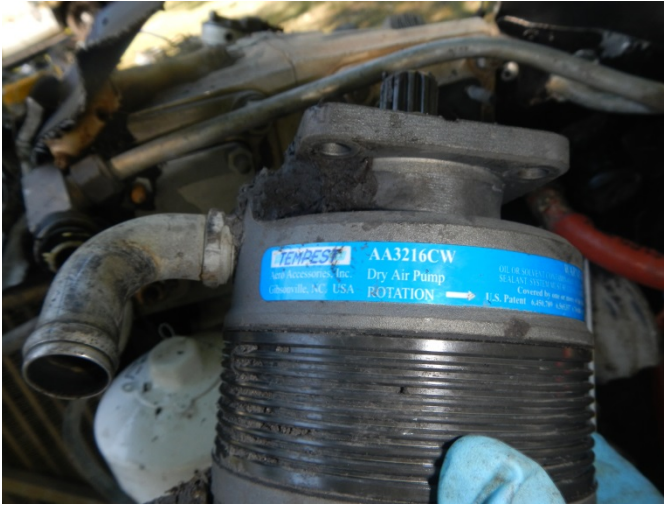
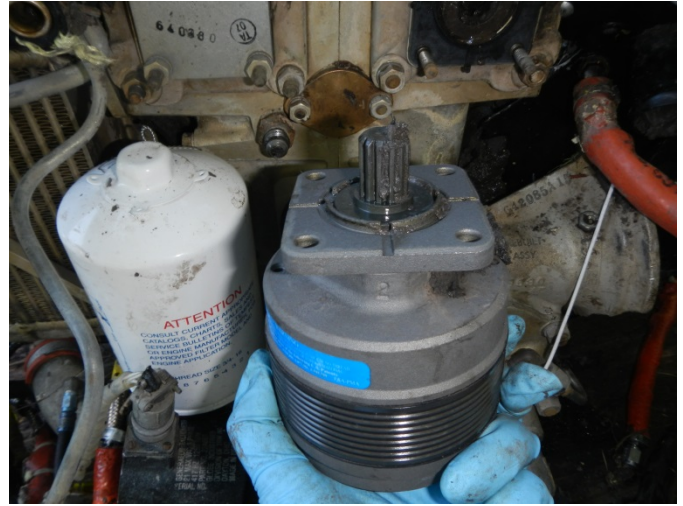
The vacuum pump remained attached to the backside of the engine. It was removed and its drive shaft and drive coupling remained intact. Rotation of the drive shaft revealed no anomalies.
