ENGINE FIELD INSPECTION REPORT

ENGINE MODEL	TSIO-520-B11B
ENGINE SERIAL NUMBER	176759-R
AIRCRAFT MAKE & MODEL	Cessna T310Q
AIRCRAFT SERIAL NUMBER	T310Q-0611
AIRCRAFT REGISTRATION	N310JA
FILE NUMBER	15-199

EXAMINATION		ACCIDENT DATA	
DATE	09/27 and 28/2015	NTSB ACCIDENT #	CEN15FA425
FACILITY	Accident Site	NTSB INVESTIGATOR	Courtney Leidler
ADDRESS	410 S. Wetmore Wichita, KS 67209	FAA INVESTIGATOR	Bobby Warren
		ACCIDENT DATE	09/25/2015
		ACCIDENT LOCATION	Wichita, Kansas

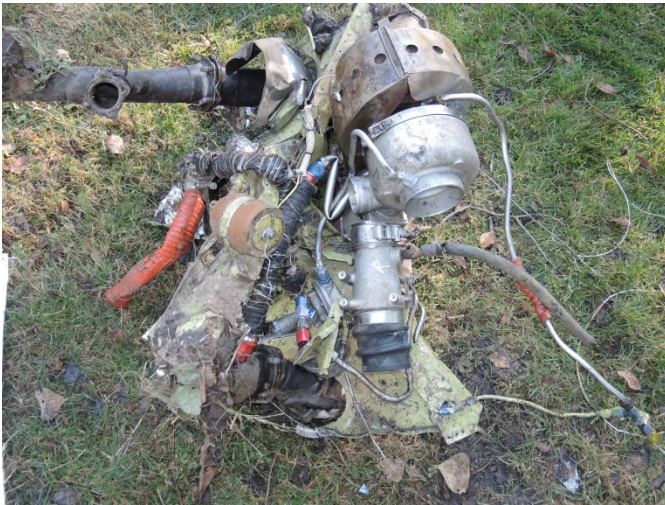
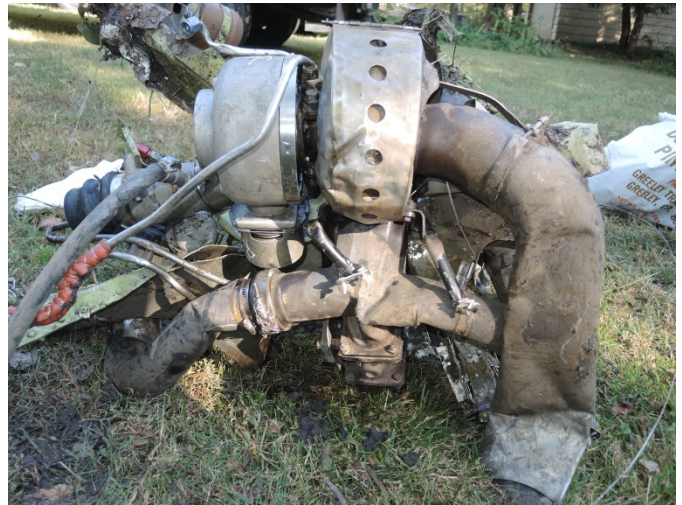
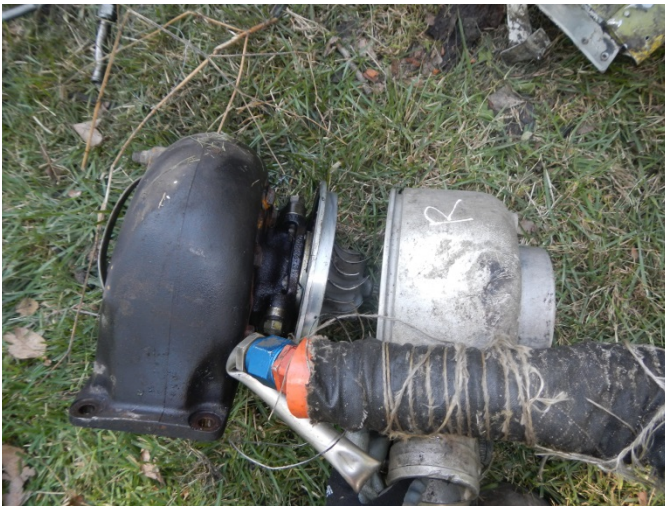
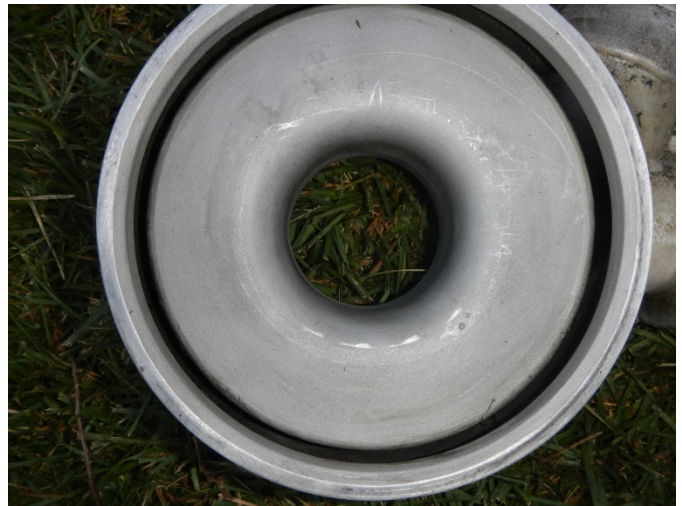
The turbocharger, wastegate, overboost valve and controller remained with the engine nacelle. Dirt and mud were observed in both the impeller and turbine sections of the turbocharger. Removal of the turbocharger impeller shroud revealed that the impeller was intact and the shaft to the turbine was intact; however, the turbine was binding on the turbine shroud and would only permit partial rotation. A small area of rotational scoring was noted on the impeller shroud.

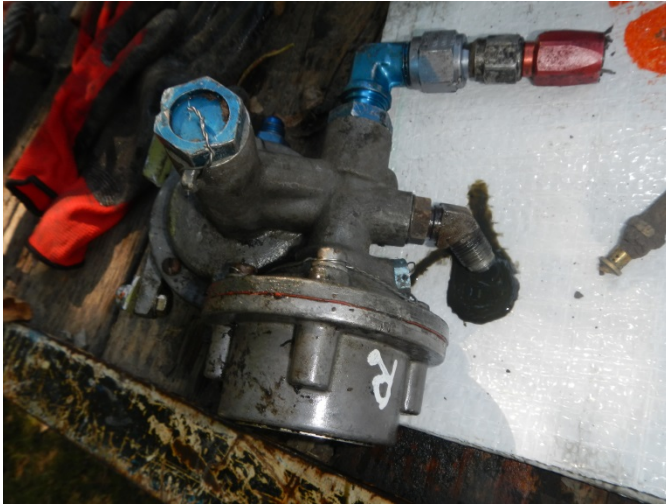
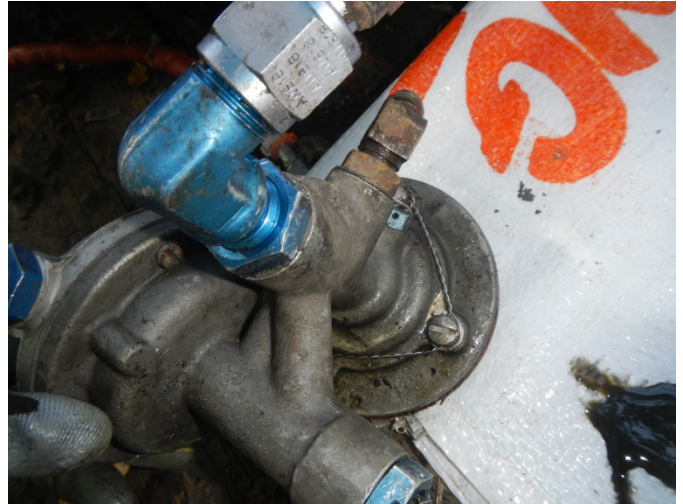
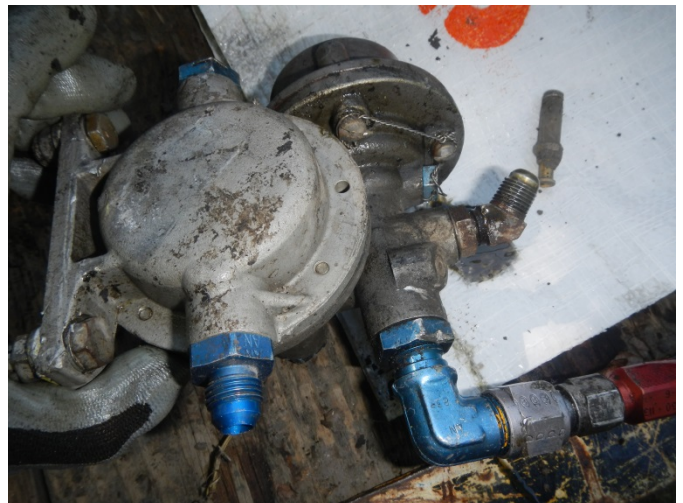
The controller remained with the turbocharger components in the engine nacelle piece. The controller was intact with no external signs of operational distress. Residual oil poured from the controller during the examination.

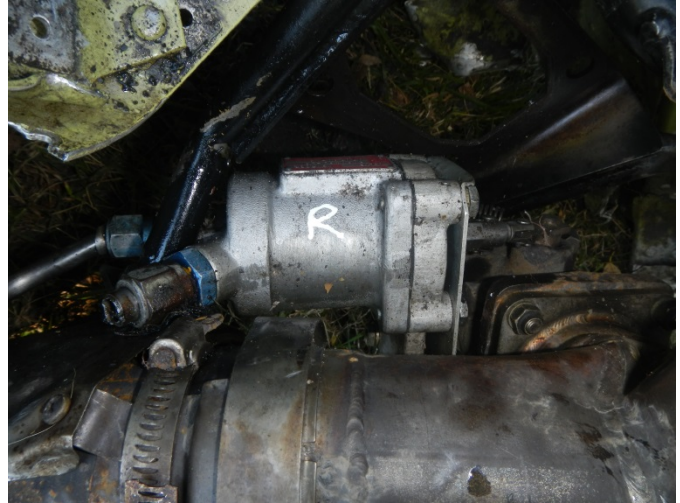
Condition: The wastegate actuator remained attached to the wastegate linkage and no pre-accident anomalies or disconnects were noted.

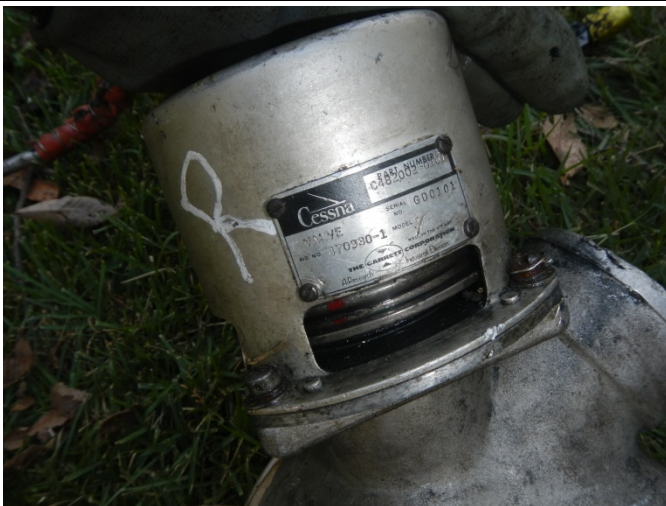
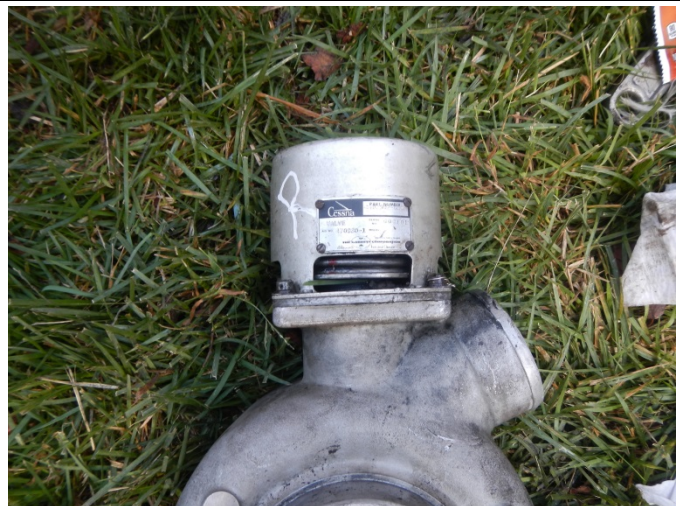
Condition: The overboost valve remained attached to the turbocharger impeller shroud and was intact and its poppet valve could be opened and the spring was intact.

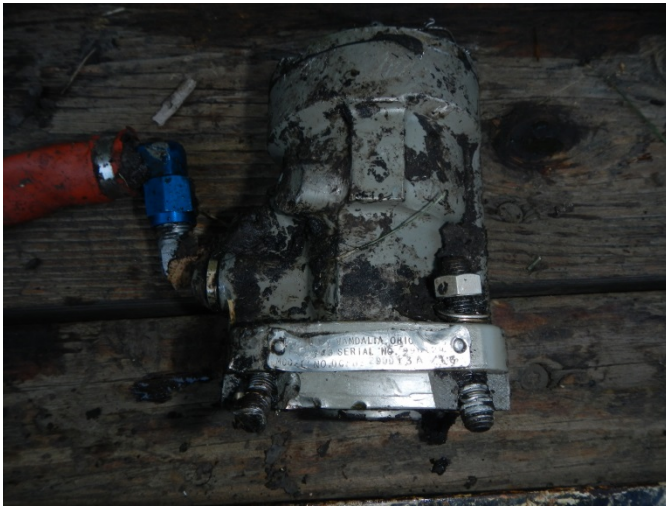
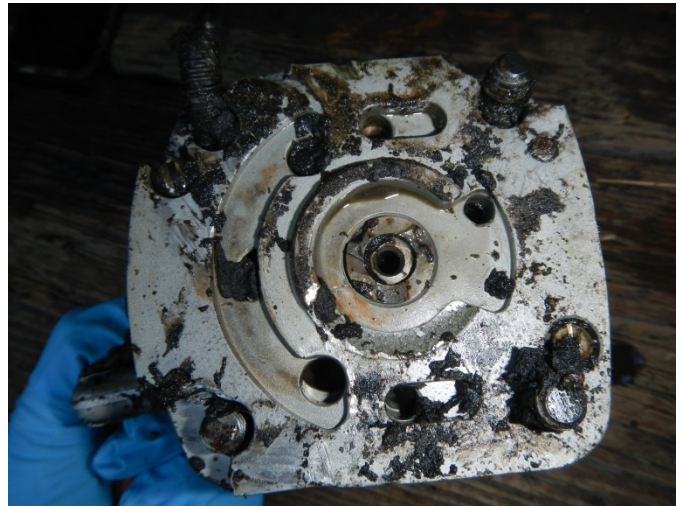
PROPELLER GOVERNOR	Manufacturer: McCauley	P/N: DCFU3290D13A/16	S/N: 99?124
Condition:	The propeller governor was separated from the engine. A governor was located at the accident site, and based on fracture features, was determined to be from the right engine. The

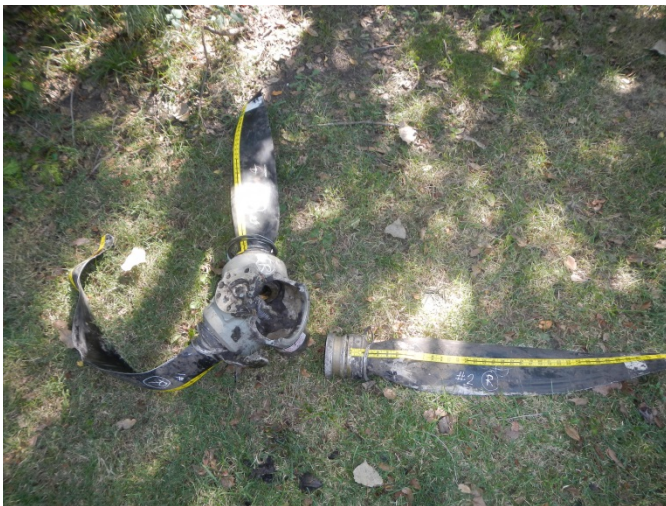
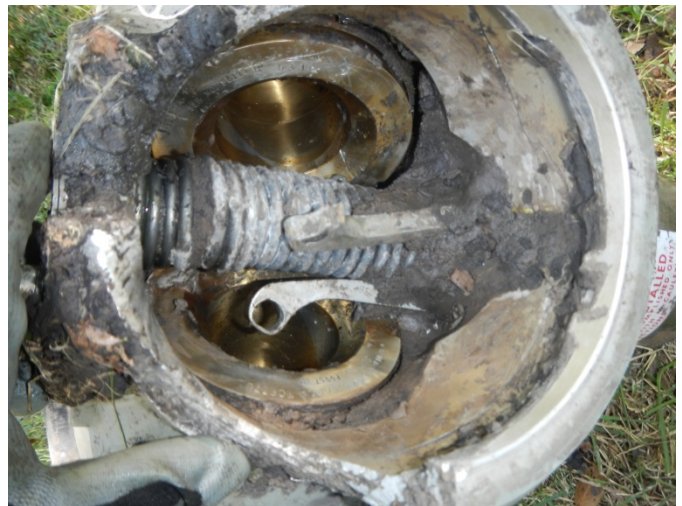
PROPELLER	Manufacturer: McCauley	P/N: 3AF32C504-B	S/N: 861365
Condition:	The right propeller hub was fractured and two of the three blades remained attached to the hub. The separated blade was recovered. All of the blades' pitch change links were fractured. All three blades were twisted toward low pitch. Blade #1 displayed heavy s-bending, leading edge gouging, and was bent in a u-shape. The #1 blade also displayed a chicken wire pattern on its camber side, and investigators observed chicken wire in one of the trees that was cut by the propeller.
