Continental Motors, Inc. Fuel System Component Test and Analysis Report

Date Received:		06/05/2013 and 07/09/2013		Analytical Date:		07/16/2013	
Warranty Claim #:		N/A		RGA #:		N/A	
Engine Model:		IO-550-B39		Engine Serial #:		684677	
Component P/N:		Metering Unit 649468-2		Component S/N:		A00HA381	
Component P/N:		Fuel Pump 646212-18		Component S/N:		B00HA286	
Component P/N:		Fuel Nozzles		Component S/N:		N/A	
Component P/N:		Fuel Flow Transducer		Component S/N:		Unknown	
Engine:	Component:	<input checked="" type="checkbox"/> New:	<input type="checkbox"/> Rebuilt:	<input type="checkbox"/> Overhaul:	Date:	Unknown	
Aircraft Make/Model:		Raytheon Aircraft Co. A36		Aircraft S/N:		E3380	Reg. #: N999PK
Engine Position:		Single:	<input checked="" type="checkbox"/> Left:	<input type="checkbox"/> Right:	Front:	<input type="checkbox"/> Rear:	
Engine Build Date:		11/22/2000		Date in Service:		03/06/2001	
Date of Occurrence:		05/28/2013		Engine/Component Hours:		Approx. 960 hours

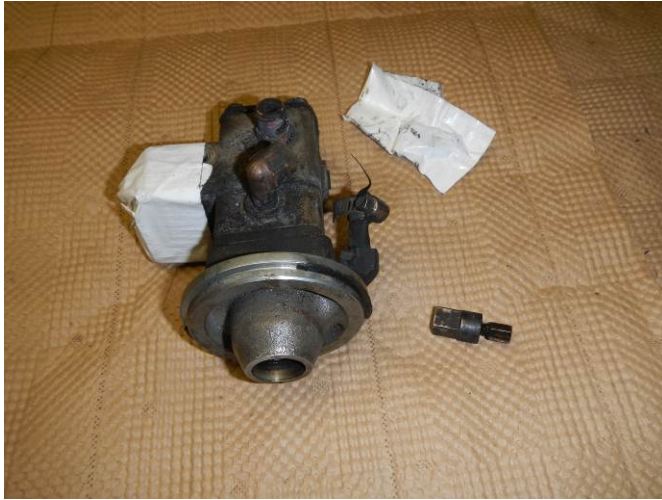
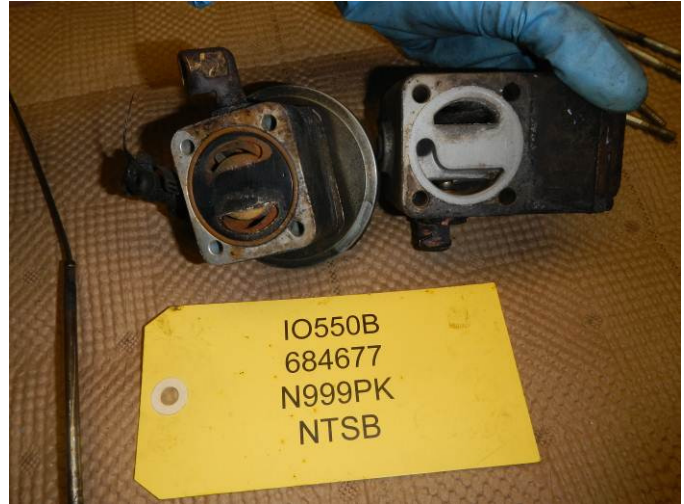
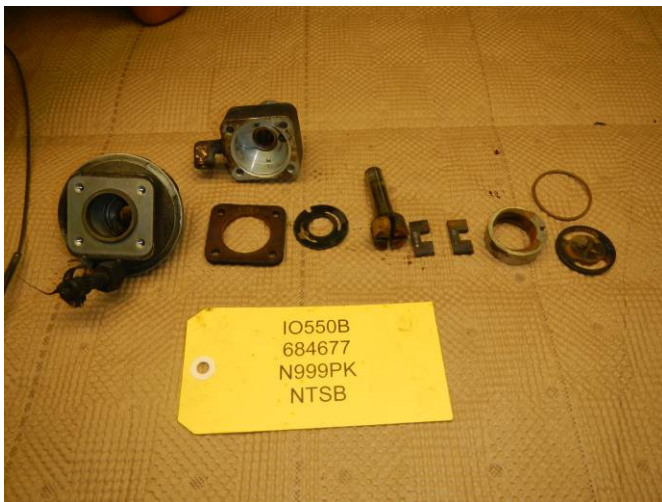
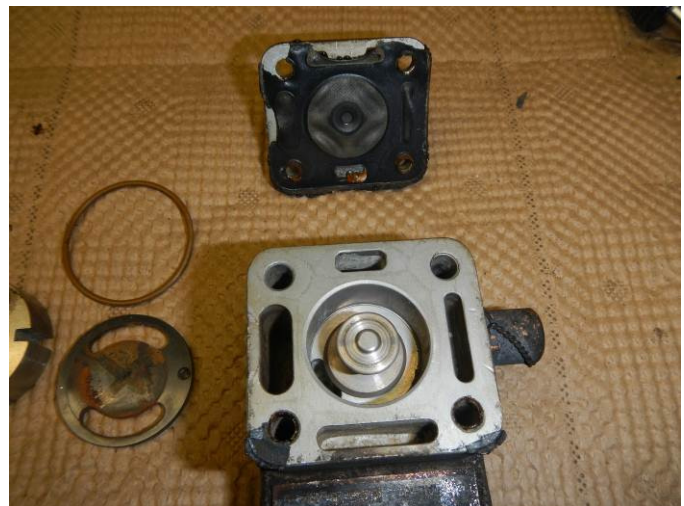
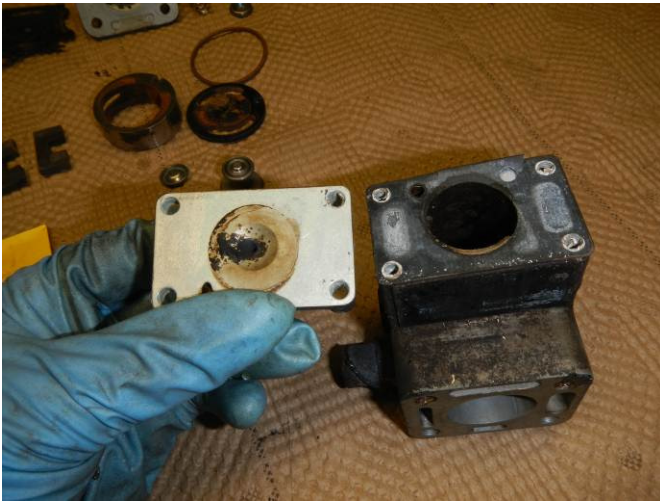
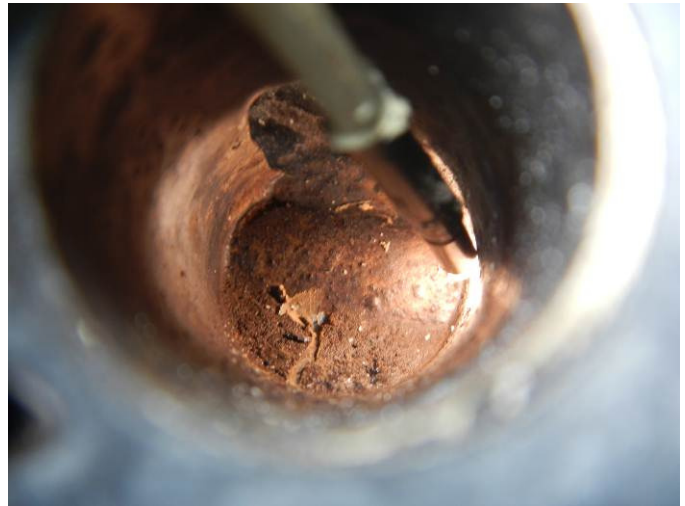
Fuel Pump

The fuel pump remained intact with its safety-wire in place, though the lead seal was thermally damaged. White tape was placed over the inlet and vapor return ports. Disassembly of the pump revealed that all of the pump's internal components were intact and in place, though many of the components sustained thermal damage. Significant amounts of brown, gummy material were found to be obstructing the vapor return ejector and coating the pump's swirl chamber. The NTSB Materials Laboratory will evaluate the material.

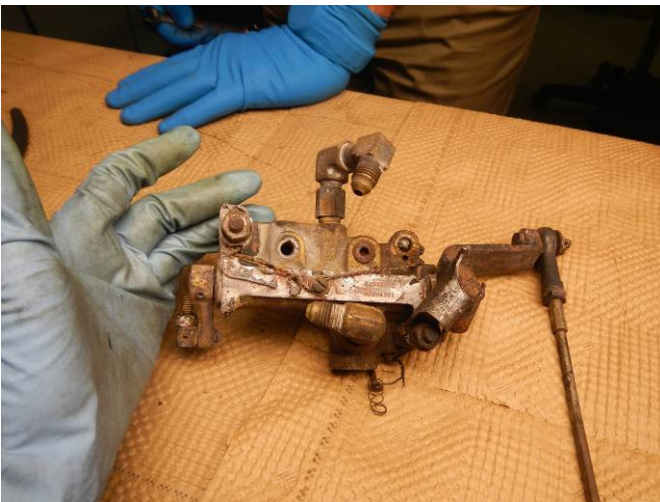
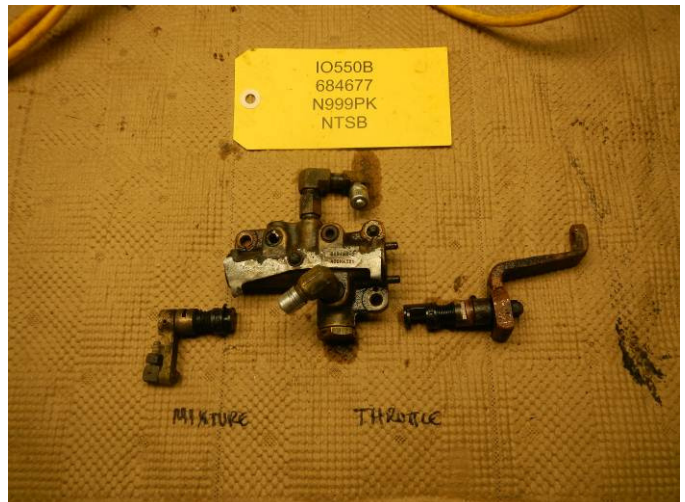
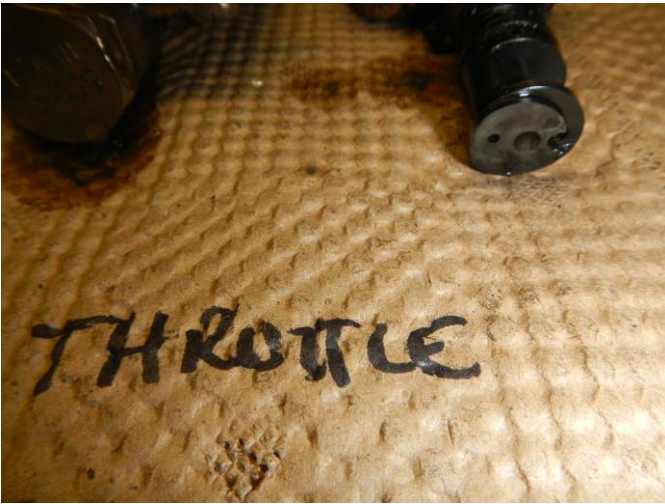
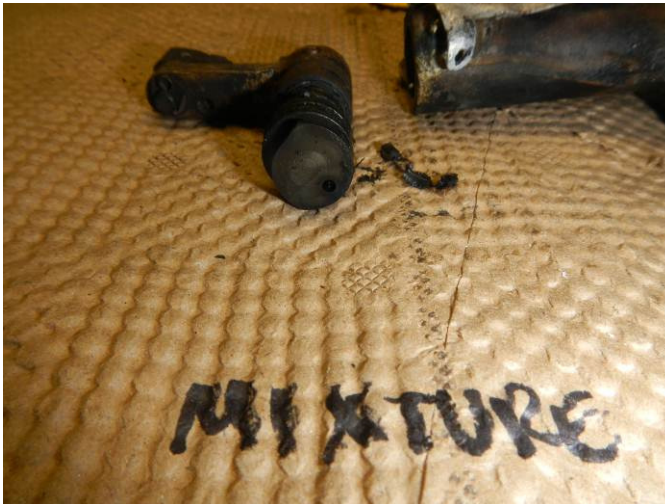
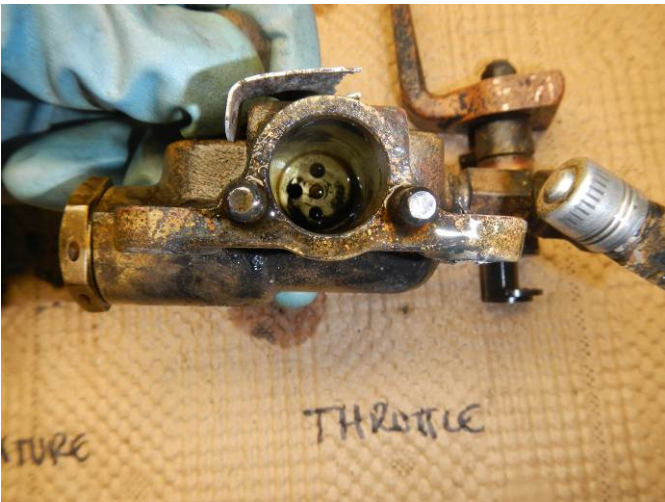
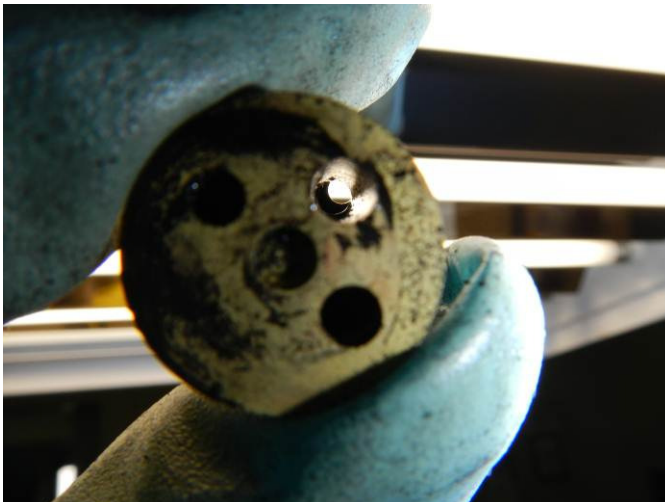
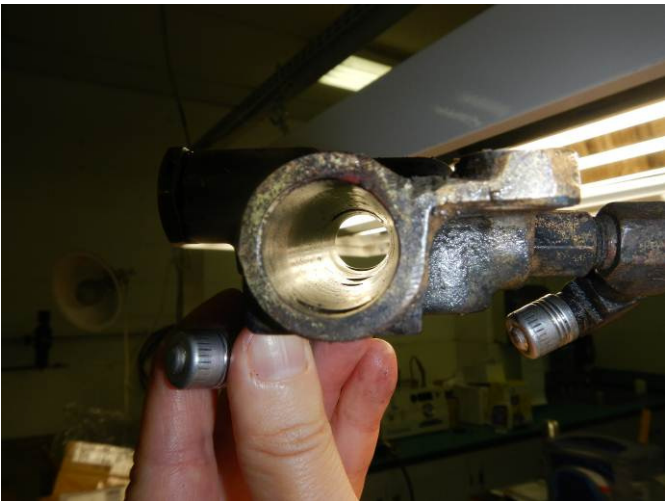
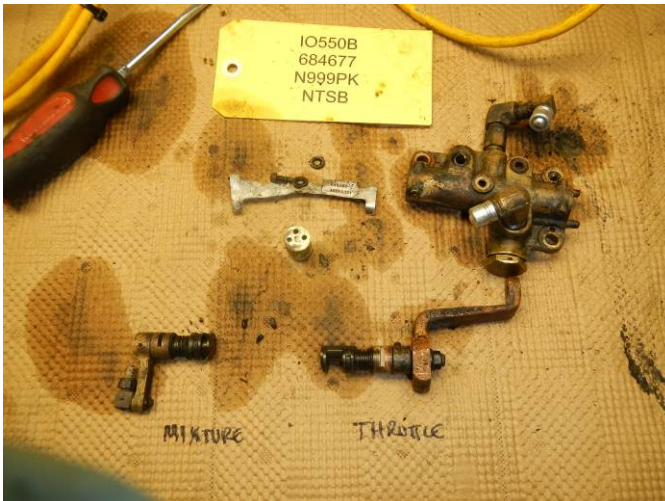
Fuel Metering Unit

Condition: The fuel metering unit remained intact though the fuel outlet fitting was fractured inside the metering unit body. The unit sustained significant thermal damage that consumed portions of the data plate and leaving only a small amount of the safety-wire lead seal in place. The fuel inlet screen was removed during a post-accident examination at the salvage facility. The throttle and mixture control shafts would not rotate within the fuel metering body. A penetrating catalyst was sprayed into all of the metering unit ports. After soaking in the catalyst, the throttle and mixture control shafts could be rotated within the body and removed from the unit. Removal of the mixture and throttle control shafts revealed that their o-rings sustained thermal damage, but the unit's internal components remained intact, sustaining only thermal discoloration.
