Continental Motors, Inc. Ignition System Analytical Report

Date Received:	06/05/2013	Analytical Date:	07/16/2013		
Warranty Claim #:	N/A	RGA #:	N/A		
Engine Model:	IO-550-B39	Engine Serial #:	684677		
Aircraft Make/Model:	Raytheon Aircraft Co. A36	Aircraft S/N:	E3380	Reg. #:	N999PK
Engine Position:	Single: <input checked="" type="checkbox"/> Left: <input type="checkbox"/> Right: <input type="checkbox"/>	Front:	<input type="checkbox"/>	Rear:	<input type="checkbox"/>
Engine Build Date:	11/22/2000	Date in Service:	03/06/2001	Date Removed:	N/A
Date of Occurrence:	05/28/2013	Magneto Hours:	Approx. 960 hours		
Components Returned:	Left and Right Magneto and Sparkplugs				
Returned By:	Mike Huhn – NTSB investigator-in-charge (IIC)				
Magneto Model/P/N:	Left: Slick 6310	Magneto S/N:	00091583		
Magneto Model/P/N:	Right: Slick 6310	Magneto S/N:	00091606		
Ignition Harnesses:	N/A (destroyed)				
Sparkplug Type:	Champion RHB32S				
Party to the Inspection:	Phillip Grice – CMI

Party to the Inspection:	Nicole Charnon – CMI				
Party to the Inspection:	Mike Huhn – NTSB				
Party to the Inspection:	Kris Wetherell – Beechcraft				
Reason for Return:	NTSB Accident Investigation – WPR13FA244				
I

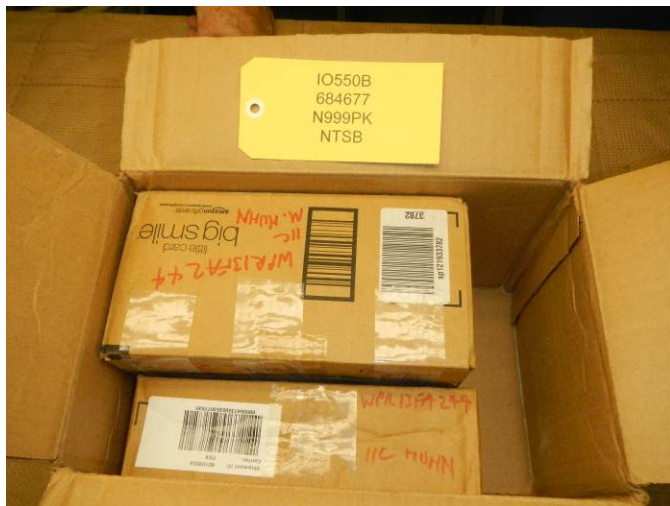
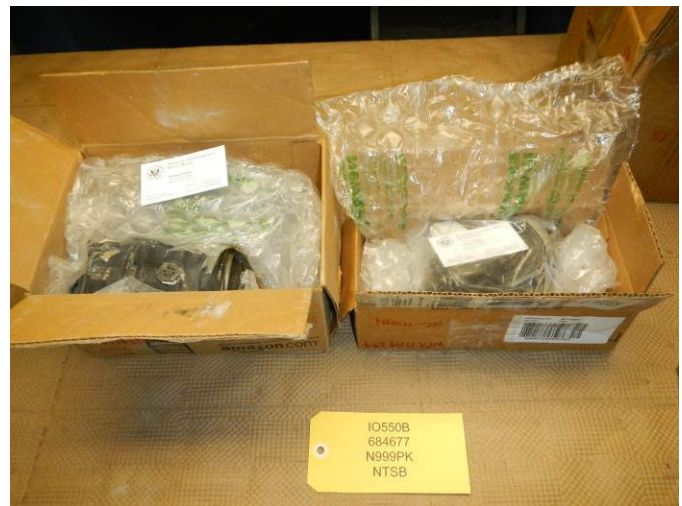
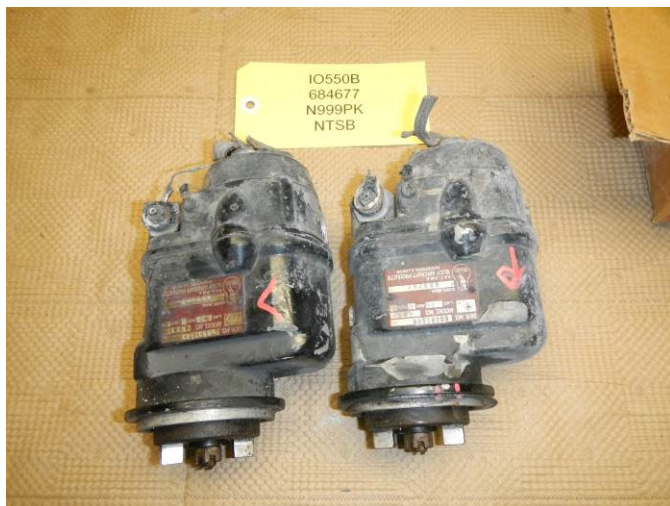
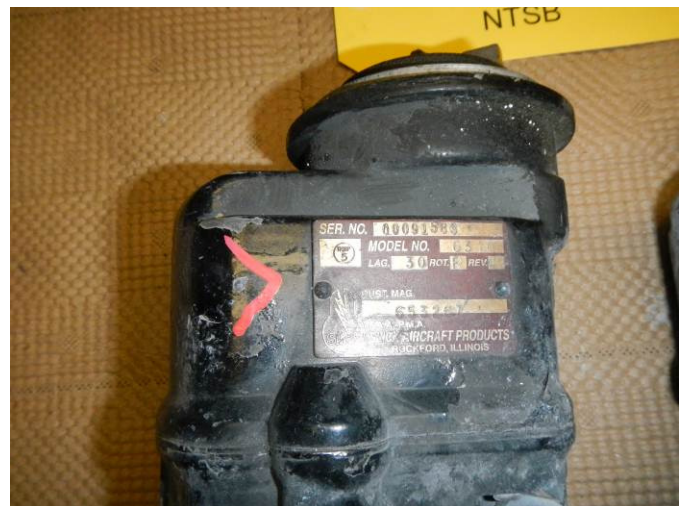
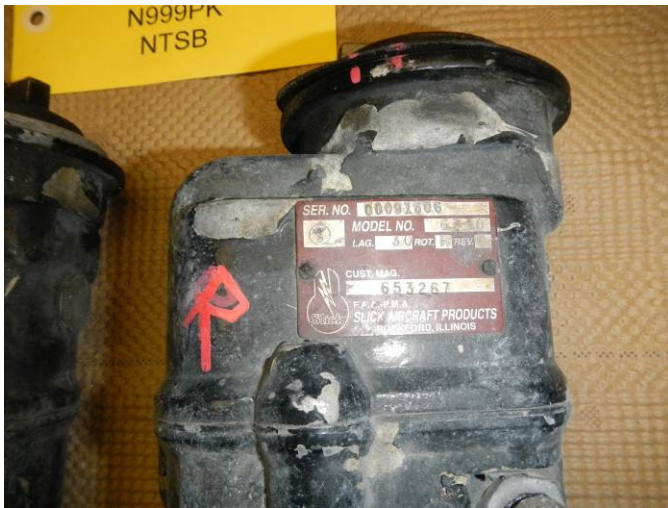
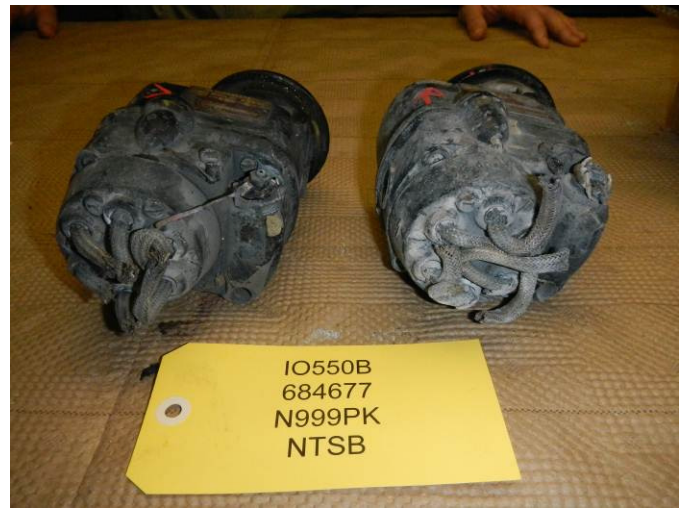
Left Magneto

Analytical Report: The magnetos were removed from the shipping package and were photographed. Both magnetos sustained thermal damage. The ignition harnesses sustained significant thermal damage and the ignition leads were cut. Manual rotation of the magneto drive shafts revealed they would turn freely with impulse coupling engagement. Placement of the magnetos on the test bench with a substitute ignition harness revealed that neither magneto would produce a spark across a 7 mm gap. The magnetos were partially disassembled and the capacitor for each magneto was found to be thermally damaged. A replacement capacitor was placed in each magneto and the magnetos were returned to the test bench. With the replacement capacitor, the right magneto produced a blue spark across a 7mm gap. The left magneto was only capable of producing a blue spark across a 7 mm gap irregularly and intermittently. The magnetos were again partially disassembled and examined. Both of the magnetos sustained thermal damage to the distributor block, capacitor, internal wires, and the coil, with the left magneto sustaining more thermal damage than the right. It is likely that the thermal damage to the left magneto's internal components provided an internal electrical short, which only permitted irregular and intermittent current to the distributor block. With the exception of the thermal damage sustained by both magnetos, no other anomalies were noted. Testing of the Champion RHB32S fine-wire sparkplugs in a SPCT-100 Spark Plug Cleaner Tester revealed that all of the sparkplugs were capable of producing a spark, with the exception of the #6 top spark plug. The #6 top spark plug had a fractured ceramic insulator in the barrel.
