TELEDYNE CONTINENTAL ® AIRCRAFT ENGINE

SERVICE BULLETIN

SUBJECT: IMPROVED CAMSHAFT GEAR P/N 656818

SB05-8A

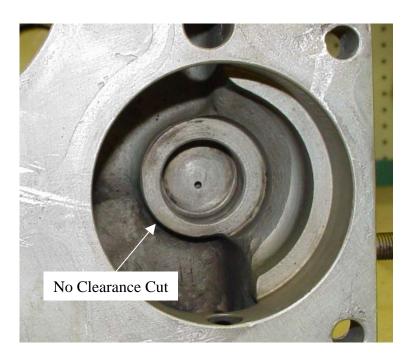
FIGURE 1 UN-MODIFIED PERMOLD CRANKCASE

CAUTION... Installation of the new P/N 656818 gear in an unmodified permold style crankcase will result in damage to the gear and/or the crankcase

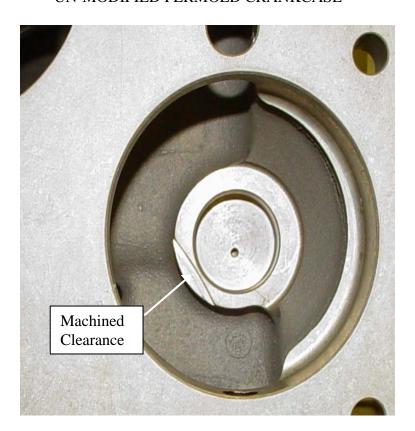
FIGURE 2 MODIFIED PERMOLD CRANKCASE

The P/N 656818 camshaft gear is nominally 0.060" wider than the P/N 656031 camshaft gear. On engine models utilizing the Sandcast style crankcase, the P/N 656818 camshaft gear may be installed as a direct replacement for the P/N 656031 camshaft gear. On engine models utilizing the Permold style crankcase, modification of the starter adapter shaftgear bearing boss is required to provide clearance for the wider camshaft gear.

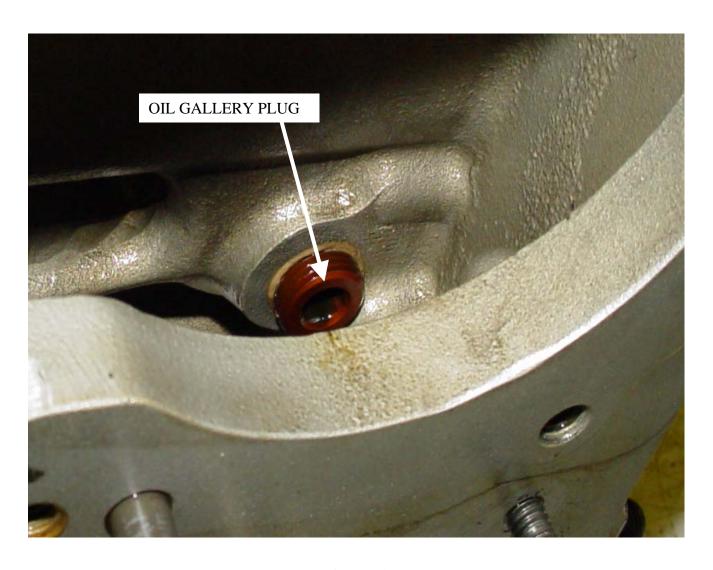
NOTE... On Sandcast crankcase installations clearance must be verified between the new P/N 656818 camshaft gear and the oil gallery plug located directly below the starter adapter boss. (Reference figure 4.)

FIGURE 4
INSTALL CAMSHAFT IN CRANKCASE HALF
INSPECT FOR MINIMUM OF .030 CLEARANCE BETWEEN THE CAMSHAFT
GEAR AND THE END OF THE OIL GALLERY PLUG (WHERE INDICATED).
