Lakehead Pipe Line Company, Inc.

In-line inspection detects early cracking on Canadian crude-oil line

FAILURE SITE MP 1009.90 MARCH 4, 1991 - GRAND RAPIDS, MINNESOTA.

LINE 3 - 34-inch, 0.281-inch wall, API 5LX-52, U.S. STEEL
MARCH 3, 1991, FAILURE GRAND RAPIDS, MINNESOTA.

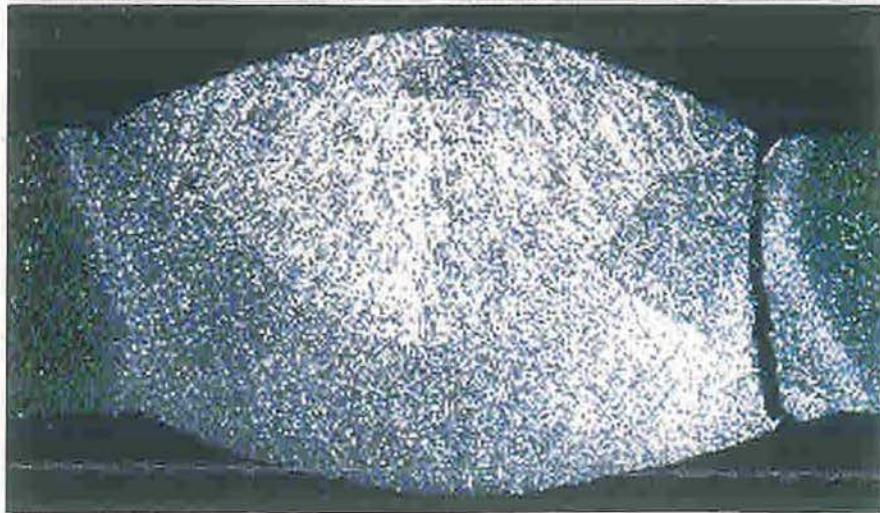
A fatigue crack, like this one shown in cross-section from a 1989 Line 3 fatigue crack, can grow gradually over years and fail under normal line operation (Fig. 3).

In 1989, Line 3 experienced an in-service rupture downstream of the Langbank, Sask., pump station. This was found to have been caused by fatigue cracking at the base of some light external corrosion (less than 8% through wall), aligned with and close to the DSAW long seam toe.

Examination of the excavated pipe joint found no evidence of metallurgical or structural weakness, and it was concluded that the corrosion had created a concentrator for in-service stress

variations. Over many years, this had allowed a fatigue crack to grow so that the joint would fail in normal operation (Fig. 3).

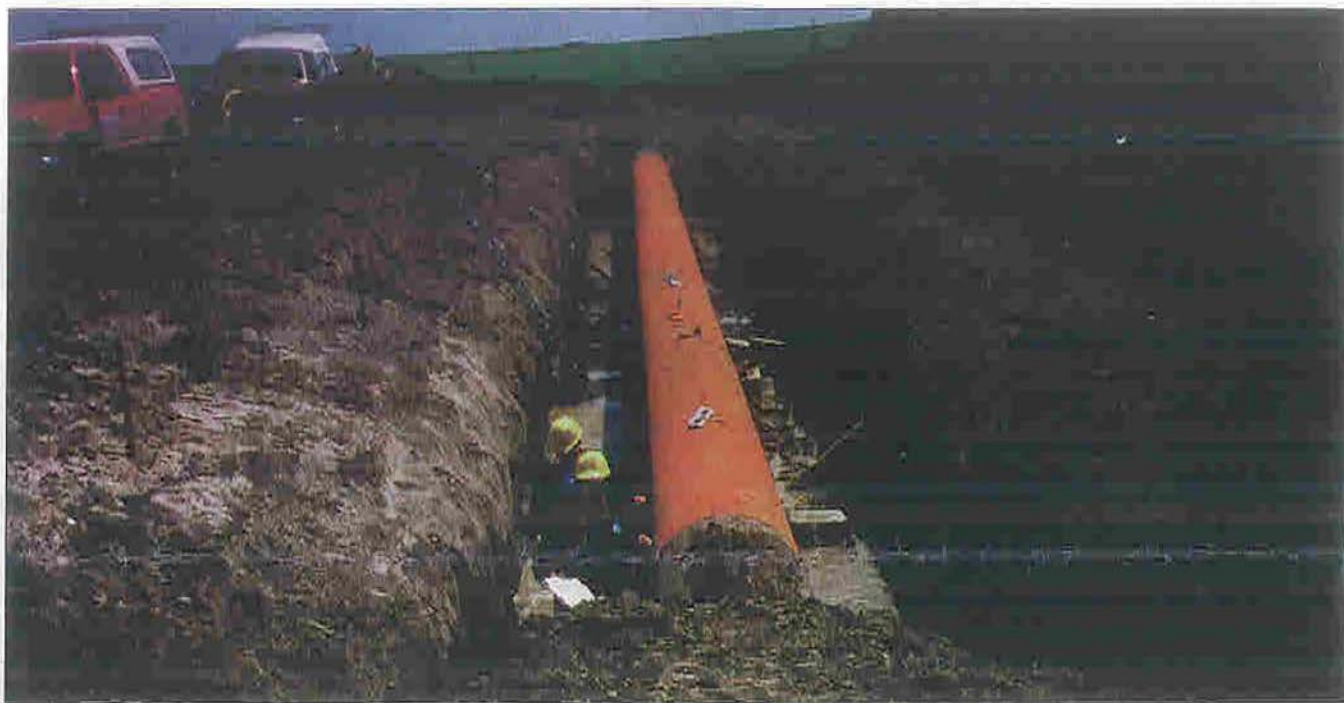
Crews excavate a section of Line 3 to verify results of the EW-vehicle analysis (Fig. 5).

IPL received reports on 73 sites, all of which were excavated (Fig. 5). Ultrasonic indications were found at all but 5 of these sites and pressure-retaining sleeves were applied at 17 locations (Table 1).

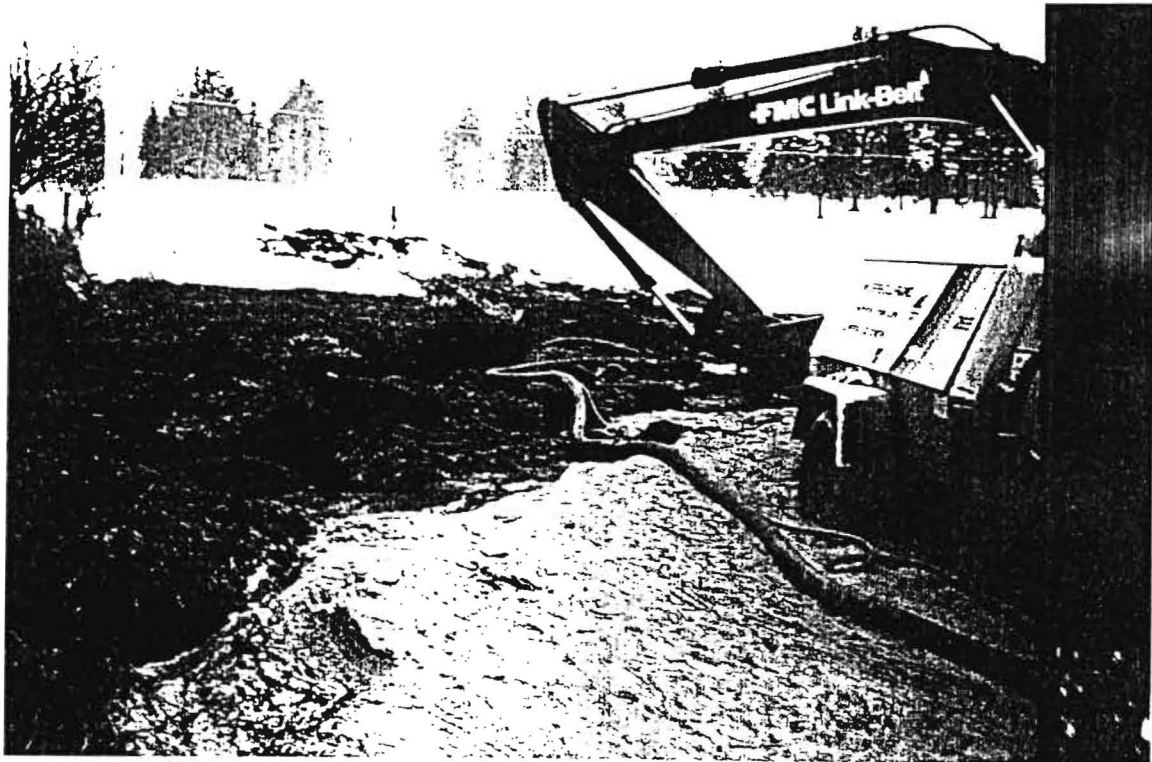
DRAIN-UP OF FAILED PIPE AND FAILURE AREA IS UNDER WAY.

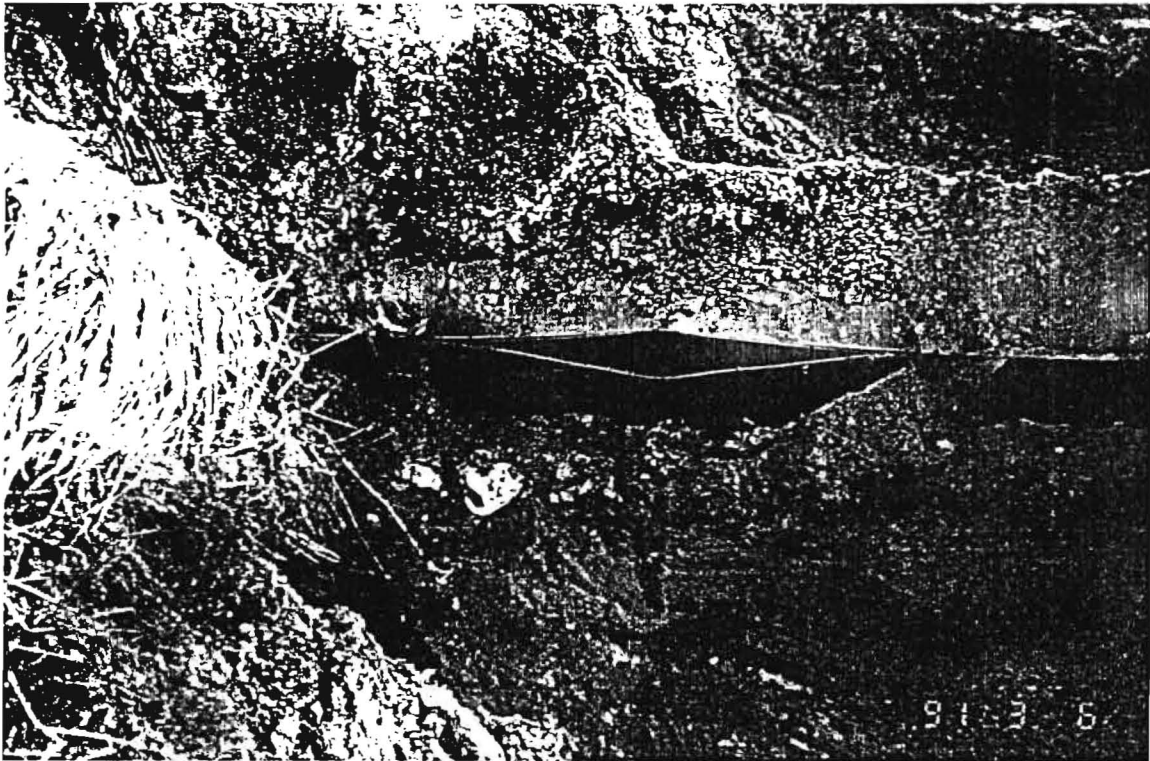
34-inch FRACTURE NEAR TOE OF LONGITUDINAL WELD SEAM.

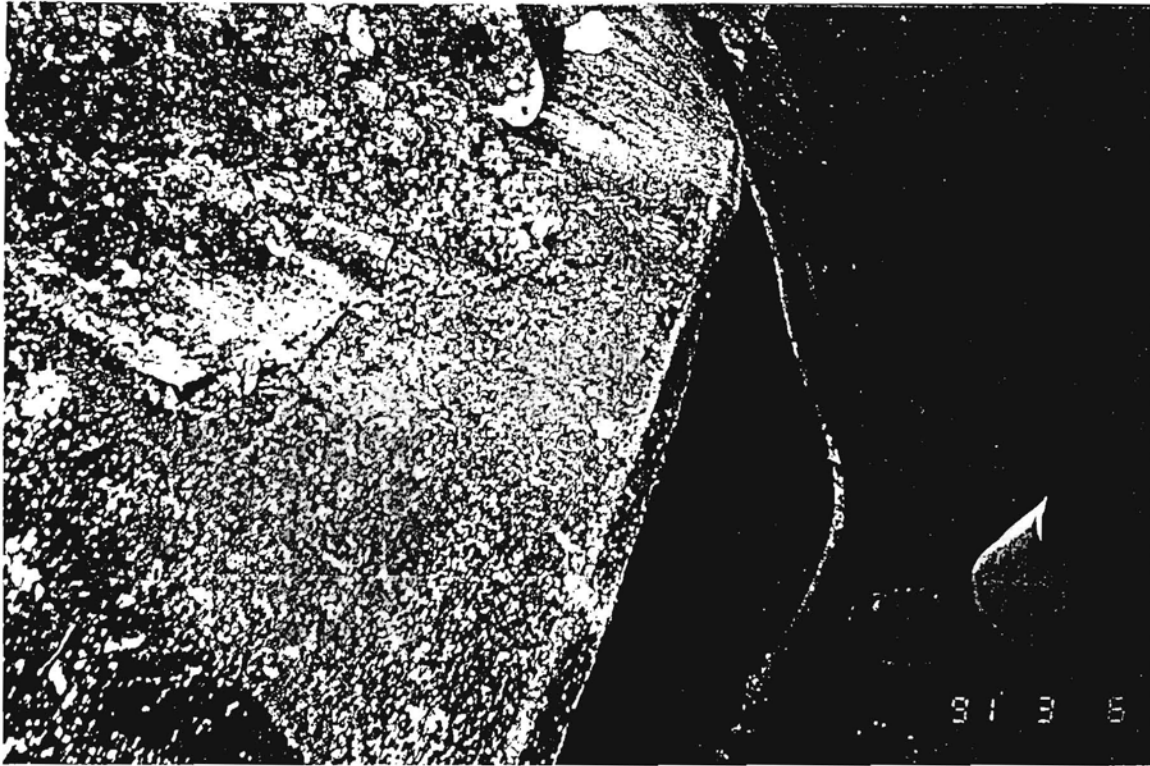
64-inch FRACTURE IN HEAT-AFFECTED ZONE NEAR TOE OF LONGITUDINAL WELD.

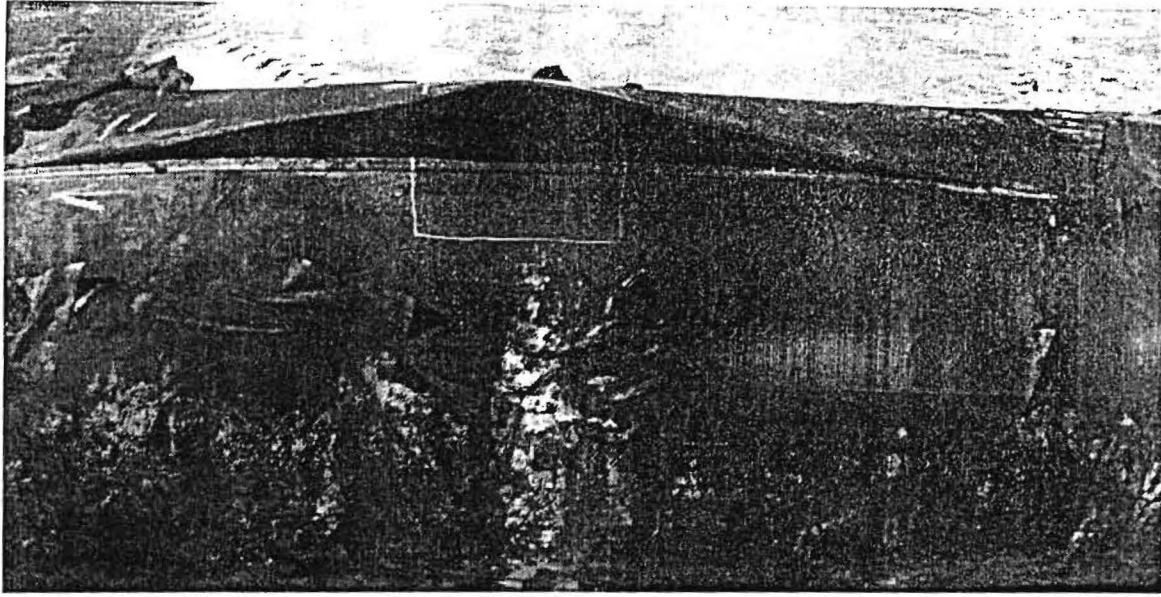
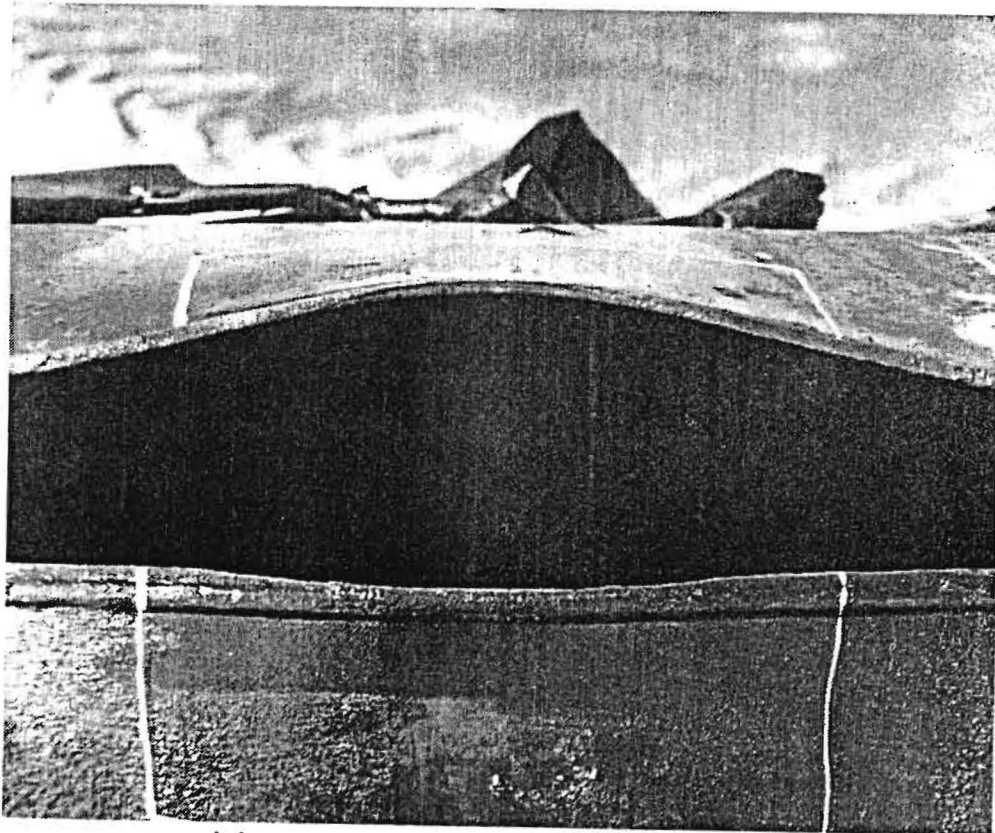
FIGURE 1. VIEW OF FRACTURE BEFORE REMOVAL OF ORIGIN SAMPLE

(a) Total fracture

(b) Close-up view of origin region

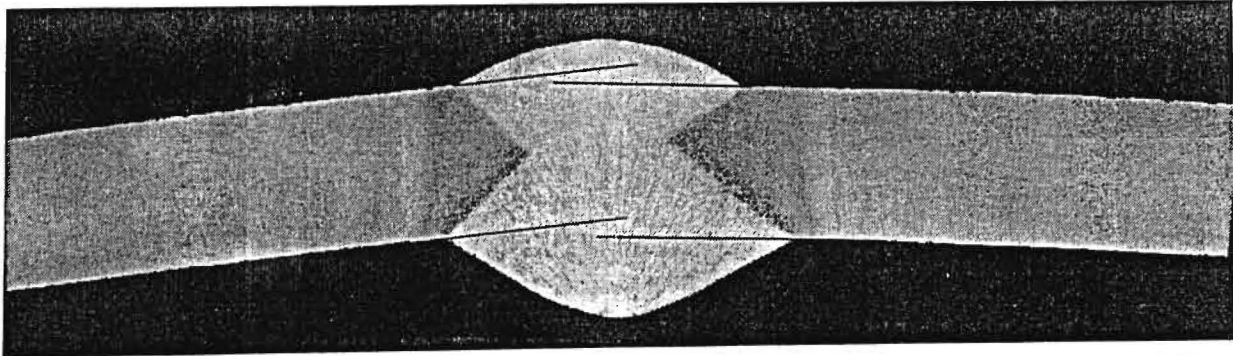
(a) Section indicating plate edge offset
