Enbridge Incorporated
Hazardous Liquid Pipeline Rupture and Release
Marshall, Michigan
July 25, 2010

NTSB/PAR-12/01
PB2012-916501
Notation 8423
Adopted July 10, 2012

Pipeline Accident Report

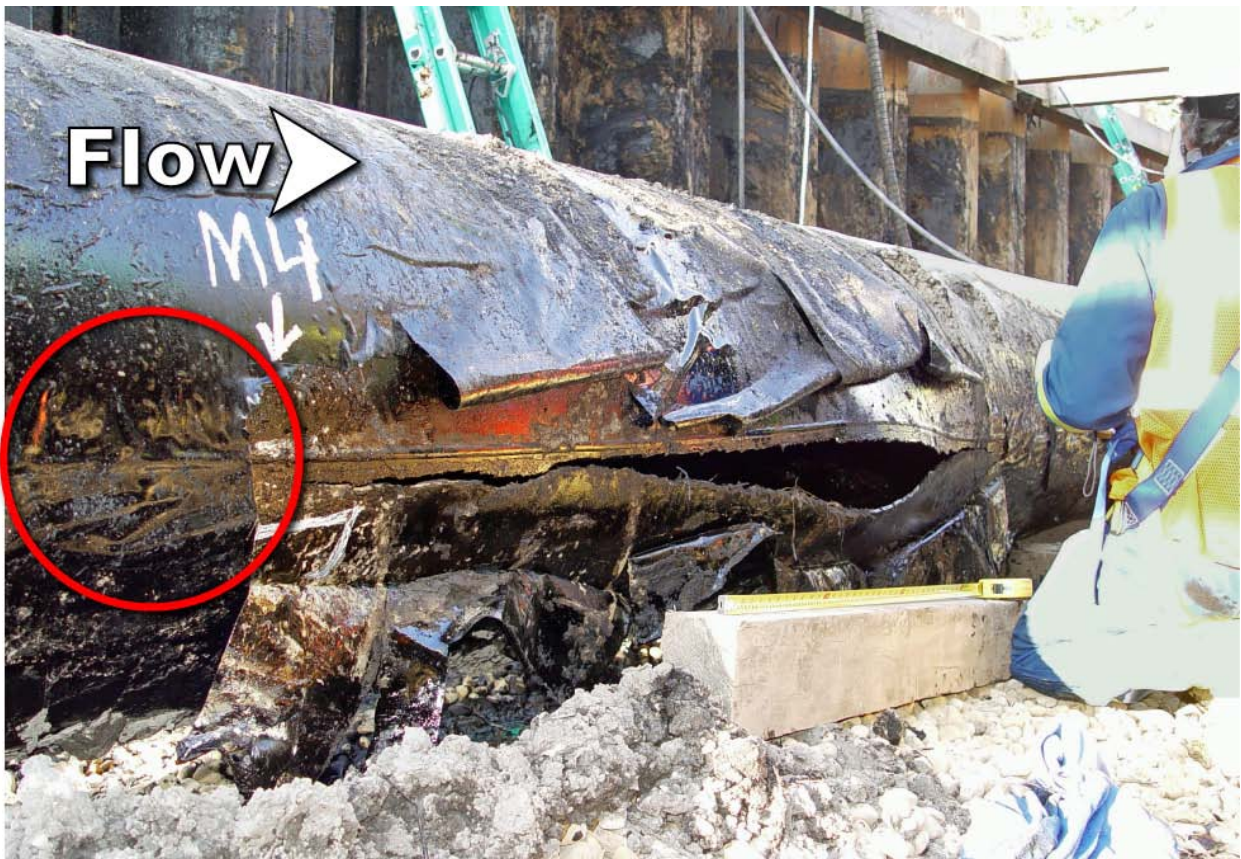
The fracture in the ruptured segment measured 6 feet 8.25 inches long and up to 5.32 inches wide. (See figure 2.) External corrosion was present along the longitudinal weld seam and in areas where the adhesive bond between the pipe and its protective polyethylene tape coating had deteriorated (disbonded). The coating was wrinkled and had separated from the pipe surface as shown in the red circle in figure 2.

Figure 2. The ruptured segment of Line 6B in the trench following the July 25, 2010, rupture. The fracture face measured about 6 feet 8.25 inches long and was 5.32 inches wide at the widest opening. The fracture ran just below the seam weld that was oriented just below the 3 o'clock position. A red circle shows a location where the coating was wrinkled and had separated from the pipe surface.

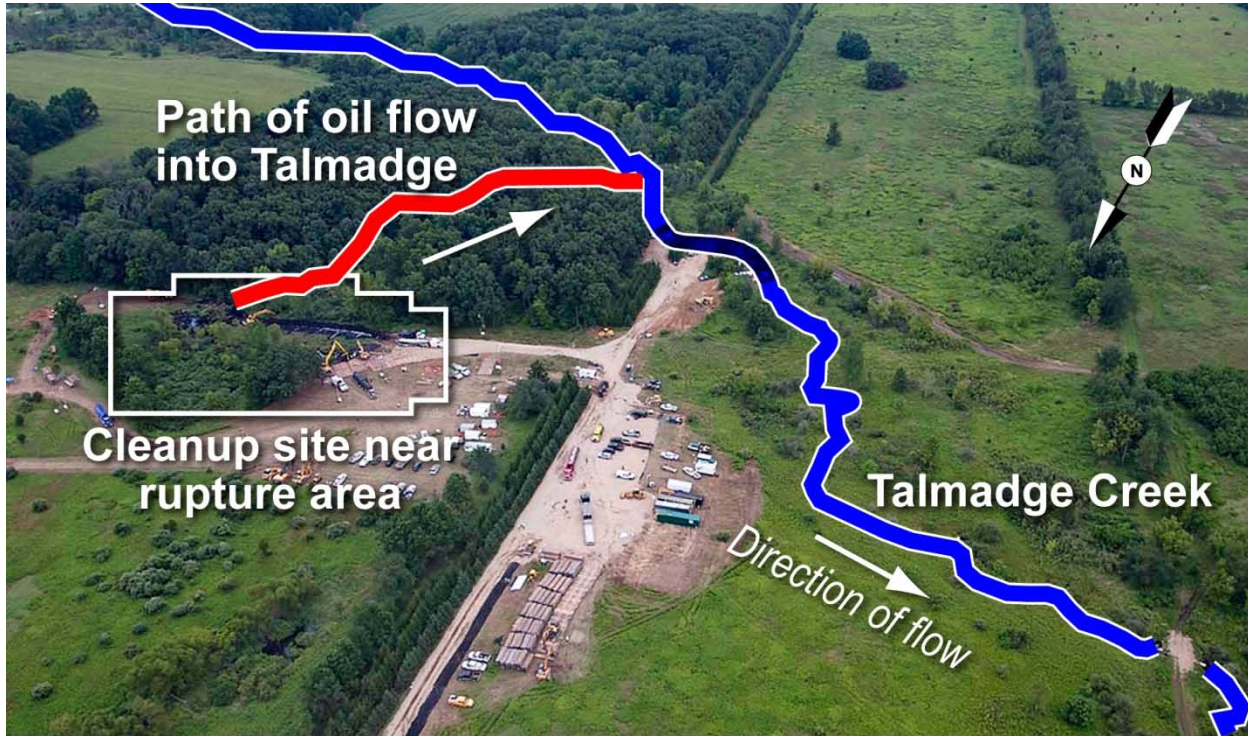
The crude oil release soaked the rupture site and the surrounding wetlands, eventually spreading to the Talmadge Creek and the Kalamazoo River. Enbridge's early response efforts were focused downstream of the rupture. Recent heavy rainfall had increased the flow of the Talmadge Creek and the Kalamazoo River, which spread the oil faster, hindering the response efforts. (See figure 3.)

Figure 3. Aerial view of the accident location showing the rupture site to the left and the Talmadge Creek flowing west toward the Kalamazoo River.

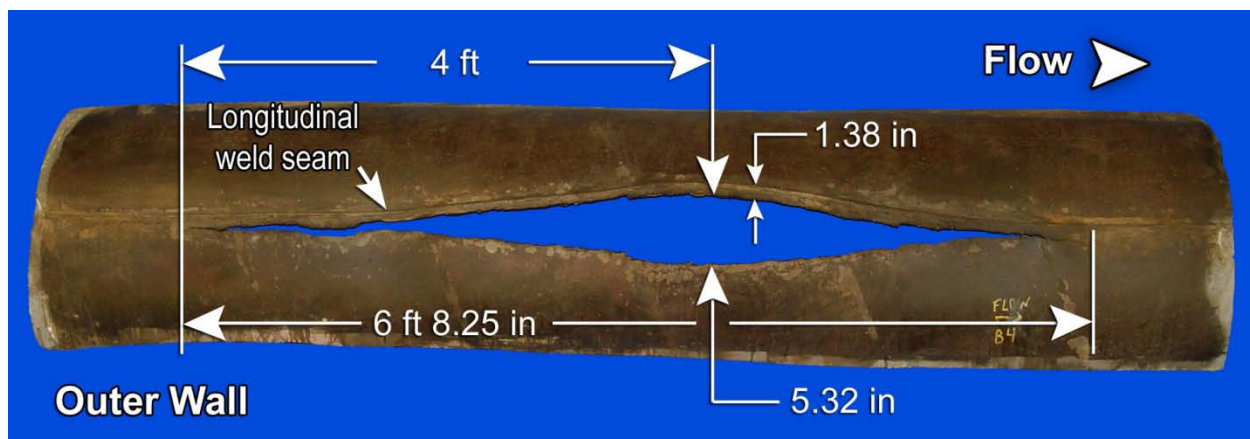
The fracture measured 6 feet 8.25 inches in length with the upstream end of the fracture located 24 feet 5.75 inches away from the upstream girth weld. The widest point along the fracture measured 5.32 inches and was about 4 feet from the upstream end of the rupture. The upper fracture face at the widest opening was measured at 1.38 inches below the longitudinal seam weld away from the heat-affected zone, with this offset ranging from 0.5 to 1.5 inches below the longitudinal weld seam for the length of the fracture face. (See figure 12.)

Figure 12. The outside surface of the pipe looking at the fracture area cut for lab examination.

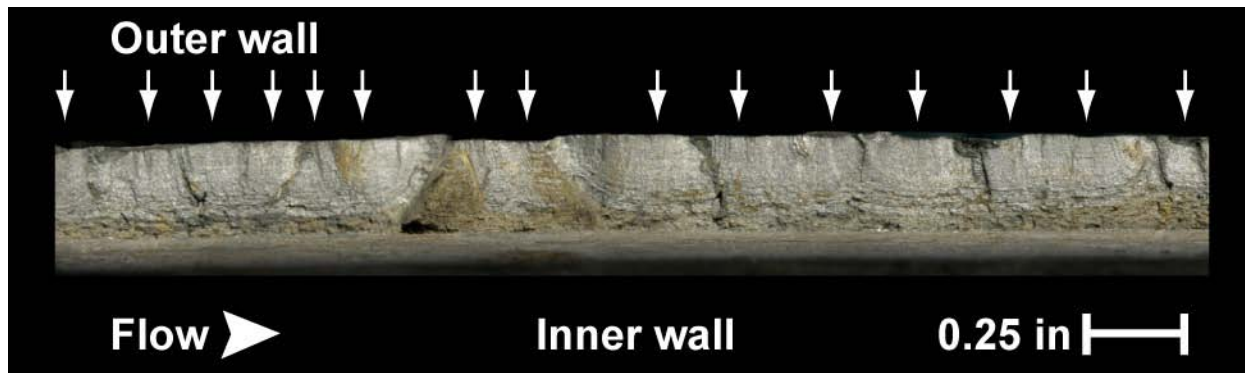
Examination of the fracture face revealed features on slightly offset planes consistent with preexisting cracks initiating from multiple origins in corroded areas on the exterior surface. Evidence of preexisting cracks at various penetration depths was observed across nearly the entire length of the fracture surface. The area of deepest preexisting crack penetration, relative to the original local wall thickness, was located 50.25 inches from the upstream end of the rupture.

observed on the preexisting crack portion of the fracture consistent with oxidation in an oxygen-poor environment.

Figure 13. Curving arrest lines of preexisting cracks along the upper fracture face shown after cleaning to remove oxides. White arrows indicate multiple origin areas of preexisting cracks.

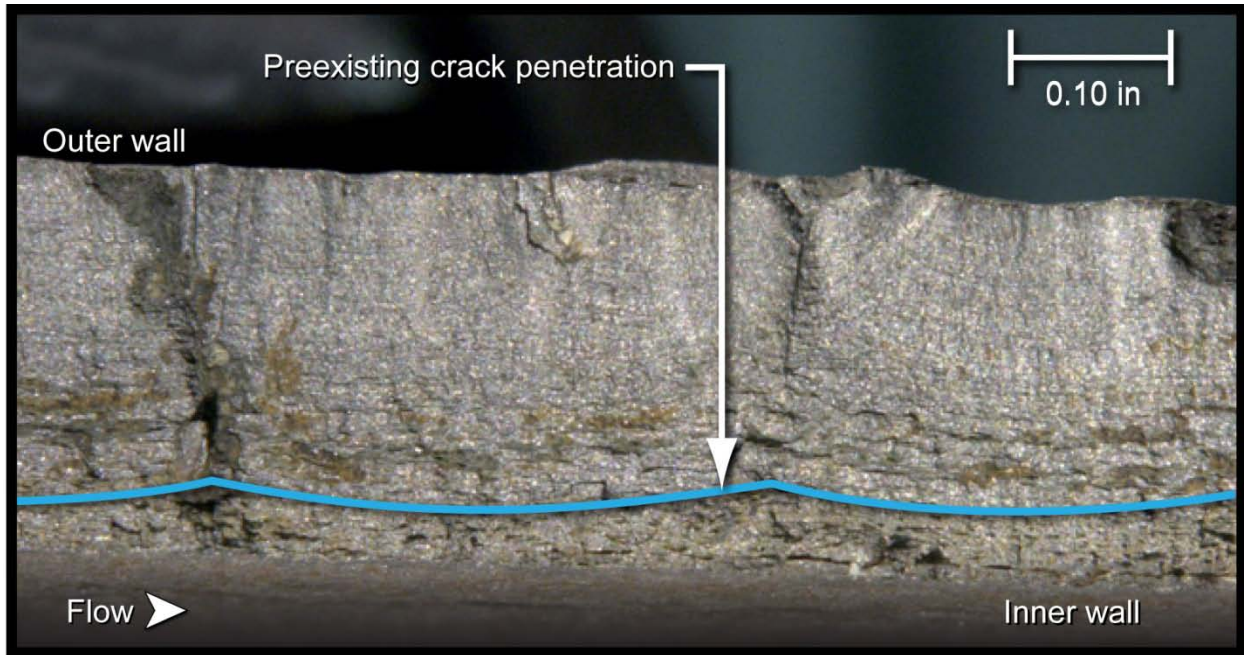
At the deepest crack penetration (see figure 14), the preexisting cracks extended 0.213 inch deep into the wall of the pipe relative to the original exterior surface, or 83.9 percent of the original wall thickness of 0.254 inch. The curving line in figure 14 indicates the extent of preexisting crack growth near the deepest penetration. The remainder of the fracture face had rough, matte gray features consistent with an overstress fracture. The preexisting cracks had fracture features perpendicular to the outside surface, consistent with corrosion fatigue^{46,47} or near-neutral pH stress corrosion cracking (SCC).⁴⁸ Fine crack arrest features were present within about 0.015 inch of the crack origins with broader crack arrest features appearing farther away from the origins. These crack arrest features were indications of progressive crack growth and can be associated with corrosion fatigue or near-neutral pH SCC.

Figure 14. Close view of fracture surface area in the area of deepest crack penetration. The solid blue line indicates the extent of the preexisting crack penetration.

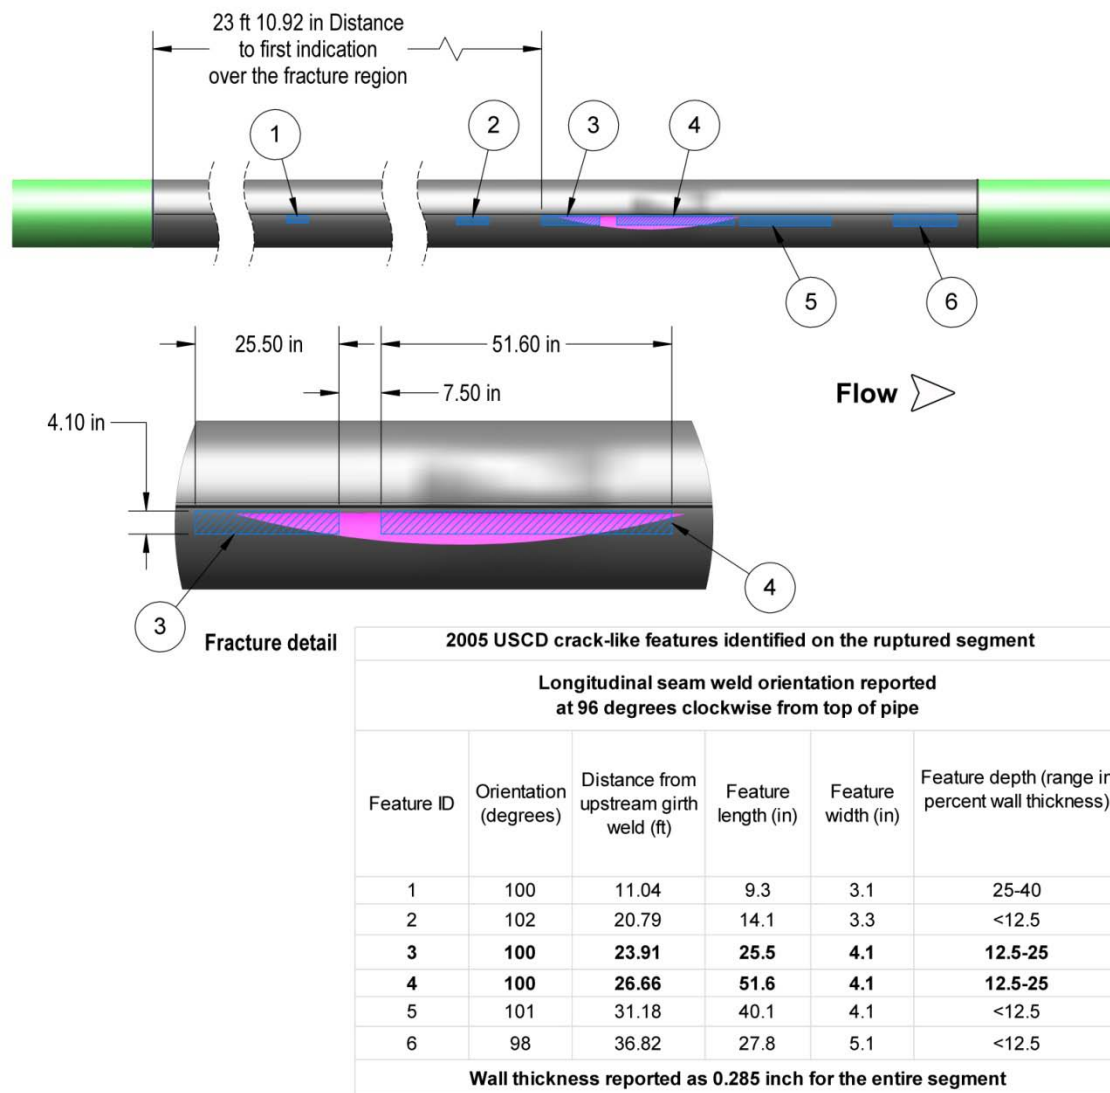
Figure 18. 2005 in-line inspection regions where crack-like characterizations were reported by PII on the ruptured segment of Line 6B.

According to PII, all six features identified on the ruptured segment, including the 51.6-inch-long crack, were originally characterized as crack-field indications by a junior analyst; however, a supervisor changed the analyst’s characterizations to crack-like defects during a final quality check.
