01 July 1999  
B-H200-16716-ASI

Subject: NTSB Recommendation A-99-27, Block Maneuvering Speeds-  
USAir 737-300 N513AU Accident near Pittsburgh, Pennsylvania-  
8 September 1999

**Number:** TBCE-11

**Subject:** MANEUVERING SPEEDS FOR 737-100/200/300/400/500

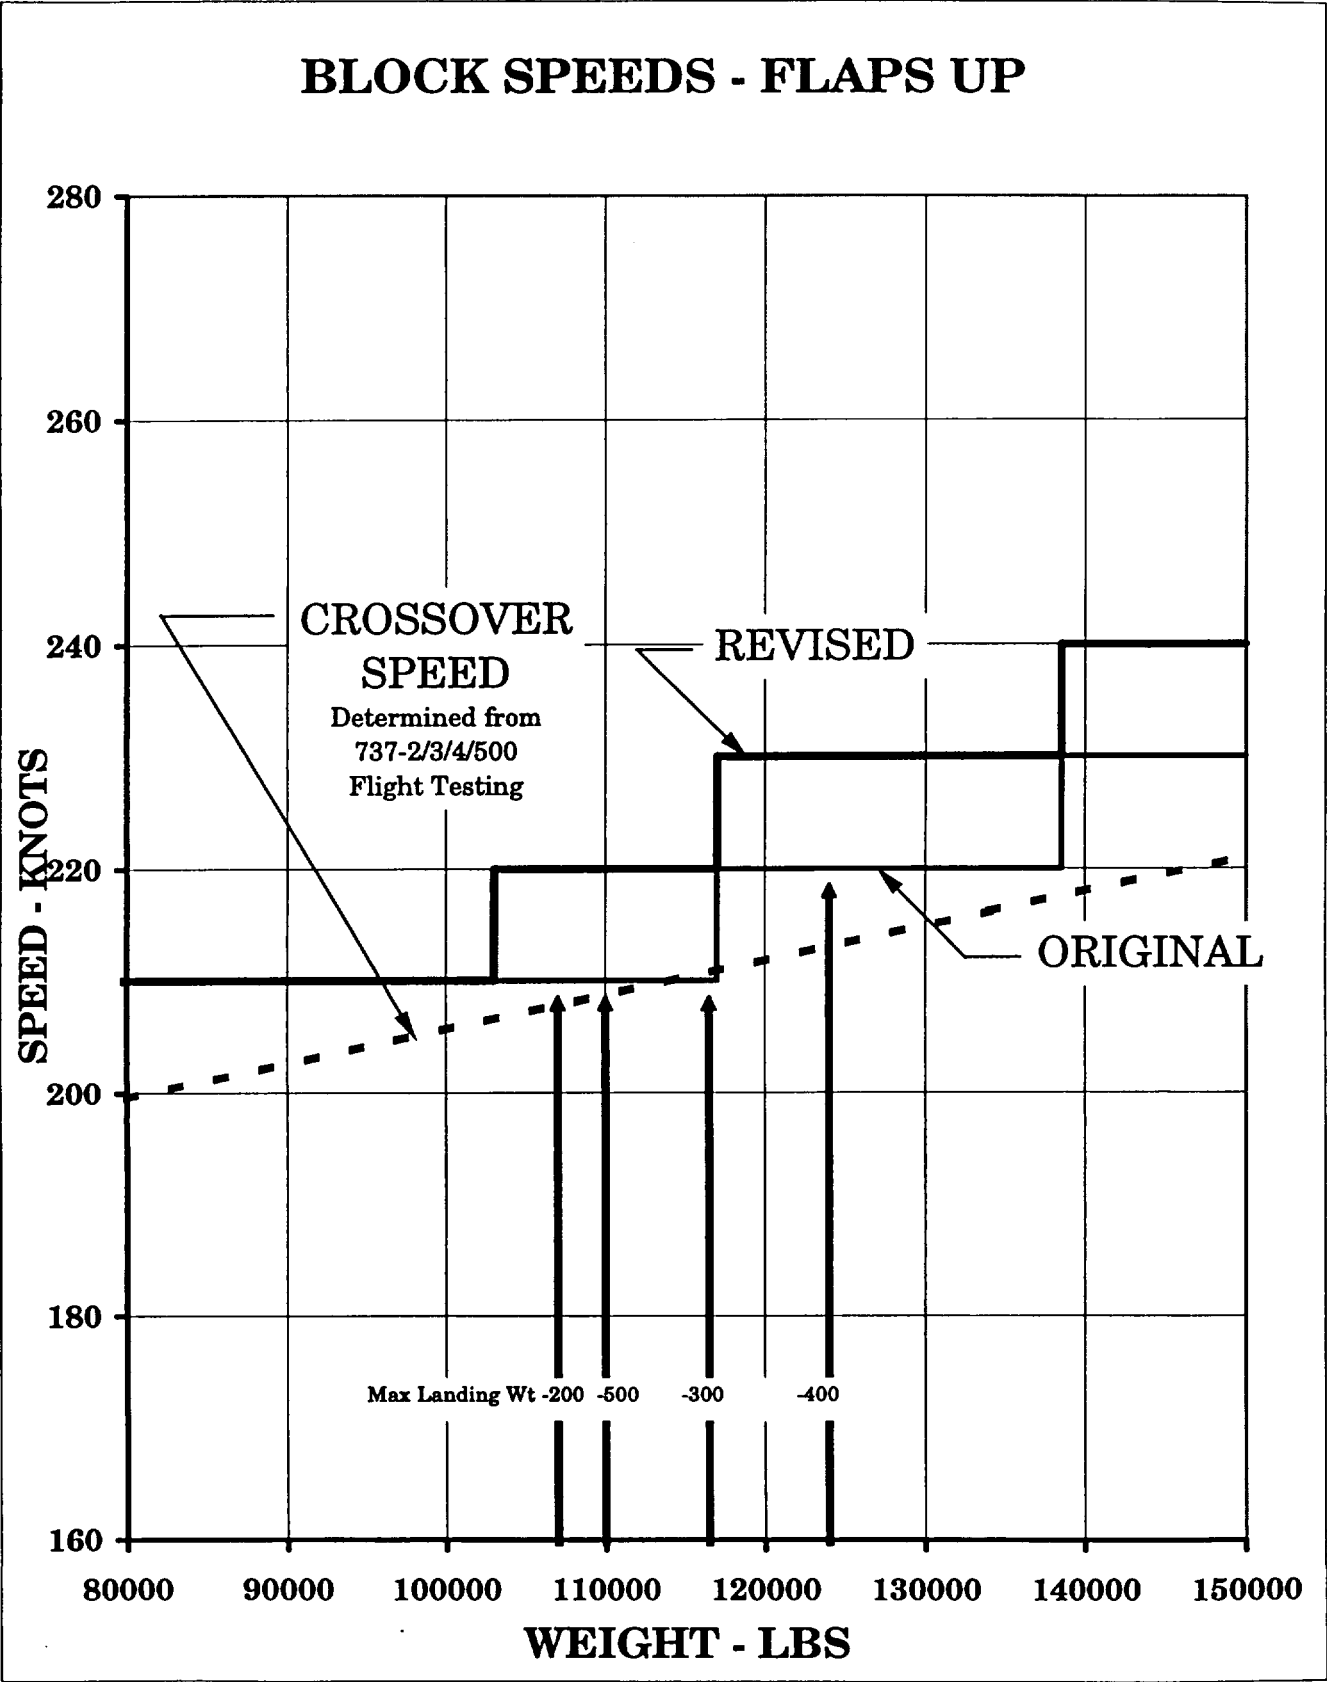
Figure 1

The original and revised recommended Block Speeds along with the crossover speeds are shown in figures 1-4 for flaps up through 10 respectively. Note that the revised Block Speeds are equal to or greater than the crossover speeds up to well beyond the maximum landing weight for any 737 model.
