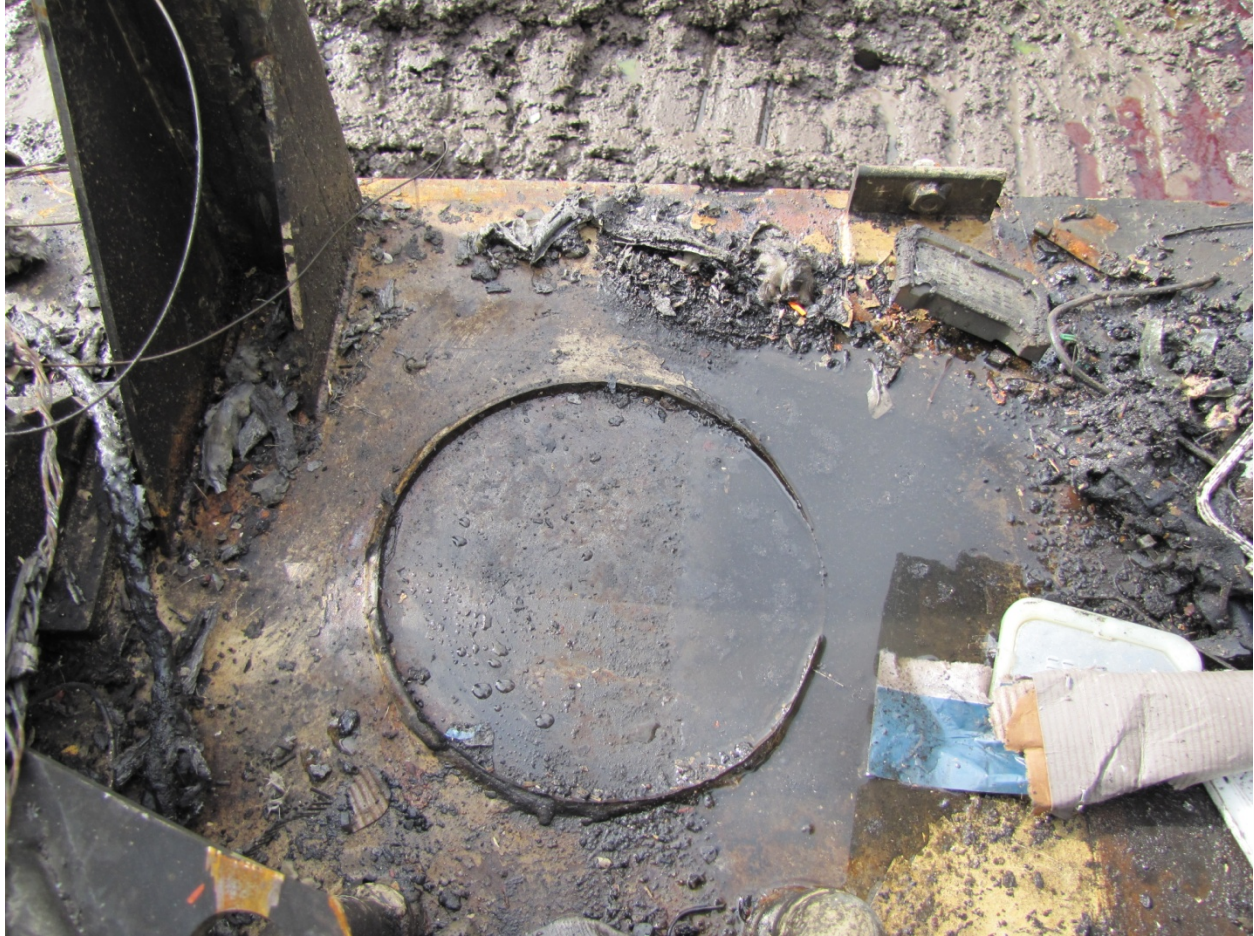
Exhibit 34- Photo Showing Broken Weld of an Operating Cab Rear Mounting Post on BNSF 9159
