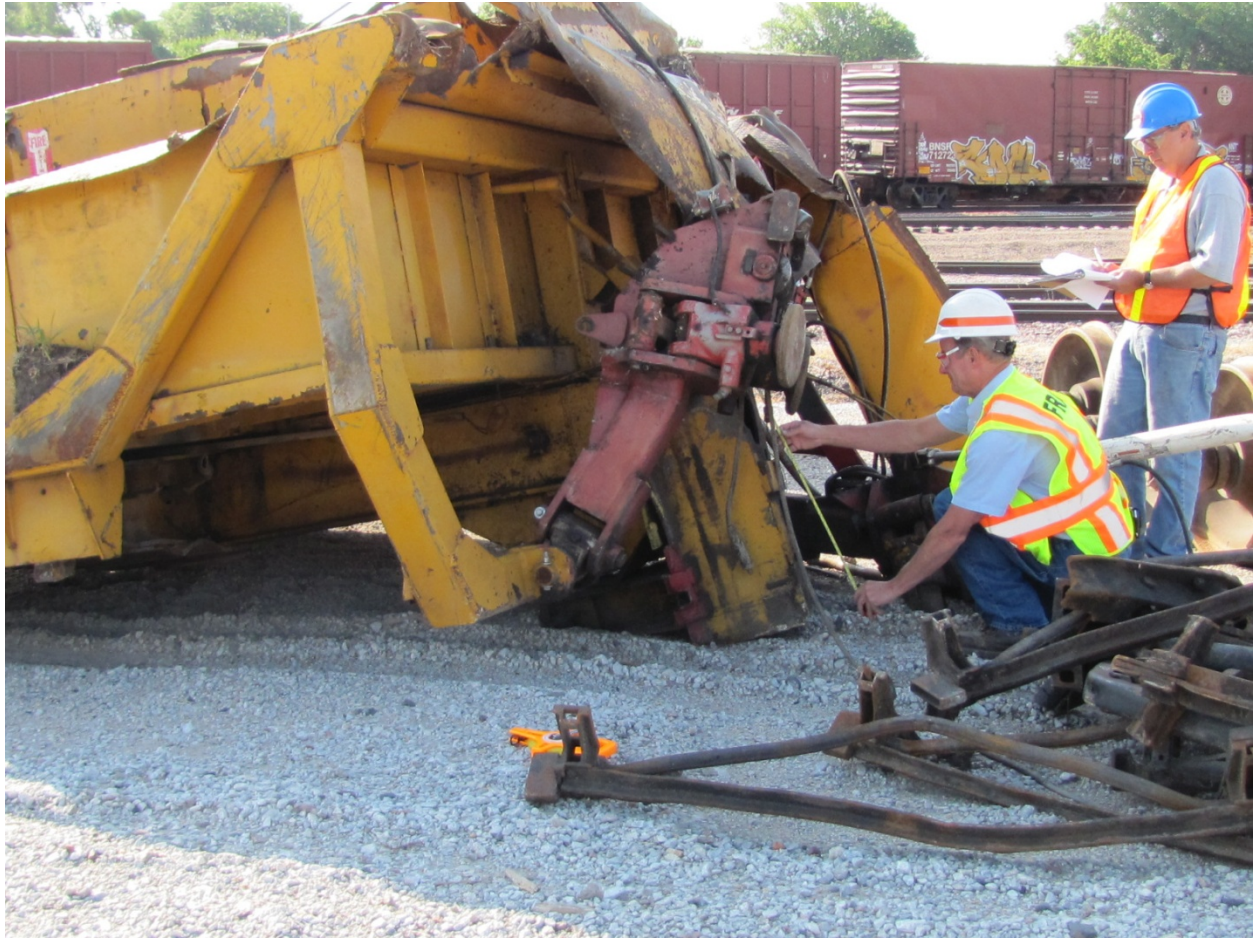
Exhibit 47-Photo Showing Front Section of Center Sill Severed and Bent on HZGX-150 Clip Car
