Exhibit 17.

Post-Recovery Technical Examination – SCRRRA Passenger Coach Equipment¹⁵⁴1. Notes of **California PUC** (typewritten, of the Party Representative)SCAX 617

3. Notes of **Bombardier** (handwritten - scanned, of the Party Representative)

UNIT #617 9/15/08
POST RECOVERY INSPECTION
Side View Cab Car

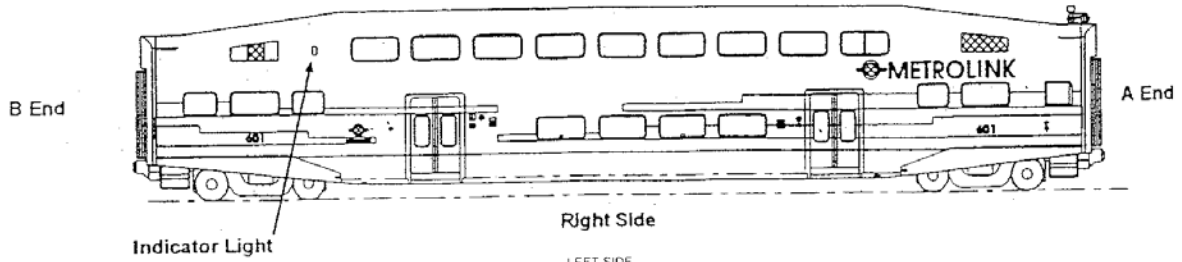
Left Side

NOTE:
UNLESS OTHERWISE NOTED,
SEATS SPECIFICALLY IDENTIFIED
W/LEADER LINES HAVE
CRACKED SEAT SHELL
HANDHOLDS
