National Transportation Safety Board
Office of Railroad, Pipeline and Hazardous Materials Investigations
Railroad Division
Washington, D.C. 20594

Crashworthiness Group Chairman's Factual Report

Train: CSX Transportation local F77703
Train: Amtrak train 91
Location: Cayce, South Carolina
Date: February 4, 2018
Time: 2:27 am EST¹
Number: RRD18MR003

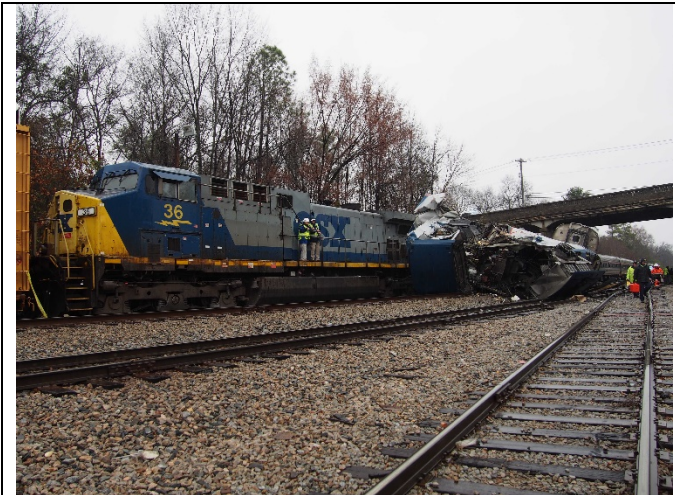
Amtrak train 91 collided head on with standing CSX train F77703. After impact, the front truck of Amtrak locomotive 47 remained on the ground in front of the leading CSX locomotive (number 130). The body of locomotive 47 continued to move forward and rode up and over onto the front and right side of CSX locomotive 130. The CSX train was pushed rearward about 15 feet.

Figure 1- A view of the accident site

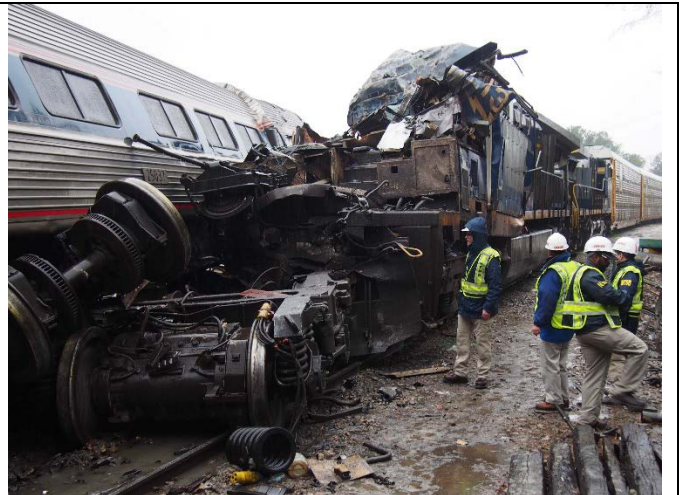
Figure 2- The front end of locomotive 130

The front coupler was pushed rearward, and the draft pocket was destroyed. Above this area, the deck was bent upward. The collision posts were sheared at the bottom of the posts. The structures surrounding the cab, the cab control stands, and the crew seats were fully displaced from the deck and destroyed. The entire body of the locomotive was pushed and displaced rearward, and the left side was crushed downward. On the right side of the locomotive behind the cab, there was a buckle in the side sill.

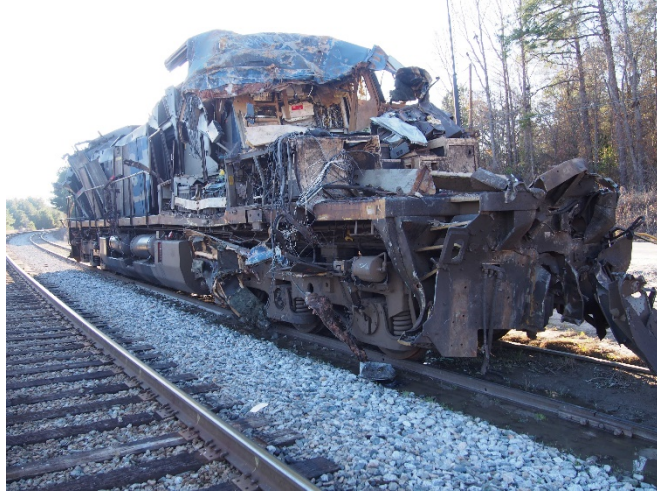
Figure 3- The front of locomotive 130

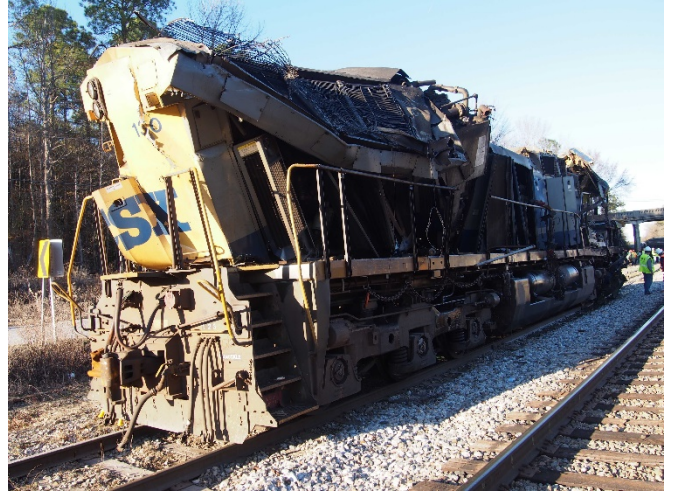
Figure 4- The rear of locomotive 130

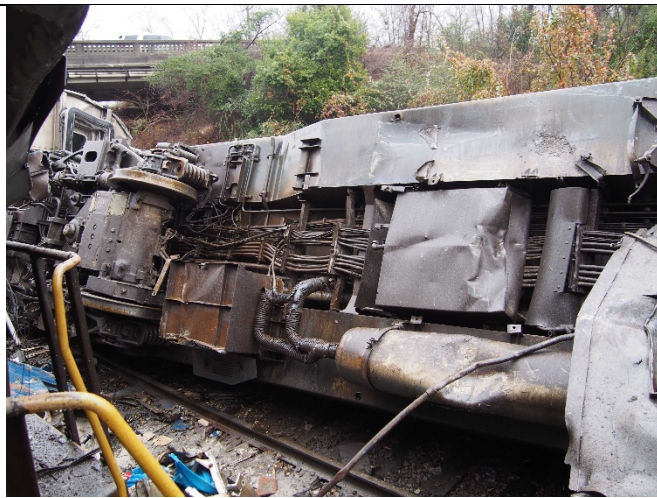
The platform of the Amtrak locomotive twisted 180 degrees and rotated underneath the body of the locomotive. There were impact marks on the front coupler, and the draft pocket was generally intact. The cab area was separated from the platform and completely crushed. The rear of the locomotive body was crushed forward and inward. On the underside of the locomotive, there was buckling of the underframe and scrape marks on exterior components. The fuel tank ruptured.

Figure 5- The underside of locomotive 47

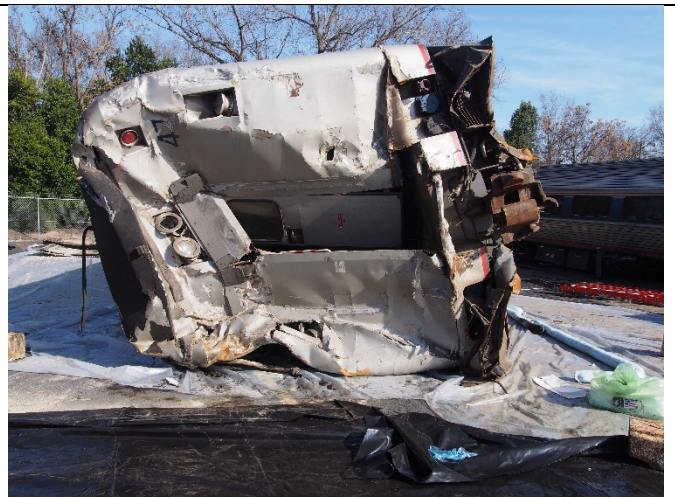
Figure 6- The rear of locomotive 47

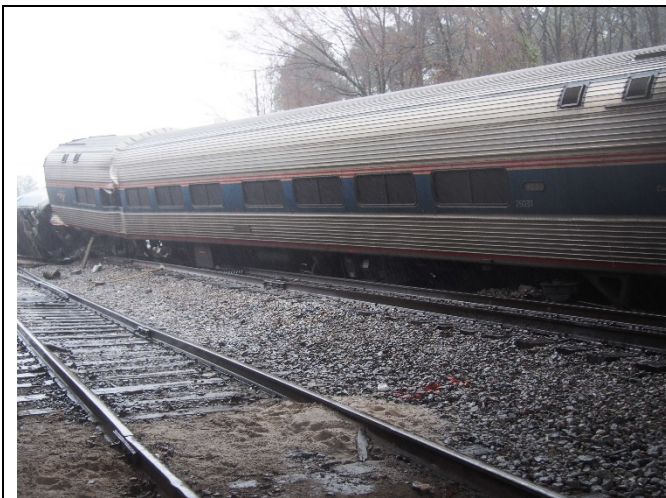
The front truck was separated from the carbody and came to rest partially on top of locomotive 47's front truck (see figure 2). The bolster was recovered from the deck of CSX locomotive 130. There were impact marks on the front coupler, and the draft sill was damaged. The rear draft pocket was buckled. The carbody came to rest raised upward next to locomotive 130. Near the second windows (from the front of the car), the carbody was buckled around the circumference of the car.⁵ On the right side, the second window was pushed inward from the sidewall. The collision posts on both ends of the car appeared intact.

Figure 7- The left side of coach 25037

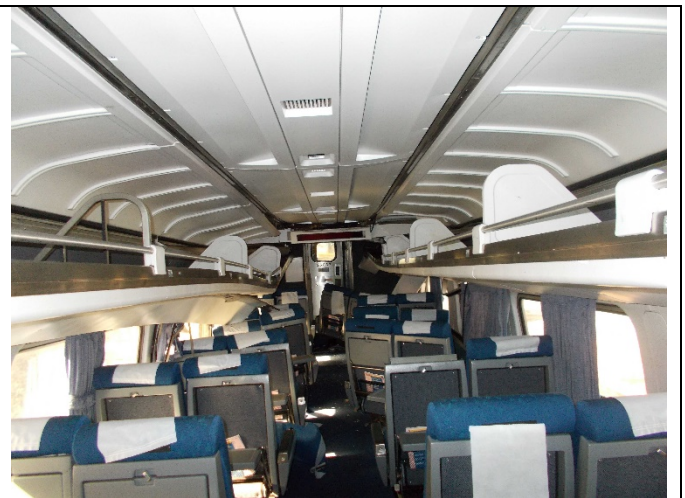
Inside of the car, the floor was buckled upward near seats 45/46, 35/36, and 25/26. In the front of the car near the circumferential body buckle, the ceiling and luggage rack fell downward toward the seat headrest level. Seat pair 59/60 was separated from the floor and wall. The seat wall mounts and the floor track were broken.

Figure 8- Coach 25037 interior (Credit: FRA)

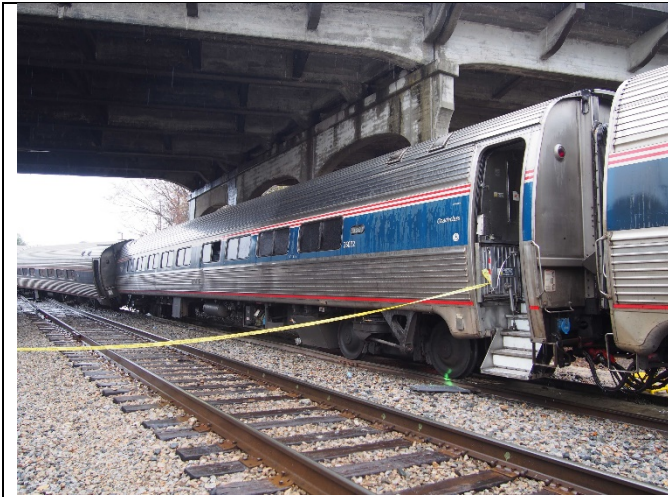
The exterior carbody structure was generally intact. There was slight impact damage to the diaphragm at the front of the car. During the initial on scene examination, the floor lighting was on, and the side doors were open.⁶ The forward interior center door was open, and the rear door was jammed in its pocket.

Figure 9- The exterior of coach 25072

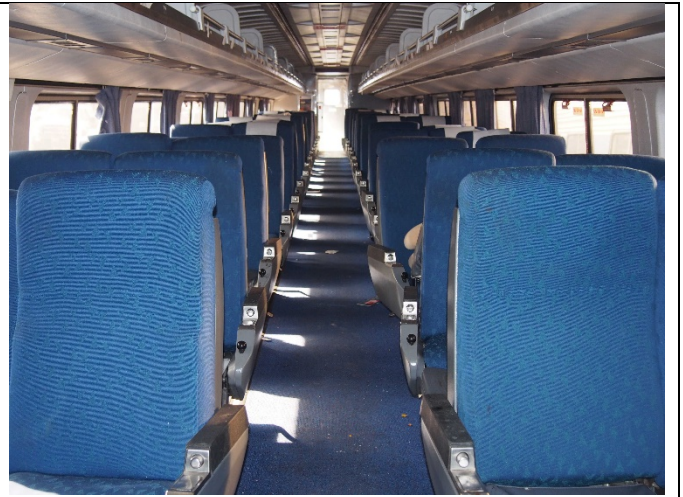
Inside of the car, there were slight floor buckles about one-third from each end near seats 35/36 and 15/16. The floor mounts for five seat pairs (5/6, 9/10, 41/42, 51/52, and 57/58) were

fractured. An interior emergency window on the left side of the car was removed. There were blood stains on and around seat pairs 59/60, 57/58, 55/56, 53/54, 49/50, and 15/16.

Figure 10- Coach 25072 interior

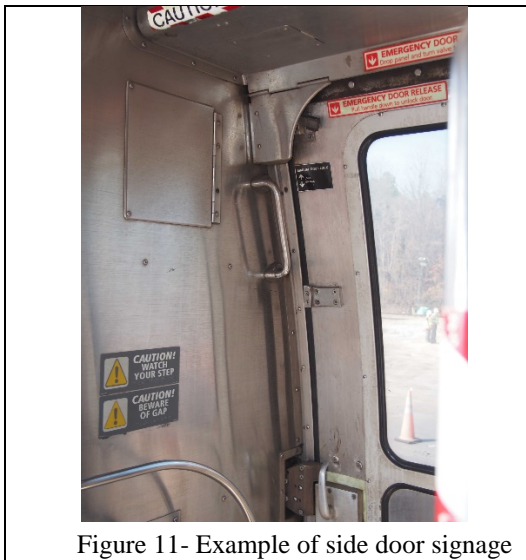
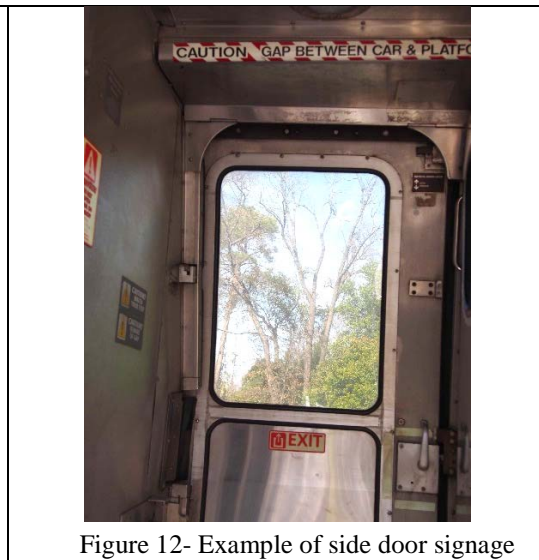
In the vestibule, signage for manual door lock on the side doors was non-luminescent; door release signage was luminescent.

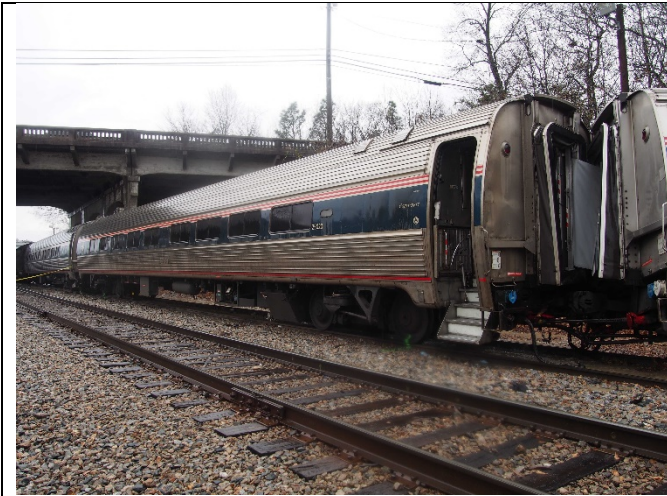
The exterior carbody structure was generally intact. There was slight impact damage to the right rear corner of the car. At the time of the initial examination, the right side door was closed, and the left side door was open. The floor lighting was on. Both center interior doors were open.

Figure 13- The exterior of coach 25020

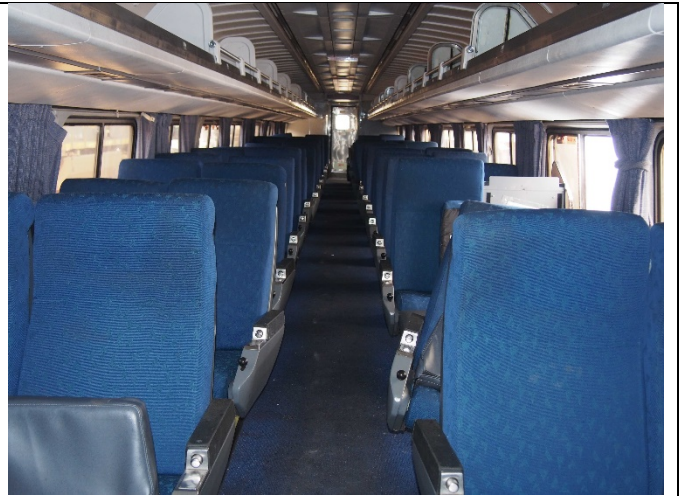
In the vestibule, signage for manual door lock on the side doors was non-luminescent. Door release signage was luminescent. Inside of the car, there were blood stains on and around seat pairs 23/24 and 43/44.

The floor mounts for seat four pairs (25/26, 51/52, 57/58, and 59/60) were fractured. For seat pairs 37/38 and 41/42, the connections between the seats and tracks were loose. The floor and wall mounts for seat pairs 1/2 and 53/54 were broken.

Figure 14 Coach 25020 interior

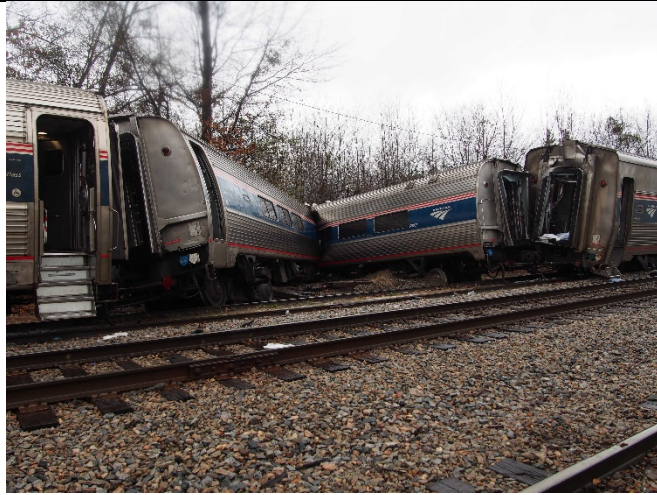
The car came to rest with the carbody bent and separated into two parts. In this position, the distance between couplers was 35 feet. On the right side of the car at the bend, the sidewall was torn fully open. Inside of the car, this opening corresponds to the rear of the service area and front of a seating area. In this area, the loss of occupant space was estimated to be 30% of the car interior.

In the separated area, the center sill collapsed, and the side sills were completely fractured and separated. At the separation, the center sill was bent laterally, and there was longitudinal tearing in the vertical web extending from the separation. Near the front of the car, a repair patch was noted at this location. On the left side of the car, there was slight buckling of the side sill at both ends of the car. No repair patches were noted at these locations.

Figure 15- The exterior of car 28002

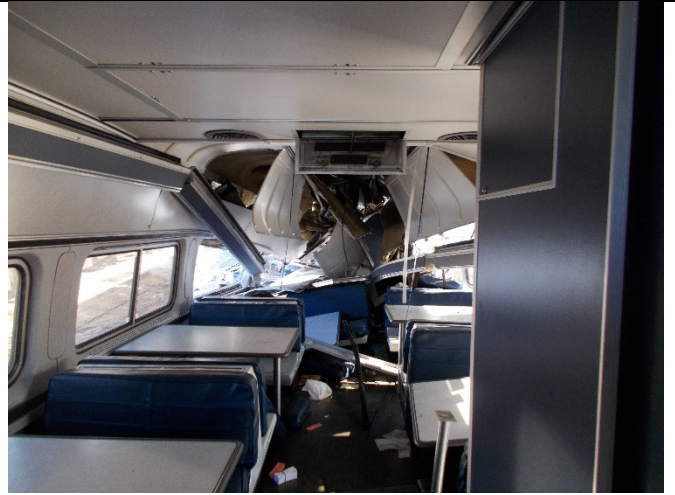
On the right side of the car, one window was removed, and the pull handle and torn rubber strip were found inside of the car. In the center of the car, the floor was deformed upward near the café service area. At the separation, the seats, tables, overhead lighting, and wall coverings were

all severely damaged. At the rear of the car, a table support leg was broken from the floor, and the table was connected to its wall support.

Figure 16- The rear section of car 28002 post recovery (Credit: FRA)

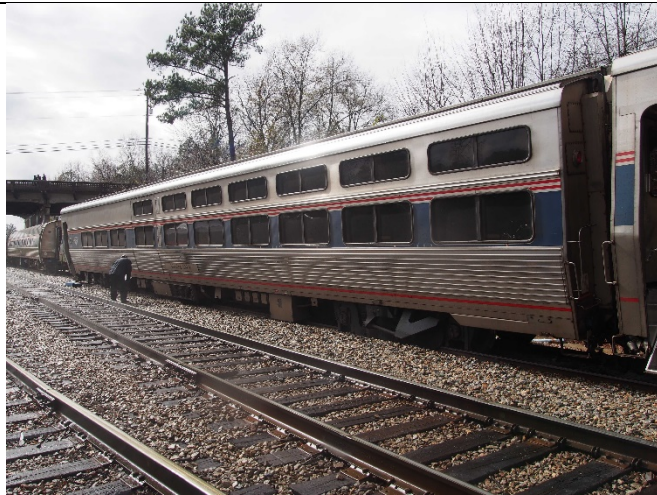
The exterior carbody structure was generally intact. There was slight impact damage to the front left corner of the car. The front coupler shank was fractured behind the coupler head. Outside of Room B, a ceiling panel was dropped down, and its release mechanism was broken. A mirror in Room B was broken. Outside of Room H, three ceiling panels were dropped down, and the release mechanism was broken on one panel. In the rooms, cushions and linens were tossed around, and there was no evidence of injury (such as blood) found.

Figure 17- The exterior of sleeper 62012

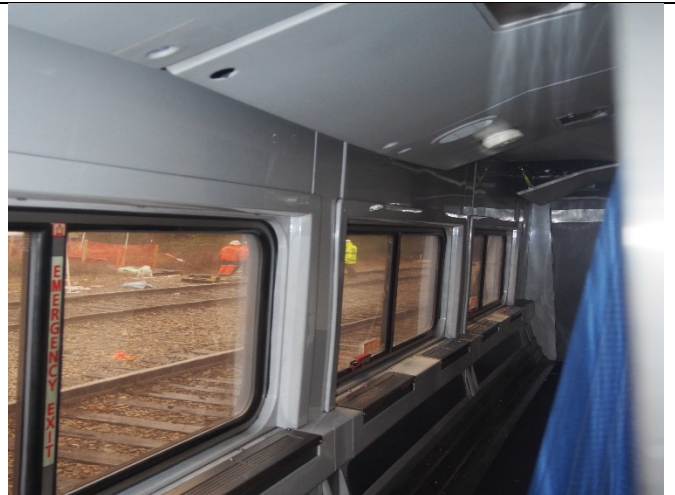
Figure 18- An example of dropped ceiling panels

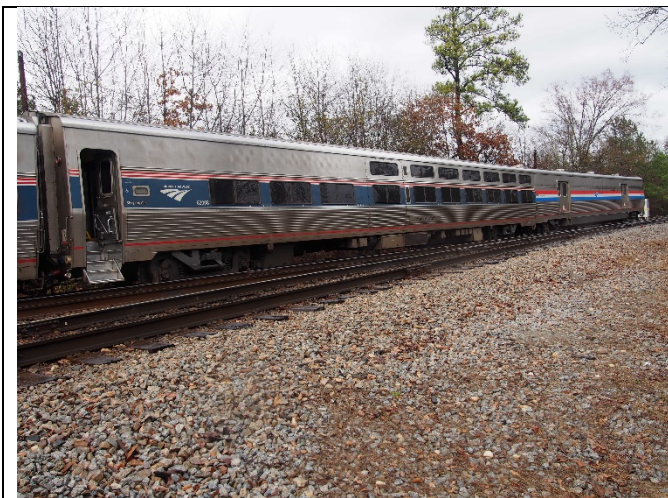
The exterior carbody structure was generally intact. Inside of the car in a walkway, a segment of low level lighting strip was dislodged and upside down. In the center aisle, two overhead panels were dropped downward, and one panel did not have its safety strap connected. In the service area, the coffee pot and coffee grounds were found on the floor. In the rooms, cushions and linens were tossed around, and there was no evidence of injury (such as blood) found.

Figure 19- The exterior of car 62008 and the baggage car

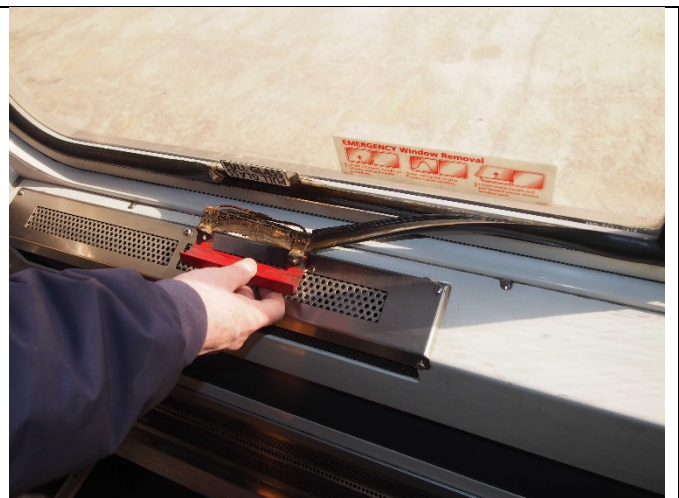
Investigators tested three emergency windows in this car. Inside of Room A, the rubber pull strip separated from the handle next to the securement cable. Two windows outside of Room B were tested. For one window, the rubber pull strip separated from the handle next to the securement cable. For a second window, the rubber pull strip did not separate.

Figure 20- An example of an emergency window test
