**CRESTMoor CANYON
GEOLOGIC AND GEOTECHNICAL INVESTIGATION
City of San Bruno, California**

by
COTTON, SHIRES AND ASSOCIATES, INC.
330 Village Lane
Los Gatos, California 95030
March 2008

SUBJECT: Geologic and Geotechnical Investigation
RE: Crestmoor Canyon
San Bruno, California

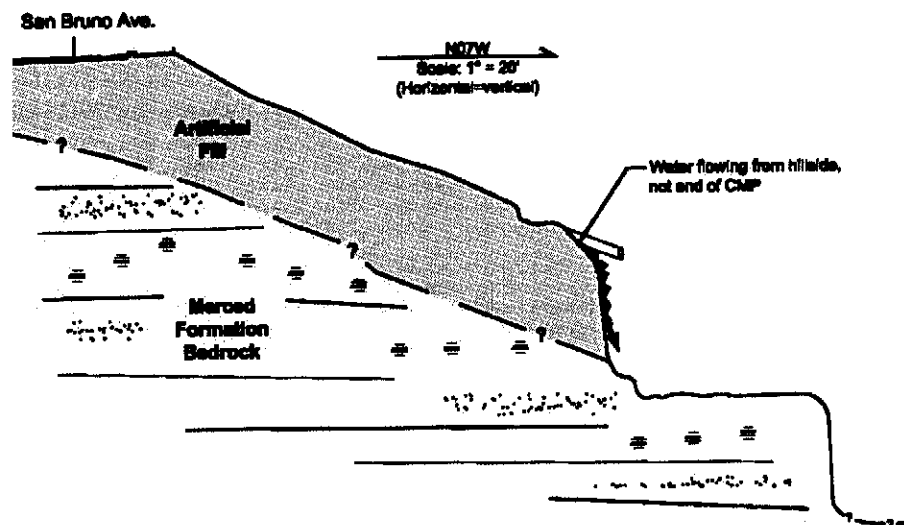
CRESTMoor CANYON SITE 1

SAN BRUNO AVENUE FILL SLOPE EROSION AND LANDSLIDING

Fill was placed beneath and on the outboard (downslope) side of San Bruno Avenue between Glenview Drive and Crestmoor Drive, possibly for the construction of San Bruno Avenue. A storm drainage culvert (24-inch ϕ CMP) runs underneath San Bruno Avenue and discharges onto the north-facing fill slope, approximately 50 feet downslope of the outboard edge of the road. Storm water discharging from the 24-inch ϕ CMP has scoured through the existing fill, exposed the underlying bedrock and created a steep gully incision in the slope up to 20 feet deep. The gully has migrated upslope approximately 10 feet from the end of the existing pipe, leaving 10 feet unsupported. We understand that the problem was previously identified and that storm discharge has been diverted to other conduits. However, we noted during several site visits that some water continues to flow from the culvert. Additionally, the bottom of the CMP has corroded throughout its exposed length, resulting in water draining at the slope/pipe interface. Upslope of the existing incised gully the slope exhibits signs of instability; a scarp, approximately 2 feet high, was observed on the slope south of the existing CMP.

The fill prism supporting San Bruno Avenue has undergone an extensive amount of erosion and continues to erode. Although the majority of the storm run-off has been diverted from this particular culvert a perennial flow of water (variations in volume of flow have not been determined) continues to drain and is contributing to further erosion and slope instability in this area. Fresh scarps are visible upslope of the incised gully. The risk of future enlargement of slope instability and adverse impacts to San Bruno Avenue is **moderate to high** under static or seismic conditions.

We recommend that a temporary flexible pipe and connection be attached to the end of the pipe and discharged at a suitable location downslope. The City should monitor this condition including looking for signs of distress in the roadway and downslope instability. If the City chooses to be proactive, then a focused geotechnical investigation could be completed including detailed surveying of the local slopes. An analysis should be completed to address static and seismic factors of safety against failure. Appropriate mitigation alternatives should be outlined as necessary. The corroded sections of the pipe should either be removed, replaced or lined. (See photos 130-133 on CD showing site conditions)

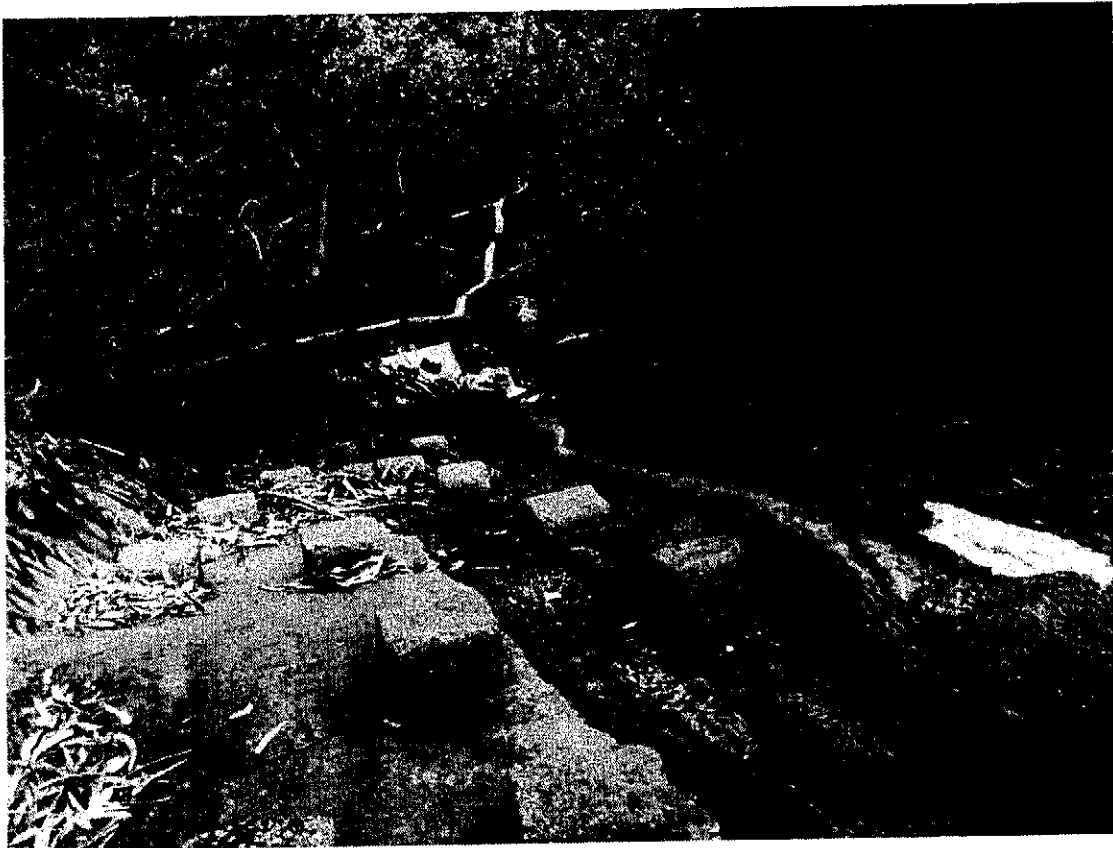
CRESTMoor CANYON SITE 2

UNDERMINING OF OUTFALL STRUCTURE, GLENVIEW PARK

San Bruno Creek flows into the far western portion of Crestmoor Canyon, just below Glenview Park. The creek is fed through two pipes, a 24-inch ϕ corrugated steel pipe (CMP) and a 48-inch ϕ reinforced concrete pipe (RCP). The two pipes discharge onto a concrete apron that extends approximately 45 feet to the east. At the end of the concrete apron water collects in a pond, approximately 20-feet wide by 40-feet long. A section at the end of the concrete apron has broken off and become detached from the structure resulting in a four-foot high drop.

The concrete apron is equipped with baffles for energy dissipation. The baffles in the center of the concrete apron have worn away resulting in the unimpeded flow of water. At the downstream termination of the concrete apron, scour has undermined the structure, creating a large void underneath the concrete.

The concrete splash apron is in need of repair to prevent further undermining of the structure. The existing pond could also cause potential failures in the slopes that surround it, or be a source of potential flooding. The hillsides behind the adjacent streets, Claremont Drive and Glenview Drive, are very steep to precipitous. These slopes extend down to the concrete apron and associated pond. The slope behind 970 Glenview Drive experienced a landslide failure in 1993. The risk of additional undermining of the outfall structure is **very high** and the potential for ponding and poorly controlled surface flow to cause instability of adjoining slopes is **moderate to high**.

We recommend that the concrete apron be fully repaired and consideration be given to corrective grading to drain the pond area. A topographic survey of the outfall area should be completed and the potential need for buttressing of eroded/undermined slopes should be considered during remedial design.
(See photos 15-19 on CD showing site conditions)

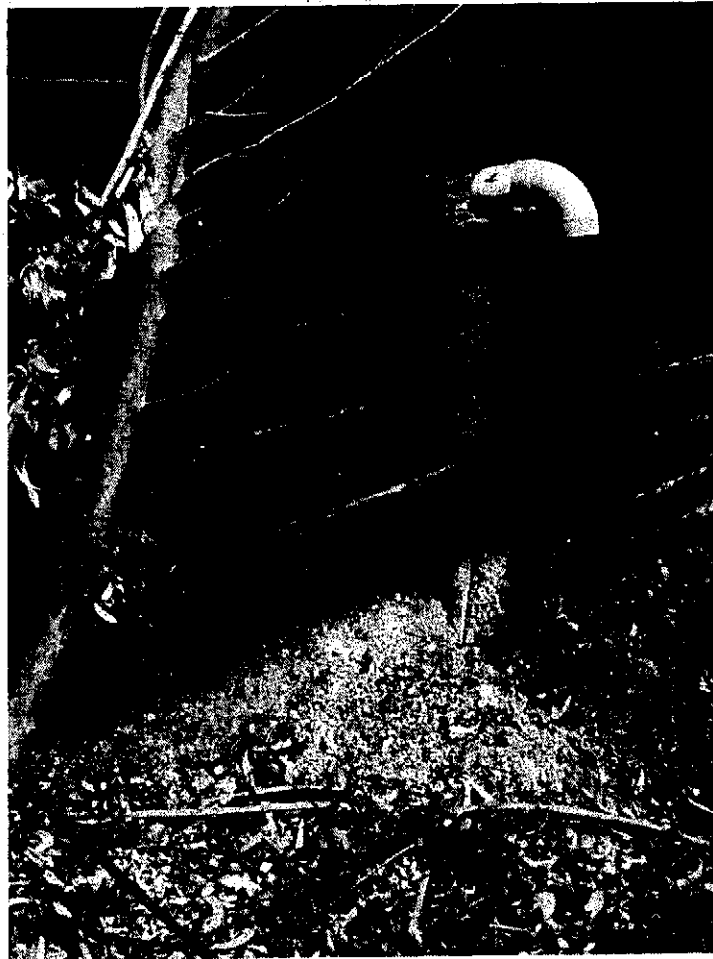
CRESTMoor CANYON SITE 3

LANDSLIDING AND RETAINING WALL BACKDRAIN FAILURE BELOW 1636 CLAREMONT DRIVE

This location is the site of several slope repairs dating from 1983 to recent. The most significant landslide repair measures consisted of a soldier pile and lagging wall with tiebacks that borders and supports the rear yards of 1610 through 1636 Claremont Drive.

During our field inspection, we noted that recent shallow landsliding has occurred behind 1646, 1636, 1620 and 1600 Claremont Drive. The slope at the base of the retaining wall has moved by landsliding and creep, exposing and in places undermining the base of the wood lagging. Subsequently the drainrock installed behind the retaining wall at 1636 Claremont has begun to ravel out onto the slope below. A drainage pipe located approximately 4 feet above the bottom of the lagging discharges onto the slope.

The slope behind the noted residences has already undergone repair for damages incurred by landsliding in 1983. With the slope below experiencing continuing instability, the material retained behind the wall (including backdrain gravel) is being undermined and poses the risk of causing distress to the yards immediately upslope. Eventually the retaining wall foundations could be undermined by ongoing landsliding.

The City could continue to maintain the wall by adding lagging where the bottom has been undermined to prevent loss of backfill/backdrain. Alternatively, a focused geotechnical investigation could be conducted to define the limits of slope instability, characterize geotechnical aspects of slope instability and to develop design criteria for appropriate measures to stabilize adjacent slopes.
(See photos 20-25 on CD showing site conditions)

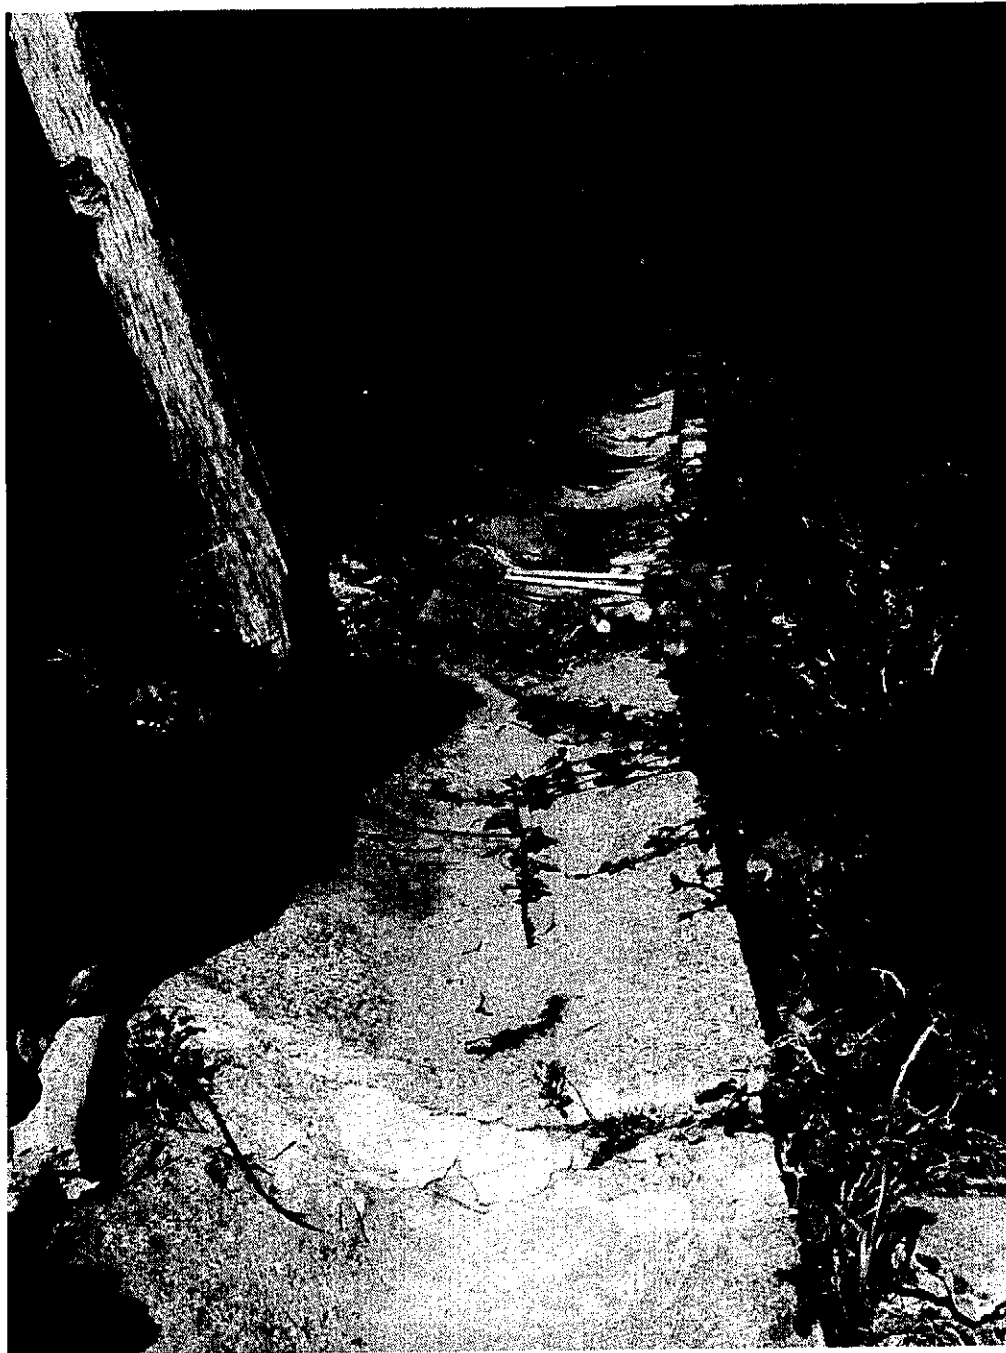
CRESTMoor CANYON SITE 5

SURFACE DRAINAGE SYSTEM PROBLEMS AND LANDSLIDING LOCATED EAST OF 1360-1420 CLAREMONT DRIVE

This area is located 5 lots to the north of the intersection of Concord Way, extending along the slope behind 7 residences (1360 through 1420 Claremont Drive). Several slope instability features were identified, including an old landslide feature (pre-development), a broken and non-functioning concrete drainage V-ditch, blocked sections of drainage V-ditch, and slope scouring related to drainage diversion. This area is also situated immediately north of three areas of post development landslide repairs, with the most recent repair completed in November 2007.

The area is located on an east-facing hillslope, with topography ranging from steep (up to 26 degree inclination) to very steep (up to 36 degree inclination) extending down to the Canyon access road. The hillside has undergone extensive grading related to residential construction that occurred between 1955 and 1958, resulting in the placement of a large fill prism. A concrete V-ditch was constructed near the top of the fill slope behind the existing residences. The stretch of V-ditch behind 1360 to 1400 Claremont Drive is in poor condition. The V-ditch has been rotated by soil creep processes and no longer has the initial design capacity. A gabion wall has been placed just below the V-ditch behind 1400 Claremont Drive. The wall was presumably placed to help support the V-ditch as mitigation for slope instability. The V-ditch immediately above (north of) the gabion wall is relatively intact.

Scour features were identified on the slope behind 1390 Claremont. We observed a cinder block obstructing the flow of water in the V-ditch and this may have caused water to be diverted onto the slope. A relatively large landslide extends from 1360 to 1400 Claremont Drive, with the headscarp located approximately 30 feet downslope from the rear of the houses.

The lack of maintenance and poor condition of the V-ditch has already contributed to slope failures in the area. A **moderate** to **high** risk for future slope failures exists if the V-ditch behind 1360 to 1400 does not convey concentrated storm drainage away from local slopes.

Appropriate repairs should be made to restore the functionality of the V-ditch and its flow capacity. The V-ditch should be evaluated throughout its length to identify specific locations for necessary repairs. Specific drainage design details should be prepared by a Civil Engineer to provide adequate capacity to properly convey anticipated flows away from adjacent steep slopes. Repairs should be completed before the onset of the next rainy season.

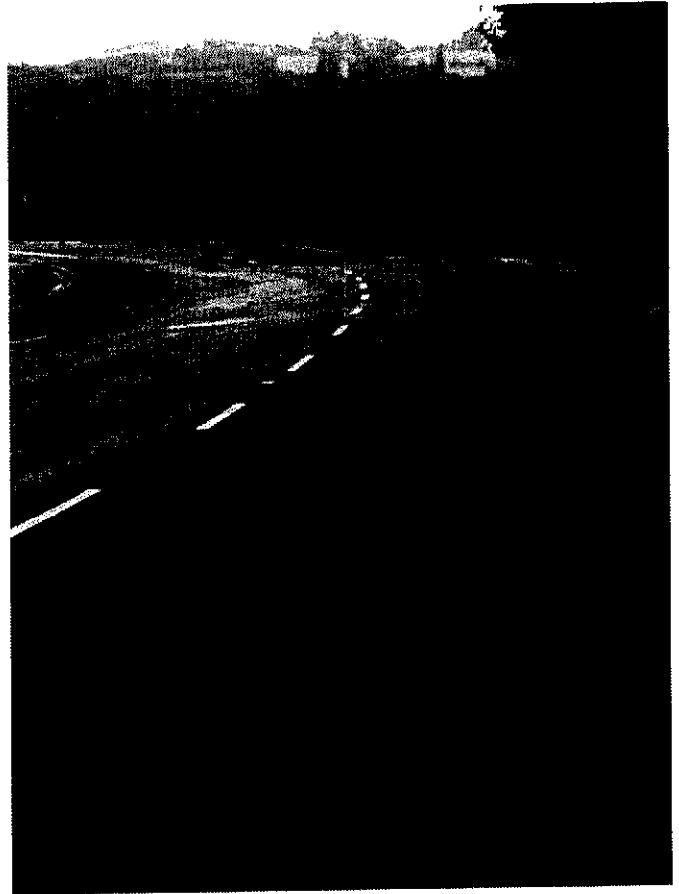
CRESTMoor CANYON SITE 6

SAN BRUNO AVENUE FILL SLOPE SETTLEMENT

This area is located along a section of San Bruno Avenue situated between Glenview Drive and Crestmoor Drive. The roadway appears to have been impacted by fill settlement and downslope creep. It appears that fill was placed beneath and on the outboard (downslope) side of San Bruno Avenue between Glenview Drive and Crestmoor Drive associated with the construction of San Bruno Avenue. Two areas of visible sagging, resulting from fill settlement, have formed along San Bruno Avenue. Significant cracking is visible in the westbound lanes of the street as well as buckling of the sidewalk adjacent to the canyon.

Distress features along San Bruno Avenue and the adjacent fill slopes located to the north should be monitored. If accelerated distress is observed, then the adjacent slope and roadway should be investigated to determine suitable stabilization measures.

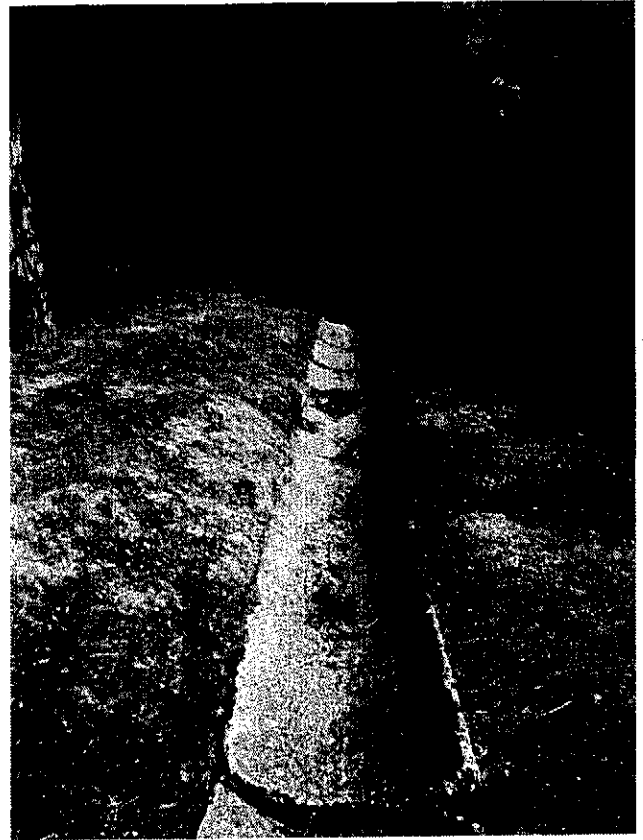
CRESTMoor CANYON SITE 7

BACKYARD V-DITCH MAINTENANCE NEAR TRENTON DRIVE AND CRESTMoor DRIVE

This site is located at the northeastern portion of Crestmoor Canyon, along Canyon rim, north of the intersection of Trenton Drive and Crestmoor Drive. The adjacent slopes are predominately north facing, (approximately 45 to 64°) to the north. The area was graded during residential construction that occurred between 1955 and 1958, resulting in the placement of relatively large quantities of fill, with artificial fill slopes established toward the rear of the properties. A concrete-lined V-ditch constructed near the top of the fill slope behind the existing residences appears to start at the property line between 2260 and 2270 Crestmoor Drive and extends east. The ditch is located within the private back yards near the edge of the Canyon. The V-ditch has deteriorated and there are very few stretches that are not broken, completely buried or blocked by obstructions. The ditch is essentially non-functional. However, many residents rely

on this ditch as a means to discharge their yard drainage and roof downspouts. During our site inspection, we noted that most properties have at least one pipe directing drainage to the V-ditch. One residence has a pipe running from their spa to the V-ditch, apparently used to drain the spa into the ditch. A small erosional feature was mapped behind this residence. Evidence of shallow slope instability was also noted on several areas on the slopes behind this portion of Crestmoor Drive.

This portion of the canyon rim is characterized by precipitous fill and native slopes. Erosional features or old slope failures have been mapped flanking slopes along this stretch of Crestmoor Drive. A large number of residents rely on the V-ditch to discharge their yard drainage and there are few stretches of intact ditch that properly convey water away from the slopes. The risk of potential future slope instability as a direct result of poorly controlled drainage is **moderate**. The risk of catastrophic damage to existing buildings from drainage related slope failures is judged to be **low**.

Appropriate maintenance should be considered to restore functionality of the original storm drain system. We recommend that concentrated water currently discharged onto local slopes be conveyed away from residential properties in a properly controlled manner. Alternative drainage control structures could be explored if a through-going V-ditch system is not viable. (See photos 88-91, 94, 96, 99 per Photo Index Map, Plate 2)
