Summary of Examination

Examination Date: 09/17/2013

Location: Air Transport; Phoenix, AZ

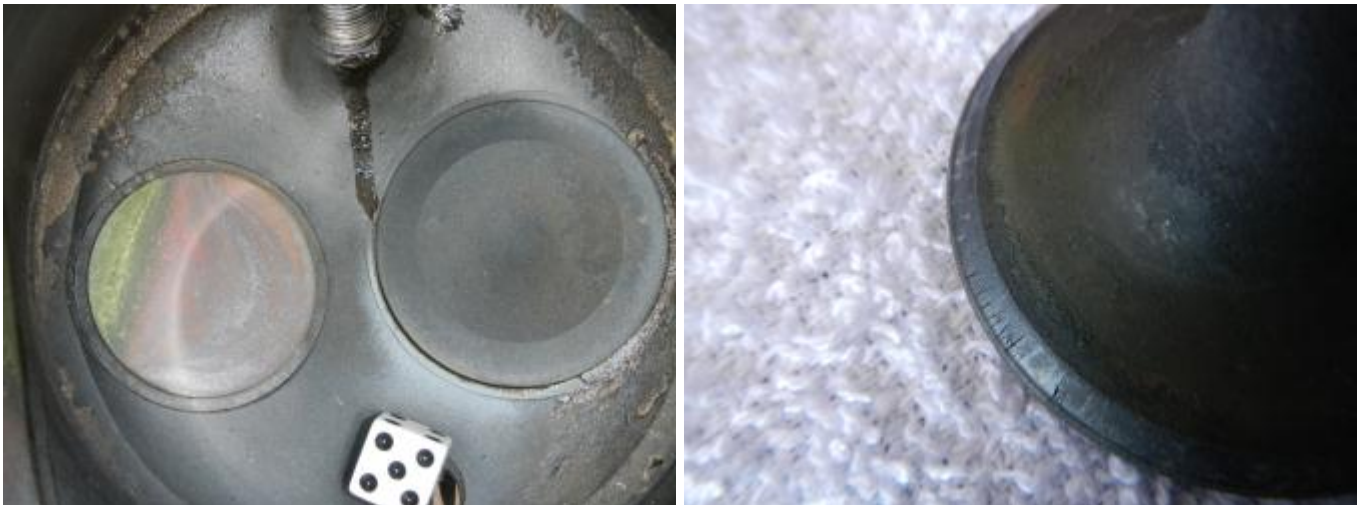
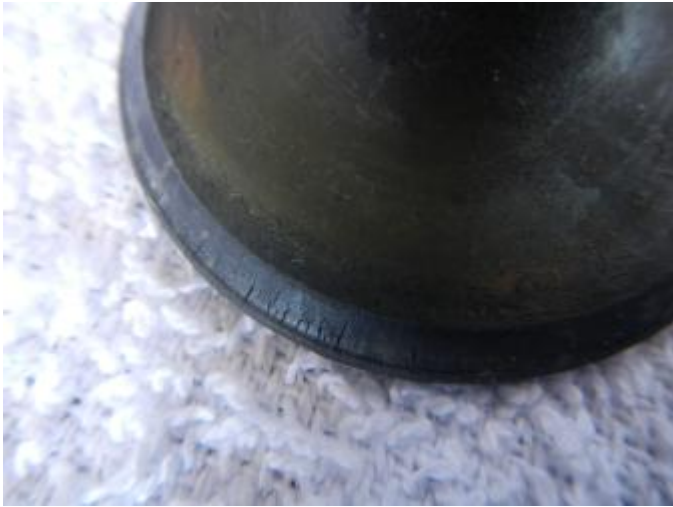
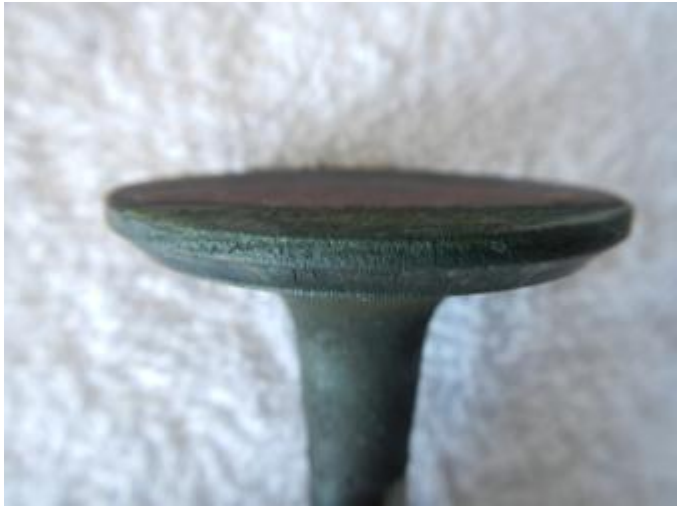
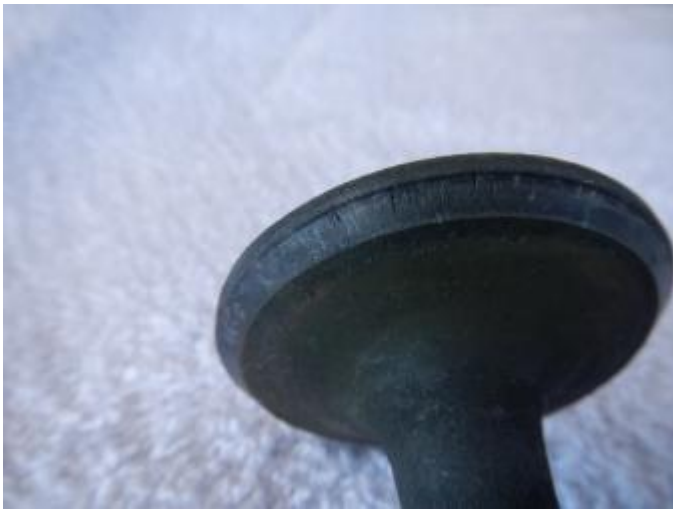
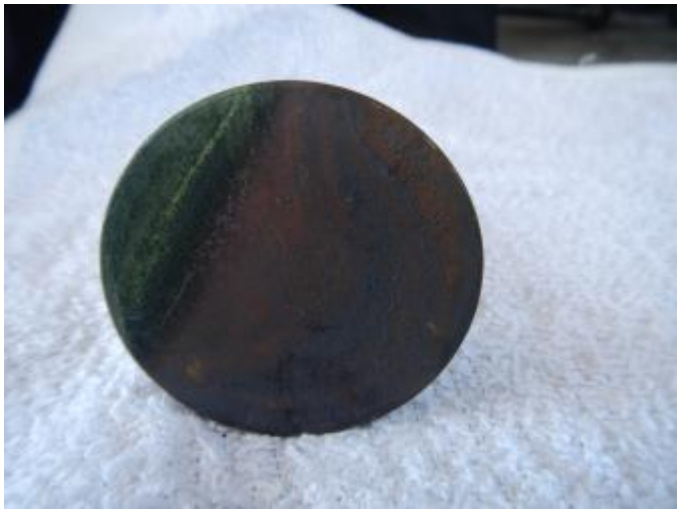
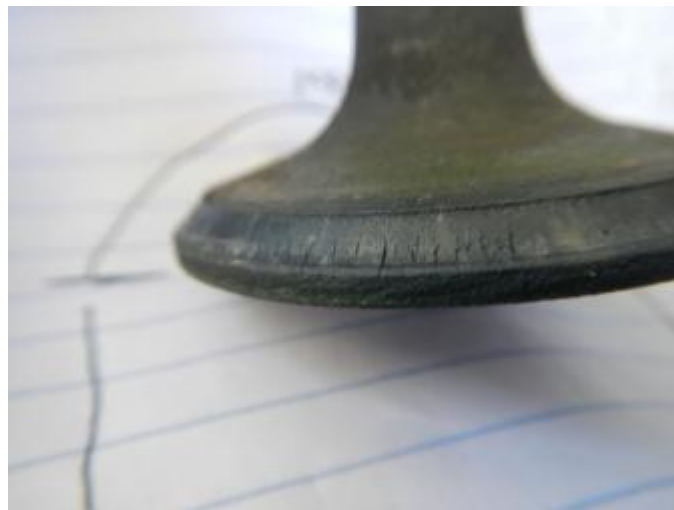
Closer Examination of #5 Exhaust Valve:

The #5 cylinder was removed from the engine during a June 28, 2013 examination. The #5 cylinder's exhaust valve displayed a green discoloration on its face indicating a possible exhaust gas leak. Close examination of the #5 cylinder exhaust valve in the area behind the green discoloration revealed small cracks on the seating surface of the valve. The following photographs concentrate on the #5 cylinder exhaust valve.

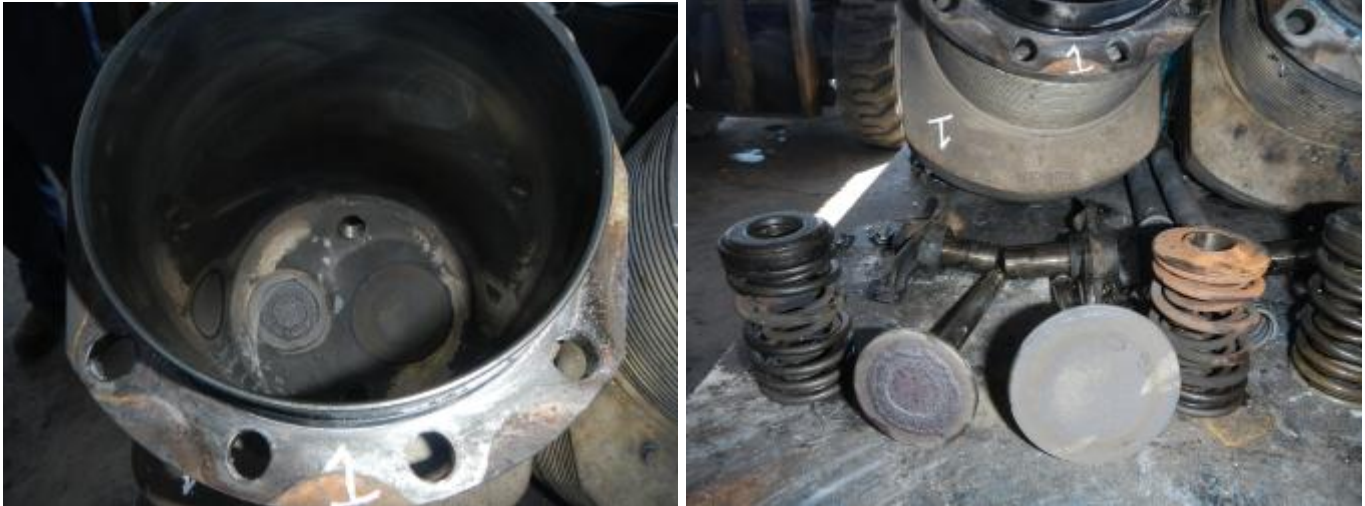
Cylinder #1:

The engine, with the #5 cylinder already removed was brought out of storage and hung from a hoist. The remaining 5 cylinders were removed from the engine and examined. The remaining cylinders and their valves displayed typical deposits and coloration.¹

¹ It should be noted that the engine underwent extensive thermal exposure following the accident. Dark coking and soot coated numerous external and internal engine components. Even some of the normal combustive byproducts that were adhering to the pistons and cylinders were covered in dark soot and coking.

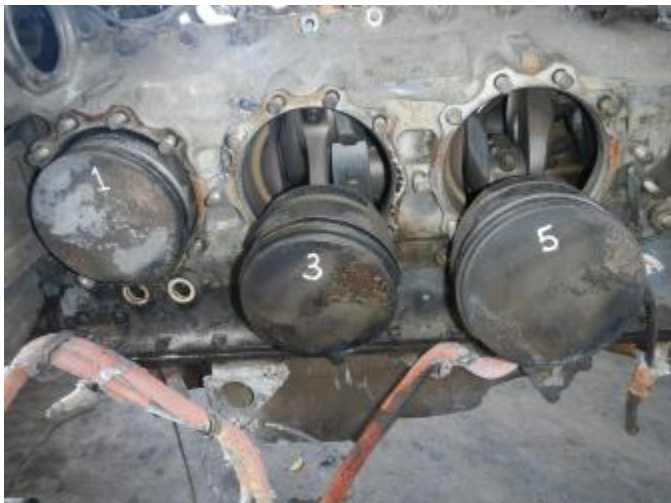
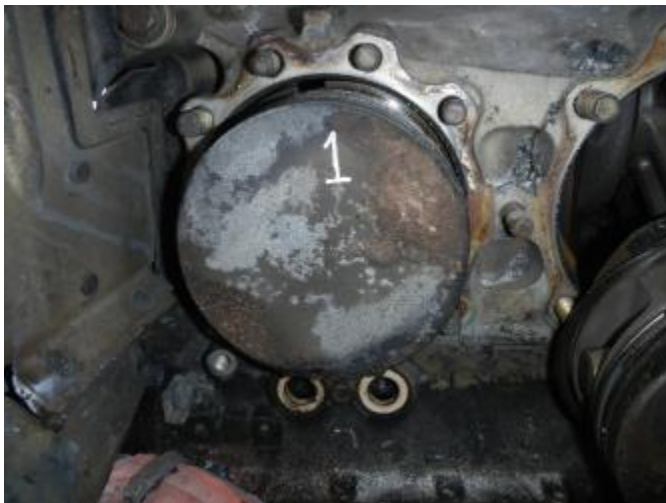
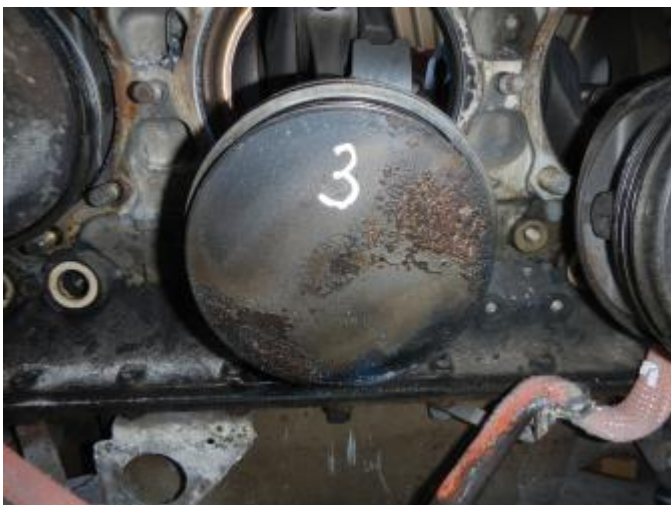
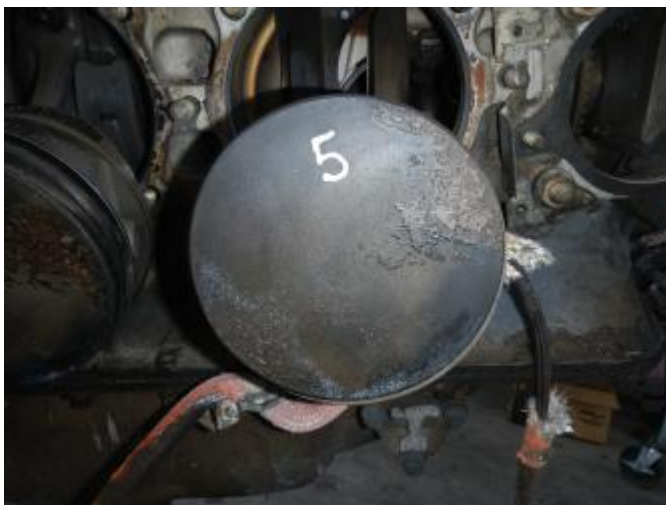
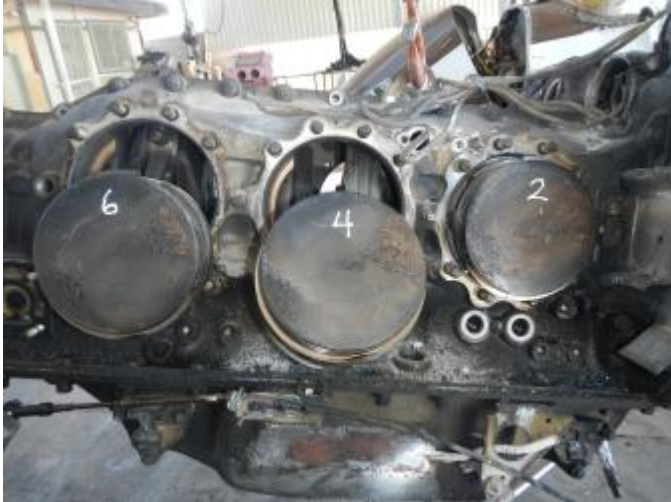
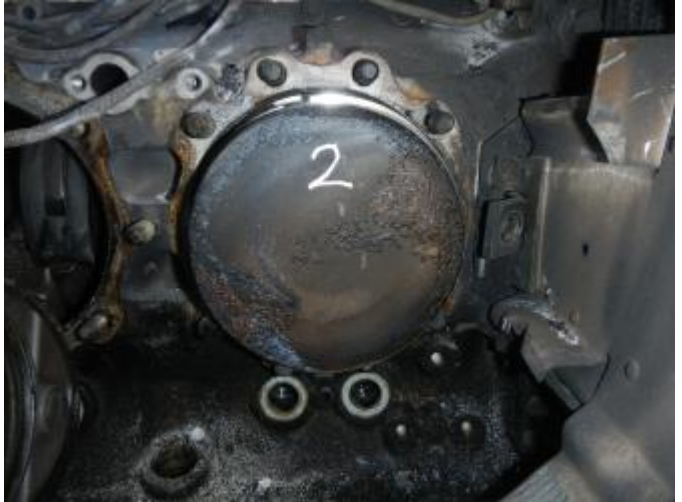
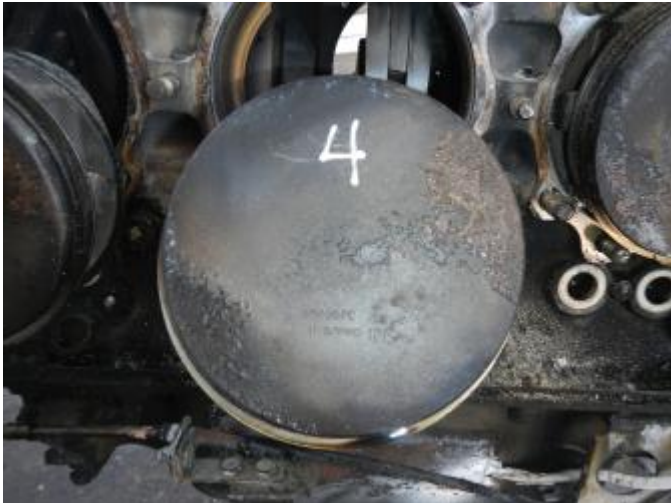
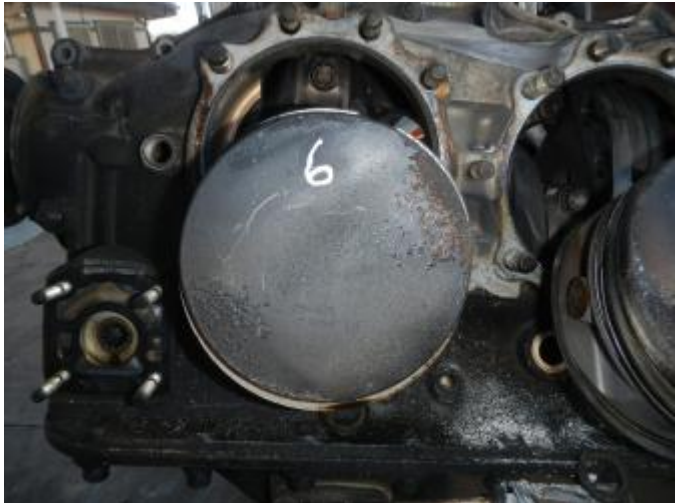
Pistons:

Examination of the six pistons revealed no anomalies or signs of operational distress. The photographs below depict each of the six cylinders.
