CZECH SPORT AIRCRAFT	SAFETY ALERT / SAFETY DIRECTIVE	Czech Sport Aircraft a.s. Na Záhonech 212, 686 04 Kunovice Czech Republic office@czechsportaircraft.com
		No.: SA-SC-011
		Date: 2018-08-30
		Page: 1 of 3
		Rev.: 1 Date: 2018-09-17

MODEL AFFECTED:	SportCruiser / PiperSport (except the aircraft under EASA Permit to Fly)
SUBJECT:	Additional information and instructions in POH with respect to: <ul style="list-style-type: none"> - handling the engine at idling flight regime; - use of correct fuel type in relation to outside temperature; - use of electrical fuel pump.
AIRCRAFT AFFECTED:	All SportCruiser and PiperSport aircraft
COMPLIANCE:	Execution of this Safety Alert is mandatory and must be performed immediately. Instructions contained herein, if not followed and observed, may lead to unsafe conditions, resulting in a possible vapor lock, loss of engine power or engine failure.

CZECH SPORT AIRCRAFT	<h2 style="margin: 0;">SAFETY ALERT / SAFETY DIRECTIVE</h2>	Czech Sport Aircraft a.s. Na Záhonech 212, 686 04 Kunovice Czech Republic office@czechsportaircraft.com
		No.: SA-SC-006
		Date: 2017-10-16
		Page: 1 of 3
		Rev.: -
		Date: -

MODEL AFFECTED:	SportCruiser
SUBJECT:	Fuel return

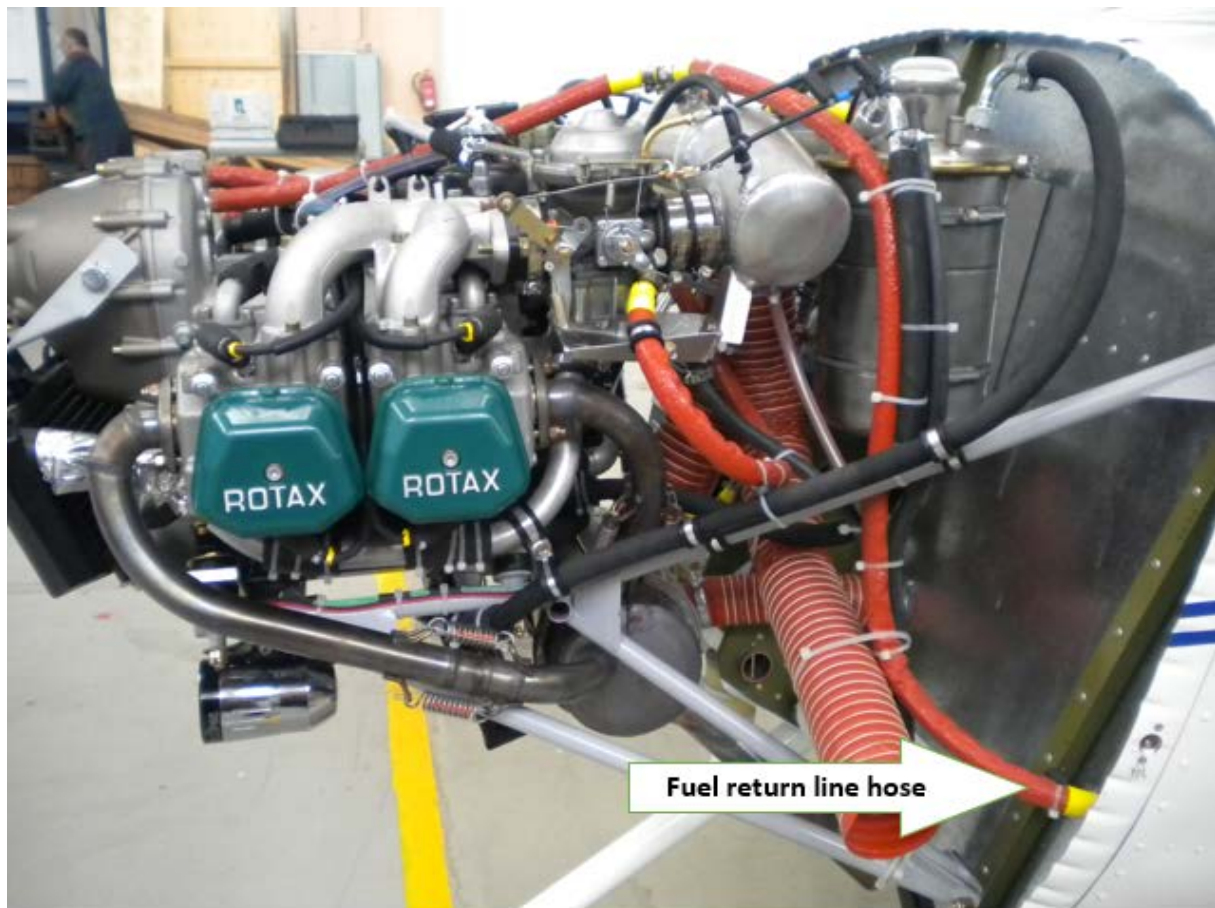
1. Check the aircraft fuel installation whether the fuel return line is installed or not (steps 2 - 4).
2. Move the aircraft to a suitable place to perform the work.
3. Remove the engine upper cowling (see the SC-AMM-1-0-00, the latest revision).
4. Look at the engine and check if the fuel return line is installed in the fuel system of the aircraft, as per the pictures below.

Figure 1 – Fuel system with the fuel return line

5. a) If the fuel return line hose is installed, enter the following text into the aircraft log book: *"The SA-SC-006 applicability has been checked with the result: not applicable"*. The SA-SC 006 compliance will be thereby duly completed in such a case.
- b) If the fuel return line hose is missing, follow and apply the following steps and instructions when operating the aircraft:
 - Switch the electrical fuel pump to "ON" and use it during take-off and landing. Operate the engine within the specified pressure limits, see the latest Operators Manual 912 Series, chap. 2.1.
 - Use only the AVGAS 100 LL fuel, according to the latest ROTAX Operators Manual 912 Series, chap.2.4.

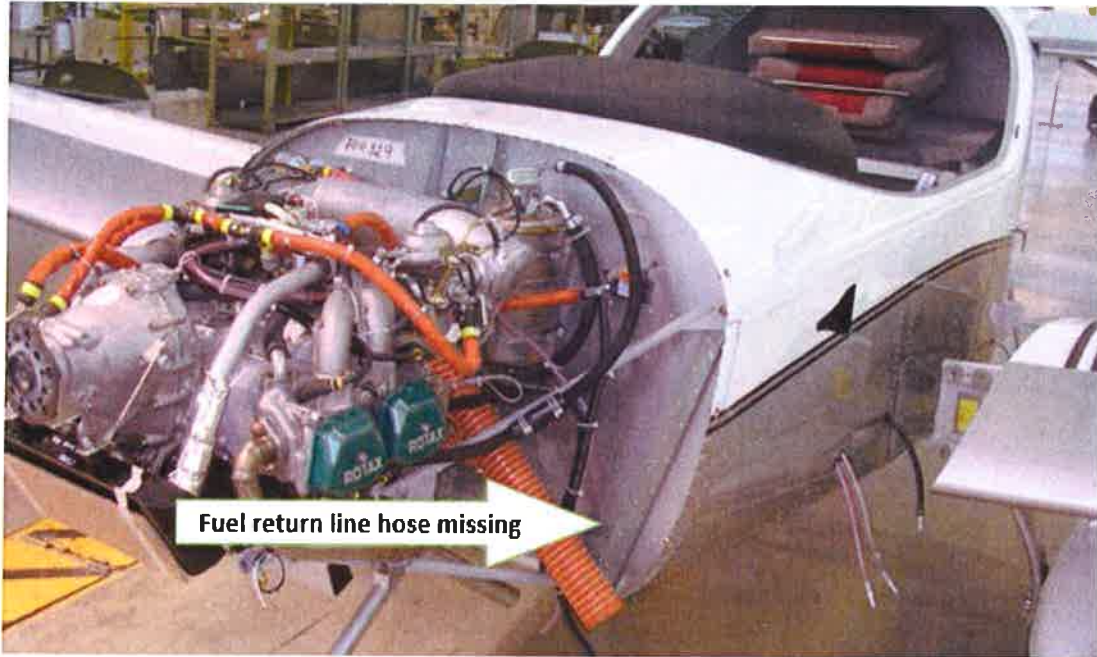
Implementation of the fuel return line is required by the Rotax Company. The purpose of the fuel return line is to bleed off any vapours that may form within the fuel system that could cause vapour lock resulting in a possible loss of engine power.

Figure 2 – Fuel system without the fuel return line

NOTE: Be aware of the maintenance checks / intervals related to the use of leaded AVGAS fuels, see the latest ROTAX Maintenance Manual, chap. 5, ROTAX Service Instruction SI912 i 001R4, SI-912-016R9.
6. Install the engine upper cowling back (see the SC-AMM-1-0-00, the latest revision).
7. Complete the aircraft records (log book) to reflect compliance with this Safety Alert.
