Contractor Statement Regarding Pipe
Bursting Video

Data Response from the City of San Bruno and 2008 Pipe Bursting Contractor regarding questions from the NTSB:

Data Response from the City of San Bruno and Installation Contractor to NTSB questions related to the 2008 San Bruno Sewer installation on Earl Avenue:

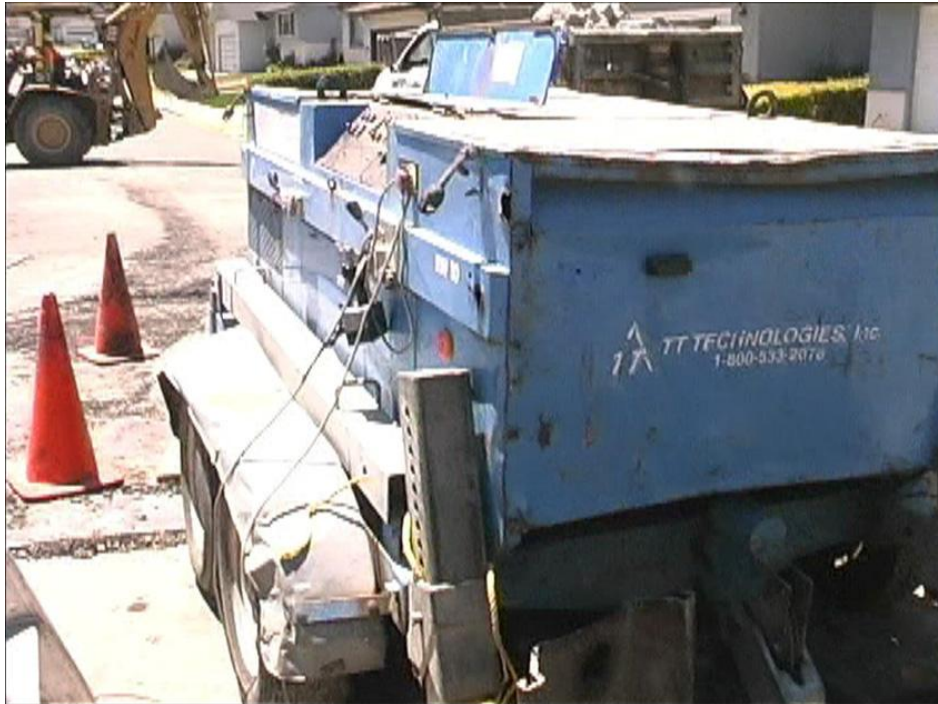
Figure 1: Winch Photo 1 - Still shot from 2008 Home Video

With regard to the first picture entitled winch photo 1: The house directly to the right of the backhoe in the photo is 1731 Earl Ave. It is the fourth house west from the corner of Glenview Dr on the north side of the street. Incidentally the first three houses from the corner have all been destroyed, 1731 still exists. This determination was made by reviewing the taped footage and comparing it with the winch photo picture, and current photos of the neighborhood.

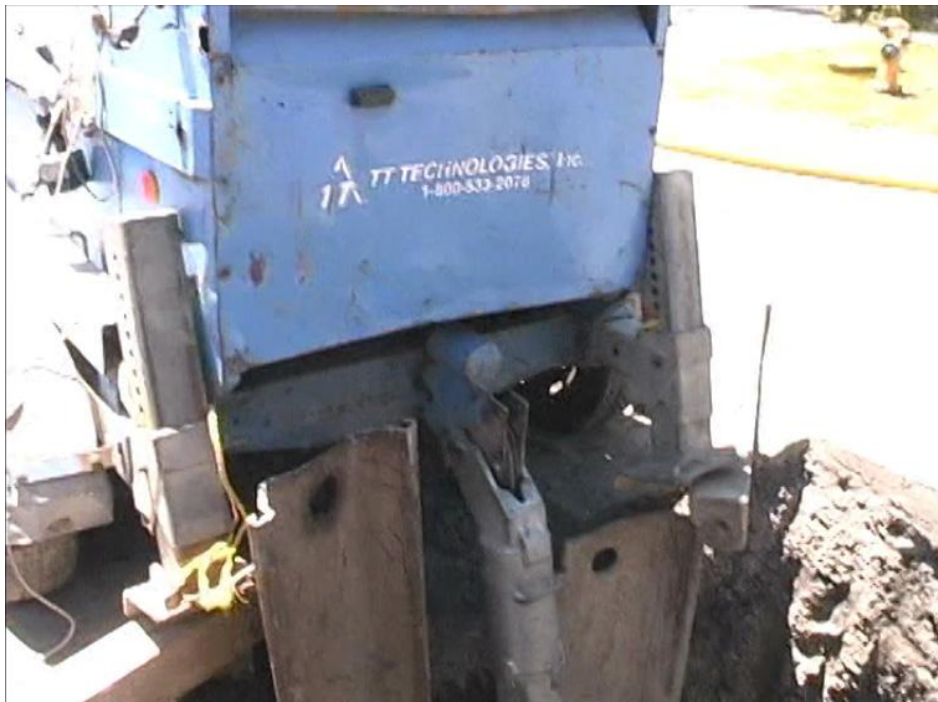
Figure 2: Winch Photo 2 - Still shot from 2008 Home Video

The second picture entitled winch photo 2, is of the fire hydrant at the n/w corner of Earl Ave and Glenview Dr. The hydrant still exists in the same location; in front of 1701 Earl Ave.
