**RAILROAD ACCIDENT INVESTIGATION
IIC FACTUAL REPORT**

**Highway-Rail Collision
Amtrak P09806 Silver Meteor
25TH St. West Palm Beach Fl.**

July 6, 2016

DCA16FR009

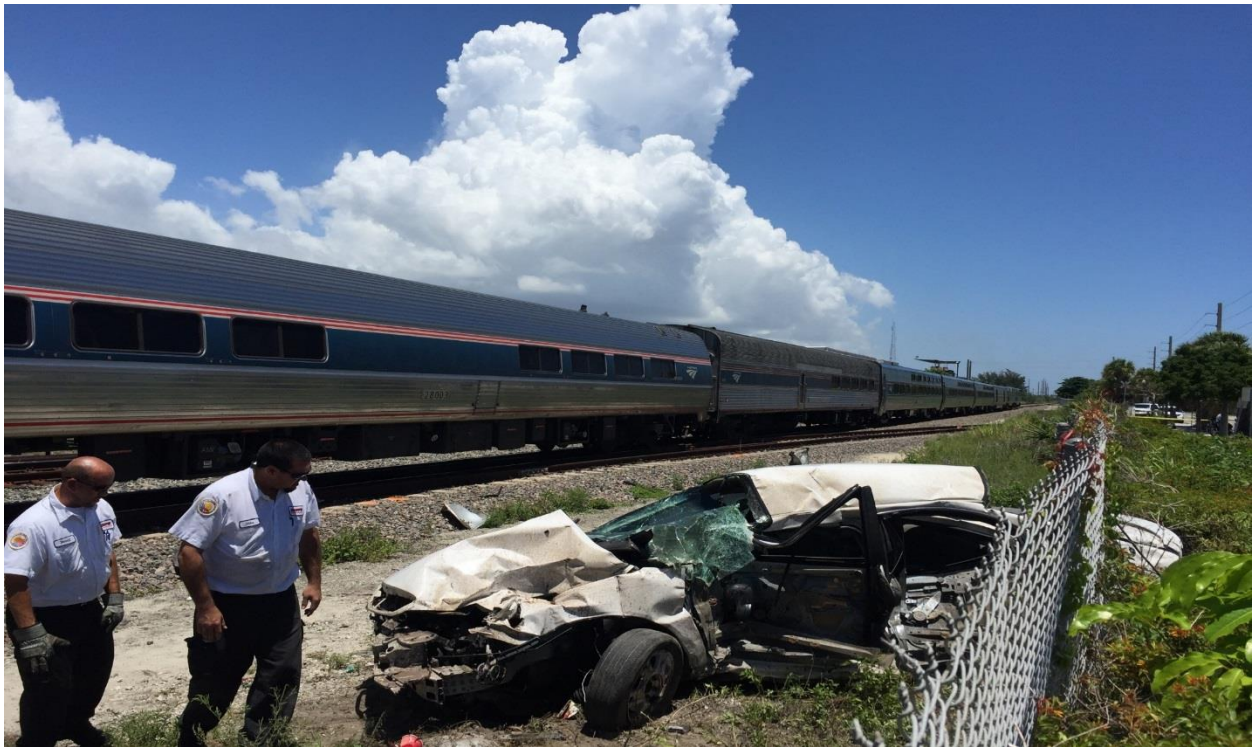
Figure-1 depicts vehicle that Amtrak P09806 Silver Meteor struck in Northeast quadrant of 25th Street Highway Grade Crossing, West Palm Beach Florida, July 6, 2016, 9:59 am.

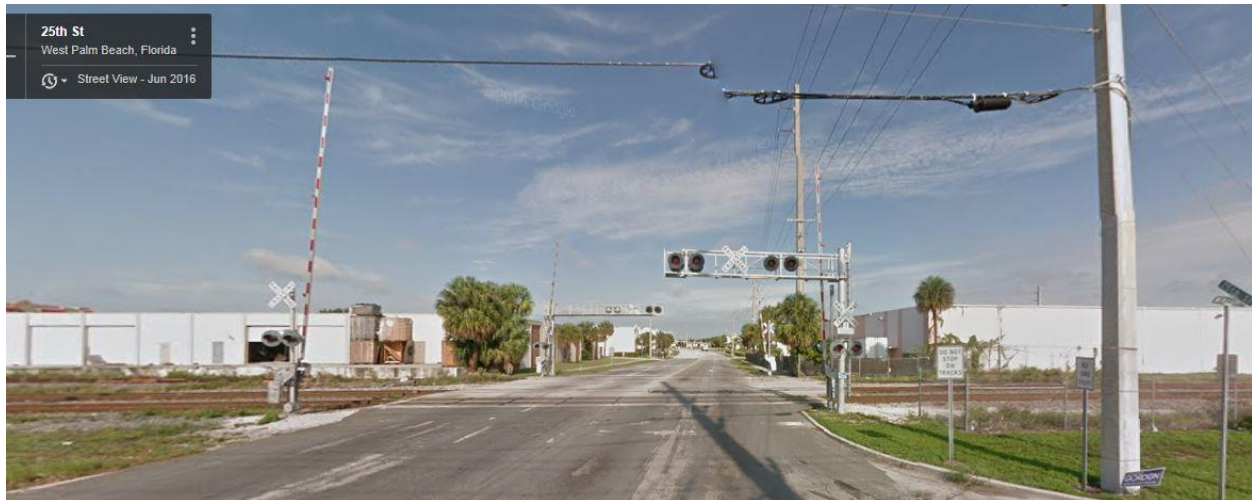
Figure-3 depicts view traveling west on 25th street, same as driver was traveling.

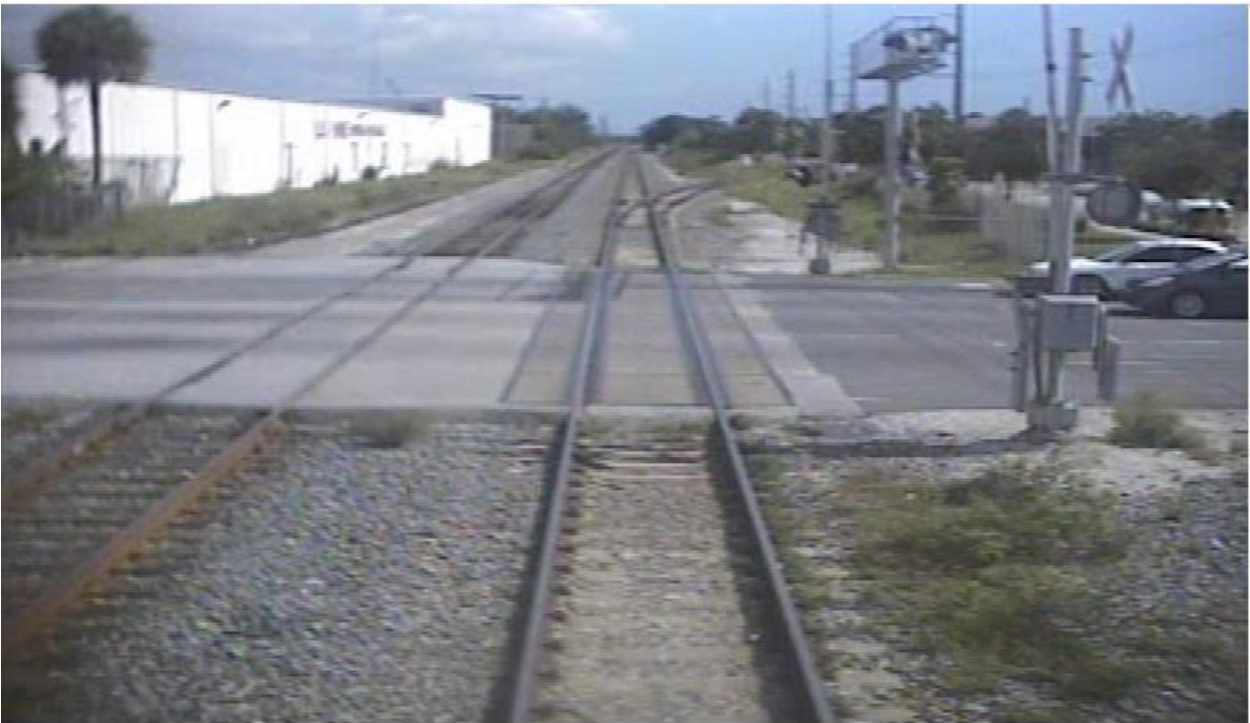
The below figure F-4 depicts ATK 146 in close proximity to the grade crossing with all four crossing gates in the up position while the private vehicle in the outer right hand lane is about to cross the Rail-Highway Grade Crossing.

Figure-4 Depicts crossing gates in the up position as ATK 146 approached the crossing.

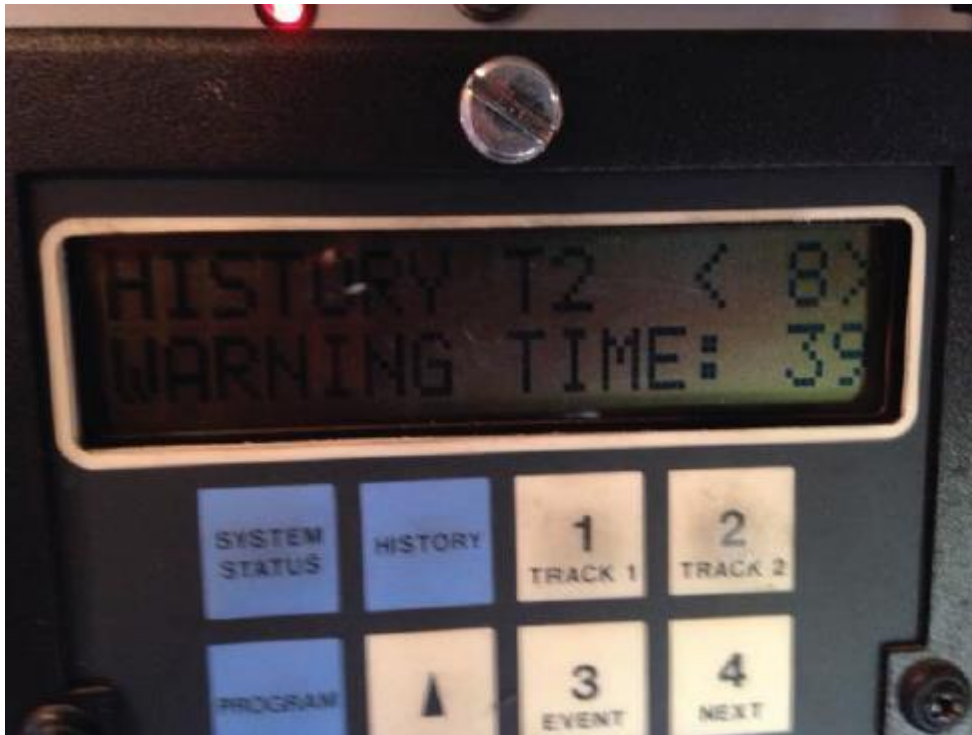
Upon arrival, a stop and flag protection order was placed on both main lines and the crossing signal bungalow was sealed. Post-Inspection began with obtaining the information contained within the GCP-3000 display panel. The warning time of the last ten trains that included the accident train were recorded and photographed. The warning time of the GCP that was recorded in the display module for the accident train was 39 seconds {P-5 pg-17}. The NAS recorder indicated actual warning time of the control relay to be only one second {table 2 pg-16}.

Figure-5 depicts warning time of the Grade Crossing Predictor to be 39 seconds
