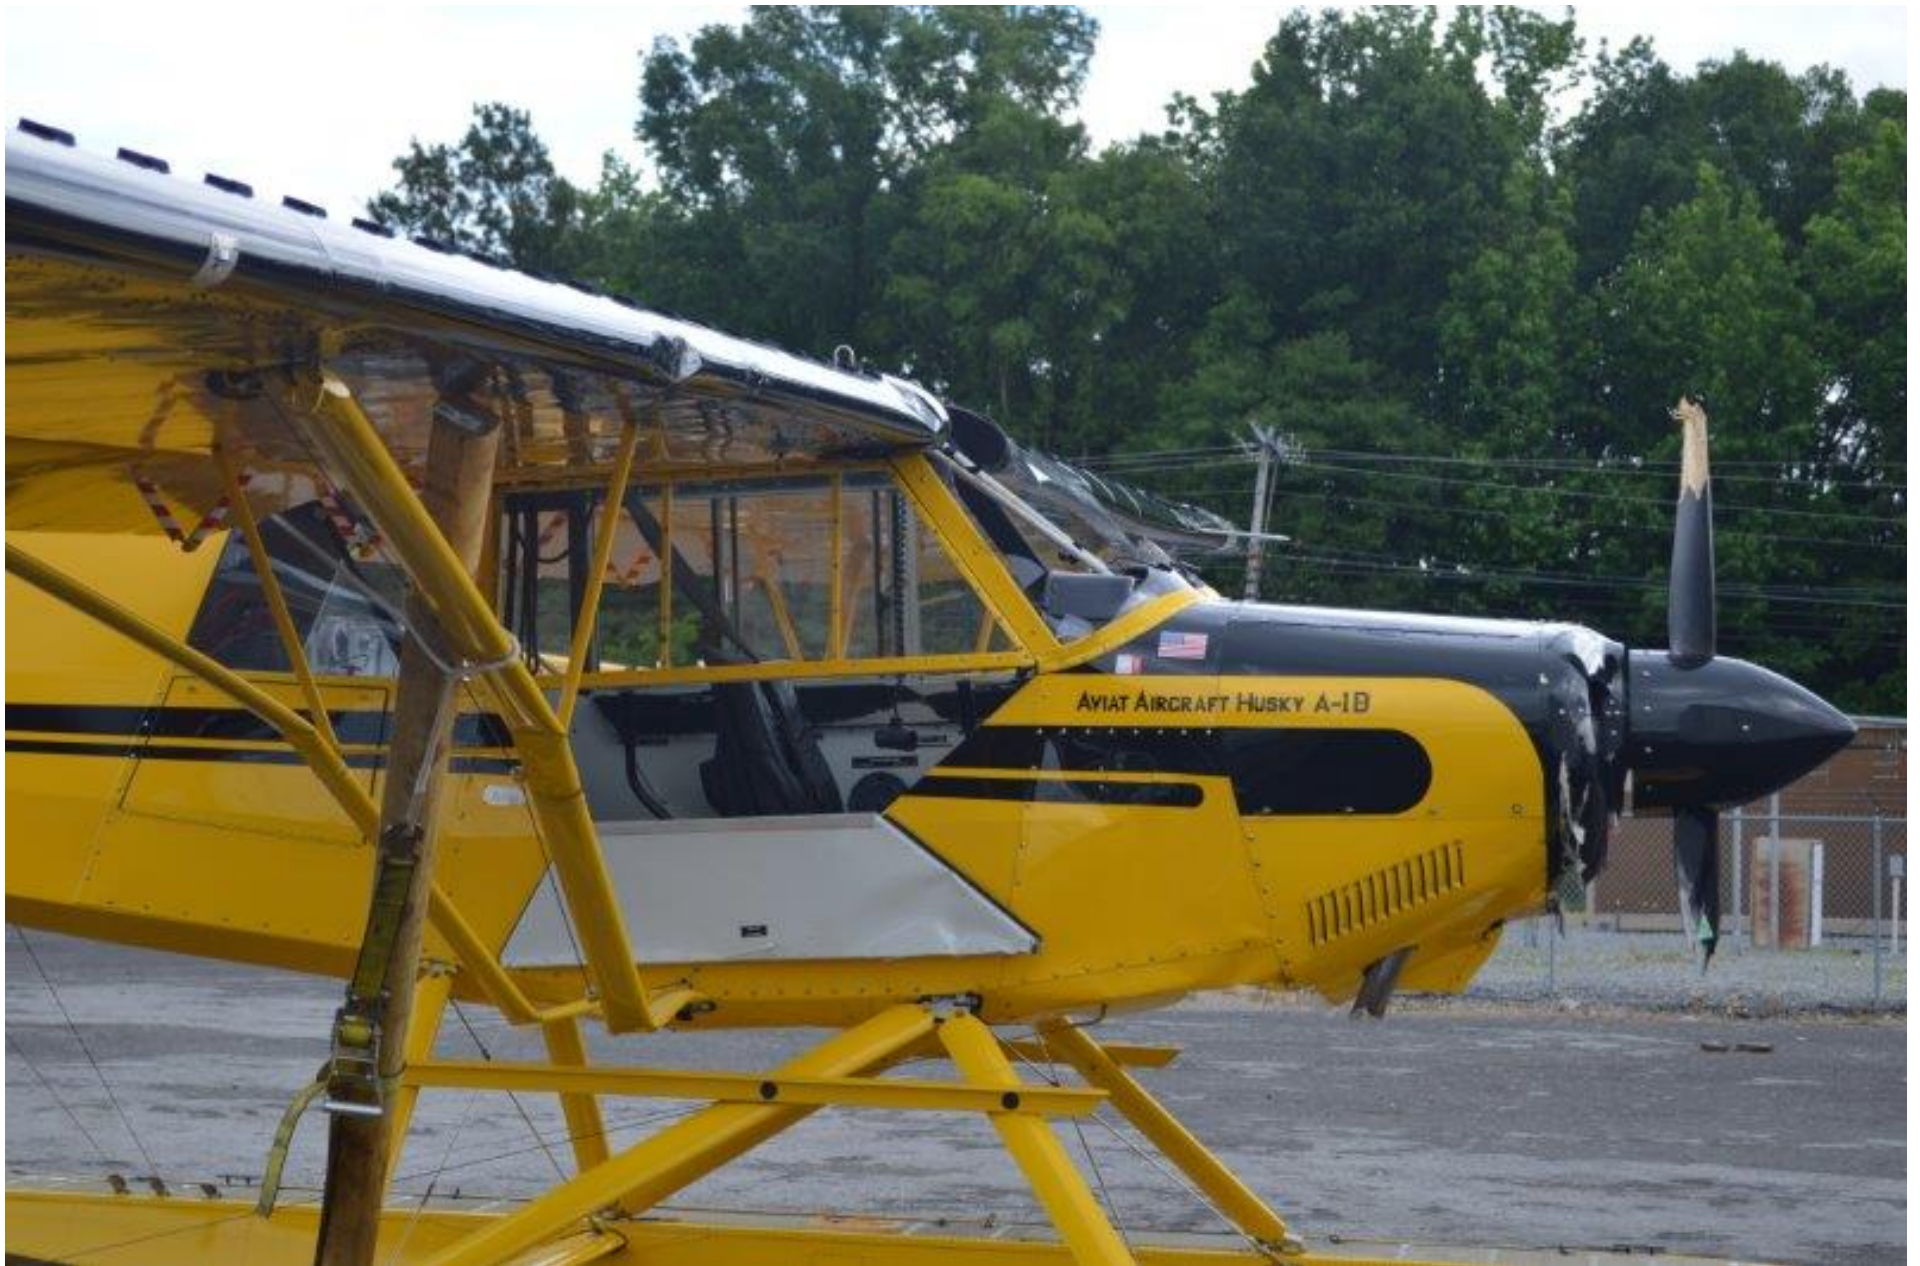
**Photo 1 – View of the right-wing lift strut damage (photo courtesy of the pilot)**
