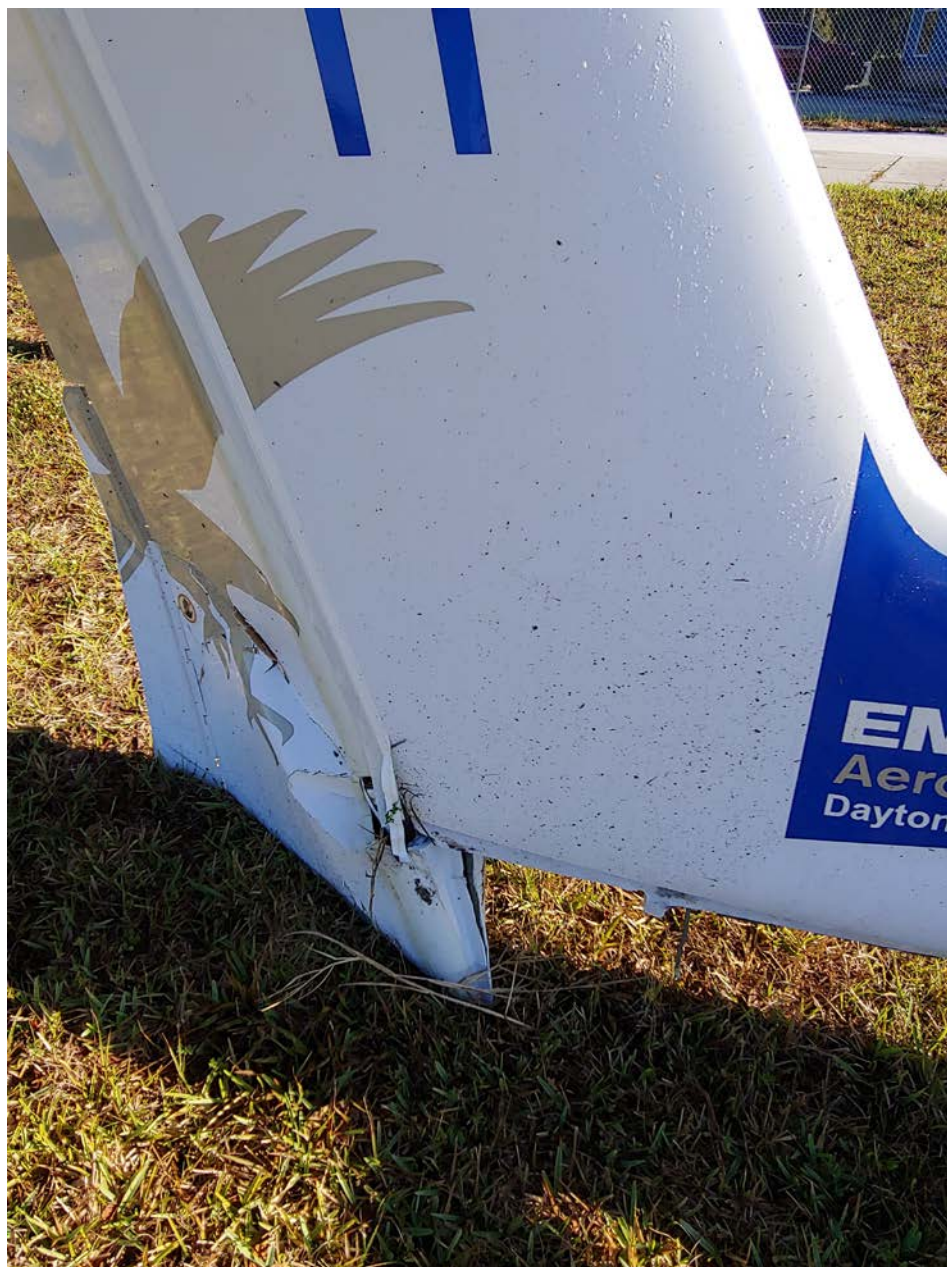
Photo 1 – View of rudder damage (photo courtesy of the FAA)

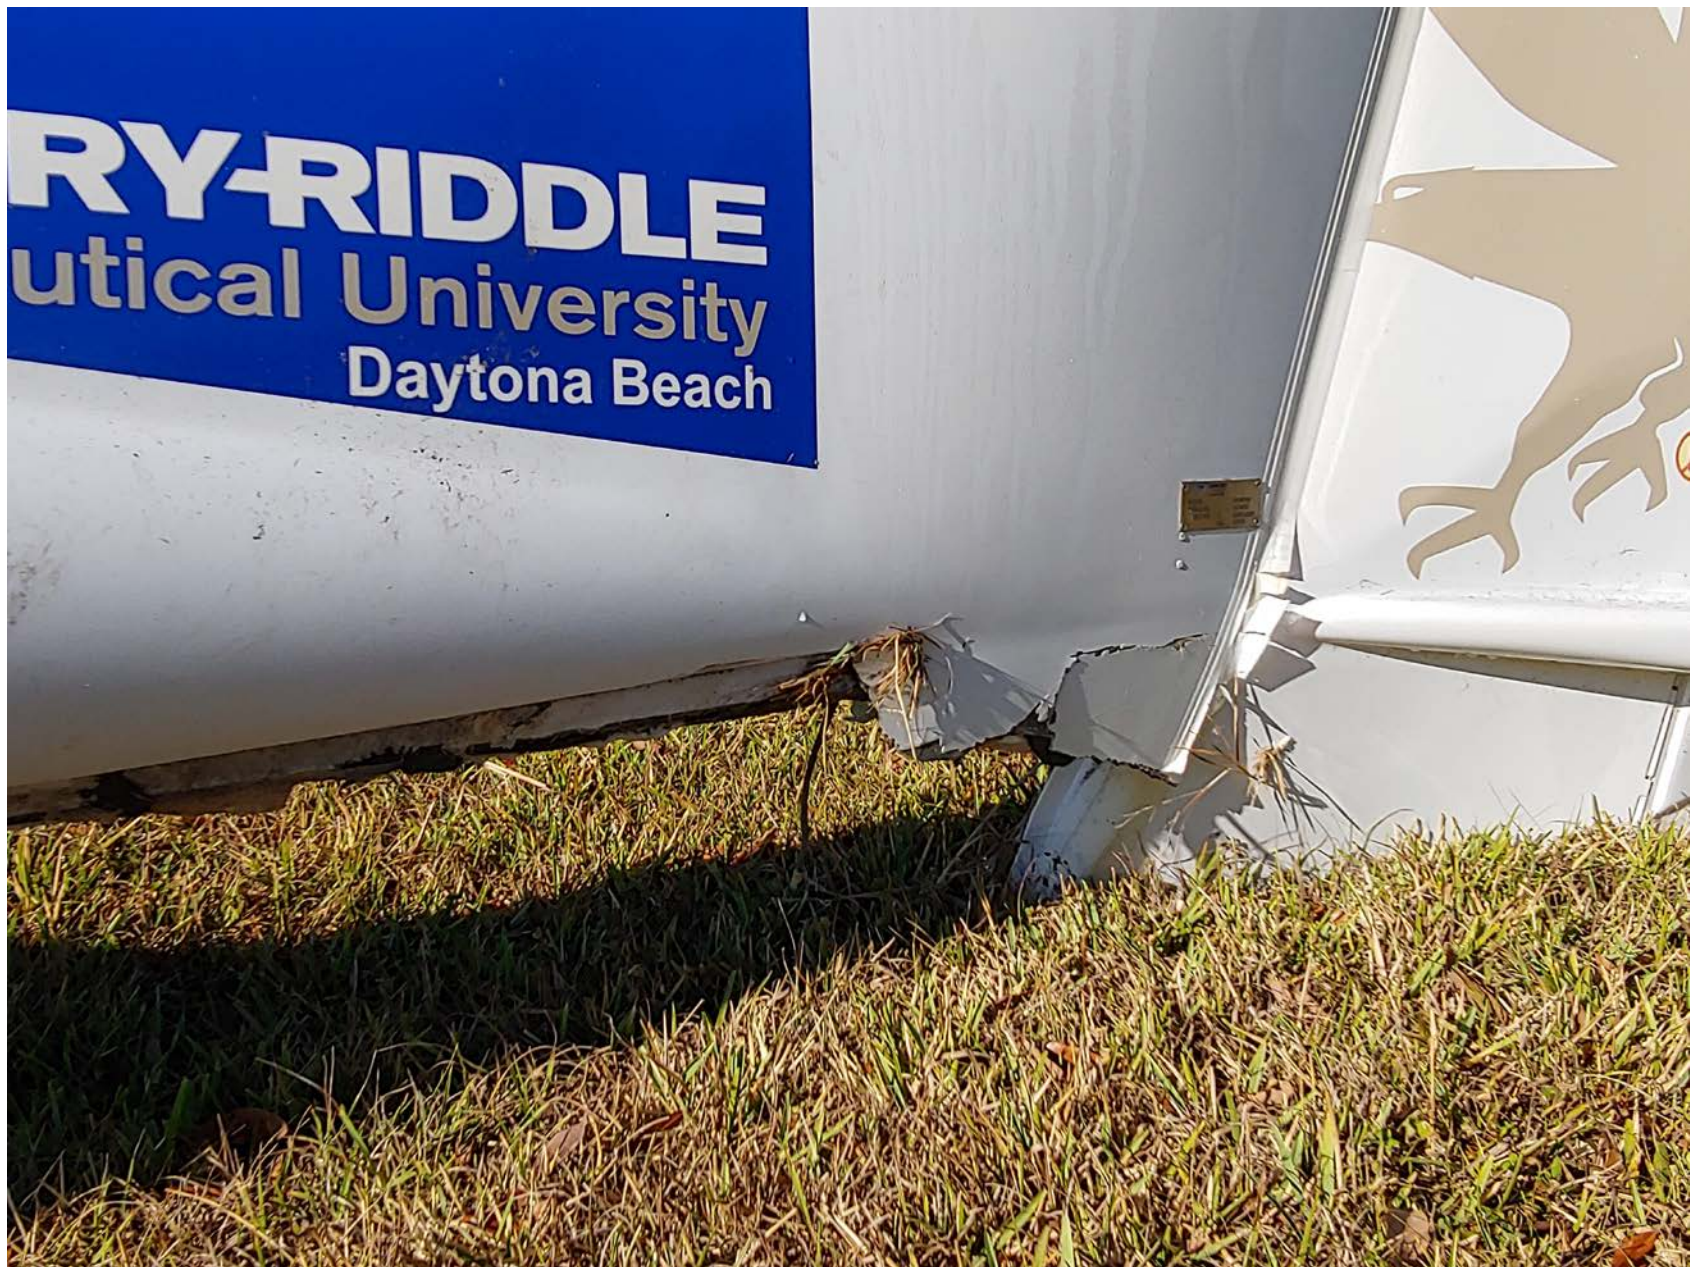
Photo 2 - View of empennage damage (photo courtesy of the FAA)
