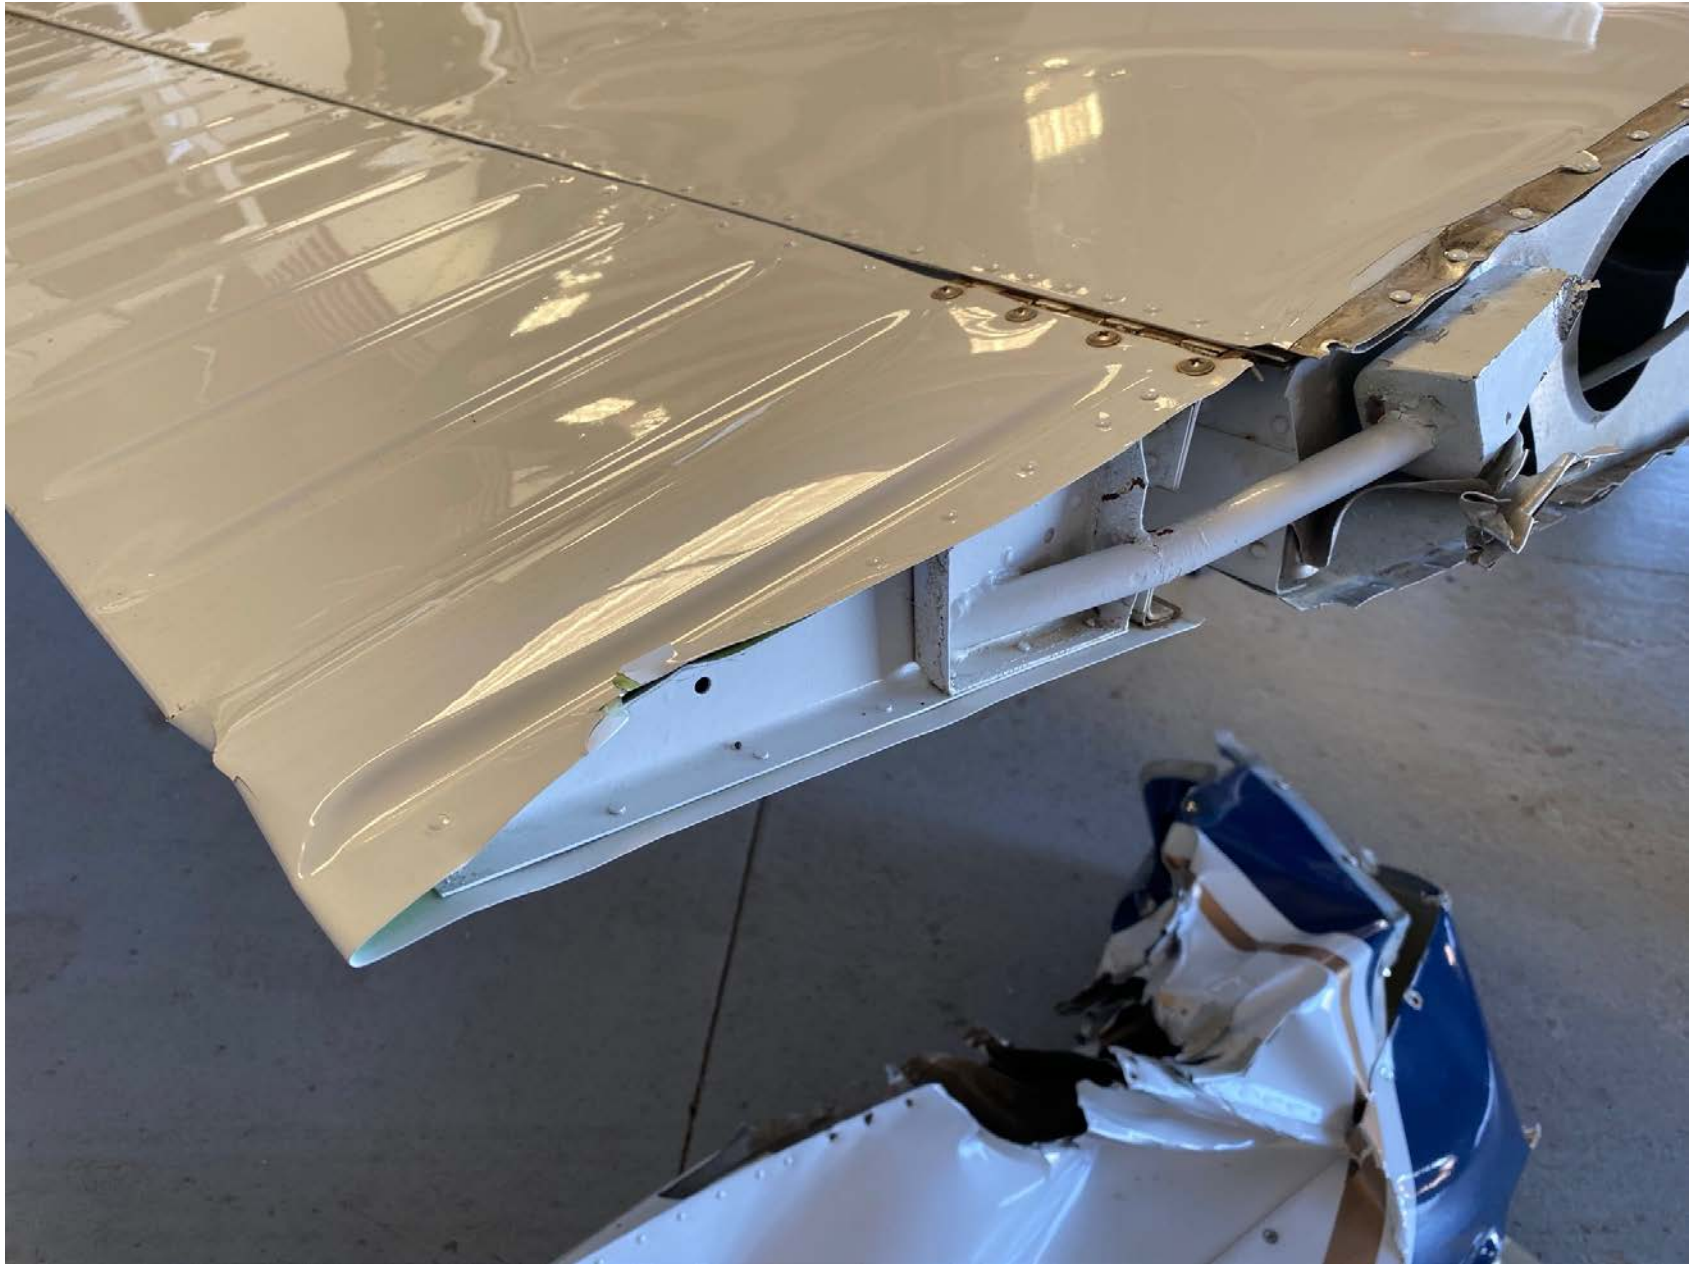
Photo 1 – View of right wing damage (photo courtesy of Velocity Air Inc.)

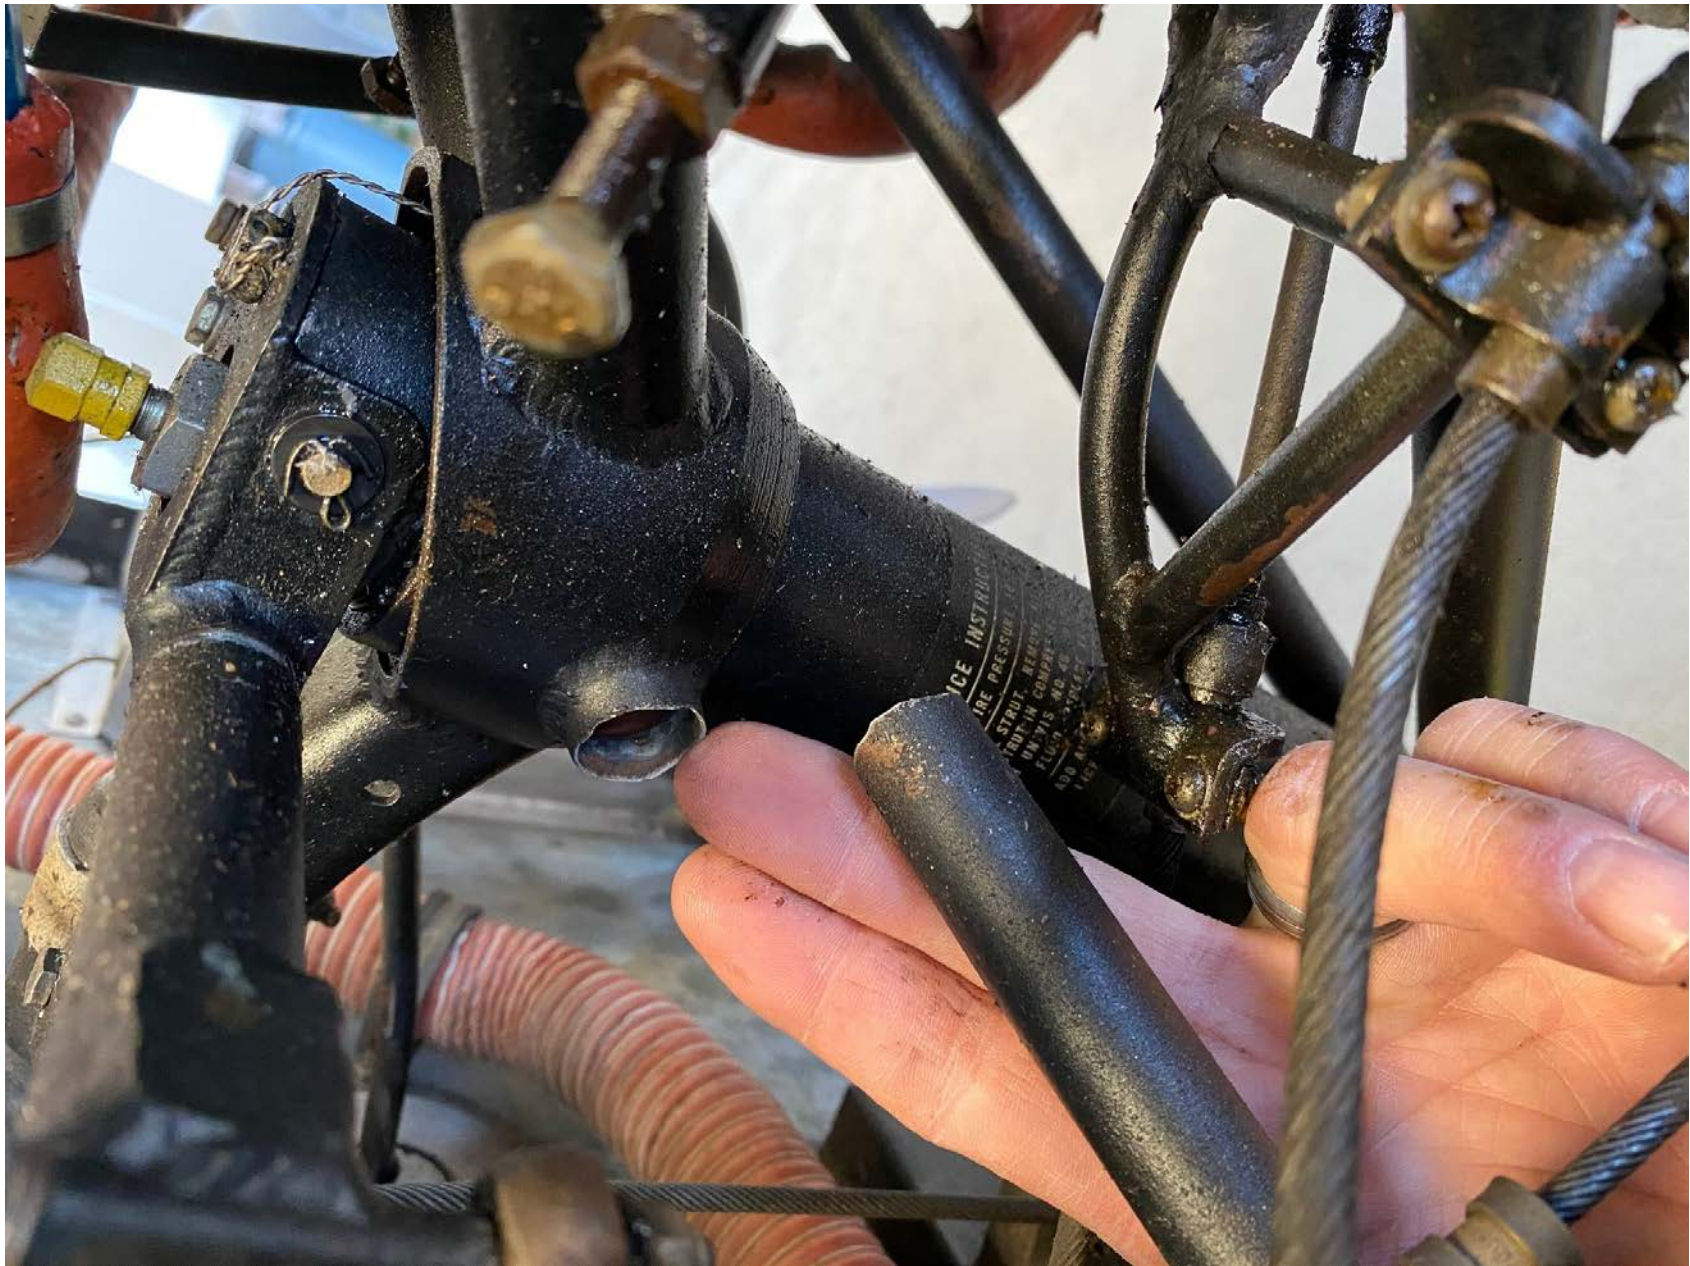
Photo 2 - View of engine mount damage (photo courtesy of photo courtesy of Velocity Air Inc.)
