WPR20CA140 Picture

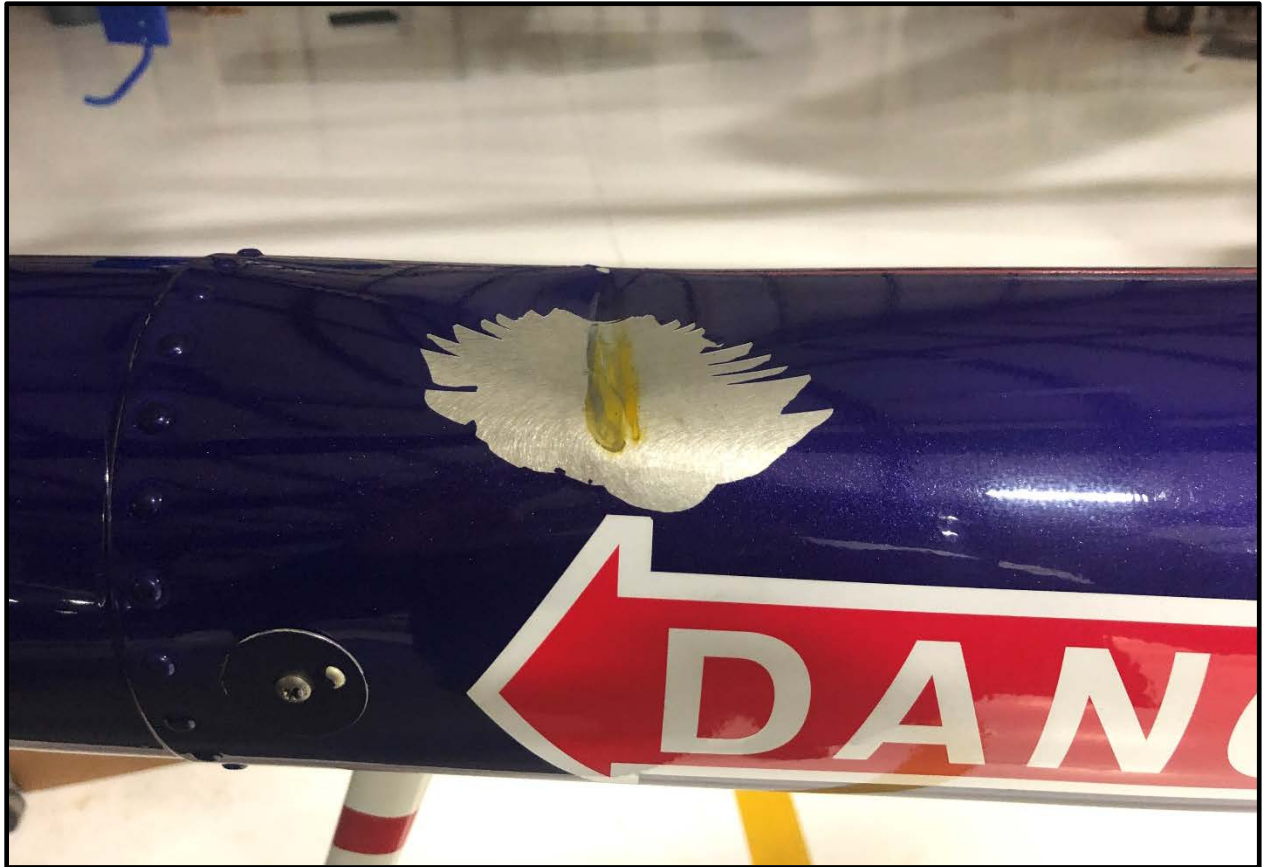
Figure 1: Dent in the tail boom.
