I. ADDENDUM

The SF Bar pilot was logged aboard the *Cosco Busan* at 0620 on the 7th of November 2007 for a scheduled departure of 0630. On the VDR the pilot can be heard introducing himself and being introduced to the master. During the aforementioned greetings the pilot produced and offered a Pilot Card¹ to the Master of the vessel. In his interview with the Safety Board the pilot produced and drew particular attention to the pilot card and its contents. In fact he read the pilot card start to finish and emphasized certain particular phrases. No comment from the ships master can be heard commenting on the card or its information. Just a general acceptance when it was handed over to him.

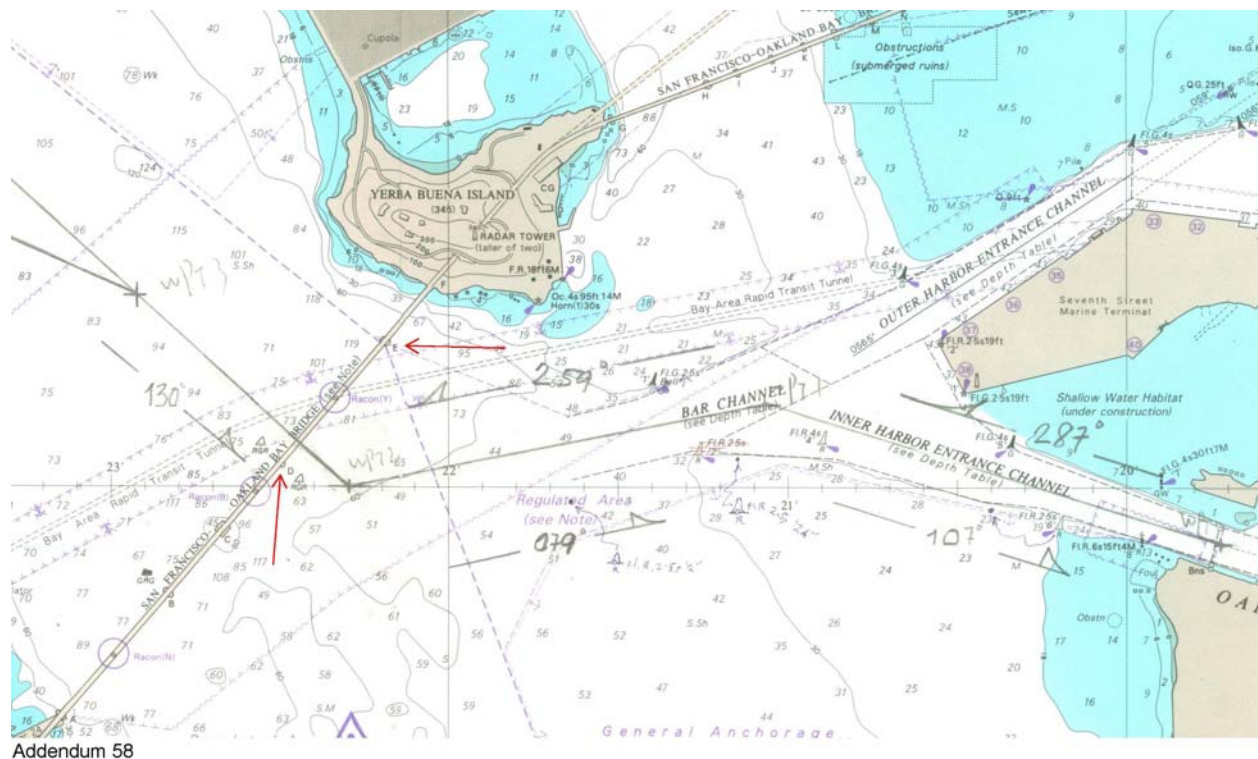
Passage Plan – chart

The chart below (British Admiralty chart No. 588, Edition 5, Edition date 29th Nov 2001, corrected through NM 38/07) was on the chart table of the *Cosco Busan* on the morning of November 7, 2007 prior to departure and during the transit up to and including the allision. The ships crew, prior to entering San Francisco harbor, constructed the chart lines and courses for the route to and from the berth. The crew was not interviewed so it can not be determined why a single line was drawn through the D and E span for both the inbound and outbound transit.

The charted course of 310 degrees true for the outbound transit of the *Cosco Busan* shown below is measured at approximately 350' off the bridge pier to the northeast. The course line is drawn in conjunction with an inbound course of 130 degrees true which then connects with two additional courses that are used as reciprocal courses for the in and outbound transits.
