**SUBMISSION TO THE NATIONAL
TRANSPORTATION SAFETY BOARD**

**UNCONTAINED ENGINE FAILURE
DELTA AIR LINES, FLIGHT 1288
MC DONNELL DOUGLAS MD-88, N927DA
PENSACOLA, FLORIDA
JULY 6, 1996**

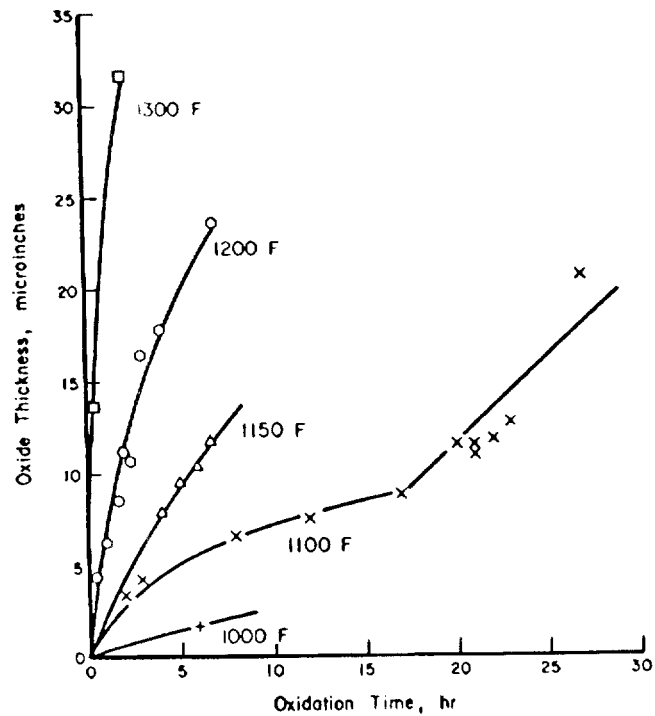
Figure 2. Thickness of the oxide layer formed on Ti-6Al-4V alloy as a function of time at different temperatures [Appendix A, Ref. 1].

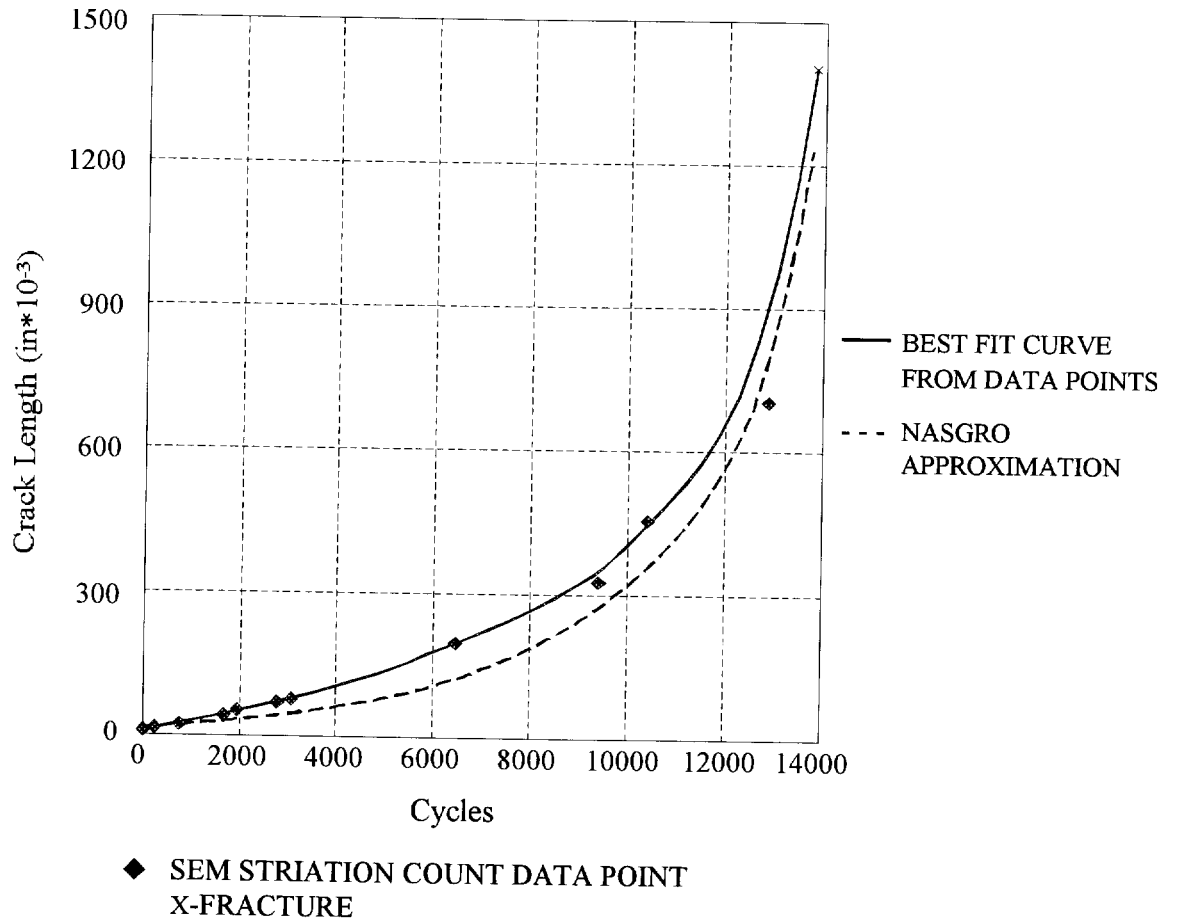
Figure 3.

JT8D-219 FAN HUB
Cycles vs. Crack Growth
