SUBJECT: Condition of Wheels, Brakes and Tires removed from Ship 678

TO: Staff Manager - Aircraft Maintenance - Shops  
FROM: Technical Analyst - Component Shops *DBD*  
SUBJECT: Report on A/C 678: Findings of Wheels and Brakes

## Aircraft 678 Shop Findings Summary

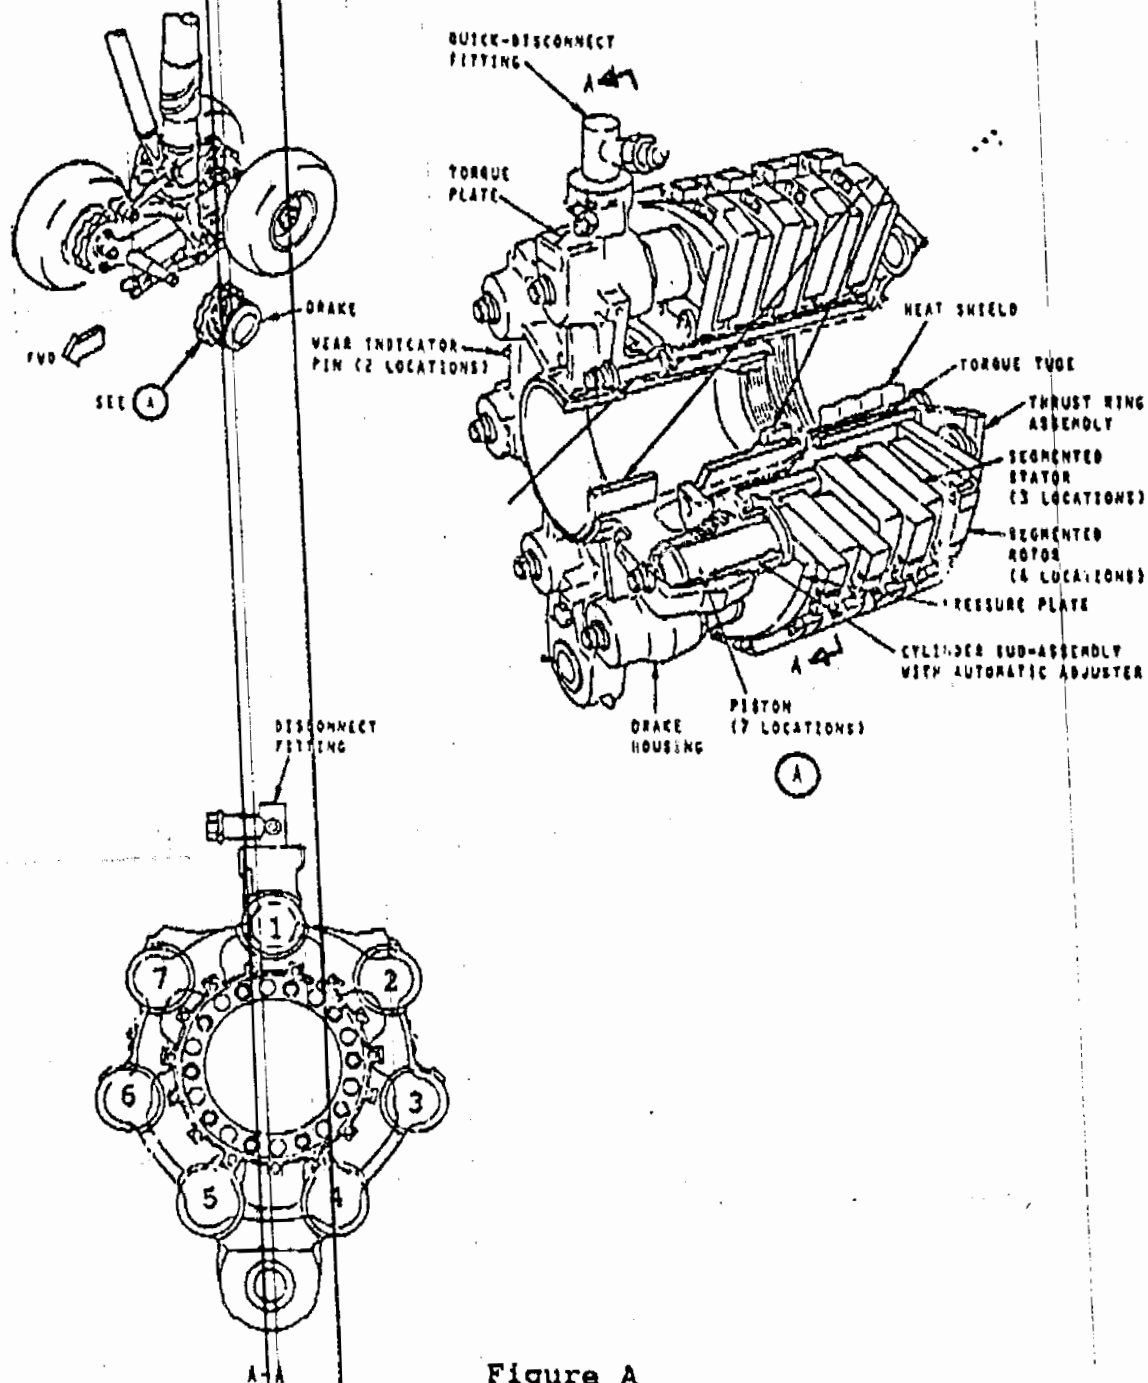
**Figure A**  
Hydraulic Brake Assembly

- \* Shows signs of excessive heat build-up in all brake assembly components (Ref. Figure A)
- \* Torque tube discolored and warped (scrapped)
- \* Heat shields delaminated (burned)
- \* Spreader plate warped by excessive heat and failed NDT eddy current test (scrapped)
- \* No pistons damaged in brake housing assembly
- \* No torque plate (brake housing) damage per NDT
- \* Temp sensor tested and returned to service

- \* Shows signs of excessive heat build-up in all brake assembly components (Ref. Figure A)
- \* Torque tube discolored and warped (scrapped)
- \* Heat shields delaminated (burned)
- \* Pistons bulged in all seven positions in brake housing. #3 piston ruptured due to internal pressure build-up (Ref. below & Figure A-A)

Piston #1 - 1.401  
#2 - 1.514  
#3 - 1.085  
#4 - 1.525  
#5 - 1.467  
#6 - 1.428  
#7 - 1.382

Hole blown in side

I HAVE NEVER  
SEEN THIS  
BEFORE. THE  
HOLE LOOKED  
LIKE A RUPTURED  
BLISTER.
