DEUTSCHE BABCOCK
WERKE
AKTIENGESELLSCHAFT

SS NORWAY

Repair to the Steam and Lateral Drum of Boiler 21 in the
 SS Norway from 7.11. - 21.11.1987

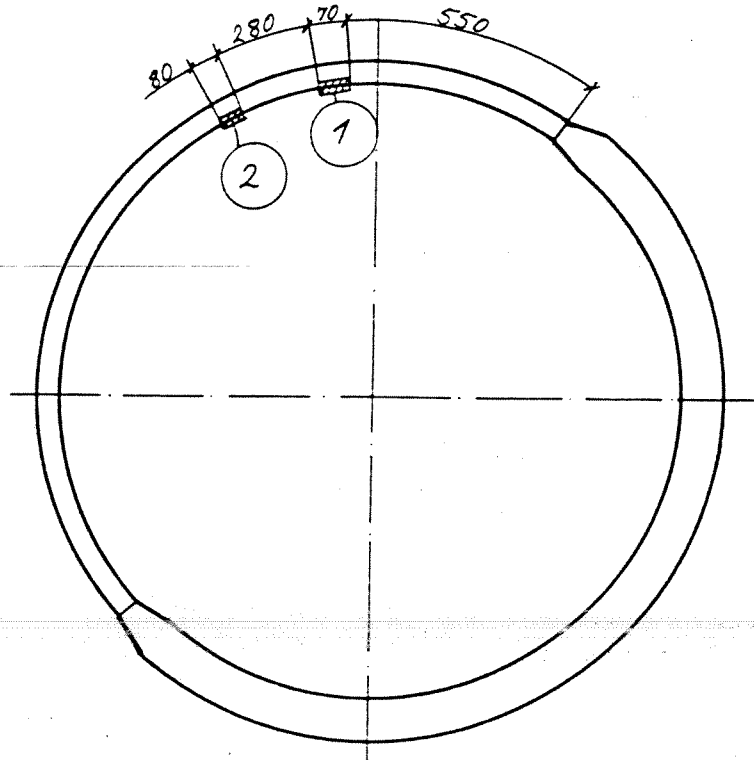
Defective position, upper drum, boiler 21, front circumferential seam seen from the back.

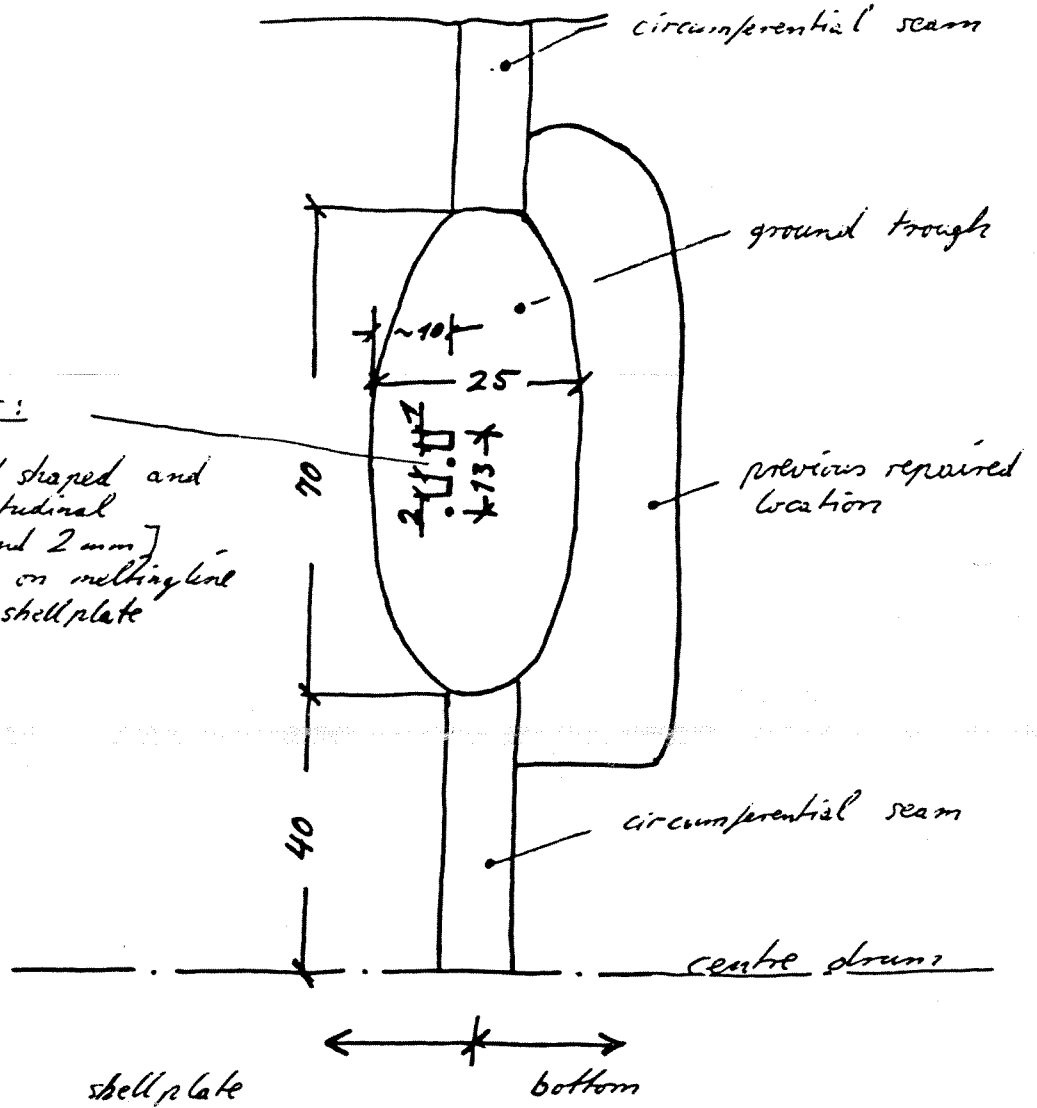
Defective position 1:

ground trough and defective position:

*2 point shaped and
 2 longitudinal
 [1 and 2 mm]
 signs on melting line
 to the shell plate*
