DEUTSCHE BABCOCK  
WERKE  
AKTIENGESELLSCHAFT

Kennwort SS Norway

Kom.-Nr. 94-8351-998

Boiler 21, 22 and 23

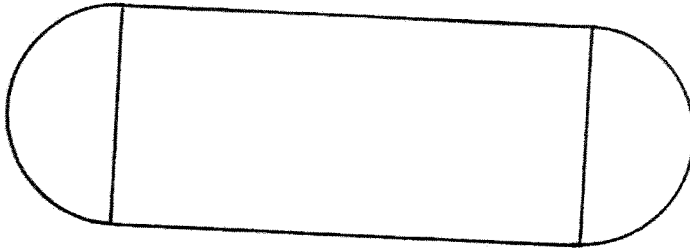
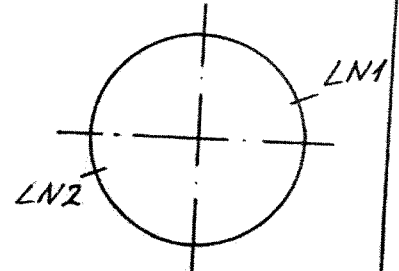
Boiler 21 Upper drum

Longitudinal welds 1 and 2 exhibit coarse corrosion pits, but no indications subject to registration.

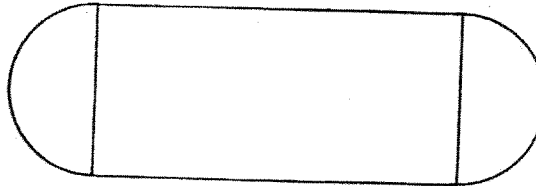
Boiler 21 Upper drum

No rework was performed.

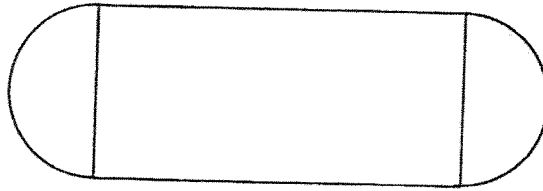
Boiler 21 Lower drum

LN1 + LN2: Severe corrosion pitting in the entire weld area.

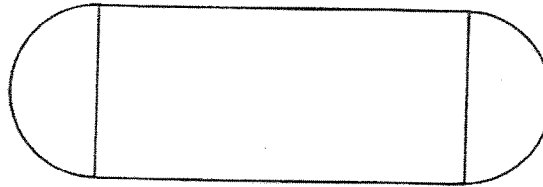
Boiler 2-1 lower drum

LN1 + LN2 : No crack indications.

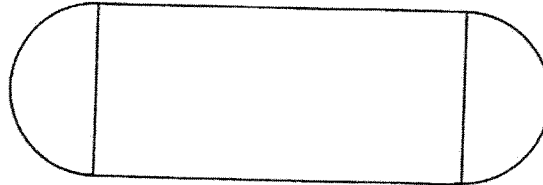
Boiler 21 lateral drum

LN1 : 0 - 1400 coarse corrosion pits with crack connections  
 2000 - 3000 7 cracks, 15-20 mm long  
 3000 - 4000 4 cracks, 20-25 mm long  
 4000 - 4350 severely pitted crack indications

LN2 : 0 - 2000 continuously small crack indications  
 2000 - 3000 6 cracks, 15-20 mm long  
 3000 - 4000 2 cracks 10 mm long

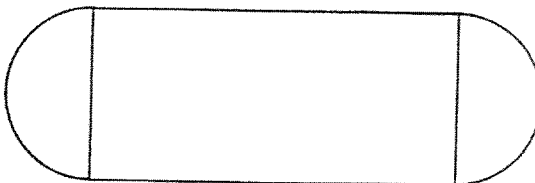
LN1: No crack indications

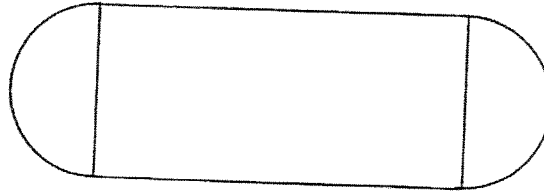
Boiler 22, Upper drum

LN1 : No crack indications  
LN2 : No crack indications

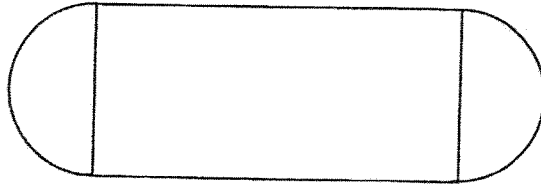
LN1: 0-500 small crack indications  
2500 interrupted crack indications about 150mm long, followed by 2 cracks about 15 to 20 mm long

LN2: 0-1500 small crack indications

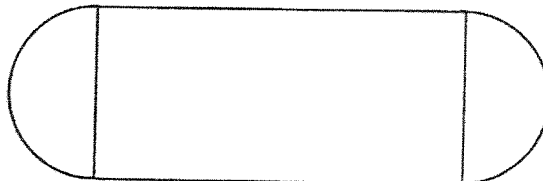
Boiler 22, lower drums

LN1 : No crack indications

LN2 : No crack indications

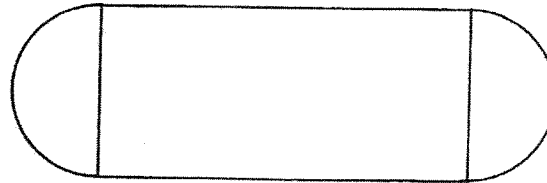
Boiler 22, lateral drum

LN1 + LN2 : continuously crack-like indications

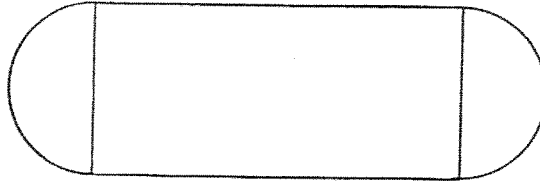
LN1: Areas of 1100 to 1350 and 3100 to 3500 were welded. No crack indications.

LN2: No crack indications.

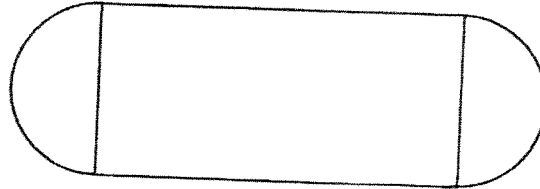
Boiler 23, Upper drum

Severe corrosion in the entire drum area.

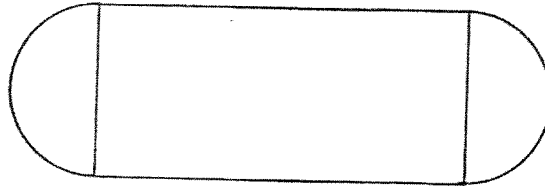
Boiler 23, Upper drum

LN1 : No crack indications

LN2 : No crack indications

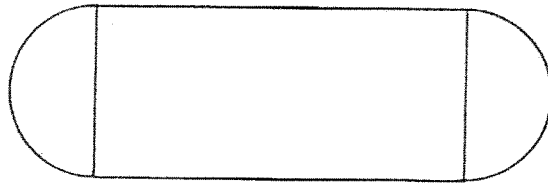
Boiler 23, lower drum

LN2: 17 areas with crack-like indications, distributed over the full length. The areas are 20-100 mm long.

4 crack areas 30 to 50 mm long

Continuously small crack-like indications.

1 point with crack-like indication

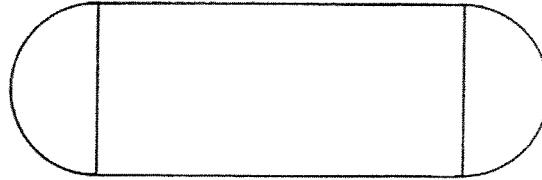
Boiler 23, lower drum

LN1: No crack indications

LN2: No crack indications

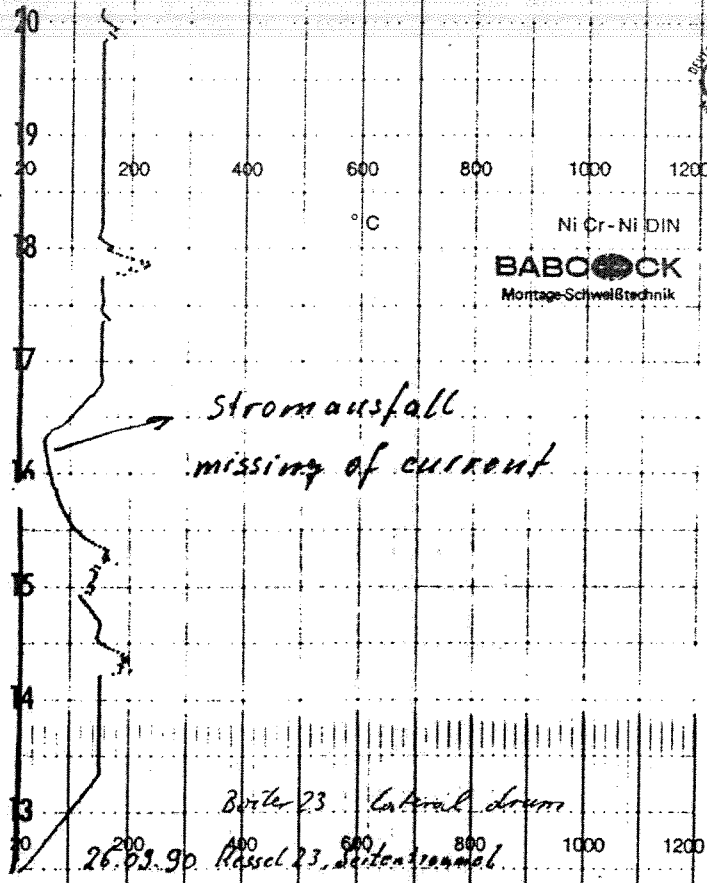
*Boiler 23 Lateral drum*  
*Kessel 23 Seitentrommel LNA*

*Stromausfall*  
*missing of current*

*Boiler 23 Lateral drum*  
*26.03.90 Kessel 23, Seitentrommel*  
 12 *oberlängsnaht / 1 Schweißnaht 1300 - ca 2800*  
*Upper long seam weld area 1300 - 2800 mm*

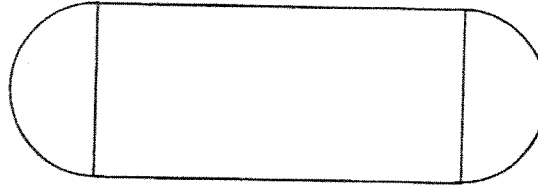
Boiler 23, lateral drum

Surface crack test: No defects detected.
