# NATIONAL TRANSPORTATION SAFETY BOARD

## FIELD NOTES

NTSB ID No.: CEN17FA183 (CEN17MA183)

Location: Teterboro, New Jersey  
Date: May 15, 2017  
Time: 1529 eastern daylight time  
Aircraft: Gates Learjet 35A, N452DA, Trans-Pacific Jets

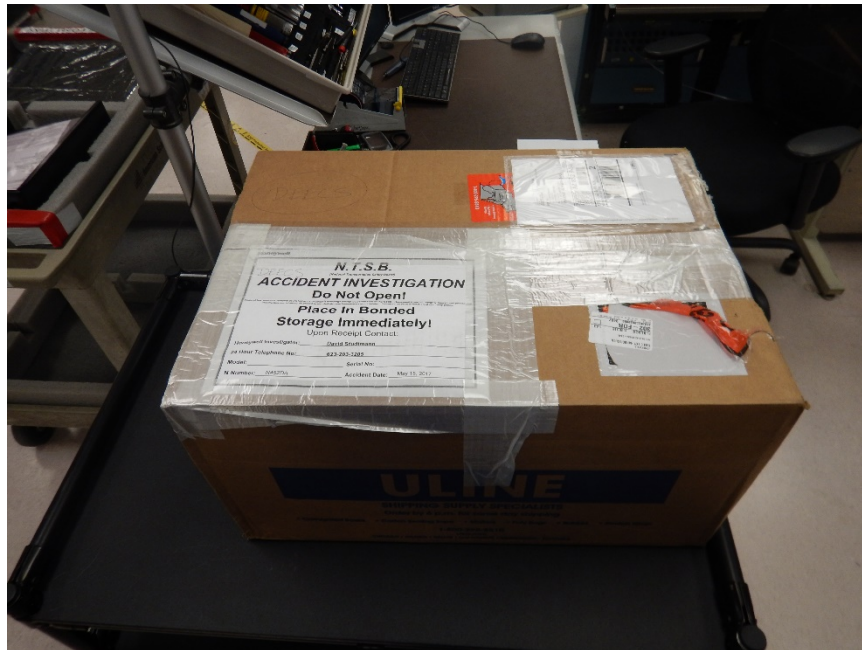
The two DEEC circuit boards along with their respective NVM chips arrived at the Honeywell Tucson, Arizona facility sealed in a box. (Photo No. 1) The box had been opened the day before by the NTSB investigator at the Honeywell Phoenix, Arizona facility to confirm the circuit boards and memory chips were in the box. Upon confirmation the circuit boards and memory chips were in the box, the box was immediately resealed for transport to Tucson.

Photo No. 1: Sealed box containing the two DEEC boards. (Honeywell)

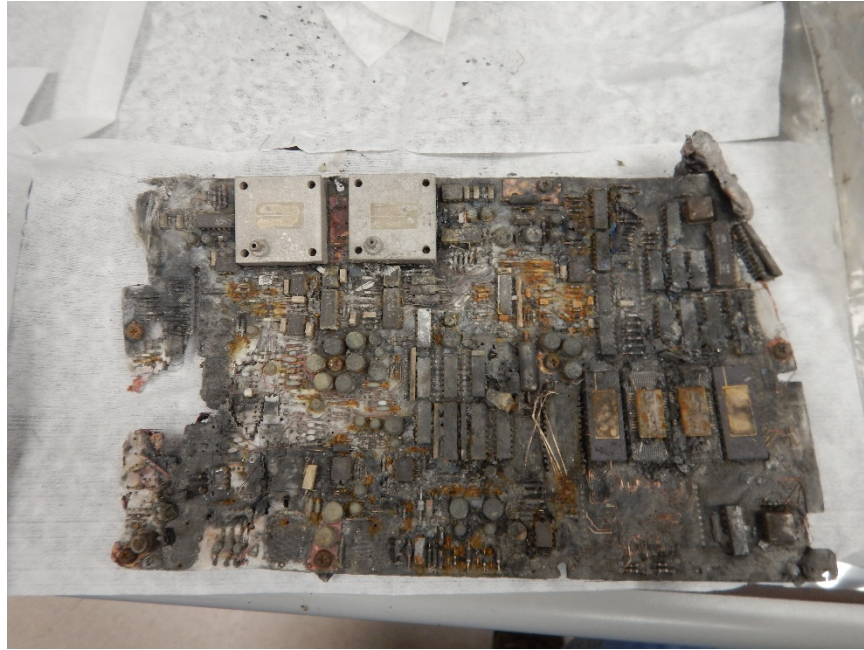
The circuit board that was identified as "A" was sealed in a plastic bag along with the NVM chip that had been removed from the board and was contained in a small box. The board was partially burned on one end. (Photo No. 2) The center part of the board was missing the

Photo No. 2: Board "A" partially burned on one end. (Honeywell)

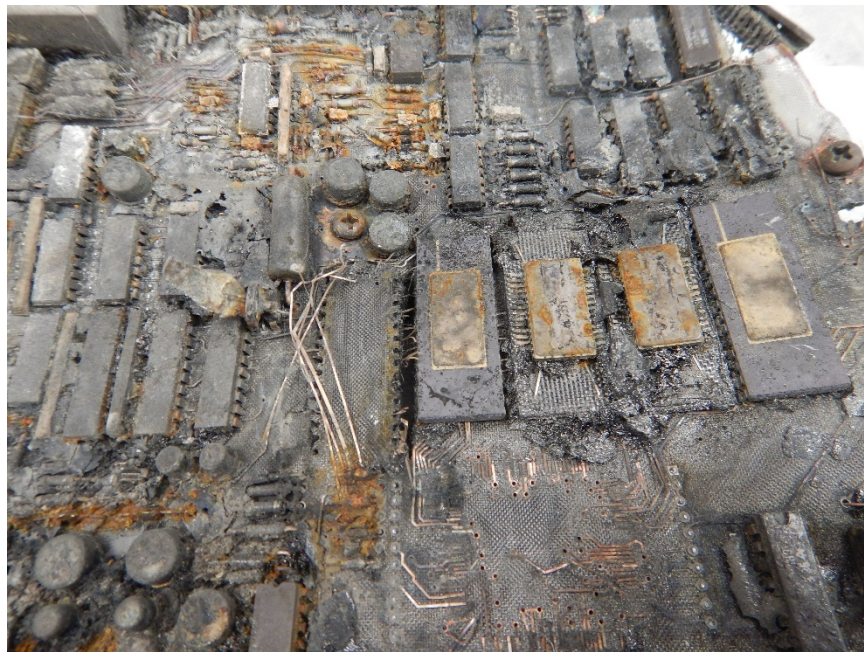
resin coating exposing the fiberglass matting. (Photo No. 3) The underside of the board had metal slag adhered to it. (Photo No. 4)

Photo No. 3: Close up view of board "A" showing exposed fiberglass matting. (Honeywell)

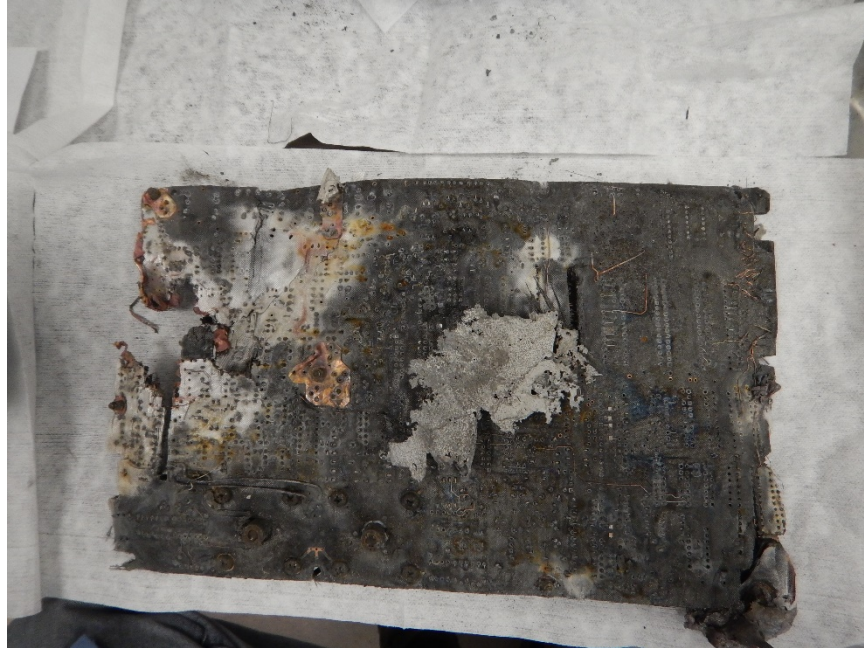
Photo No. 4: Underside of board "A" showing metal slag. (Honeywell)

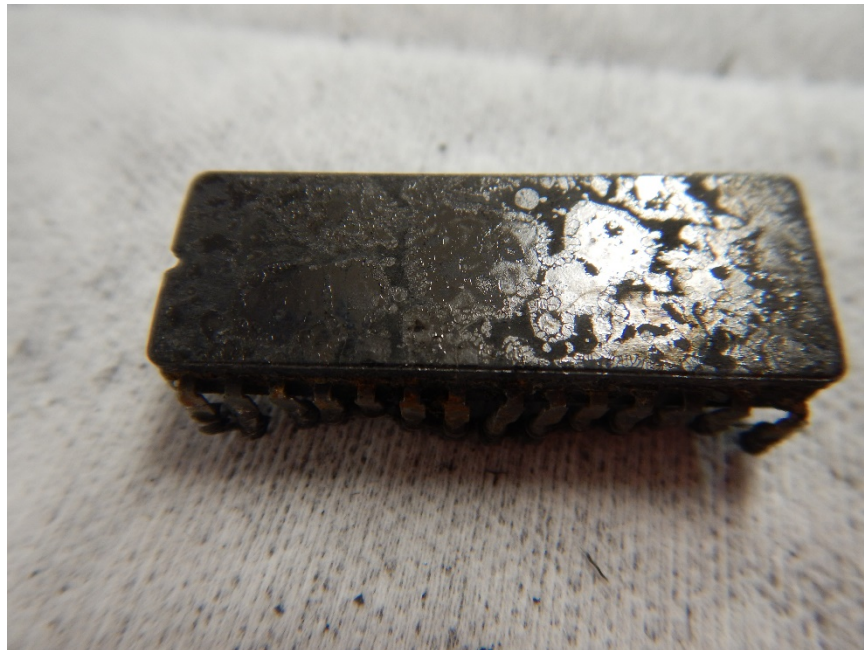
The memory chip was intact and the cover was in place. The cover and the underside of the chip had a mottled appearance and there was no legible writing on either side. (Photos Nos 5 and 6) Although the cover was in place, it was partially lifted at one end. (Photo No. 7) All of the pins were in place on the chip, but there were many pins that were bent slightly. (Refer to Photo No. 6) The pins had a lot of layered debris, consistent with the layers of material from the fiberglass board. (Photo No. 8)

Photo No. 5: Top of chip. (Honeywell)

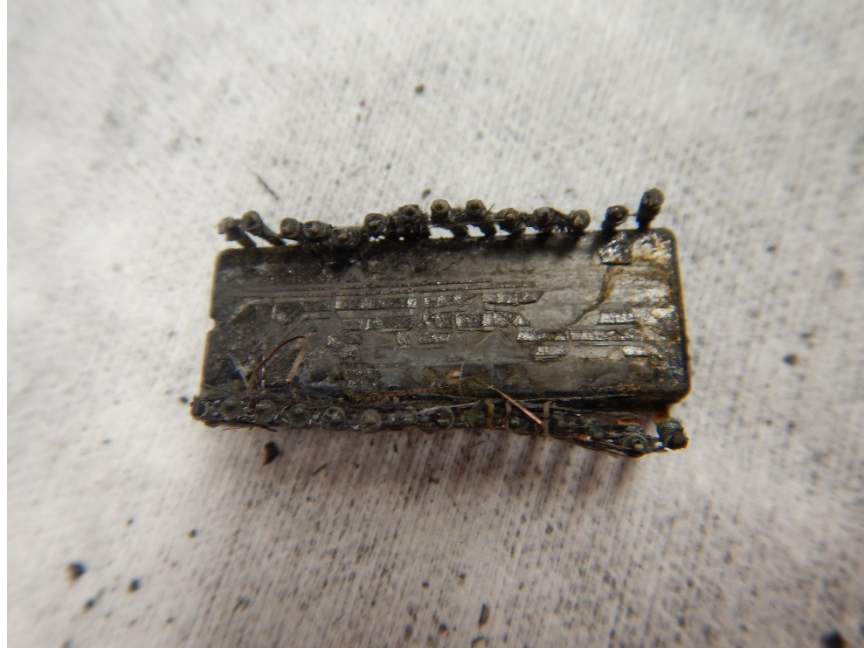
Photo No. 6: Underside of chip also showing the bent pins.(Honeywell)

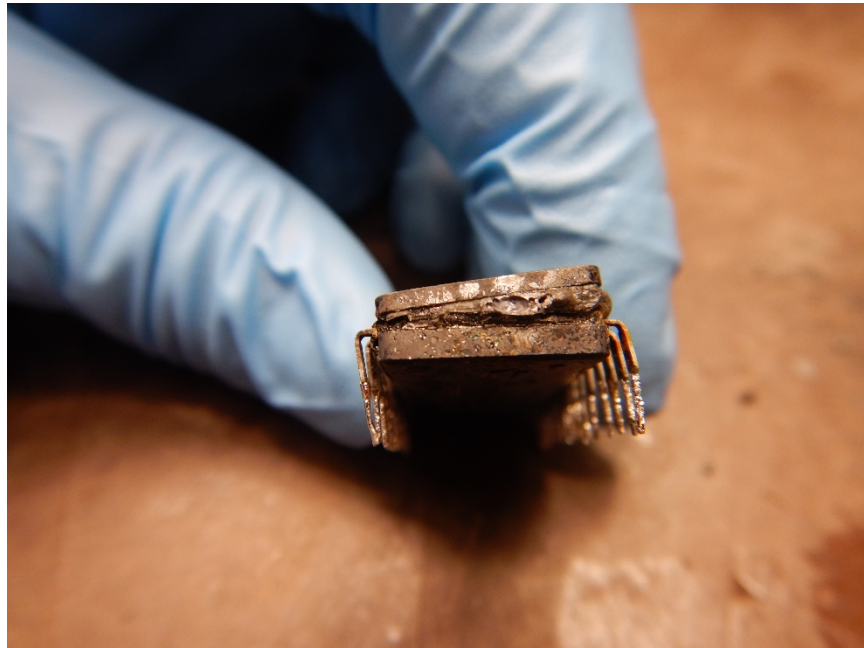
Photo No. 7: Side view of chip showing partially lifted cover. (Honeywell)

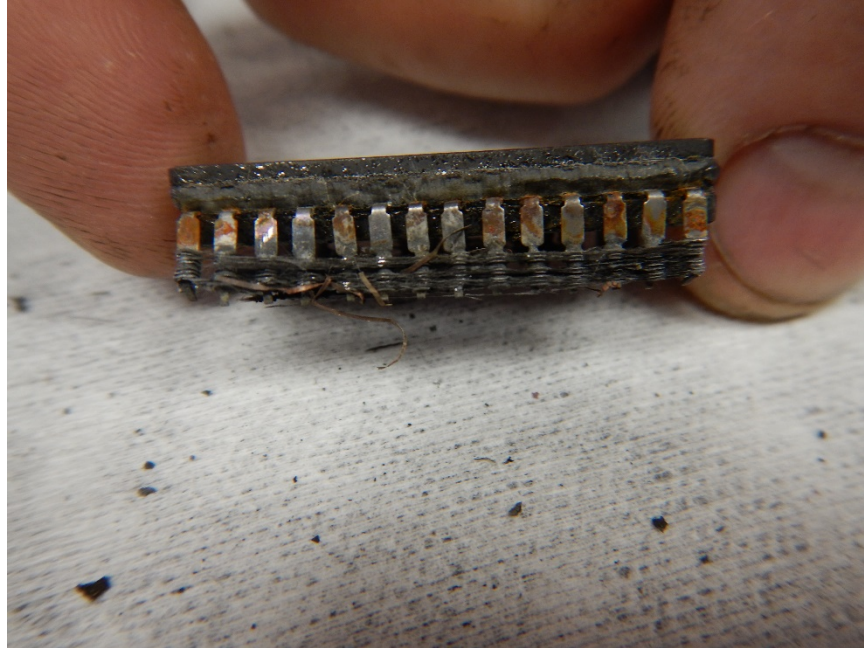
(Photo No. 8: Close up view of pins showing layers of debris. (Honeywell))

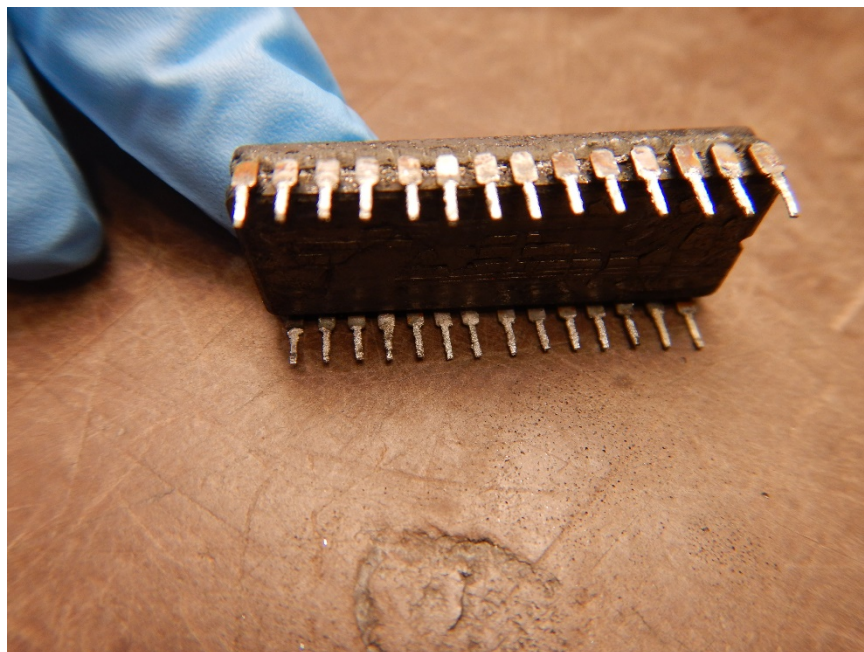
After the pins were cleaned (Photo No. 9), the chip was positioned into the receptacle of a data reader. Several attempts were made to read the data, but all resulted in indications of a continuity fail message or a message that indicated there was no data stored in the NVM. A digital multimeter was used to check the continuity between the chip's two power pins, Nos. 14 and 28, that indicated there was no continuity. When the multimeter was used to check the continuity between the power pins on an exemplar memory chip, it showed that there was continuity between the two pins.

Photo No. 9: Close up view of pins after they had been cleaned. (Honeywell)

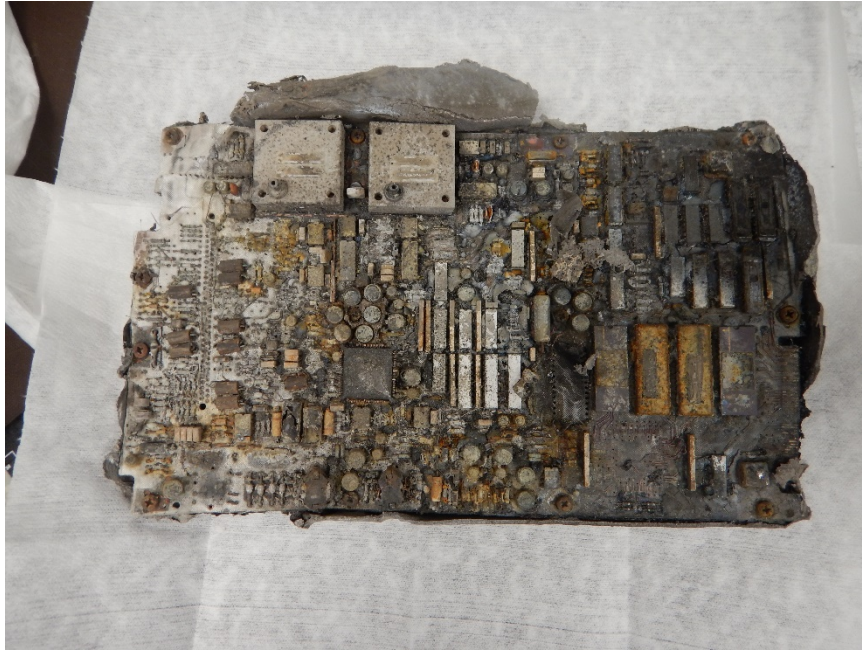
The board that was identified as "B" was sealed in a plastic bag along with the NVM chip that had been removed from the board and was contained in a small box. The board was intact. (Photo No. 10)

Photo No. 10: View of board "B" showing it was intact. (Honeywell)

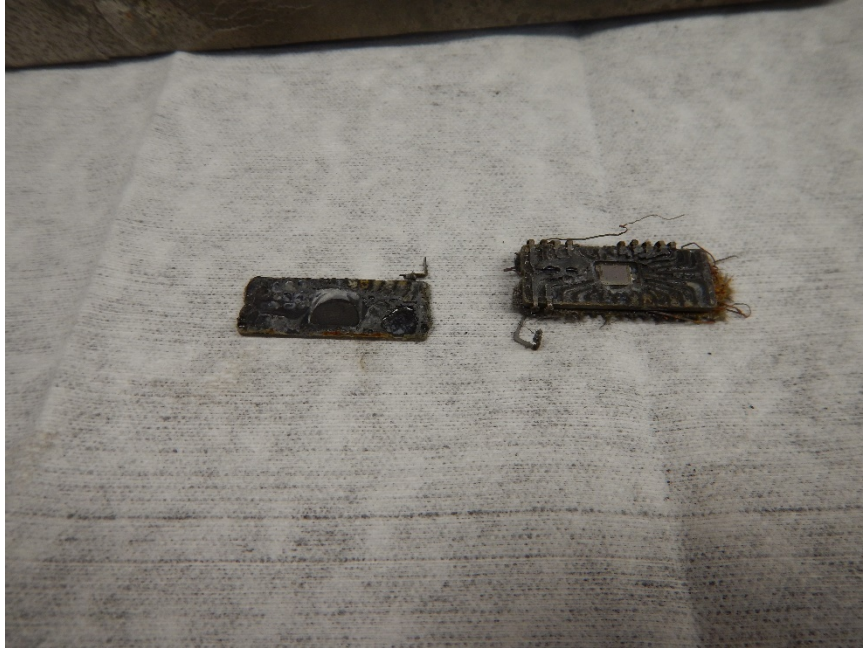
The body of the chip was intact, but the cover had separated from the body exposing the die, the leads to the pins, and the fly wires. (Photo No. 11) Most of the fly wires between the pins and the die were missing. Of the 28 pins on the chip, 17 were broken away and missing from the chip. Of the 11 pins that remained on the chip, 9 were on one side and 2 on the other side. (Photo No. 12) The ends of most of the missing pins could be felt or seen still in the board. The die appeared to be intact. (Photo No. 13)

Photo No. 11: Chip showing the cover had separated exposing the inside: (Honeywell)

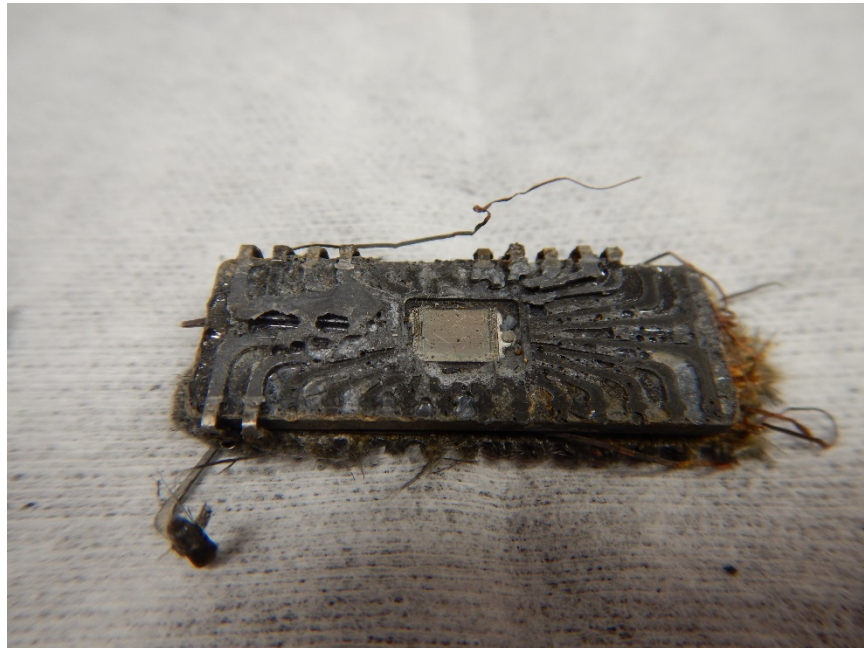
Photo No. 12: Close up of chip showing most of the fly wires were missing. (Honeywell)

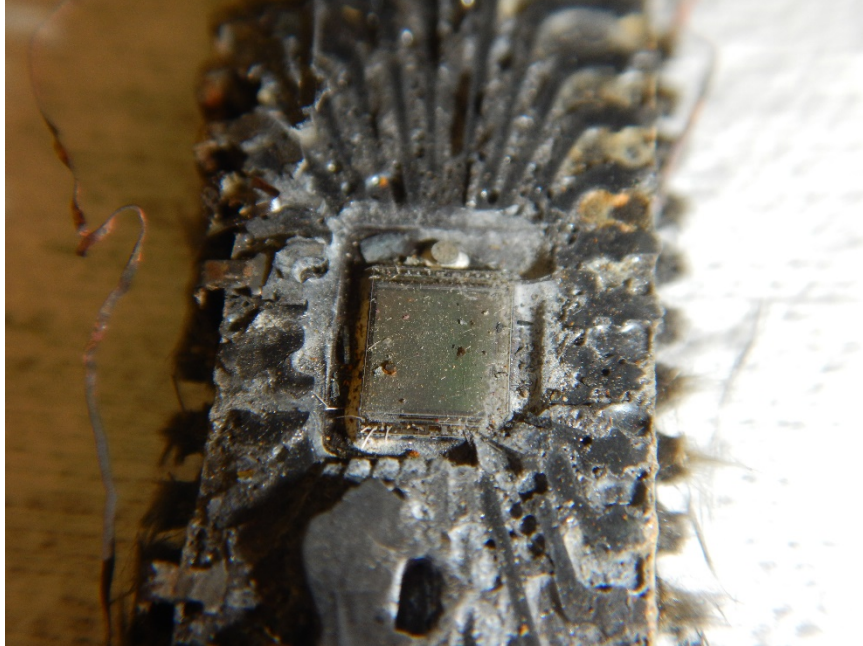
Photo No. 13: Close up of die showing that it was intact. (Honeywell)

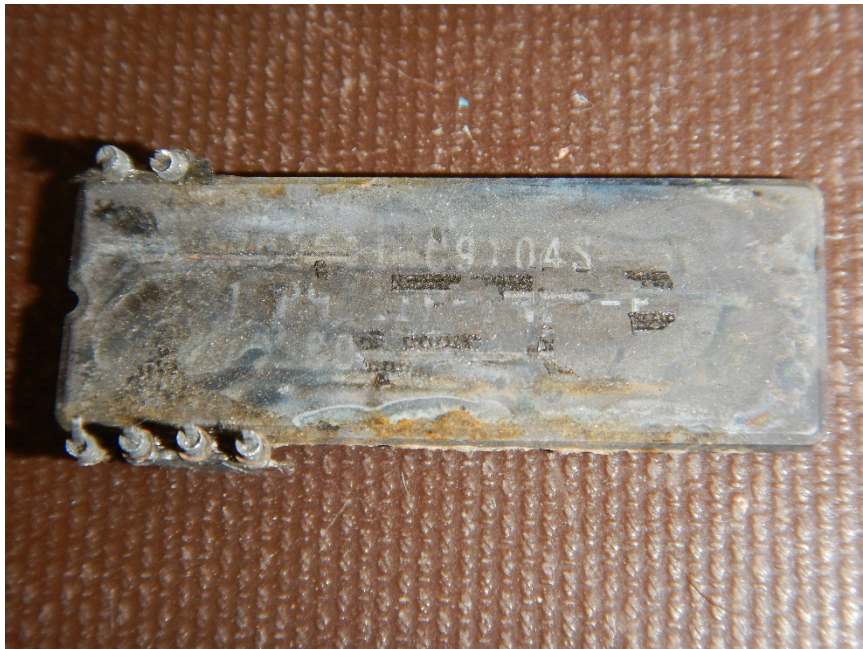
Markings that were noted on the underside of the chip and compared to an exemplar memory chip indicated the chip had been manufactured by Atmel. (Photos Nos. 14, 15, and 16) According to Honeywell, Atmel, which is based in San Jose, California, was the designated vendor for the memory chips in the DEECs that were installed on the accident engines.

Photo No. 14: Markings on underside of memory chip from accident DEEC. (Honeywell)
