RE: Microchip Memory Products Division evaluation of two AT28HV256 devices to harvest data from those devices.

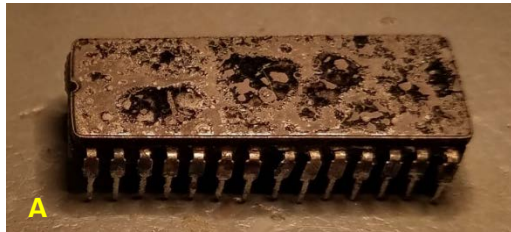
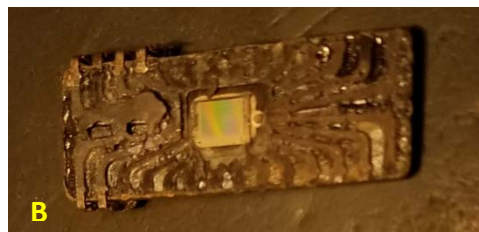
David Studtmann from Honeywell Aerospace in Phoenix signed into Microchip Fab 5 site at 0804MDT. The evidence was retrieved from secure storage still sealed as shipped from Honeywell. We opened the sealed box and took pictures of the devices as received.

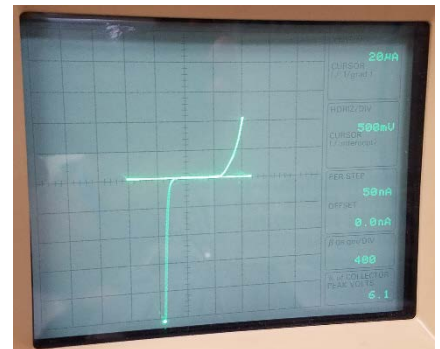
Sample A was curve traced to determine correlation to the Honeywell observation of no device ID in their Data I/O EEPROM reader. A KGD (known Good Device) was curve traced first to make the curved line showing the ESD protection diode break over that occurs at -0.3Vdc and the turn on of the CMOS circuitry that occurs at +0.7Vdc. Sample A device made a horizontal line. A horizontal line means the circuit is open and no current can flow. The Microchip open observation correlates to the Honeywell open observation on Sample A.

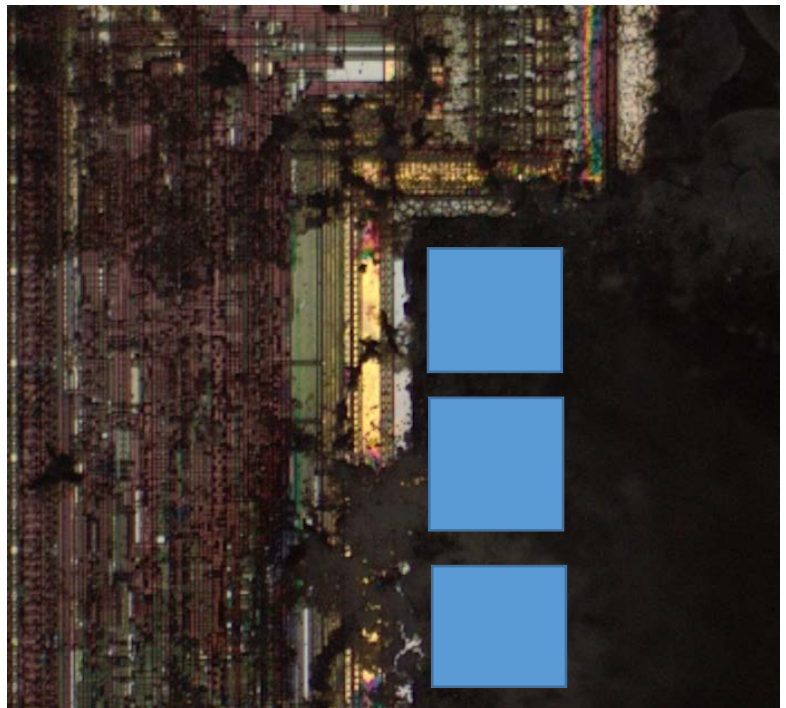
Sample A was de-lidded to determine if ground or Vcc bond wires were compromised. Once open, many bond wires were gone. Sample A was exposed to sufficient heat to reflow the frit that seals the ceramic DIP package halves together (>410°C). The frit has covered numerous bod pads preventing any connection to those signals. The blue squares represent the die bond pads that are covered with frit that reflowed. Attempts were made to remove the frit encroachment over the die to no avail. Lack of connection to die bond pads prevents the harvesting of data from this device. Other issues compromising die operation were also observed; missing top metal, cracks in the die, exposed barrier metal. This die is damaged too severely to allow data recovery for this device.

The two samples received were too severely damaged to facilitate read back of their NVM array contents. These devices experienced temperatures above 410°C to cause the ceramic device package frit to reflow. The spots of missing top metal (Al) are where the Aluminum vaporized and cracked the passivation due to pressure indicate exposures above 660°C. The mechanical damage and the heat damage to the die inside these two devices resulted in the devices being non-operational.

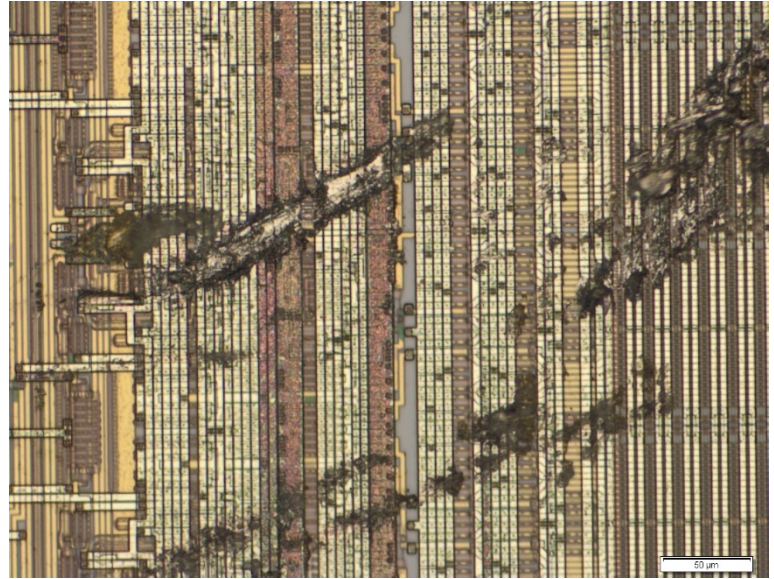
Sample B exhibited a large scratch through the passivation (barrier glass over die) that has cut more than 18 parallel distribution circuits to the NVM array. This scratch is too severe to allow FIB (focused ion beam) repair of the 18 signals in question. There are other issues compromising die operation; frit encroachment over die bond pads from excessive heat, missing top metal, cracks in the die, exposed barrier metal. This die is damaged too severely to allow data recovery for this device.
