NATIONAL TRANSPORTATION SAFETY BOARD
Vehicle Recorder Division
Washington, D.C. 20594

Digital Electronic Engine Controls

Specialist's Factual Report
By Bill Tuccio, Ph.D.

Location: Teterboro, New Jersey
Date: May 15, 2017
Aircraft: Gates Learjet 35A
Registration: N452DA
Operator: Trans-Pacific Air Charter LLC dba Trans-Pacific Jets
NTSB Number: CEN17MA183

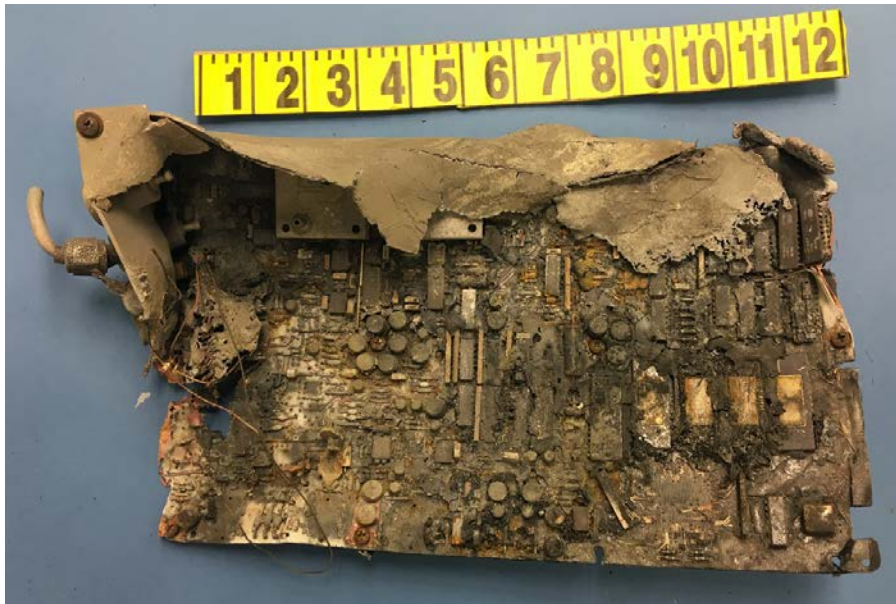
Upon arrival at the Vehicle Recorder Laboratory, an examination revealed the units had sustained significant impact, heat, and water damage. It was not possible to determine which engine was associated with which DEEC; therefore, the units were marked “A” and “B”. Figures 1 and 2 show units A and B, as received. Figure 3 shows DEEC B after the metal cover was removed. Figures 4 and 5 show the identification of the DEEC A and B NVM chips, respectively.

Figure 1. DEEC A, as received.

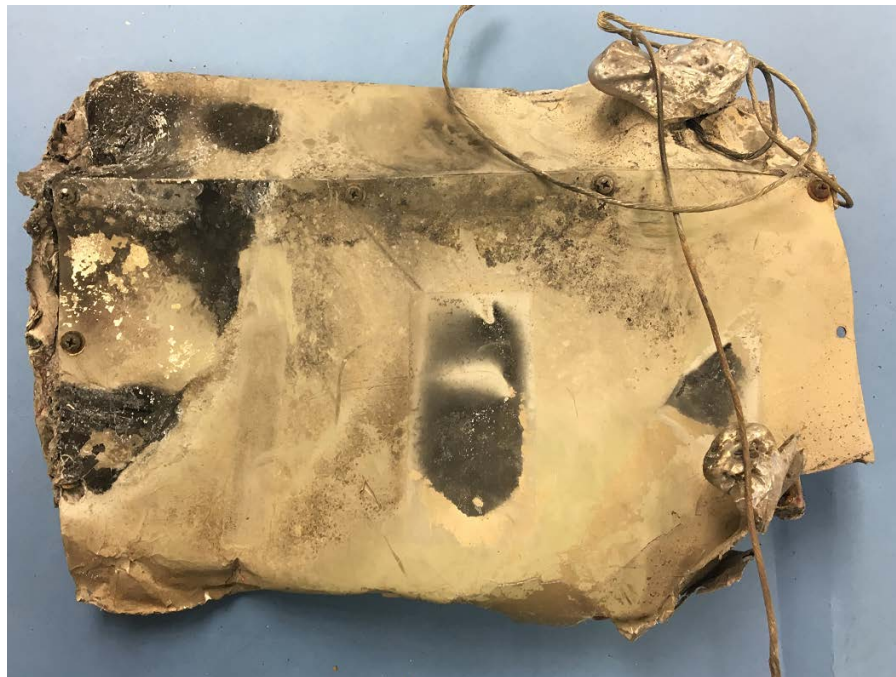
Figure 2. DEEC B, as received.

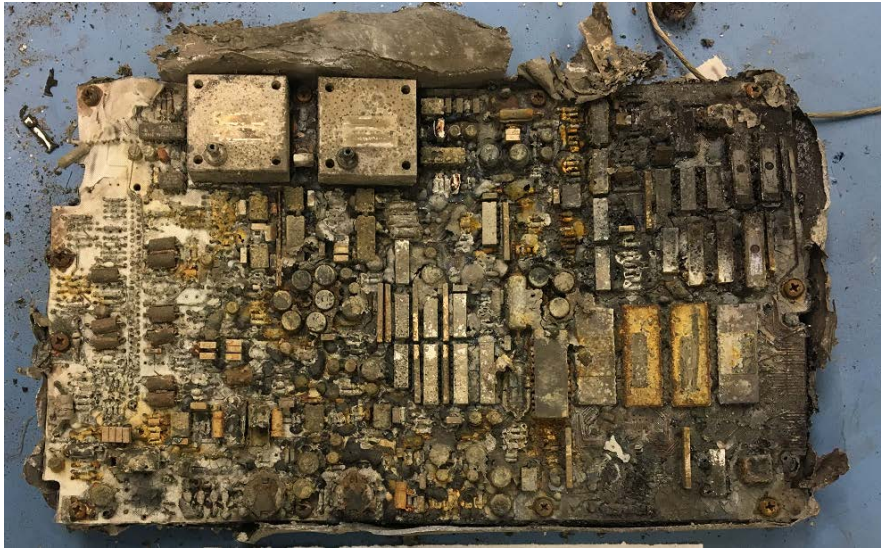
Figure 3. DEEC B, after metal cover removed.

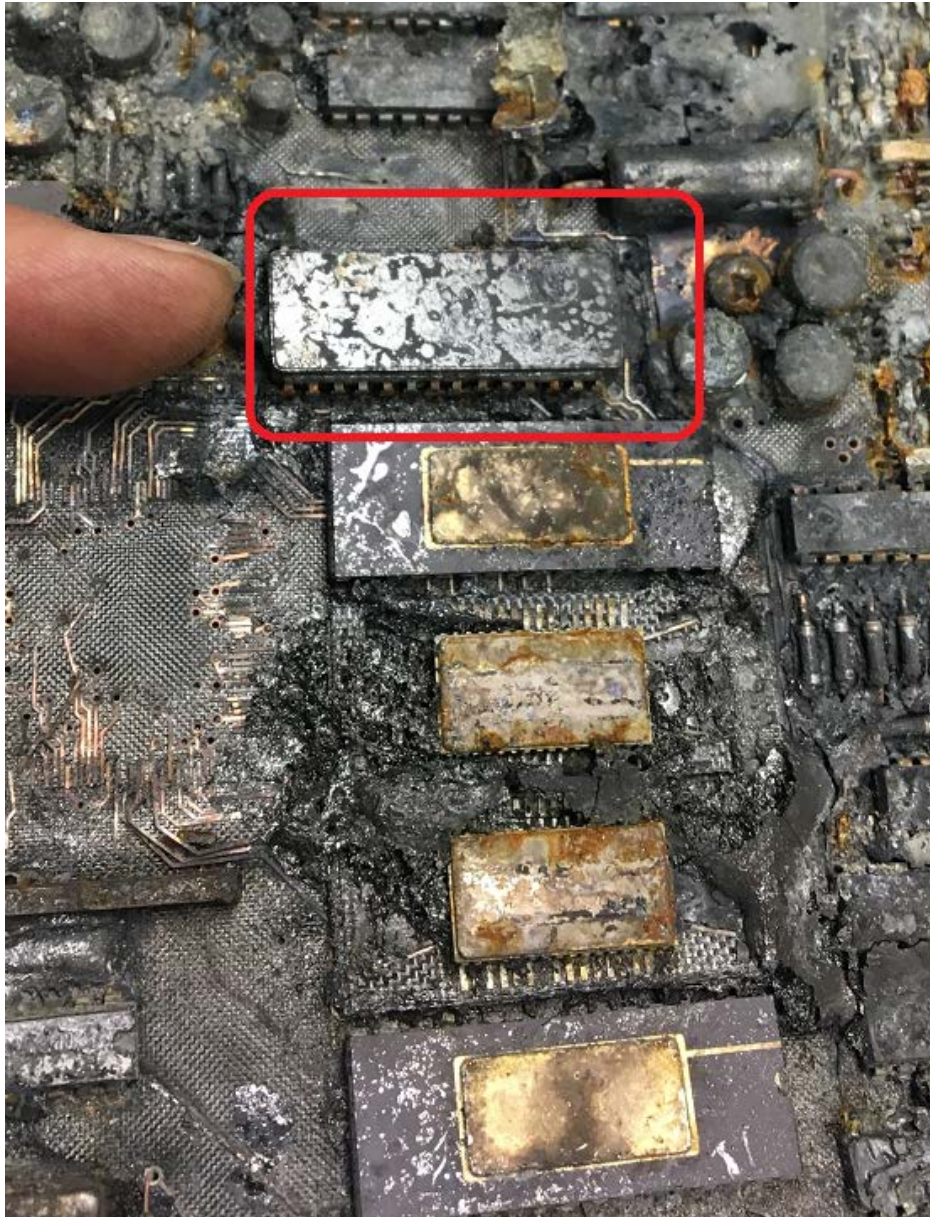
Figure 4. DEEC A NVM chip.

The extent of the damage destroyed any electronic artifacts in the NVM. Therefore, no data recovery was possible.

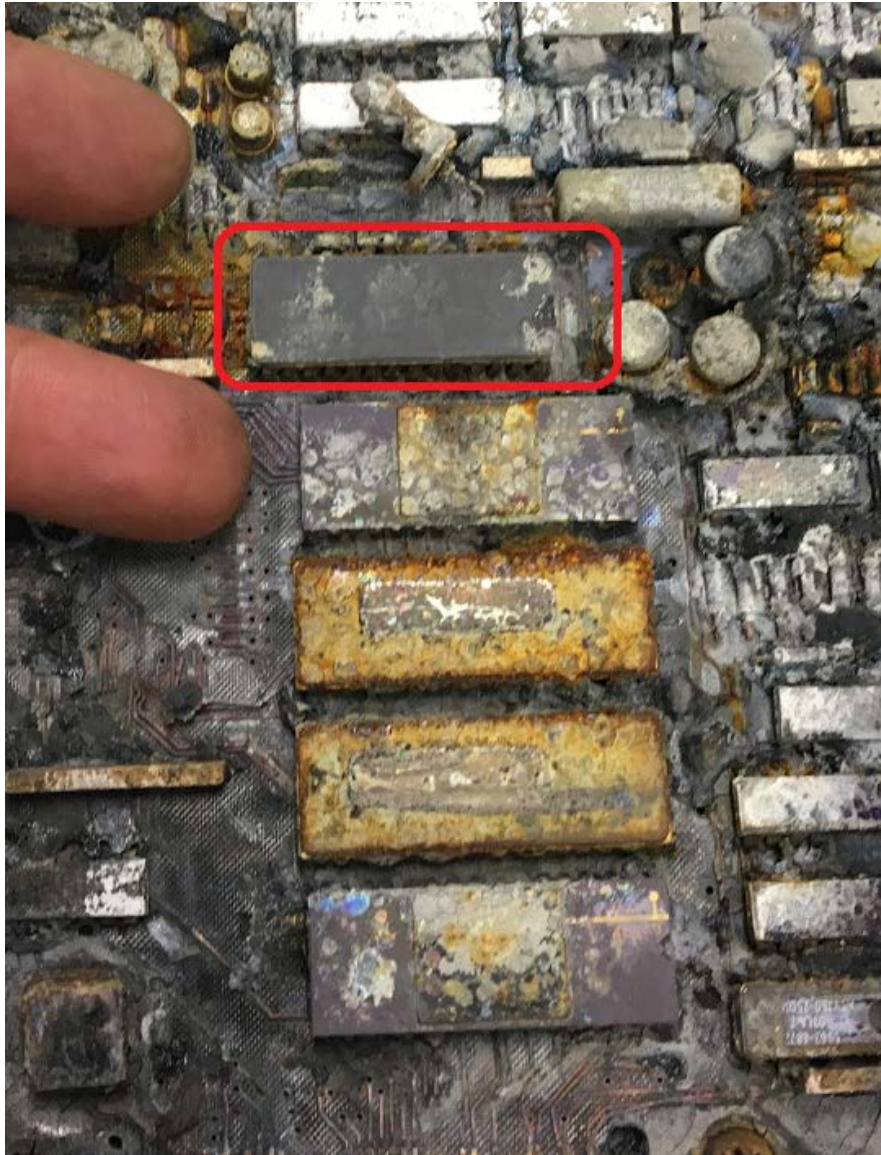
Figure 5. DEEC B NVM chip.
