NATIONAL TRANSPORTATION SAFETY BOARD

Digital Engine Control Unit (DECU)

Specialist's Factual Report
By Sean Payne

Location: Frisco, Colorado
Date: July 3, 2015
Aircraft: Airbus Helicopter AS 350 B3E
Registration: N390LG
Operator: Air Methods Corporation
NTSB Number: CEN15MA290

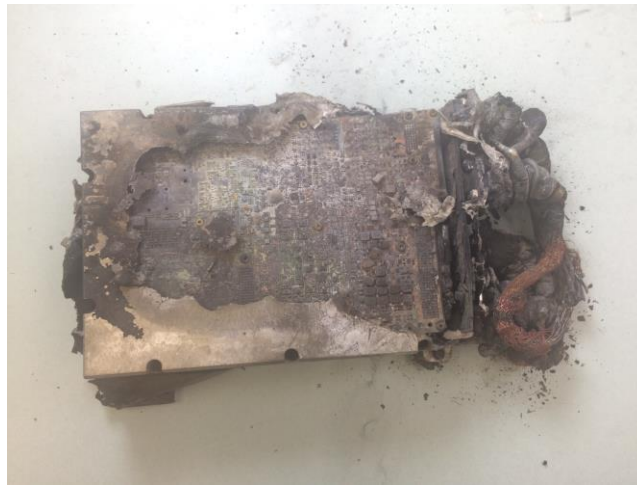
Upon arrival at the Vehicle Recorder Laboratory, an examination revealed the unit had sustained significant thermal and impact damage. Figure 1 shows the DECU as received by the laboratory. Figure 2 shows the device after its casing was opened using a rotary cutoff wheel. The unit's two sets of boards were removed from the device and

Figure 1. The DECU as received by the laboratory.

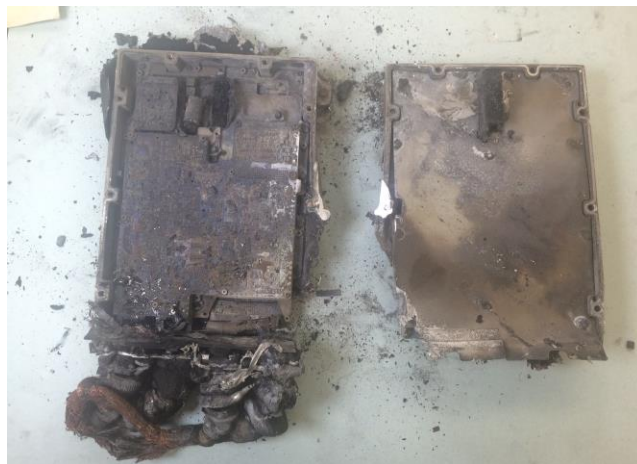
Figure 2. The DECU after its external housing was carefully opened with a cutoff wheel.

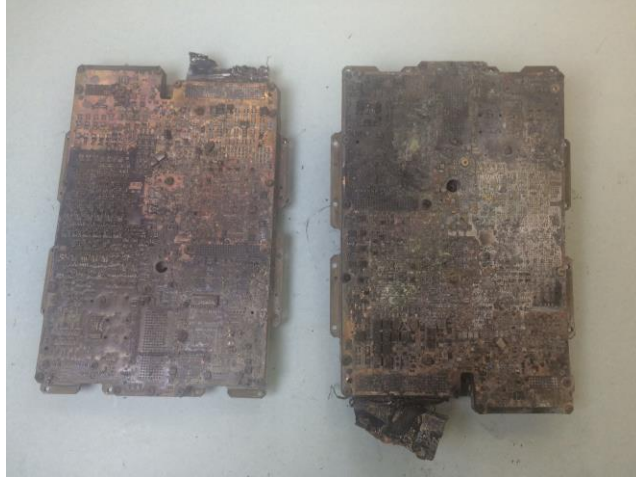
photographed. Figure 3 shows the one side of the circuit board sets and figure 4 shows the reverse side. High temperature thermal damage was extensive throughout the device and many electronic chips had shed off their solder locations on their respective boards.

Figure 3. Face one of the internal circuitry boards as removed from the device.

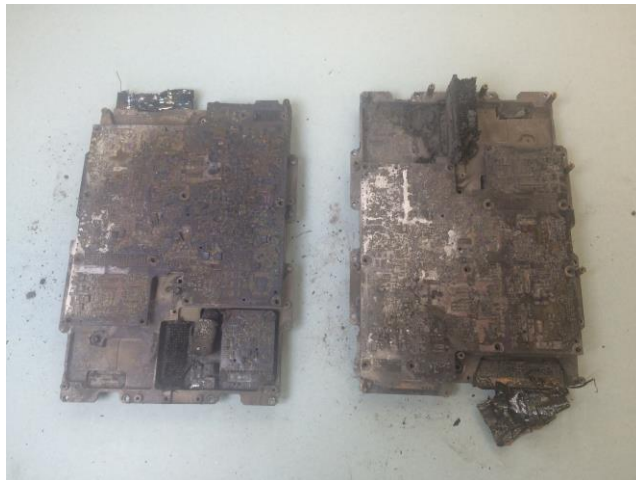
Figure 4. Face two of the internal circuitry boards as removed from the device.

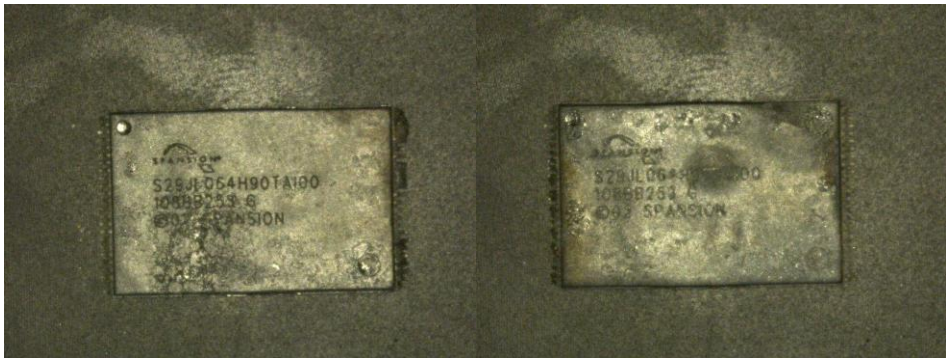
Discussion with the manufacturer led to the identification of a number of non-volatile memory chips potentially containing electronic records. The chips were identified as “MN30” from each set of boards (Figure 5) as well as “MN75” and “MN76” (figure 6) from the same boards.

Figure 5. "MN30" chips identified and extracted from their respective board sets.

One “MN30” chip exhibited potentially zero internal damage; however, the chip contained significant damage to the lead frame structure. The damage was attempted to be corrected in the laboratory, but upon a readout attempt, the chip failed to produce successful readout results.

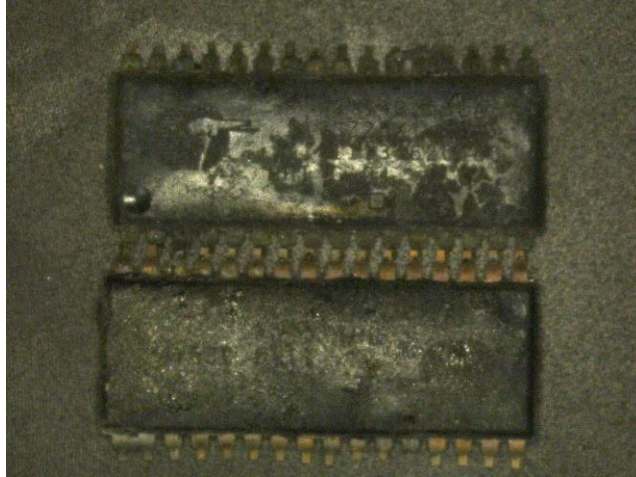
Figure 6. Chips “MN75” and “MN76” as found in the DECU debris packaging.
